WMWI – METRO LANDFILL

PROJEC	CT NO. 1036.100)56		CITY OF FRA	NKLIN				
DAT	E March 15, 20	024					TIME	1:01 PM	
	Auditor on sit	te at:	Open		Close				
PREVIO	US DATE:	Februa	ary 27, 202	4	Comple	ted [
\^/E ^ TLIE	D Olasa aldaa aad						MAND	West 0 to 5	
VVLAIIIL	R Clear skies and	sunny, very	/ ary				WIND	N S	E W
TEMP	Maximum	52	°F I	Minimum -	38	°F	B.P.	30:15	
MAJOR	EQUIPMENT US	ED IN LAN	IDFILL OP	erations					
No.	DESCRIPTION		Rented	Contracted	No.	DESCRIP	TION	Rented	Contracted
1	Trailer Tip	pper							
2	Compa	ctor							
1	Doze	er							
	Excava	ator							
	Haul Tri	uck							
	Water T	ruck							
MAJOR E	 Quipment boney	'ARD							
No.	DESCRIPTION		Broken	Maintenance	No.	DESCRIP	TION	Broken	Maintenanc
1	Compa	ctor	1						
Working	g Face Size and	d Location	า:						
Two we	orking faces								
	in fluff layer taking	select fill							
	in Phase 2b taking		s and waste	e unaccentable t	or fluff				
		, 9							
						7	CY	ENVIDO	VMENTAL

WMWI - Metro Landfill, AUDIT PHOTOS

PROJECT NO. 1036.10056

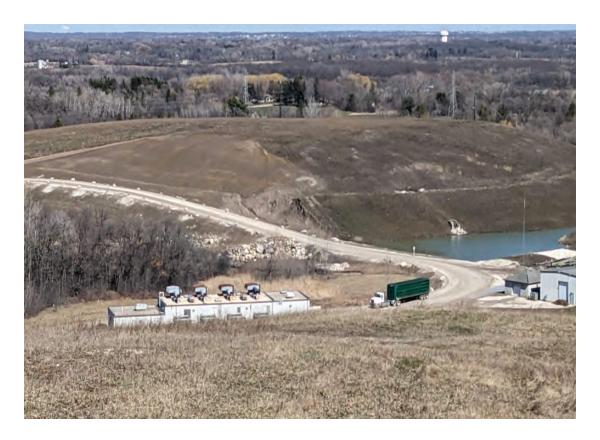
Long access road run from scale house, past gas plant to stockpile before reaching North Expansion West

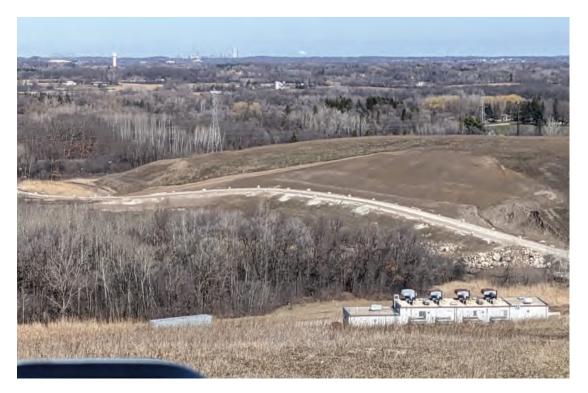
Stock pile and access road to North Expasnsion West

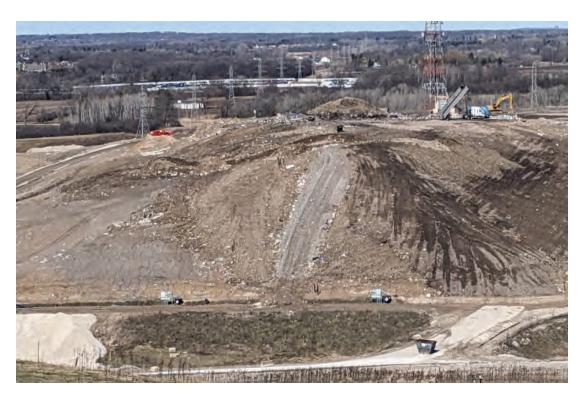
North Expnsion West well covered; new cover being improved on East side

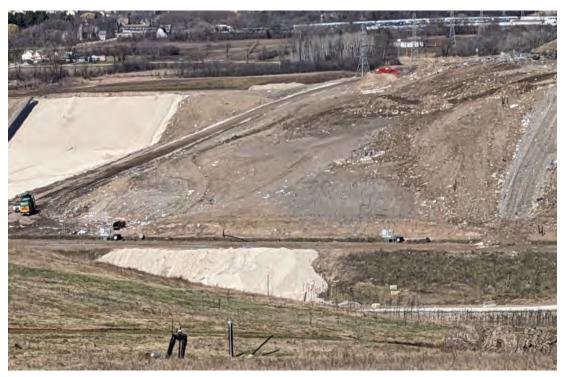
South slope of North Expansion West, fully coveredf in intermediate cover

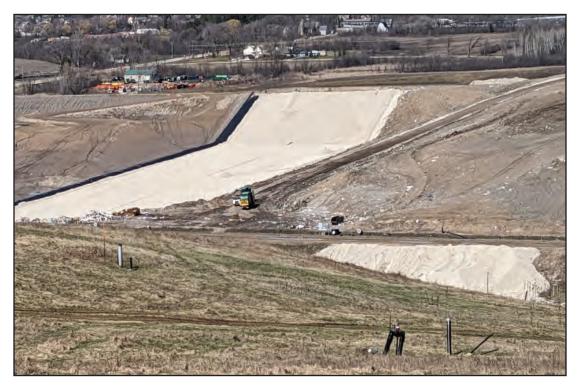
Transition into Phase 3; North Expansion West

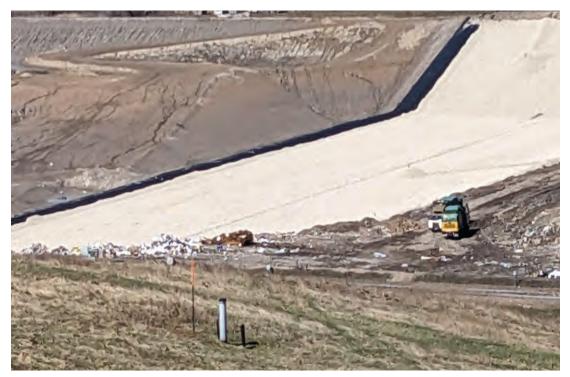
New cell receiving the start of the fluff layer

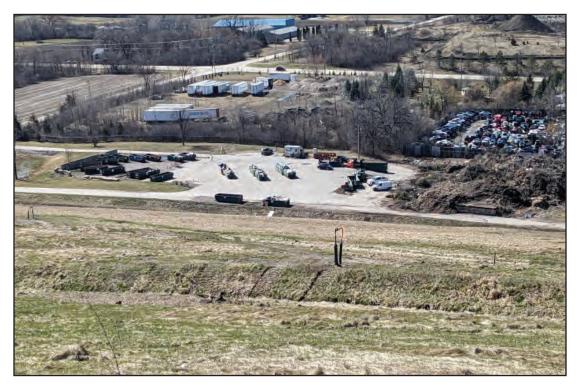
Resi-dfop-off clean and boxes mostly empty
