WMWI - Metro Landfill, *AUDIT PHOTOS*

PROJECT NO. 1036.10056

WMWI - METRO LANDFILL
Action Items Checklist
City of Franklin Audit

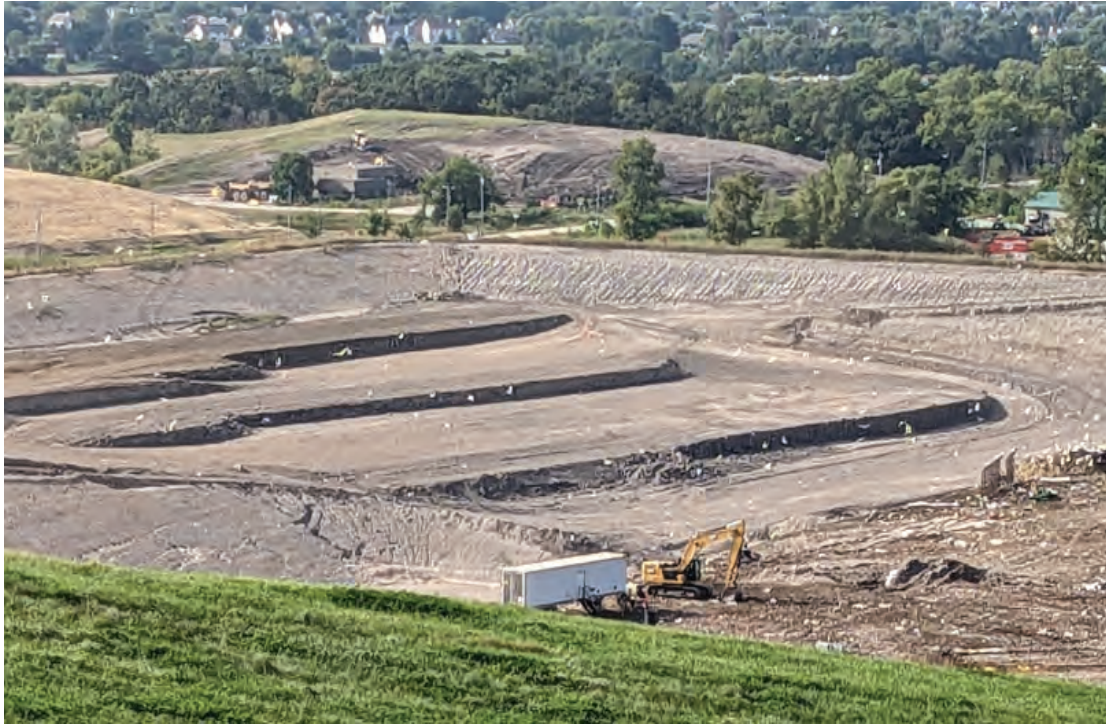
Future cell excavation

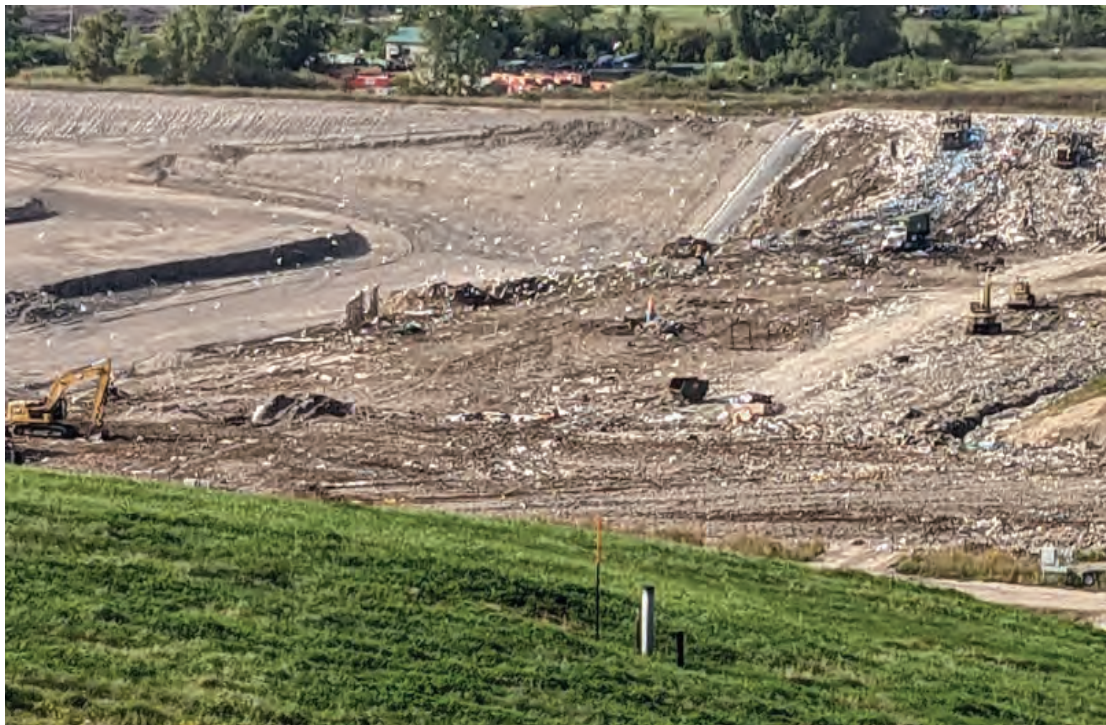
Future cell location

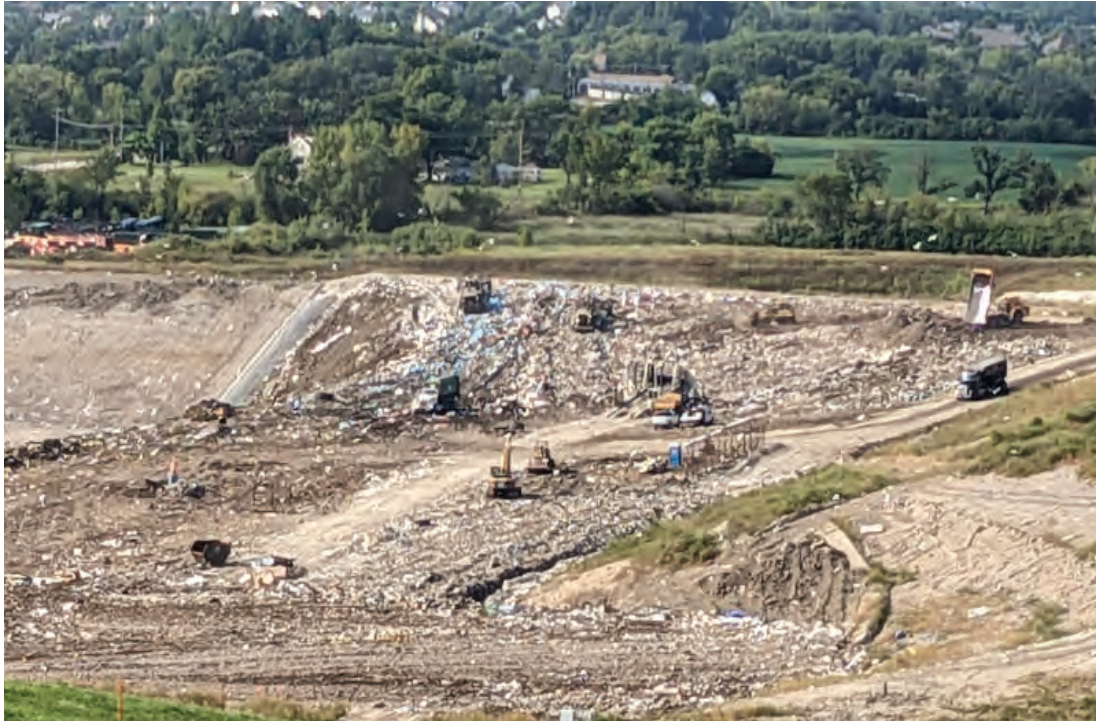
Current cover of Phase 3

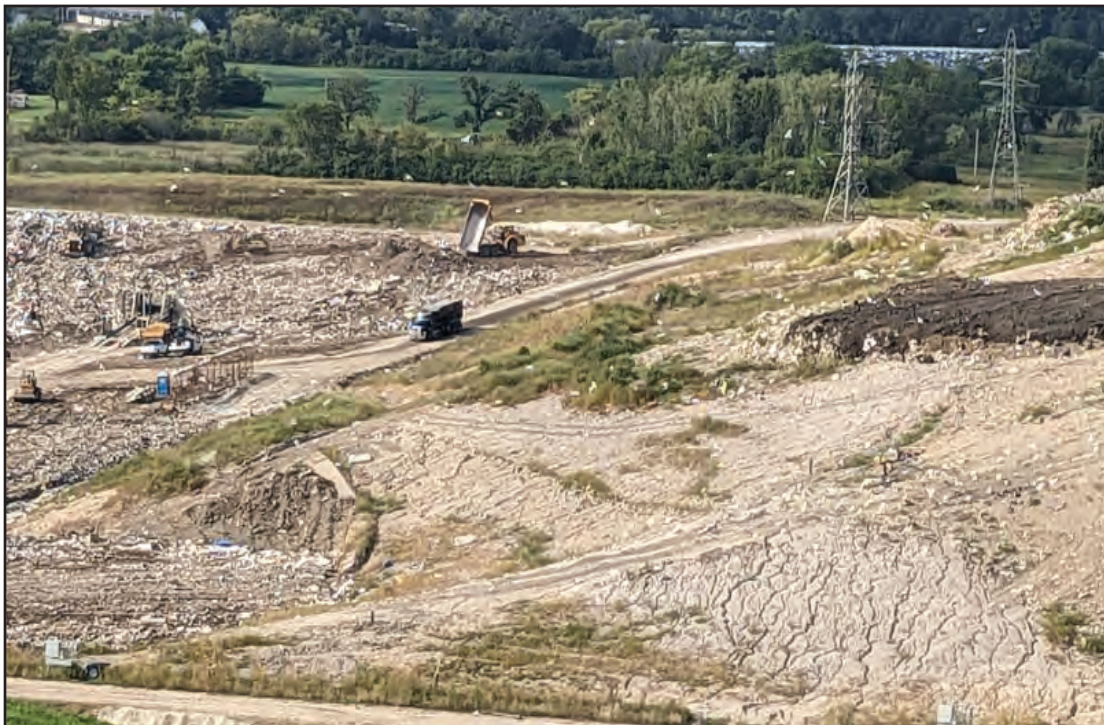
Working face at North end of Phase, being covered

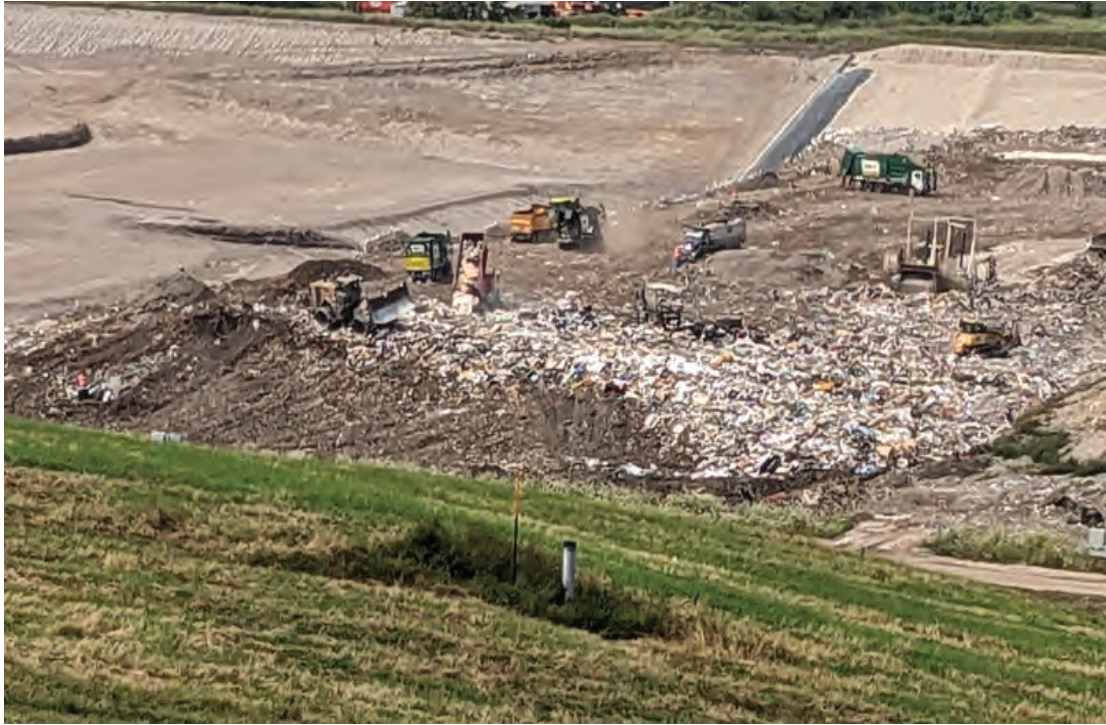
Delivery of cover to Phase 3

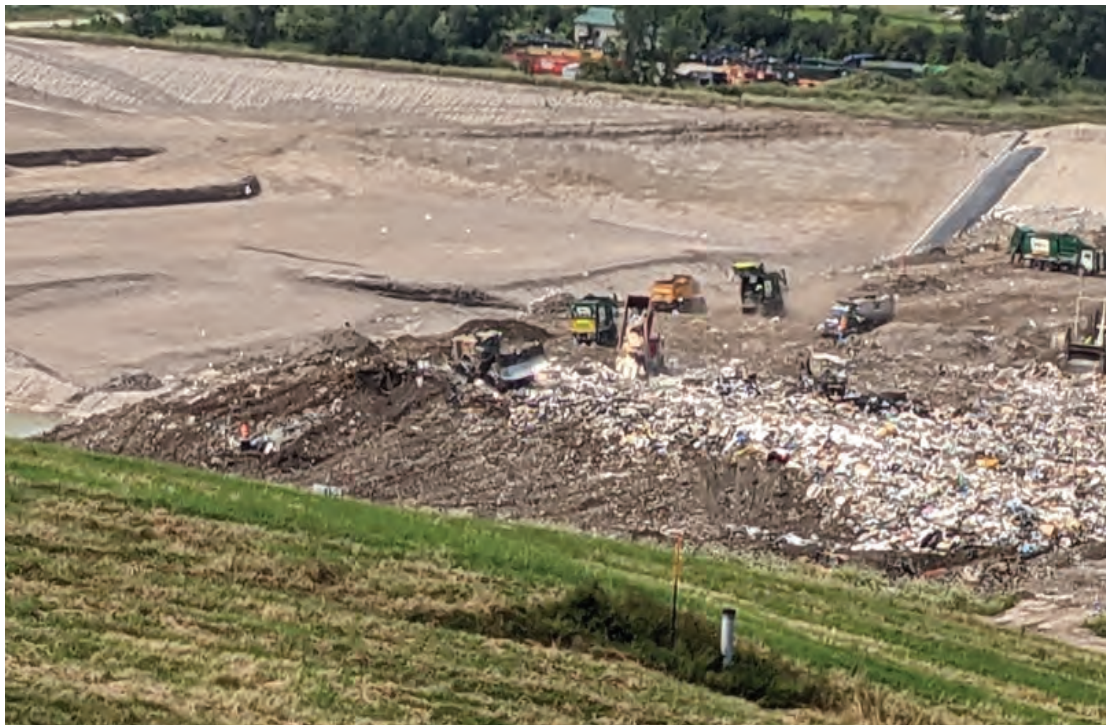
Tipper outside of working face in Phase 3

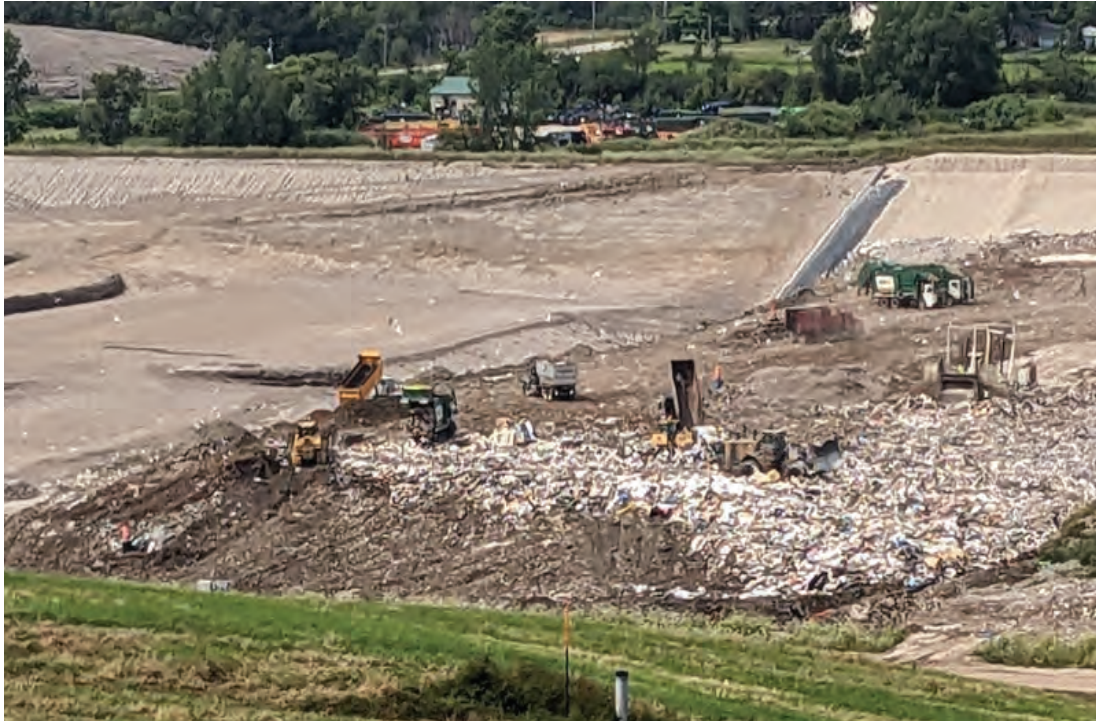
Dozer starting cover at Southwest corner of Phase 3

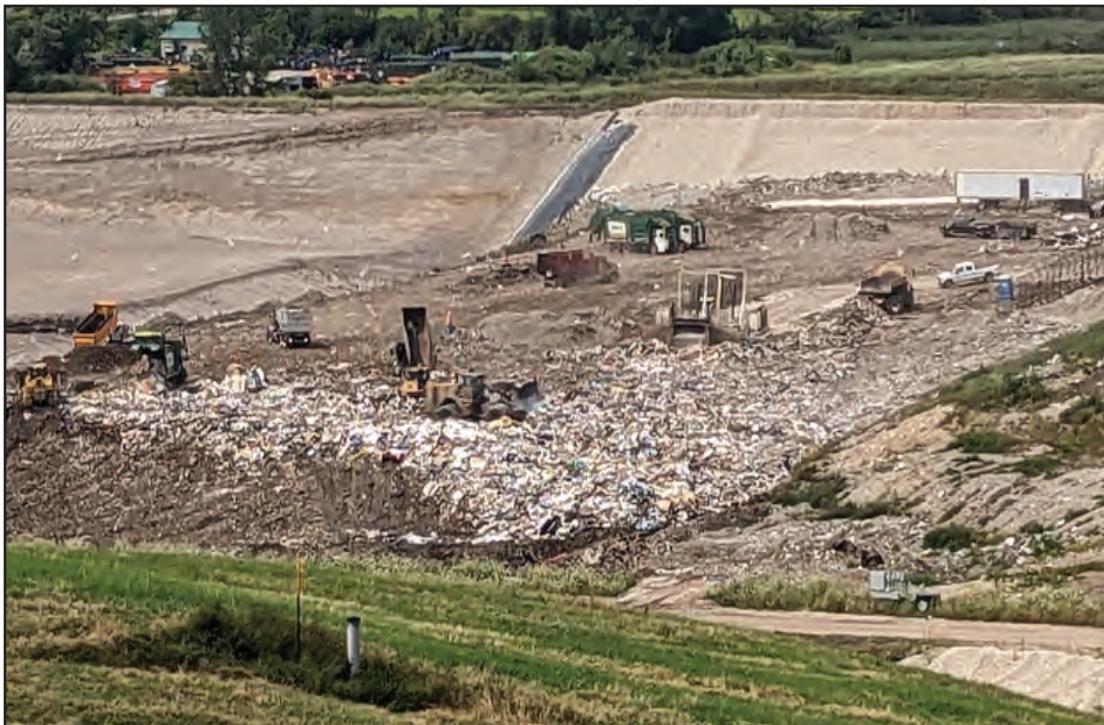
Working face with cover prepared on South edge

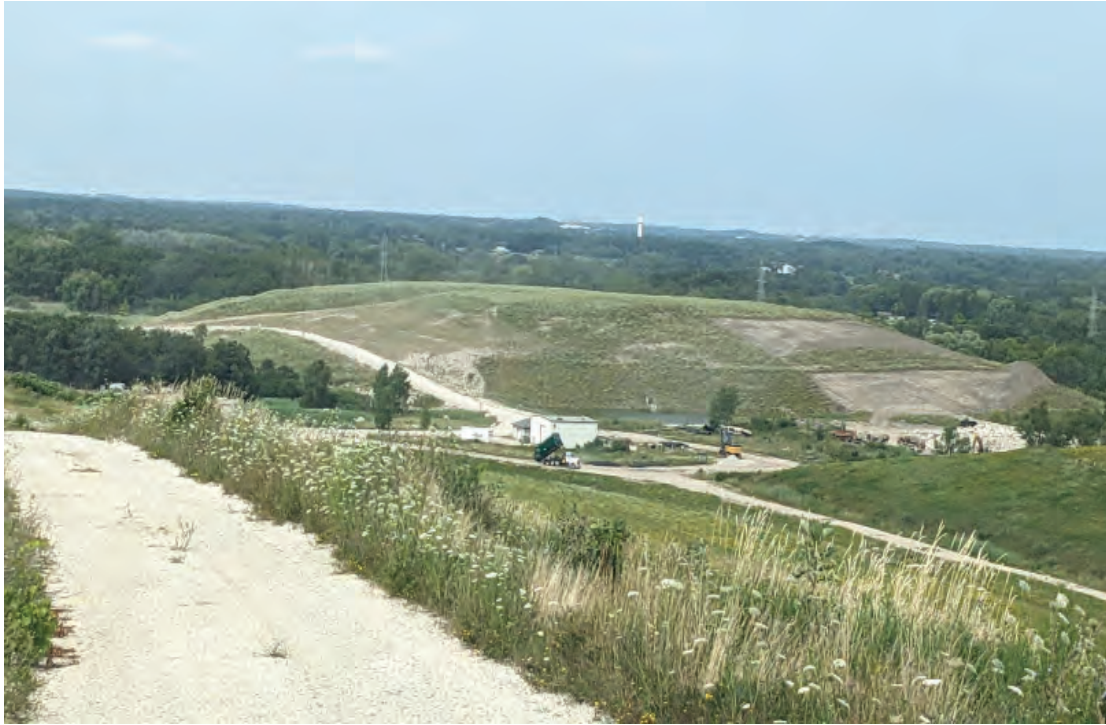
"L" shaped working face in Southeast corner of Phase 3

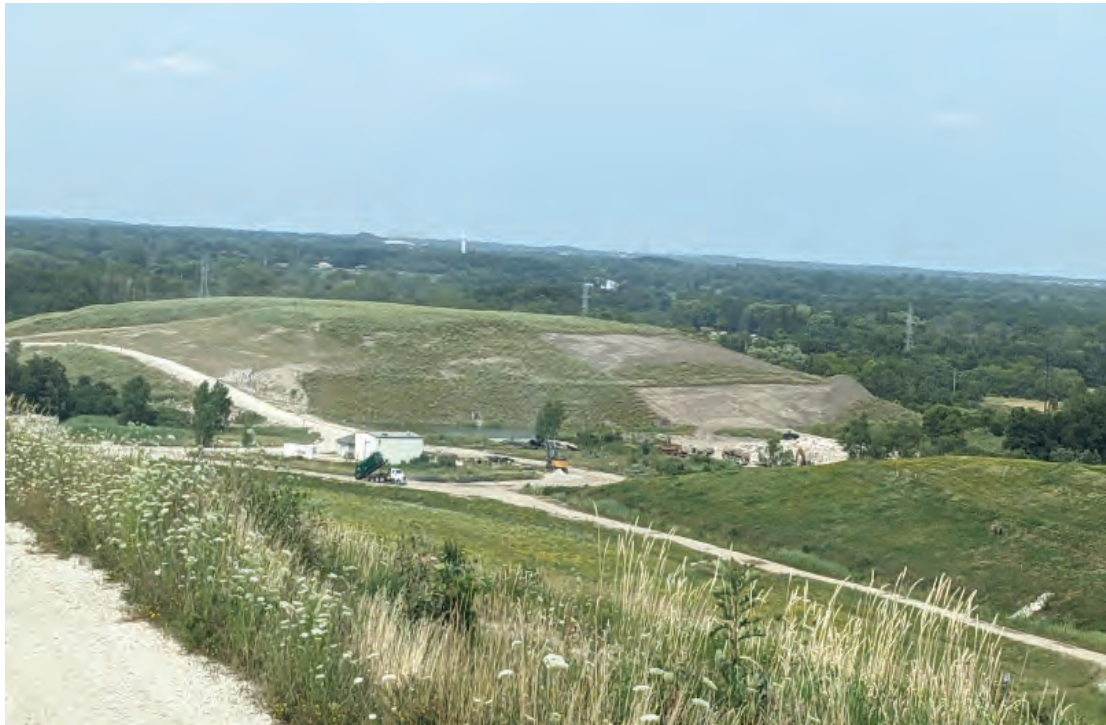
Stockpile reshaped and seeded after minor use

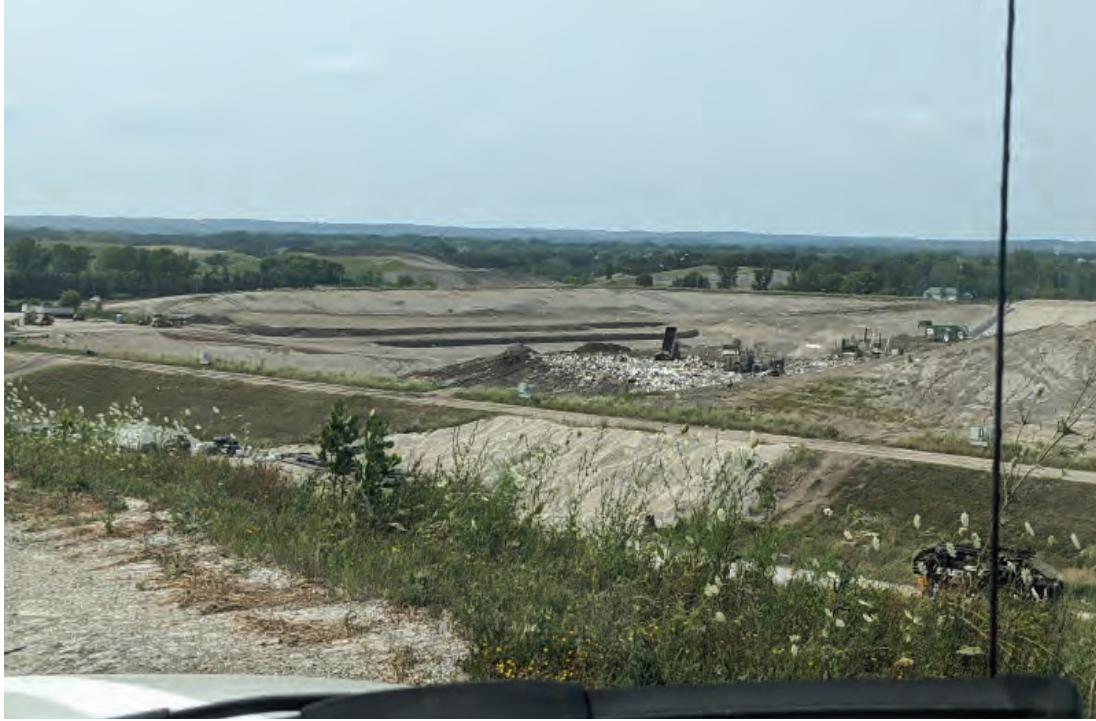
Stockpile revegetating

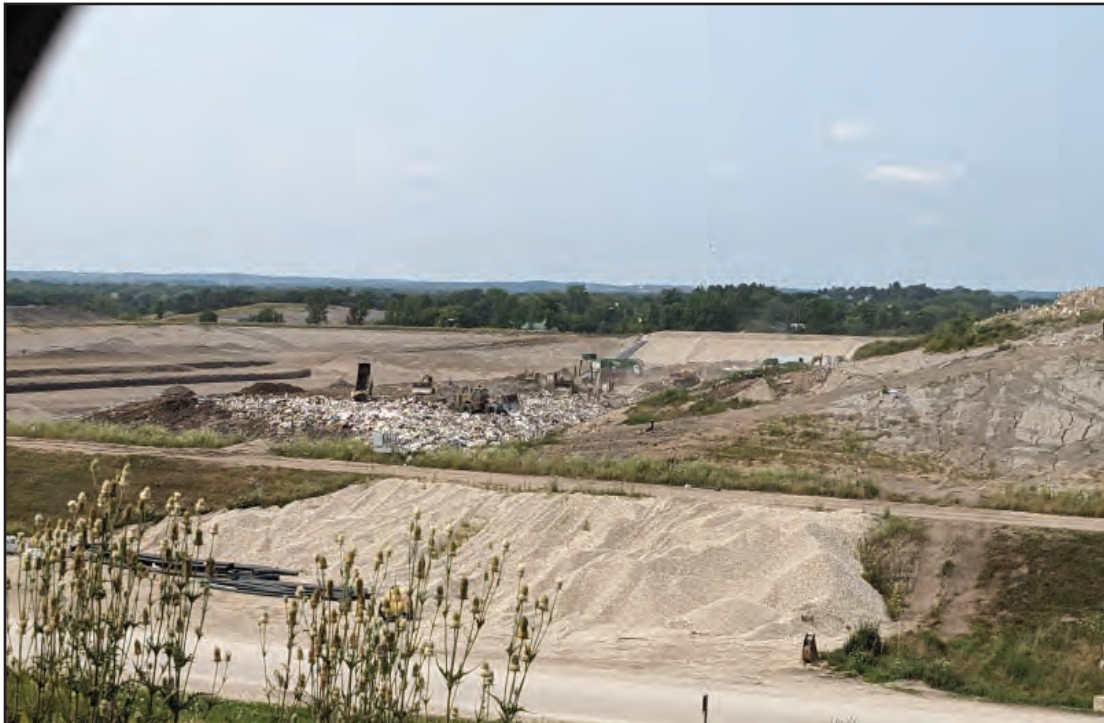
Terraced excavation of future cell
