WMWI - Metro Landfill, AUDIT PHOTOS

PROJECT NO. 1036.10056

AUDIT PHOTOS - 1

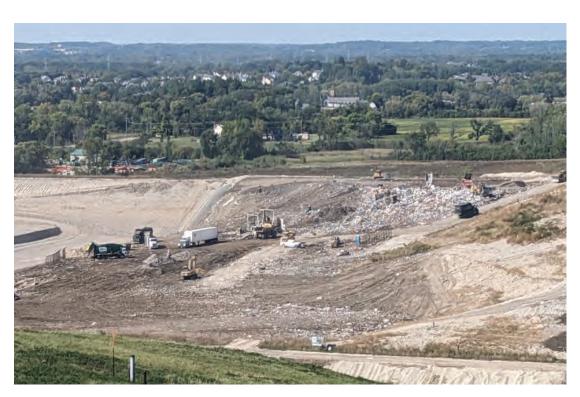
Future cell excavation

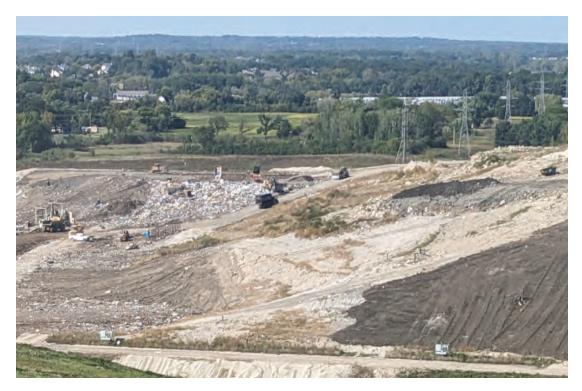
Phase 3 receiving waste

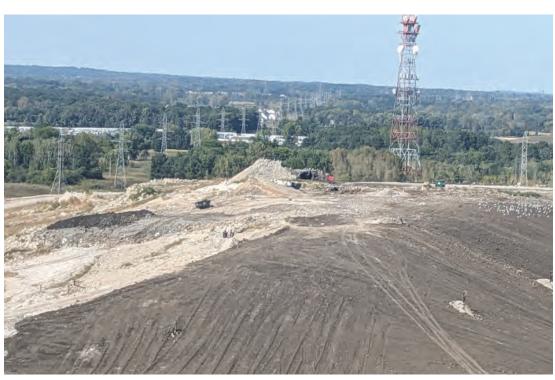
Phases 2 & 3 viewed from the South

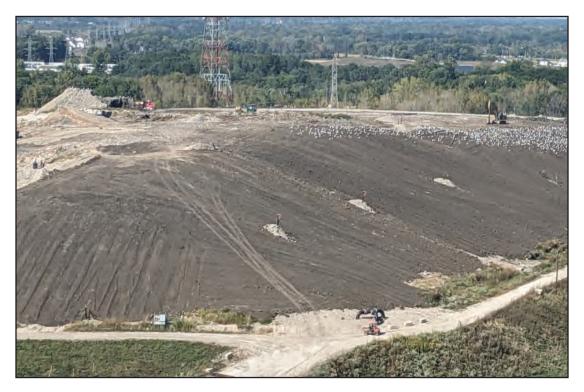
Working face at North end of Phase, being covered

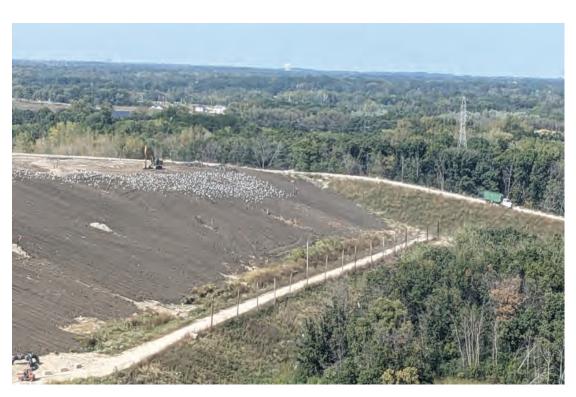
Phase 1 & portion of 2 with top soil cover to grow vegetation, reduce erosion and dust

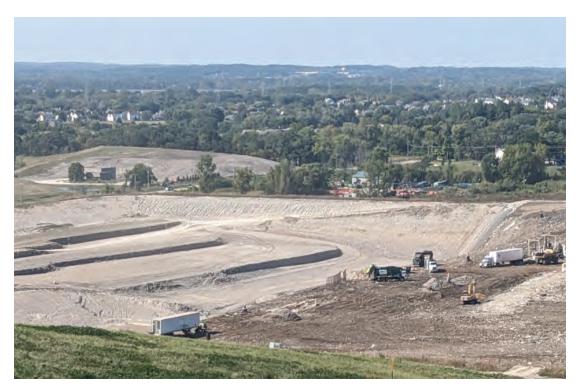
East slope of Phase 1 top soil cover for vegetation growth

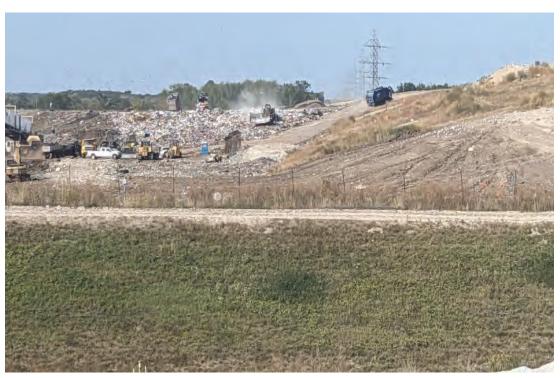
Previous lift across Phase 3 and future cell location

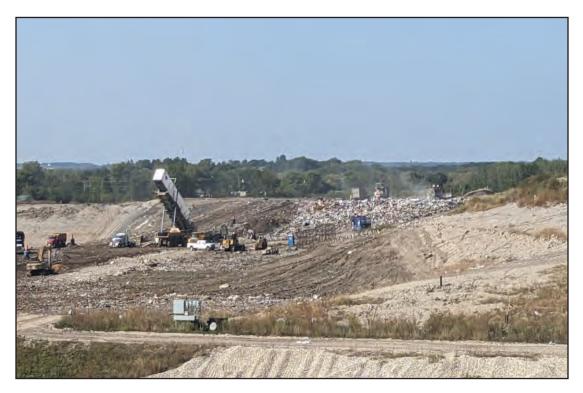
Working face at North end of Phase 3, waste mass nearly cresting
