WMWI - Metro Landfill, AUDIT PHOTOS

PROJECT NO. 1036.10056

AUDIT PHOTOS - 1

WMWI - METRO LANDFILL Action Items Checklist City of Franklin Audit												
Opened:	Opened: Updated: 01/11/2024											
Item Number	DATE	Condition Description	Permit or Contract Reference	Reported to	Initial Schedule for Completion	Actual Completion Date	Elapsed Time (Days)	Notes				
1

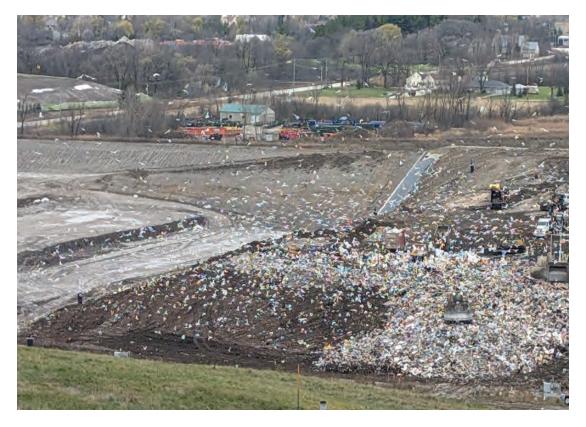
Working face at South end of Phase 3 for most of the month finishing previous and starting new lift. Shaping slopes and corners

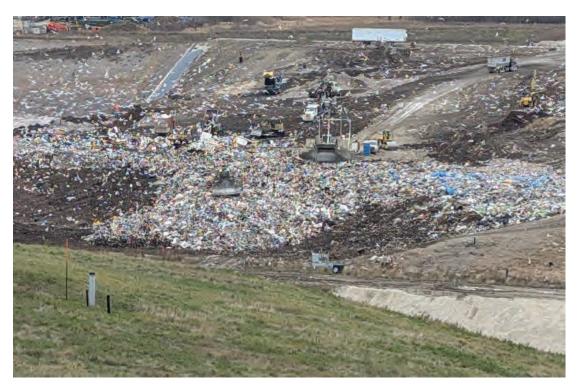
Working face at South end of Phase 3 for most of the month finishing previous and starting new lift. Shaping slopes and corners

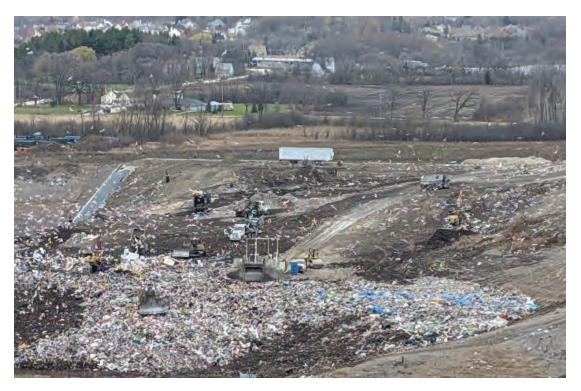
Working face at South end of Phase 3 for most of the month finishing previous and starting new lift. Shaping slopes and corners

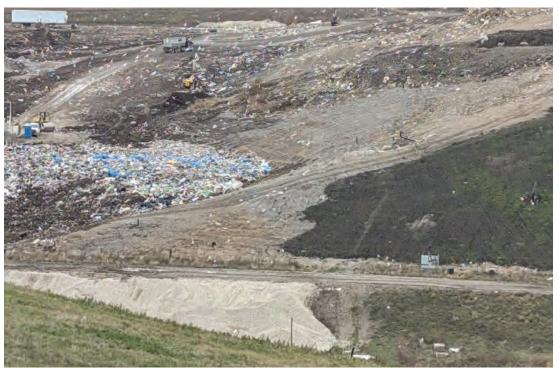
Working face overlaying from Phase 3 into Phase 2 South end

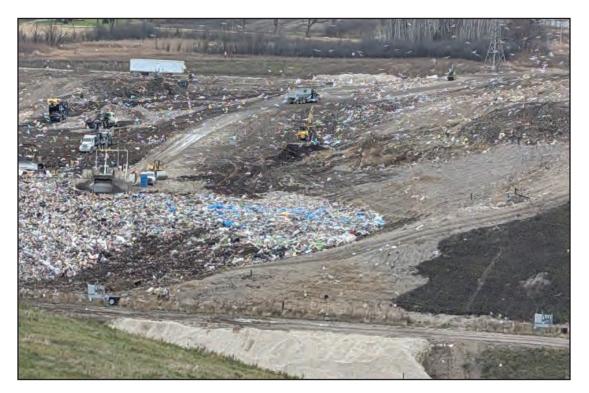
Working face at South end of Phase 3 for most of the month finishing previous and starting new lift. Shaping slopes and corners

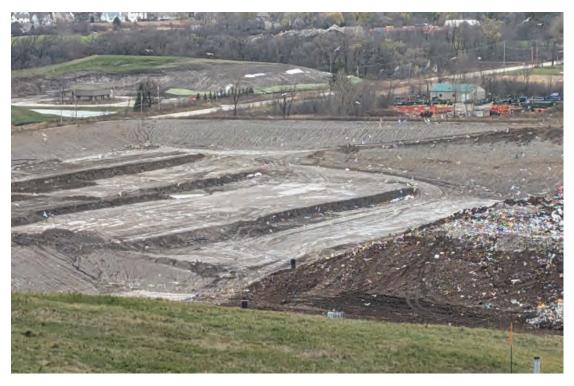
Future cell and covered Southwest corner of Phase 3

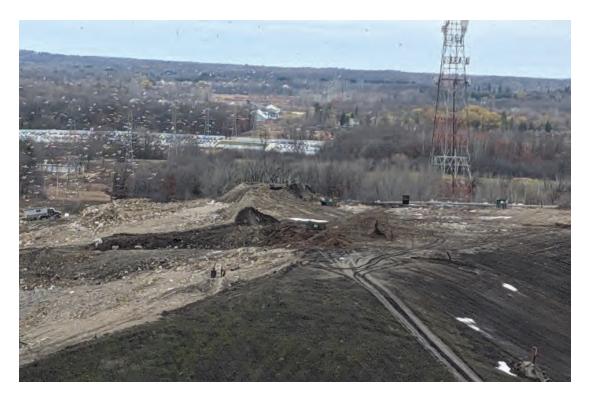
Stockpile soil cover being harvested by excavators and dozers

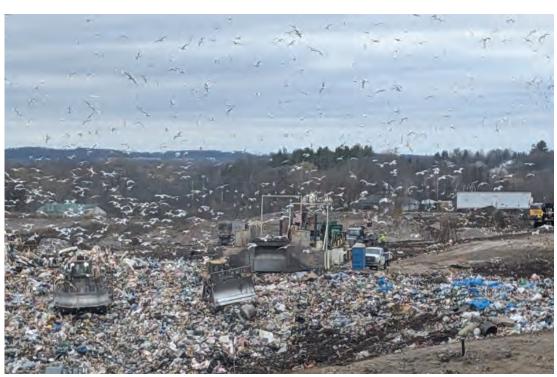
Working face at South end of Phase 3 for most of the month finishing previous and starting new lift. Shaping slopes and corners
