WMWI - Metro Landfill, AUDIT PHOTOS

PROJECT NO. 1036.10056

AUDIT PHOTOS - 1

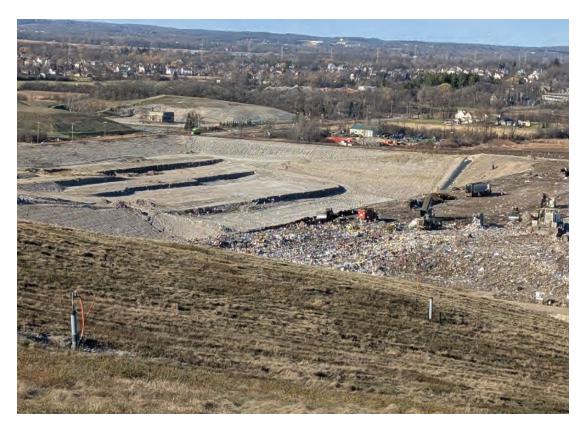
Future cell and current cell 3 in operation

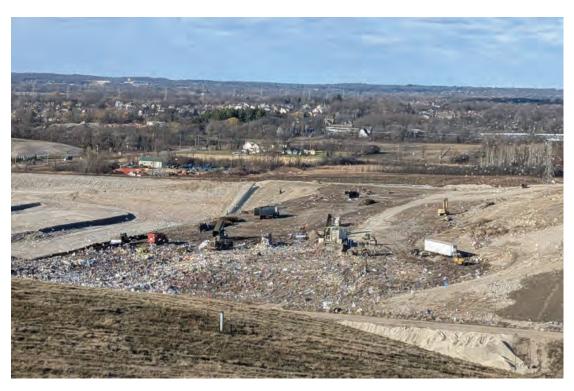
Working face at South end of Phase 3, filling out cell boundaries

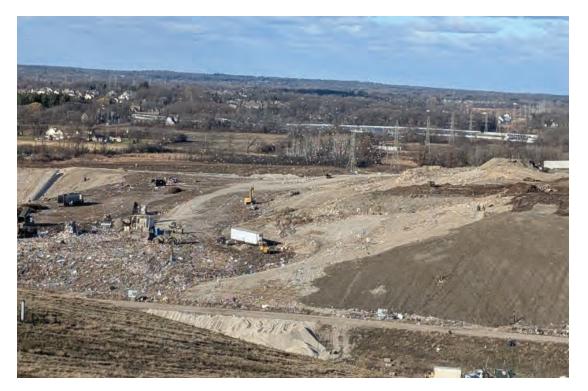
Top soil placement on slopes of North Expansion West, vegetation slow to cover; adjacent to working face

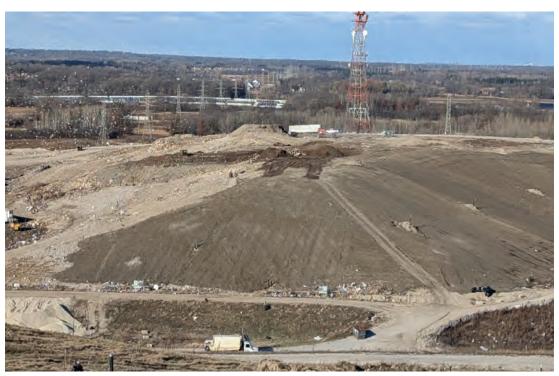
Top soil placement on slopes of North Expansion West, vegetation slow to cover

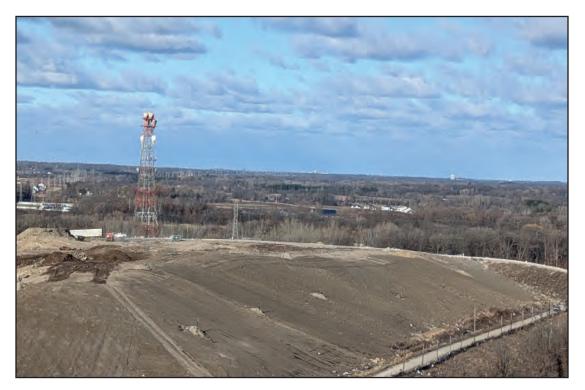
Top soil placement on slopes of North Expansion West, vegetation slow to cover

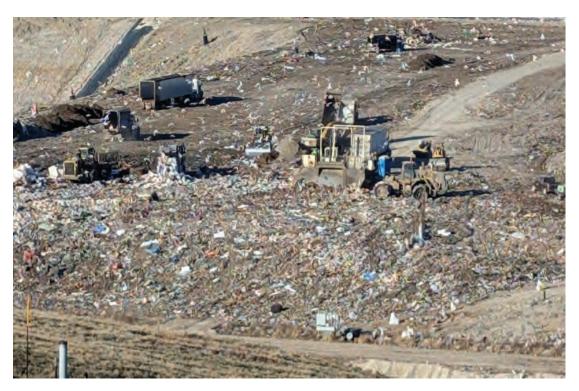
Tipper at very South end of Phase 3

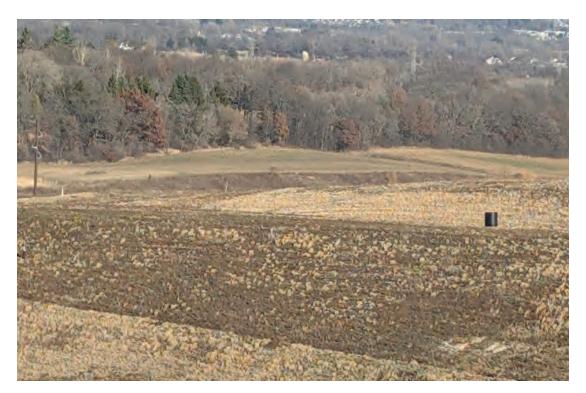
Typical cover condition of Clearwater pond

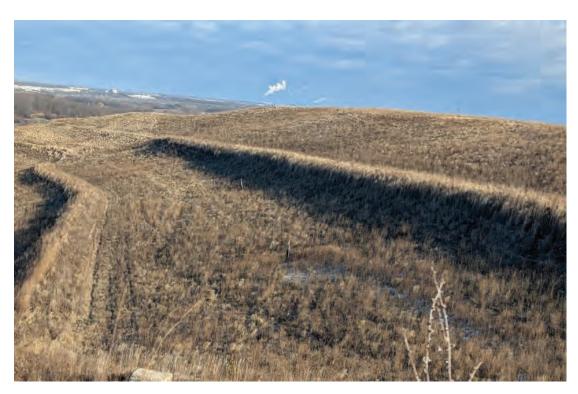
Typical cap condition on Phase 6 & 7

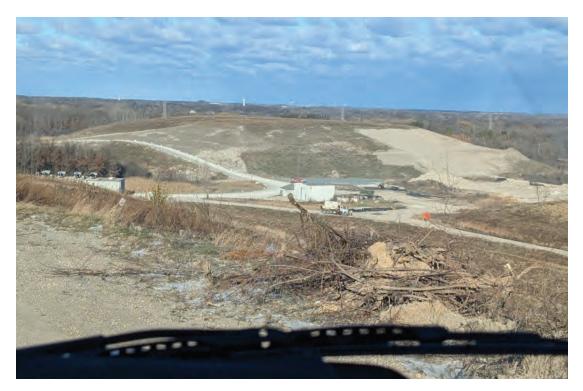
Soil stockpile mostly vegetated for the winter
