2020 Year End Summary of Audits of the Emerald Park Landfill

Prepared For:
City of Muskego
Green For Life Emerald Park Landfill Standing Committee

2020 Green For Life Emerald Park Landfill Year End Compliance Officer Report and Audit Summary

TO: Advanced Disposal Services Emerald Park Standing Committee
FROM: Jo-Walter Spear, Jr., P.E.
COPIES: File
DATE: 03/29/2021
PROJECT NUMBER: 1012.10030

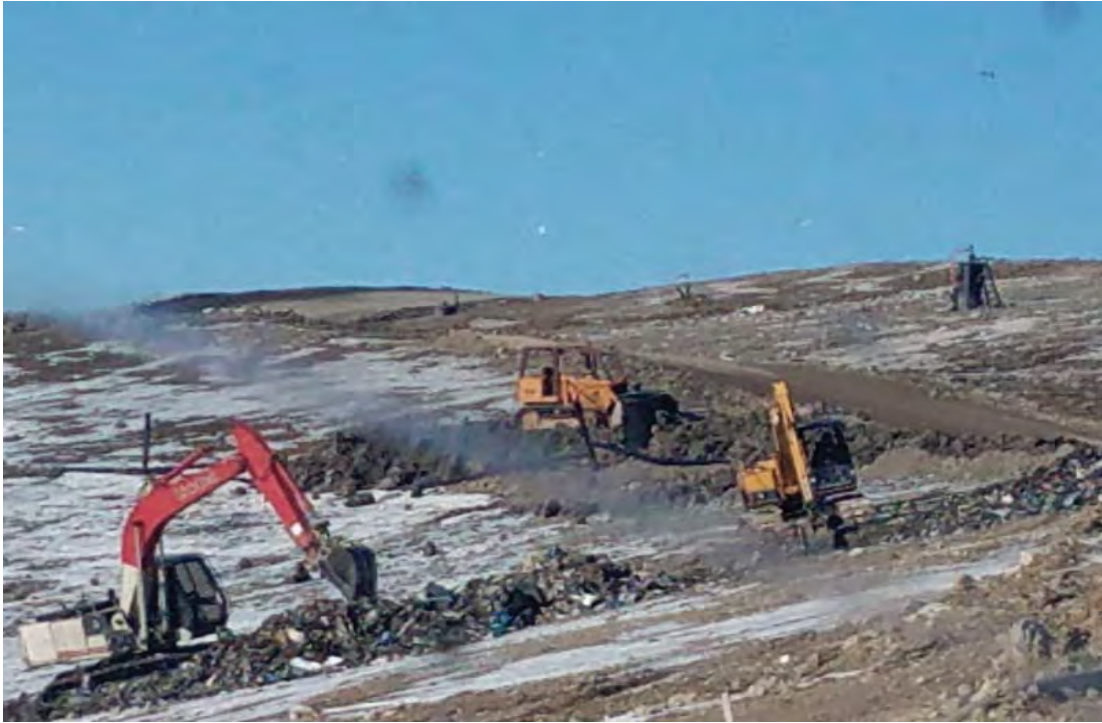
Seep repair and horizontal gas extraction trench construction on West slope of Phase 7; West of access road

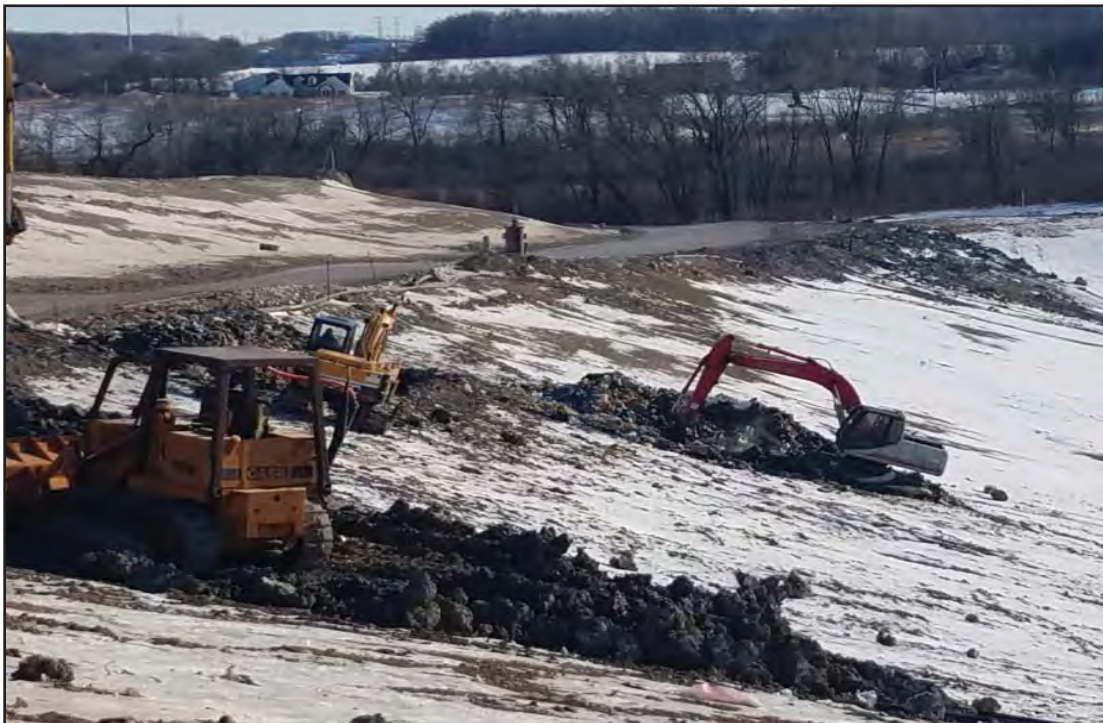
Seep repair and horizontal gas extraction trench construction on West slope of Phase 7; West of access road

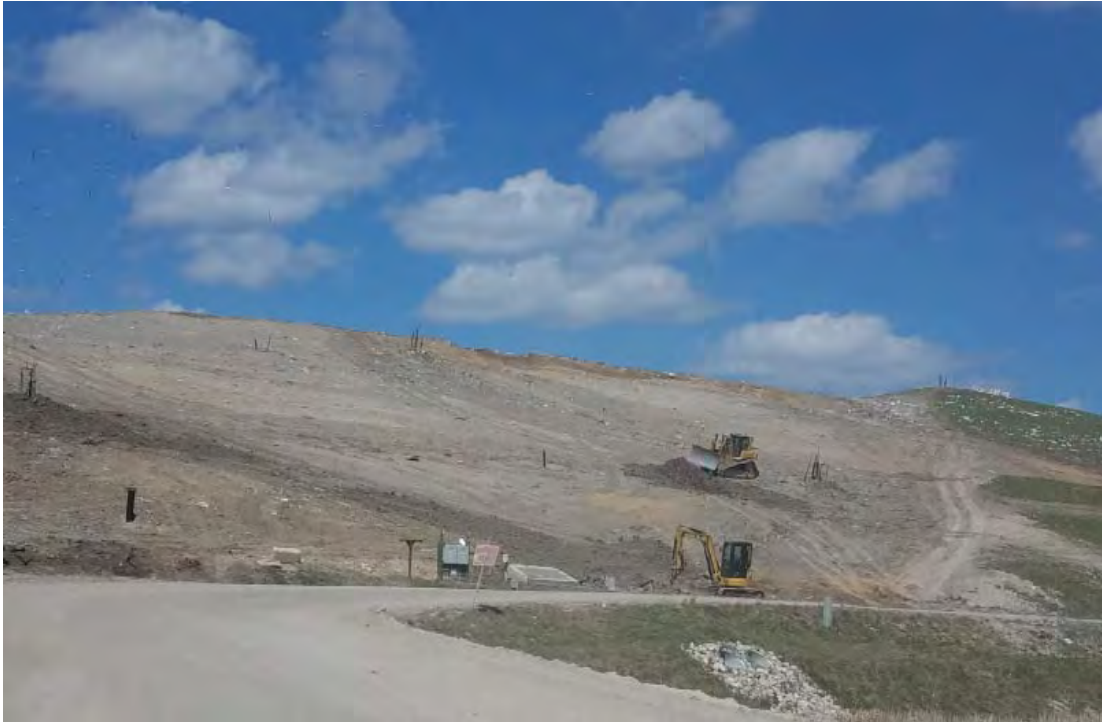
South slope of Phase 7 South, contractor repairing slope after trenching

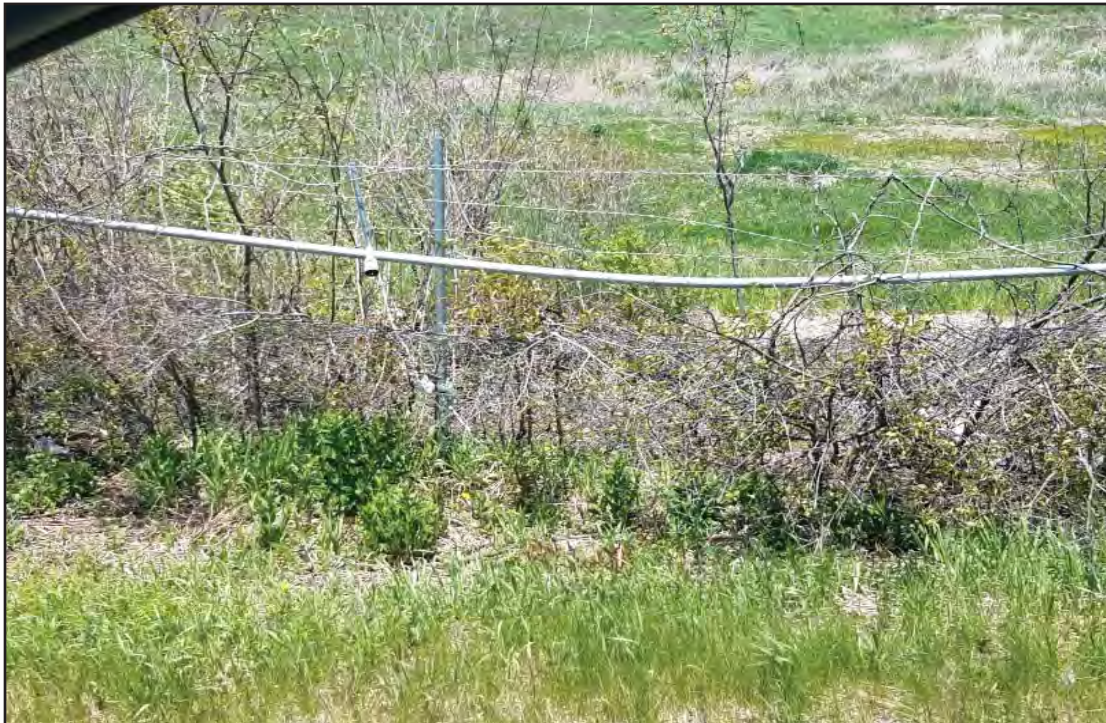
South section of perimeter fence in need of repair

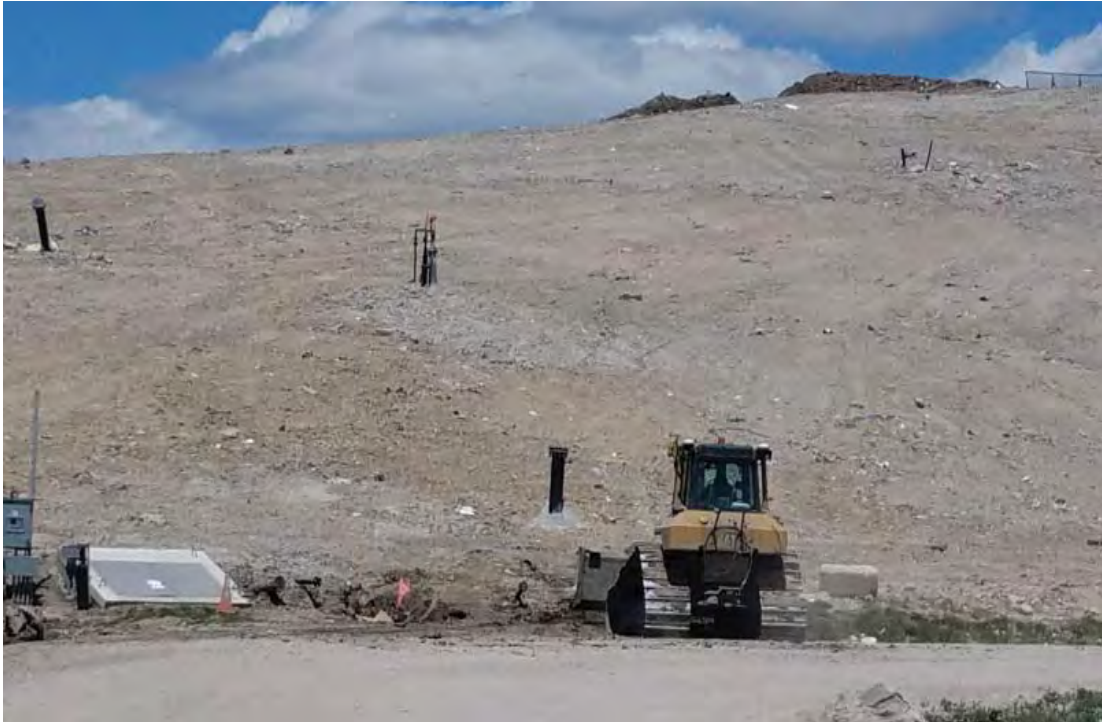
South toe of Phase 7 slope, pipe repair to left of dozer

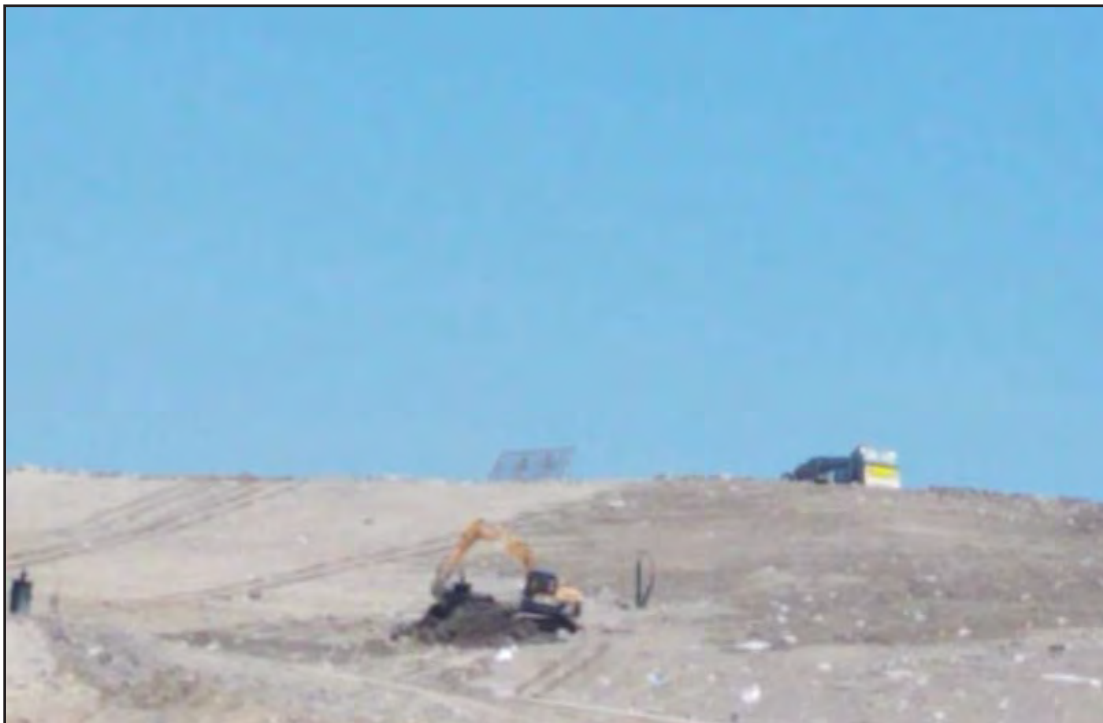
Slope repairs to improve gas collection

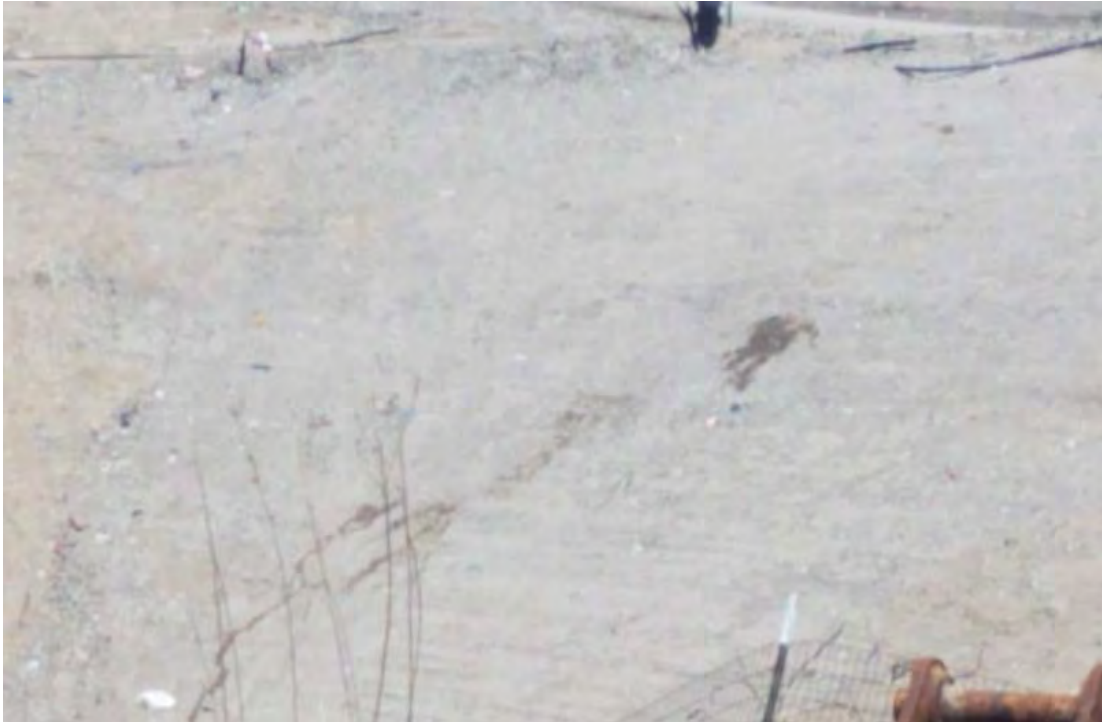
Small seeps on West slope of Phase 7

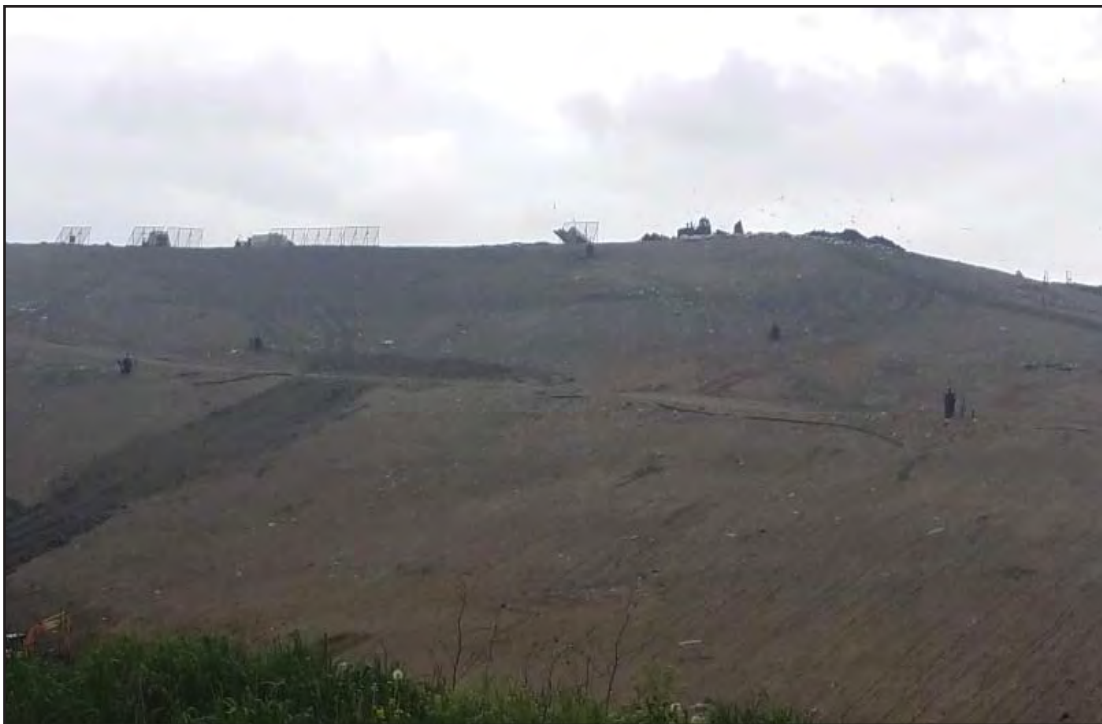
2. West slope of Phase 7 South, seep repairs by placement of soil cover

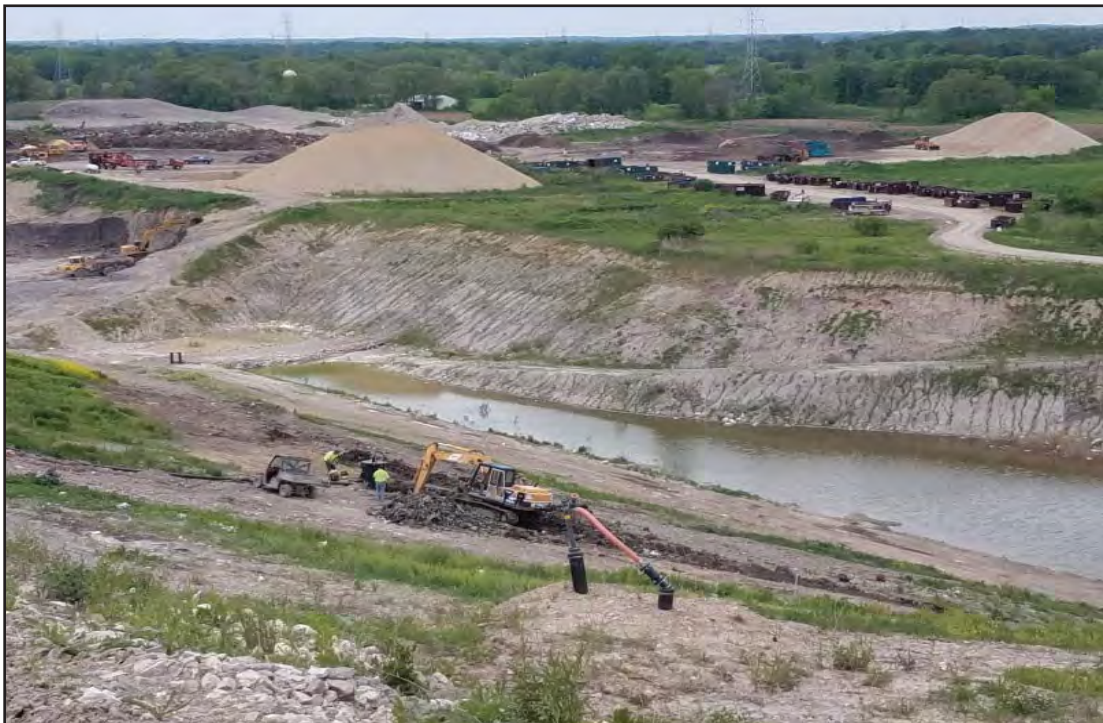
Gas system repairs on Phase 7 North, West slope

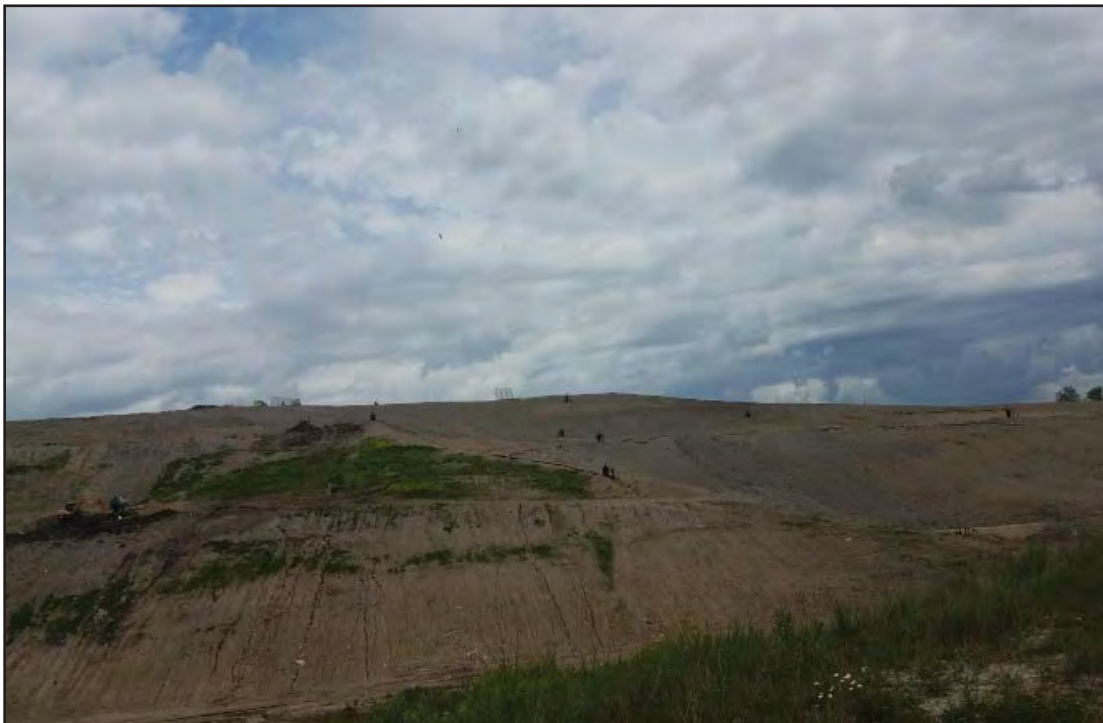
West slope of Phase 7 North, some seep repairs evident

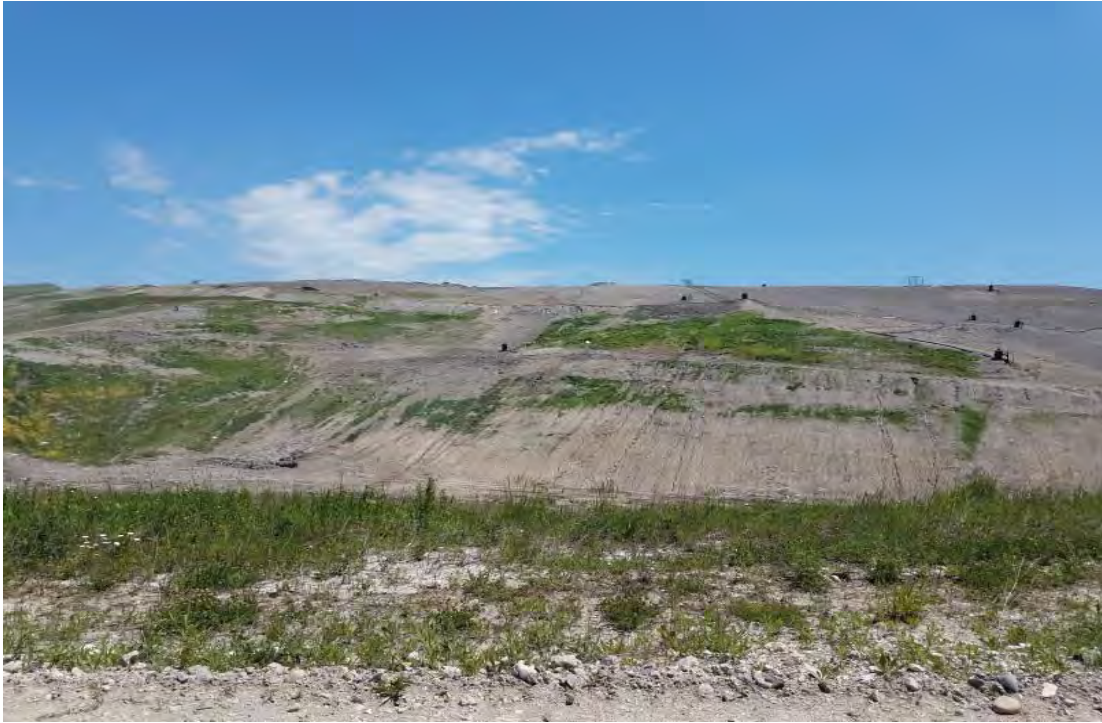
West slope of Phase 7 North, several seep repairs were done in last two weeks

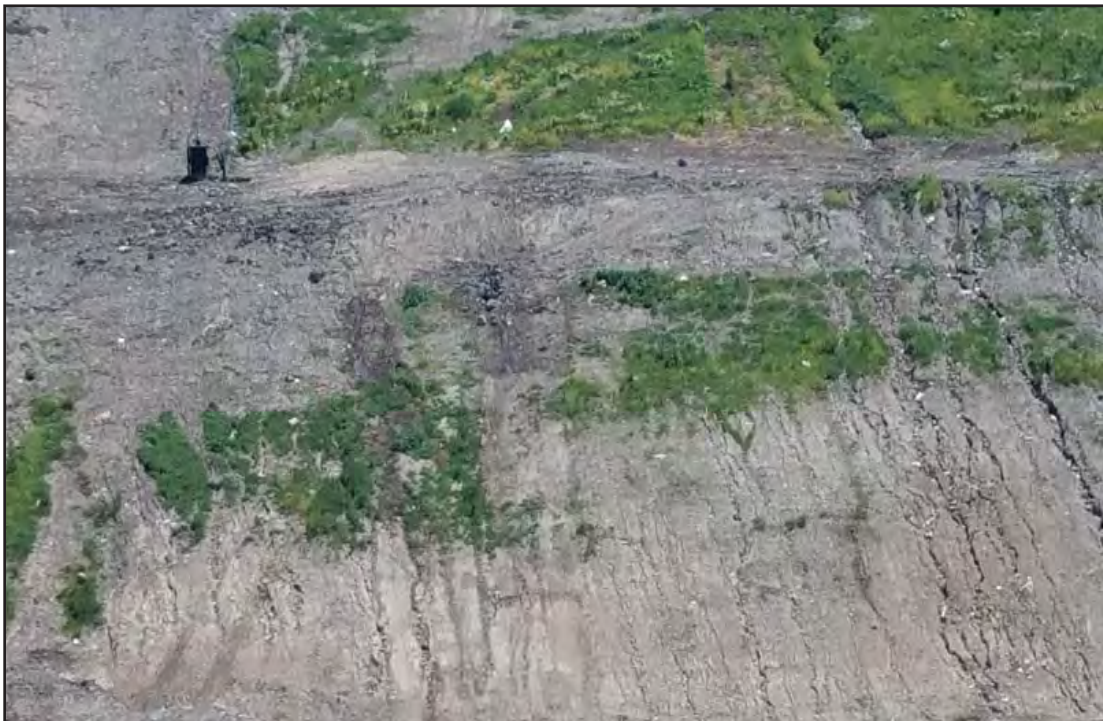
Seep repair on West slope of Phase 7 North, was a large seep

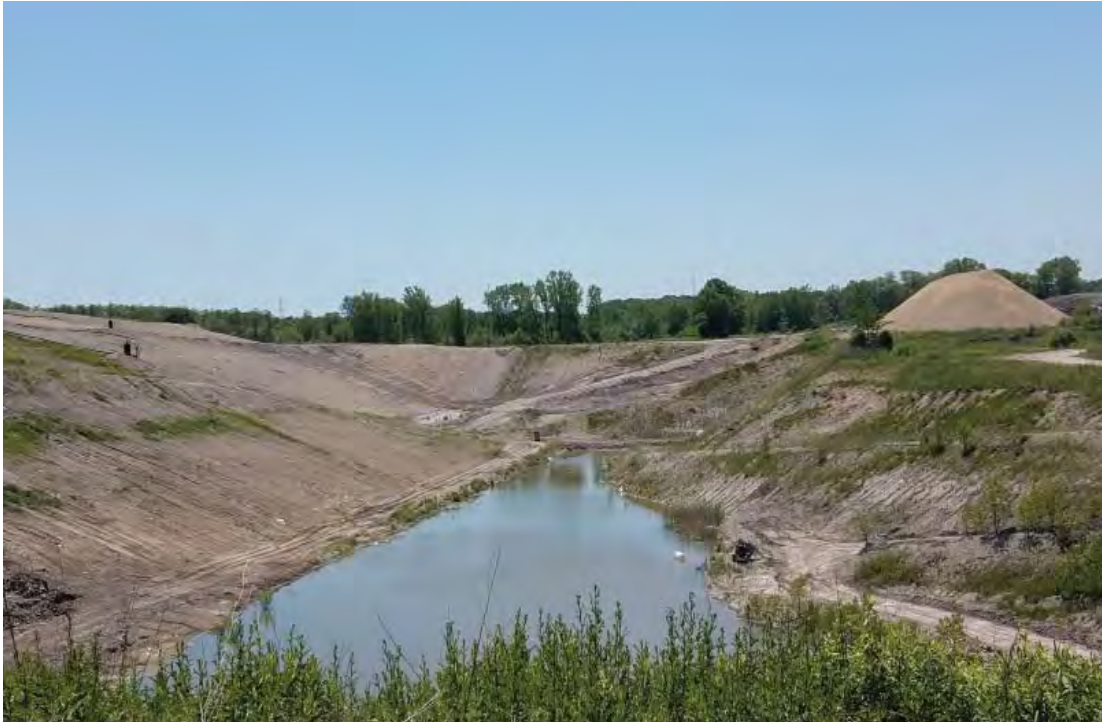
Temp Sed Basin, contaminated with leachate, pumped to tanker for removal

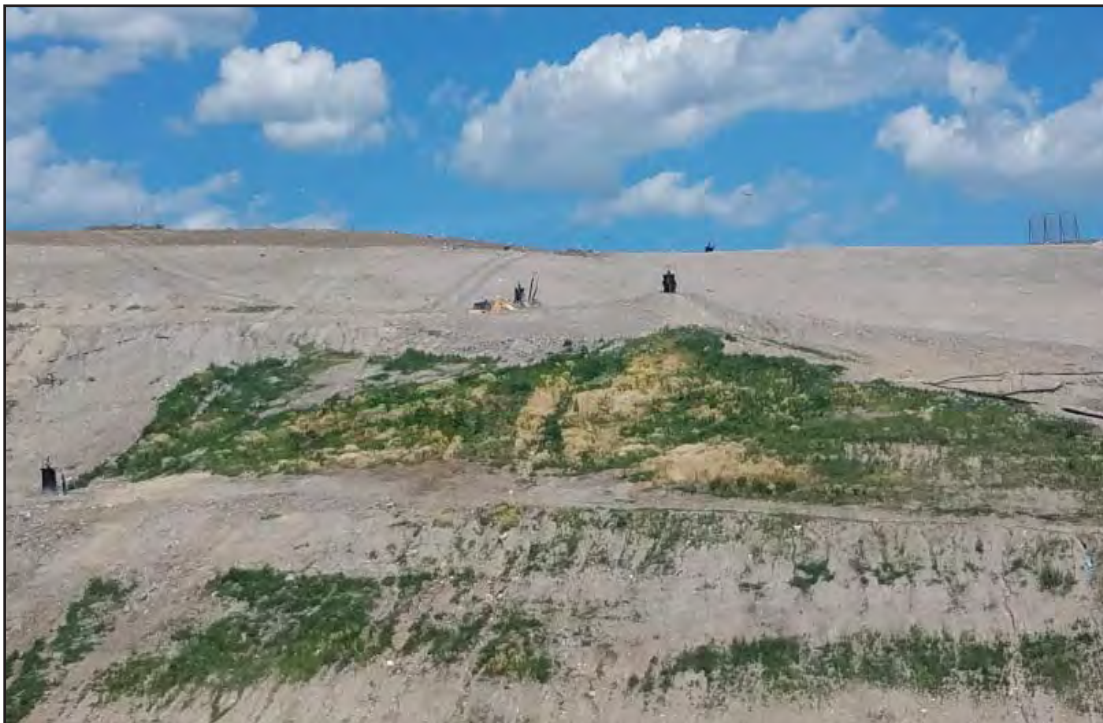
Vegetation slow to grow on West slope of Phase 7. Yellowing areas are potentially evidence of vegetative stress caused by LFG

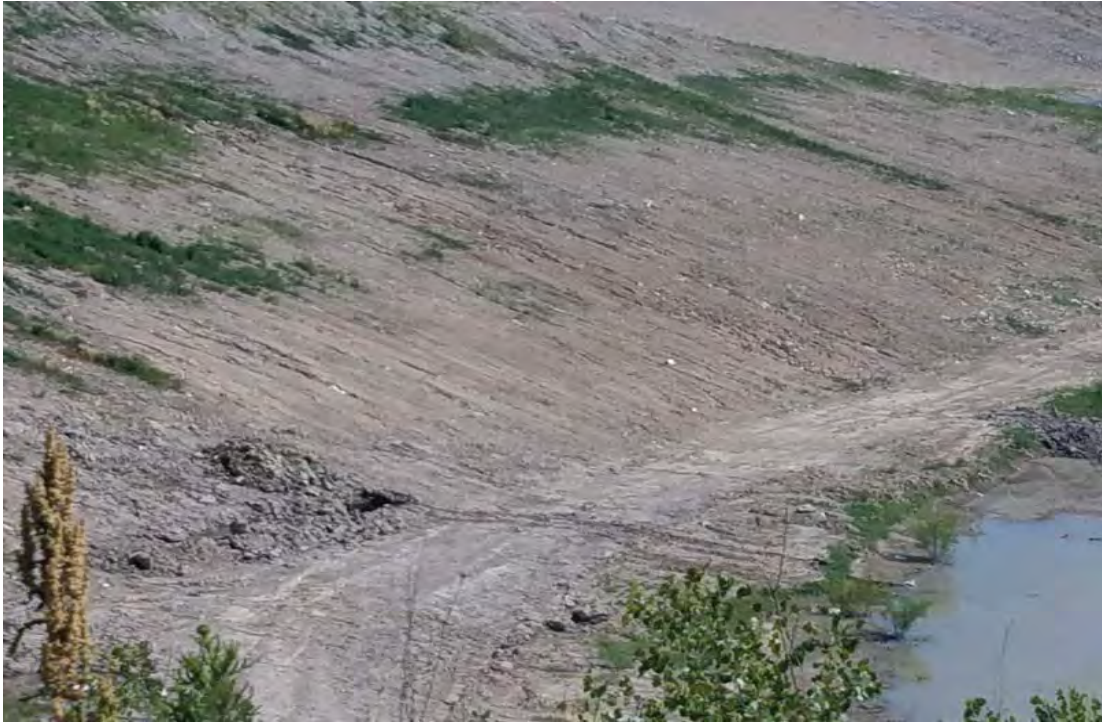
Seep in West slope, just above Temp sed basin. This is a re-accuring seep

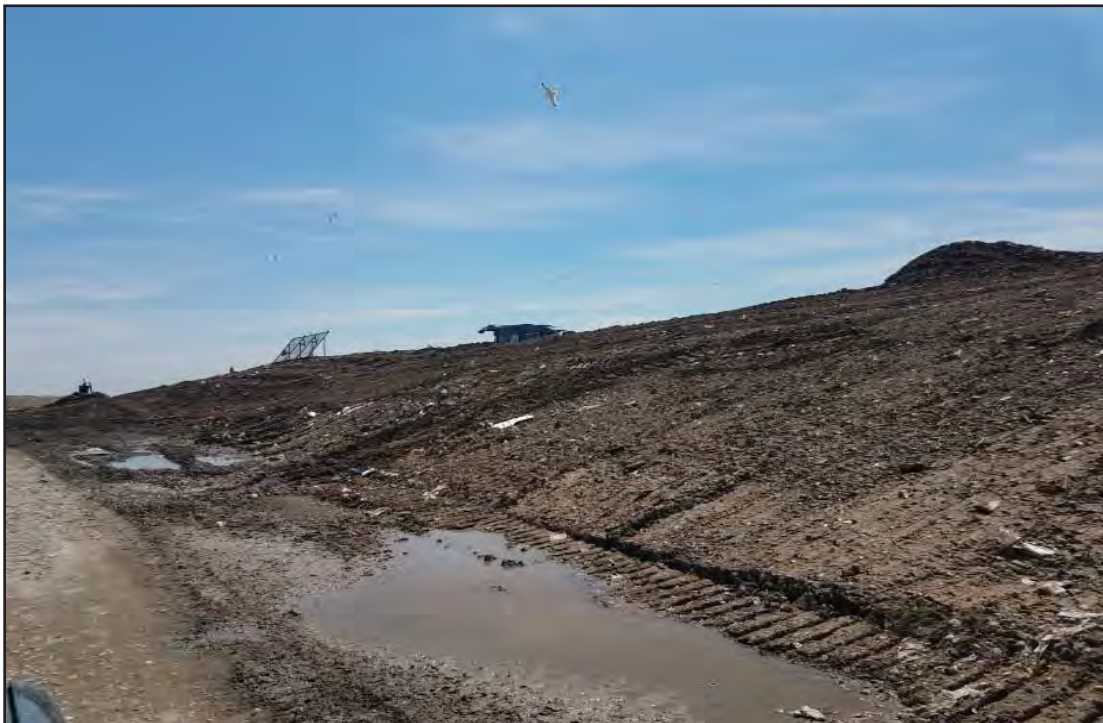
Wet area above previously repaired seeps along access road

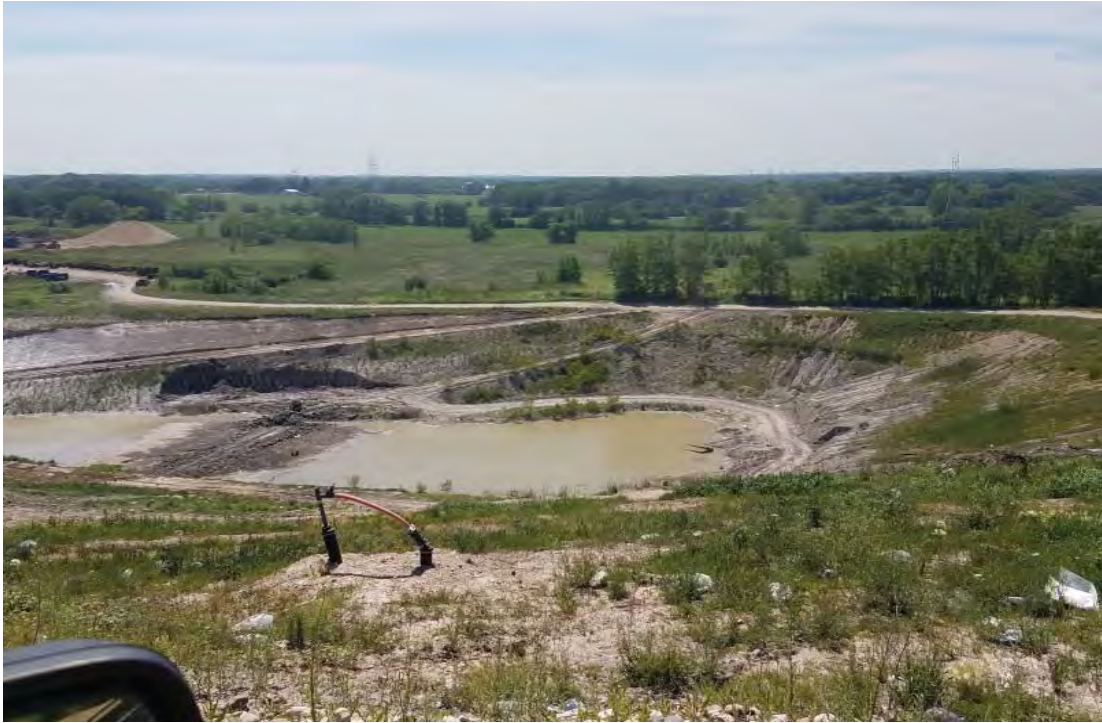
Temp sed basin split to manage leachate contamination

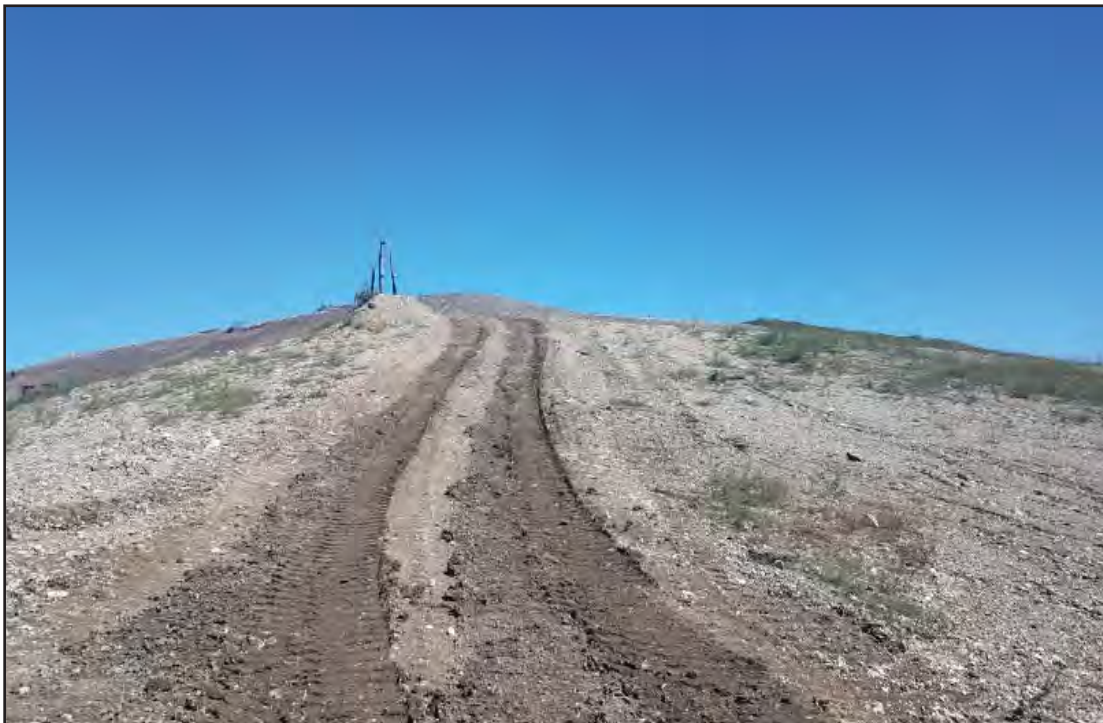
Damage to slope at Southwest corner of Phase 7 South by repeat travel of bull dozer

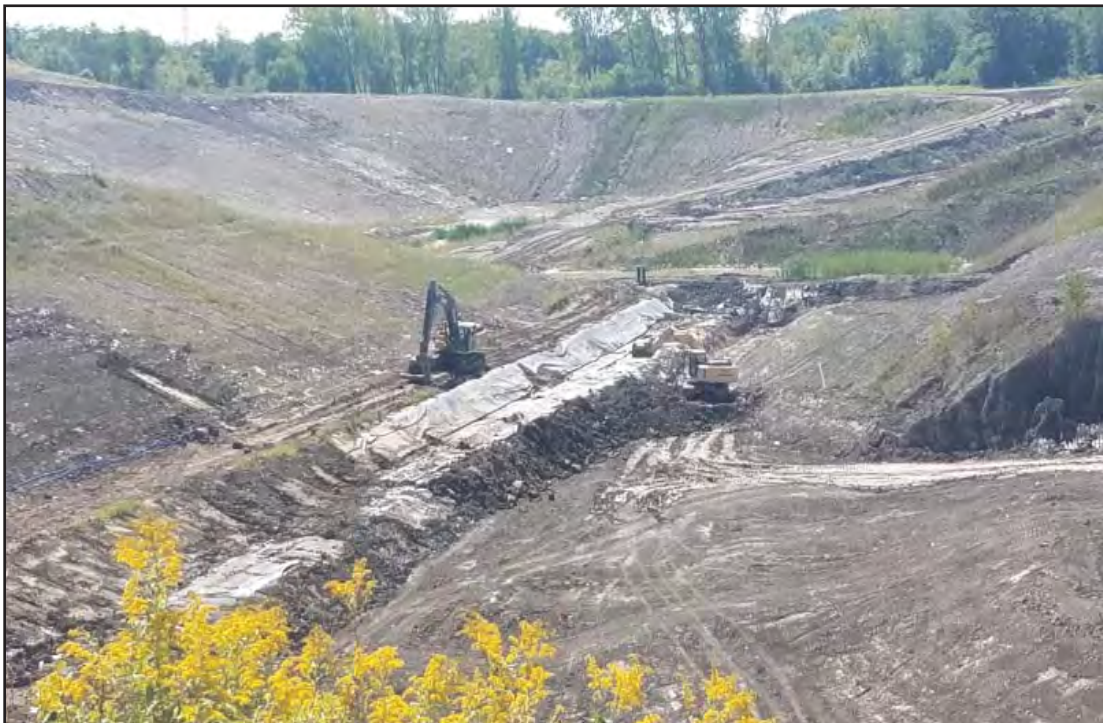
Seep repair to rainflap ongoing, there was a large volume of trapped leachate

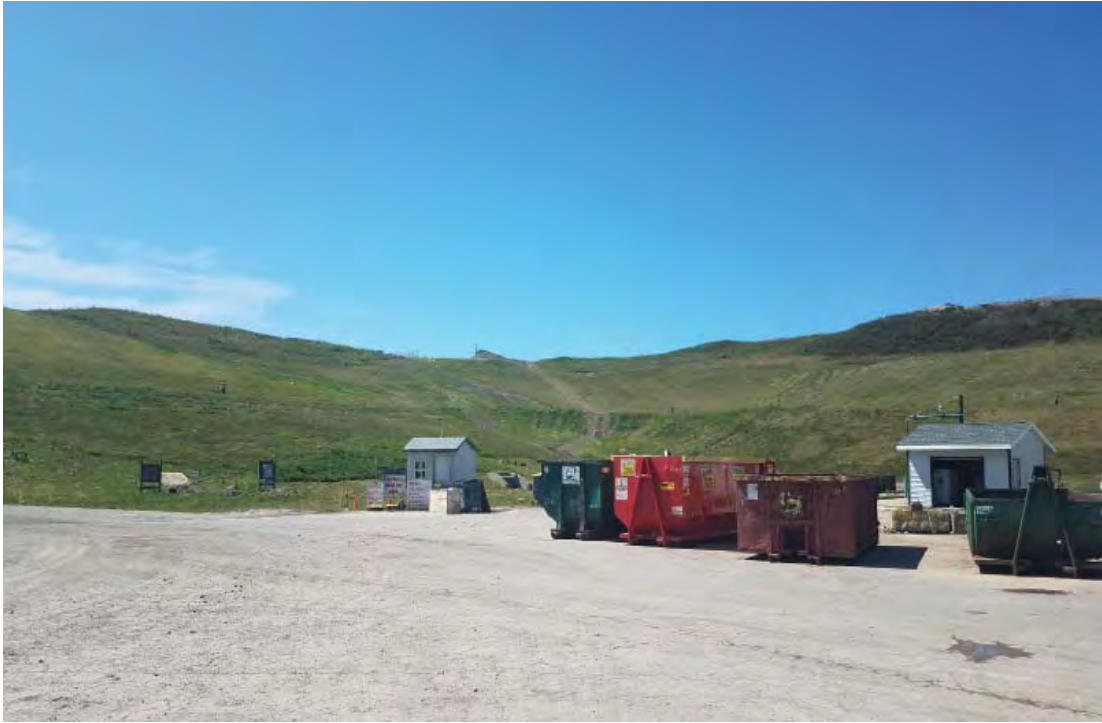
North slope of Phase 4, some wear and tear from vehicle traffic

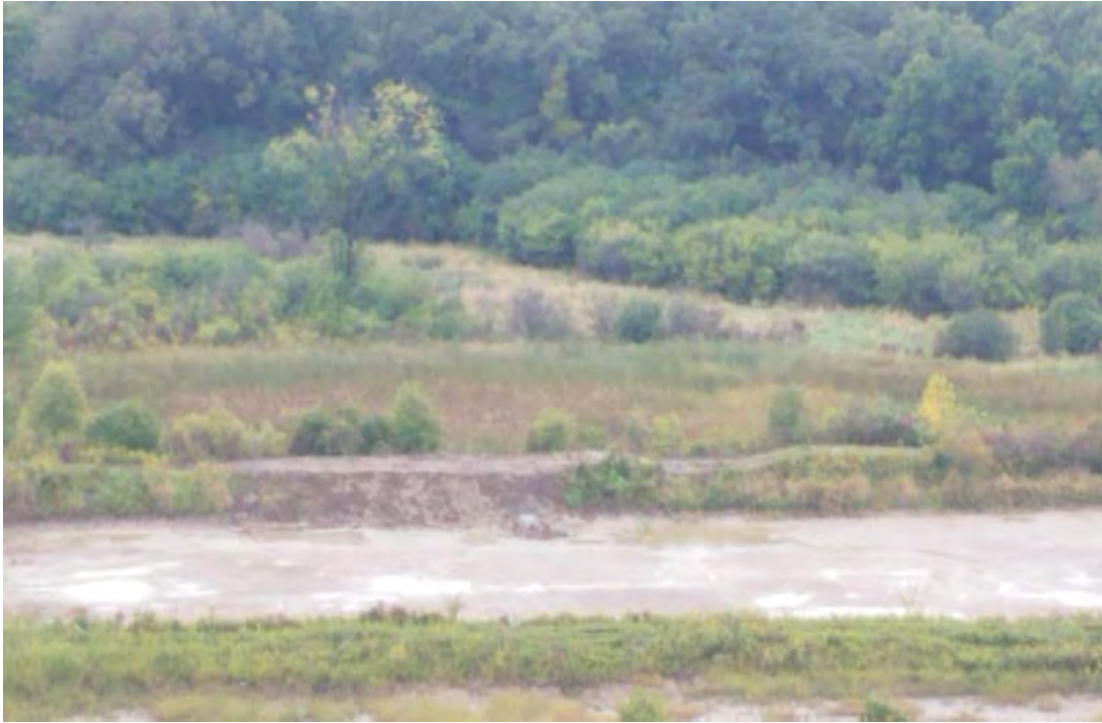
Basin #1, cleaned and control structure replaced

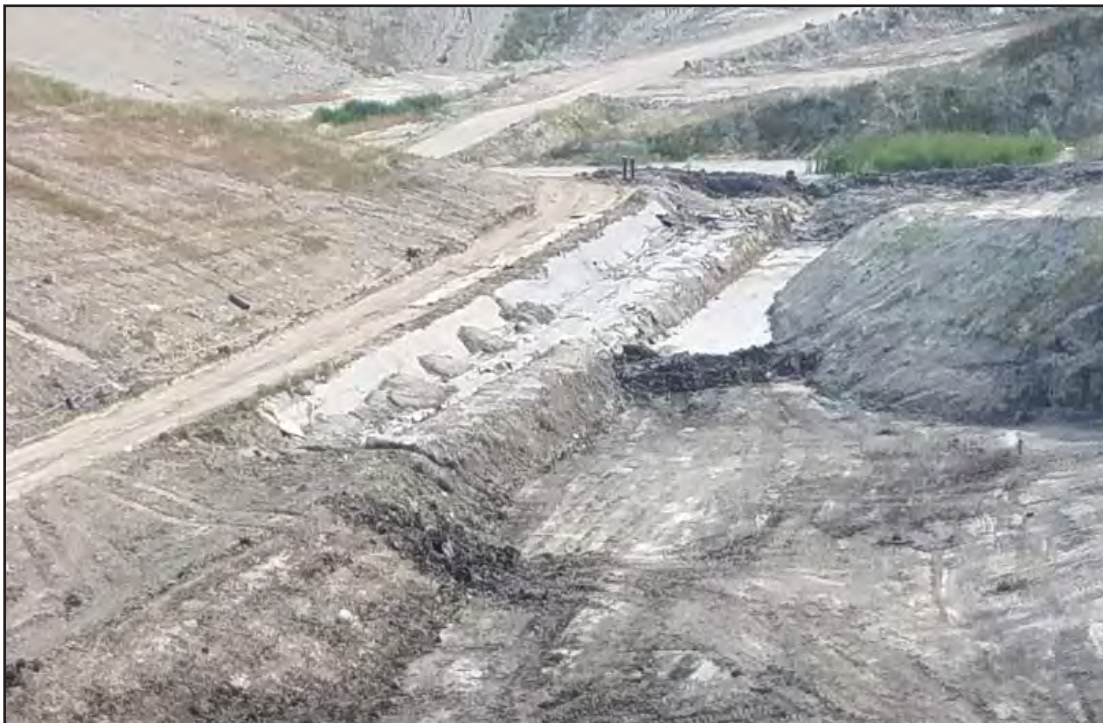
Exposed rainflap, awaiting liner crew for repairs.

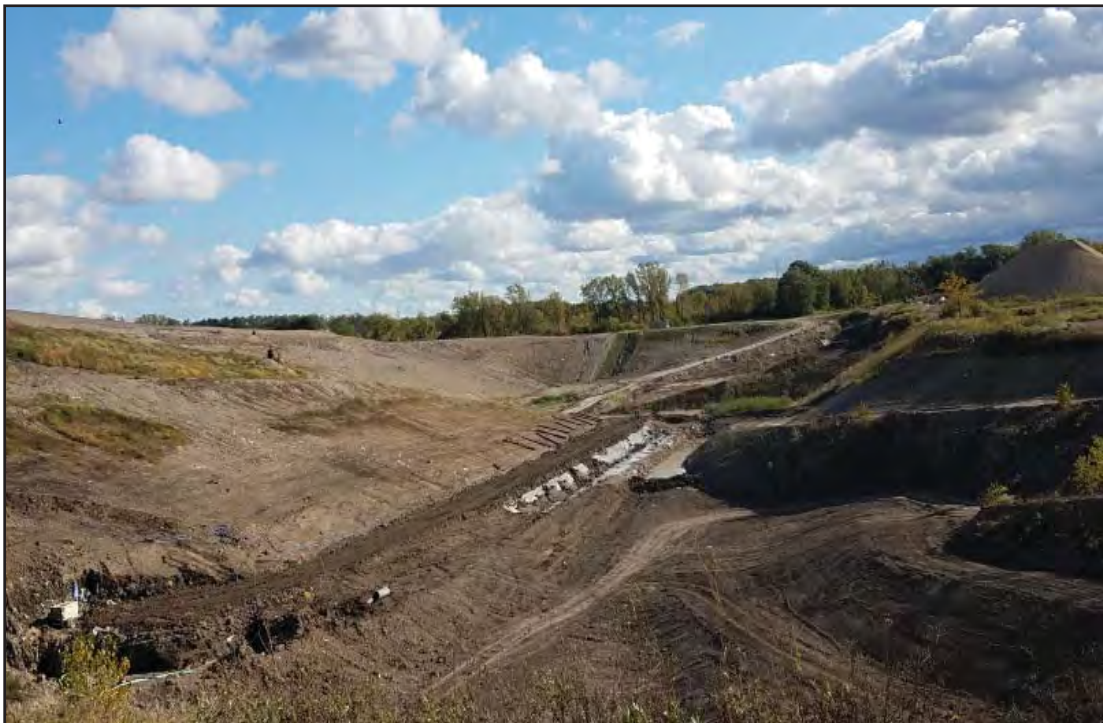
Temp sed basin, rain flap of Phase 7 exposed for repairs, awaiting scheduling of liner crew

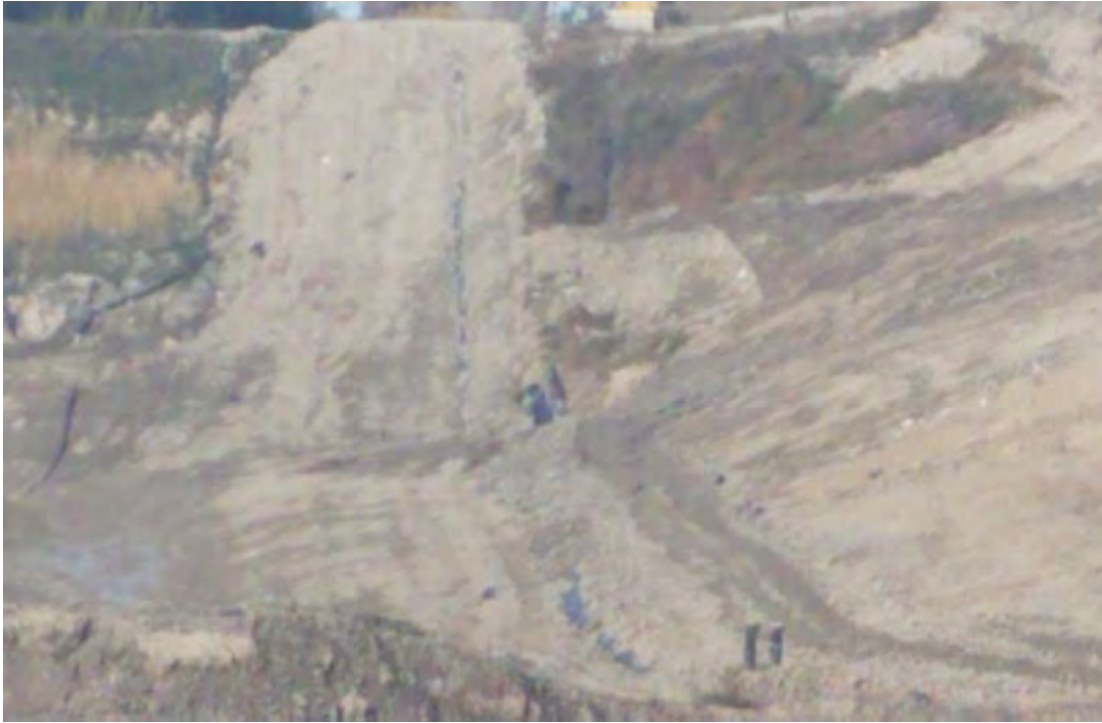
Rain flap and sump repair completed on West toe of slope, Phase 7

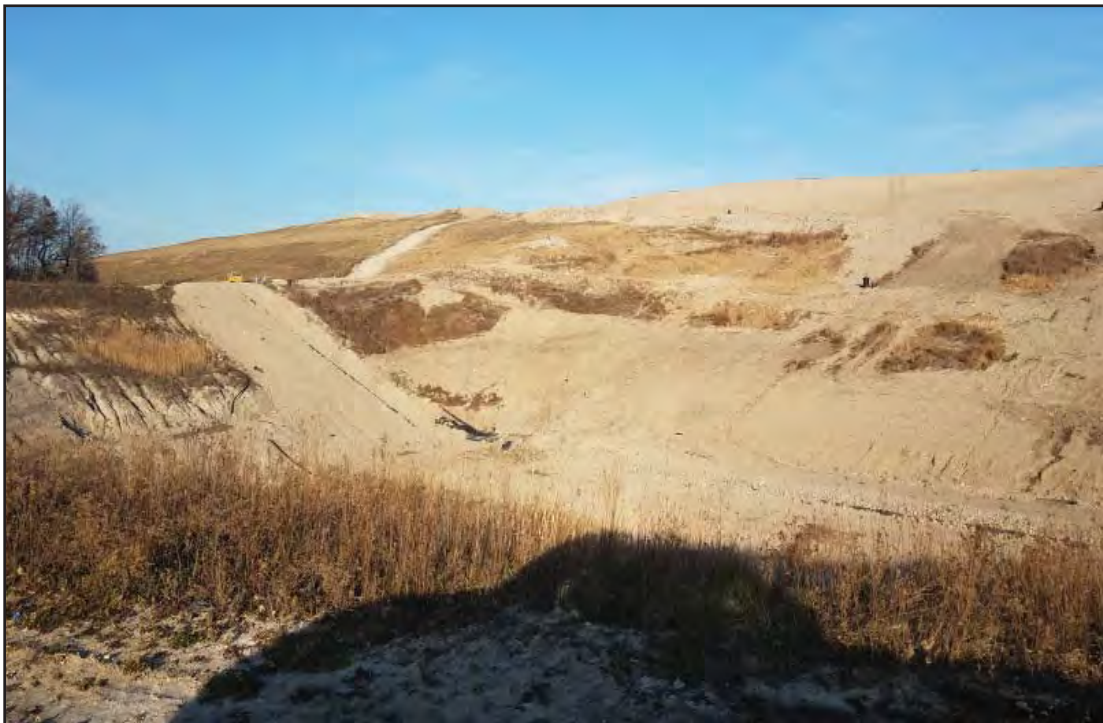
West slope of Phase 7

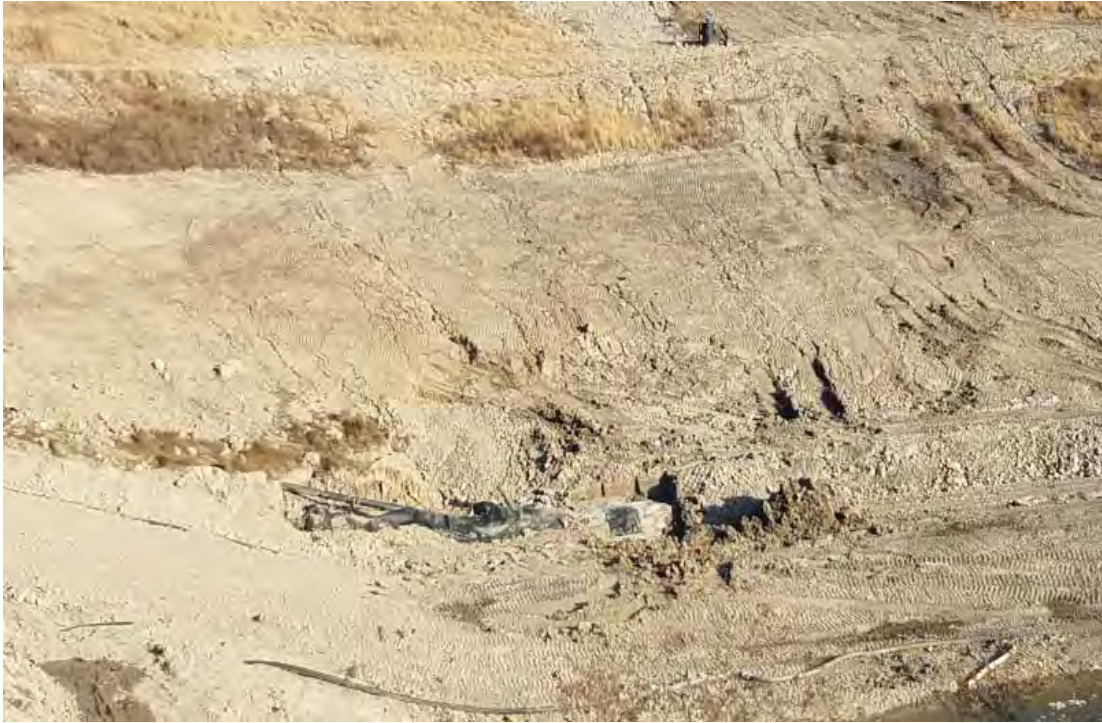
Repaired rainflap, base of Phase 7 South, to be covered

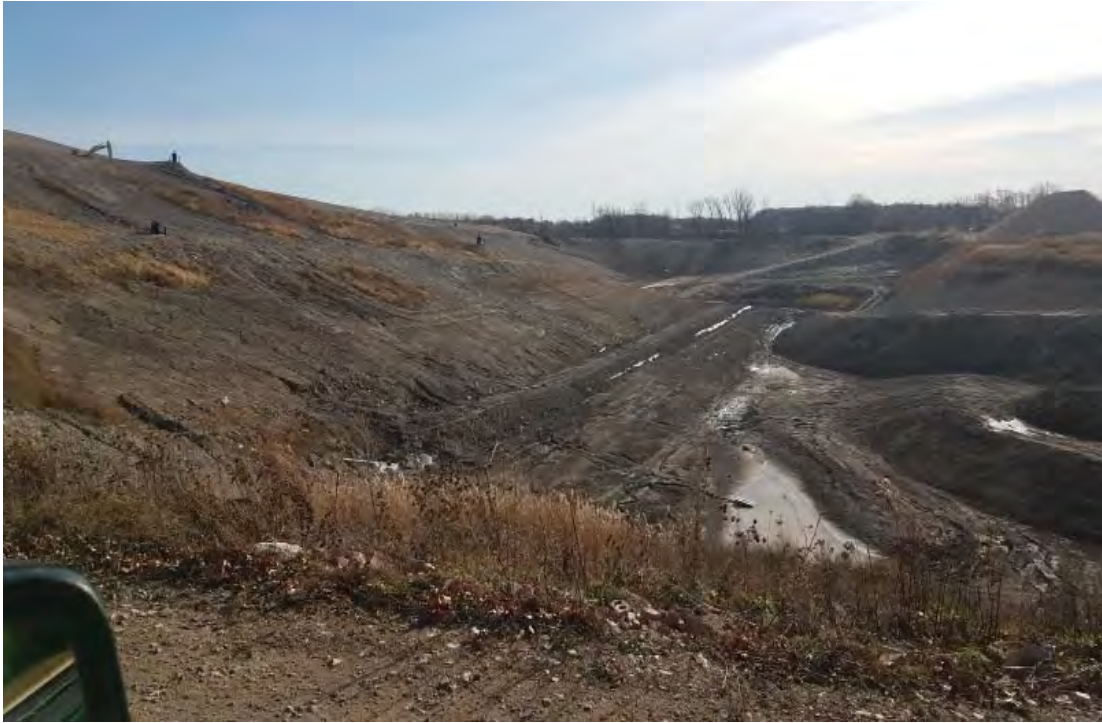
West slope of Phase 7, repaired rain flap and access road
