WMWI – PHEASANT RUN LANDFILL

WMWI PHEASANT RUN LANDFILL / TOWN OF PARIS AUDIT PHOTOS

PROJECT NO. 1155

Action Items Checklist Town of Paris Audit

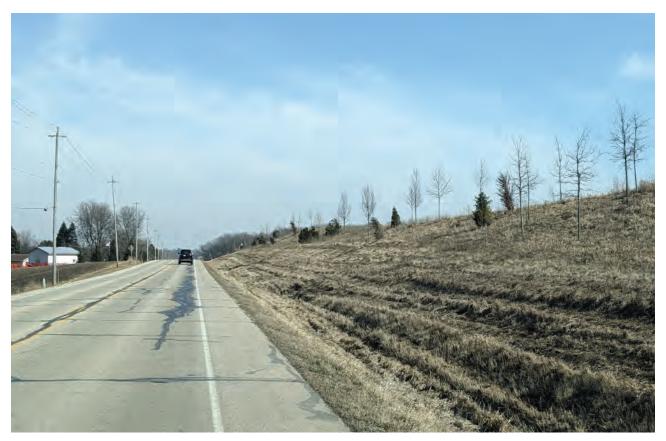
North screening berm, near corner of 38th Street and HWY 45

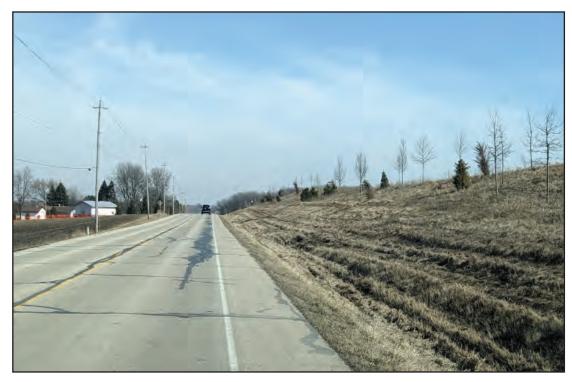
Screening berm along 38th Street; plantings appoear to be in bad shape.

Contractor responsable for restoration

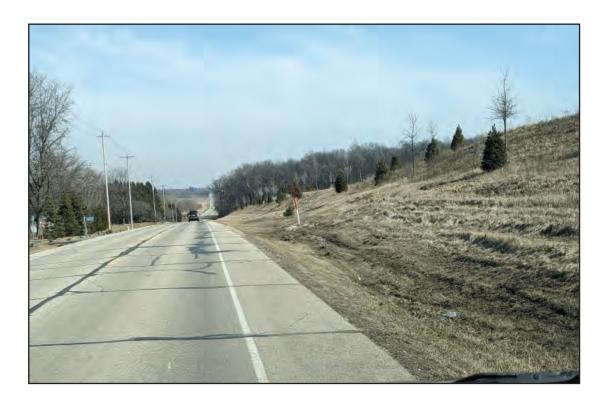
Screening berm along 38th Street; plantings appoear to be in bad shape.

Contractor responsable for restoration

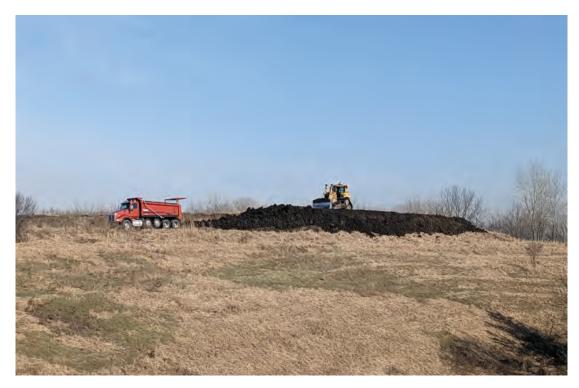
Cap project awaiting seeding and minor erosion repairs

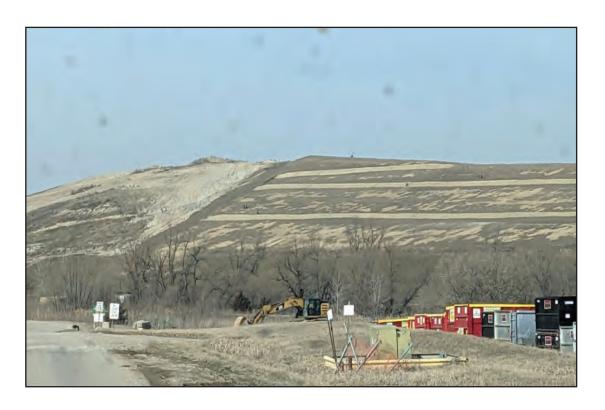
Cap project awaiting seeding and minor erosion repairs

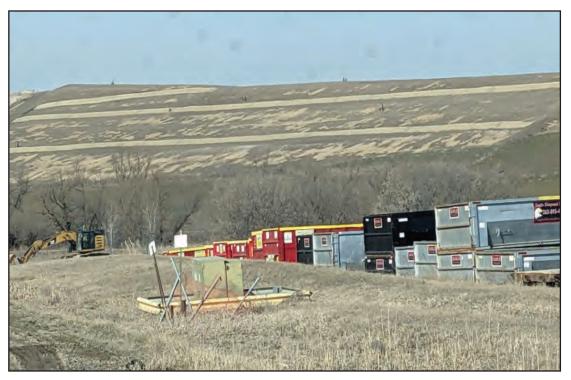
Cap project awaiting seeding and minor erosion repairs

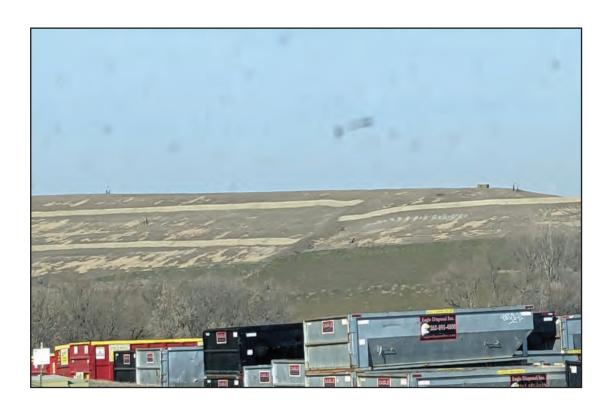
Cap project awaiting seeding and minor erosion repairs

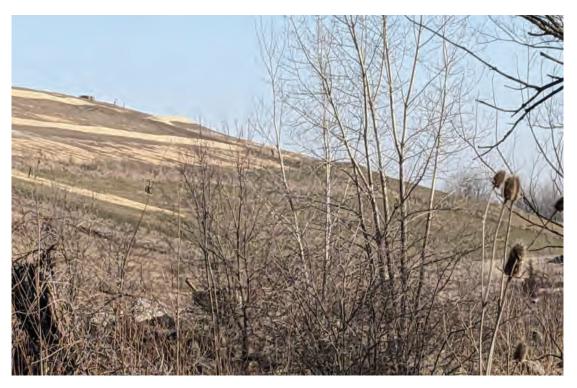
Cap project awaiting seeding and minor erosion repairs

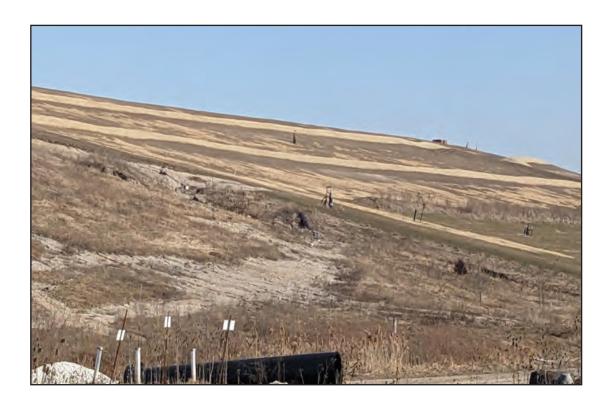
Cap project awaiting seeding and minor erosion repairs

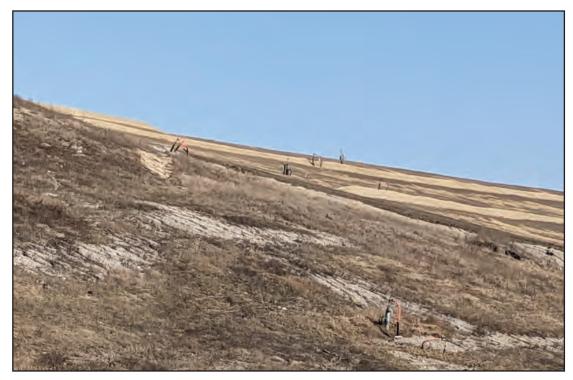
Cap project awaiting seeding and minor erosion repairs

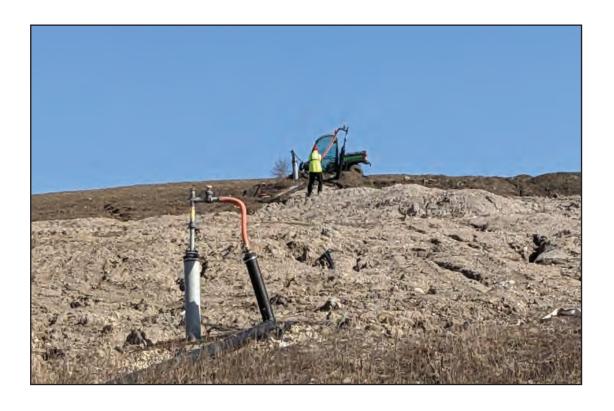
Slope erosion on Phase 2 and gas tech actively tweaking well field

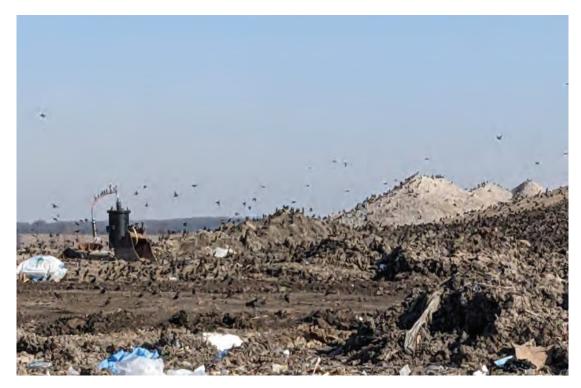
Cover roughly placed during operations

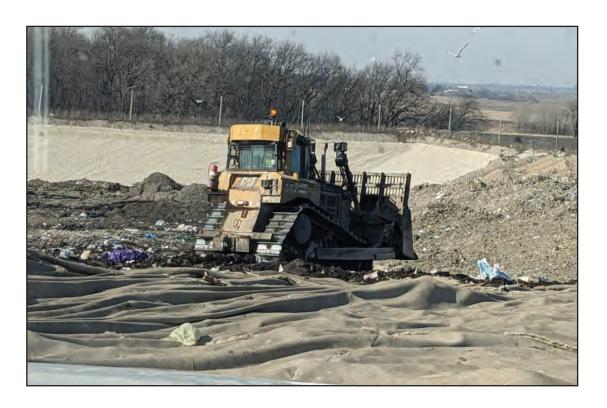
Dozer shaping cover, tarp pulled back on covere

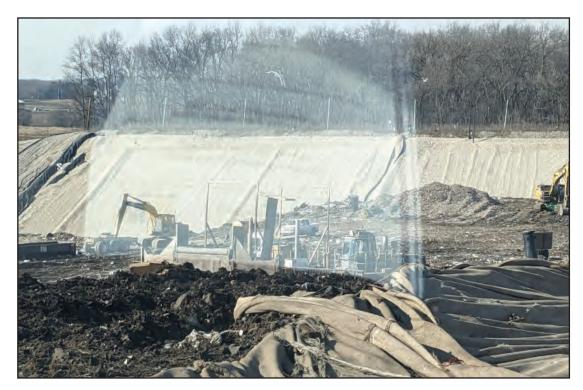
Tipper in Phase 4

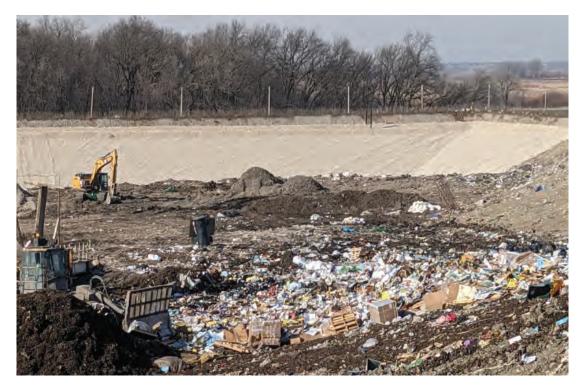
Phase 3 & 4 being brought to same elevation

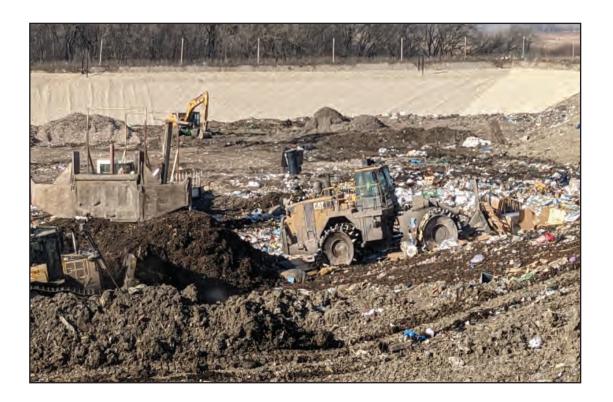
Phase 3 & 4 being brought to same elevation
