WMWI – PHEASANT RUN LANDFILL

WMWI PHEASANT RUN LANDFILL / TOWN OF PARIS AUDIT PHOTOS

PROJECT NO. 1155

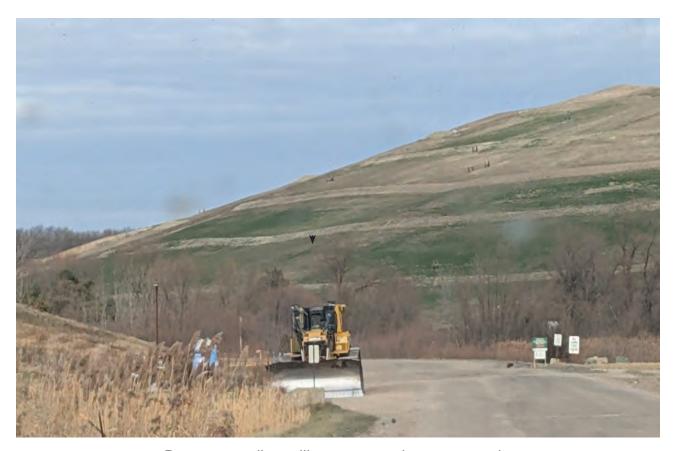
Dozer spreading tailings to smooth access roads

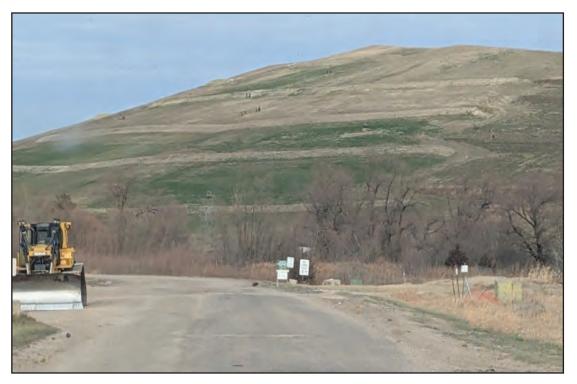
West slope of cap project, vegetation is developing quickly

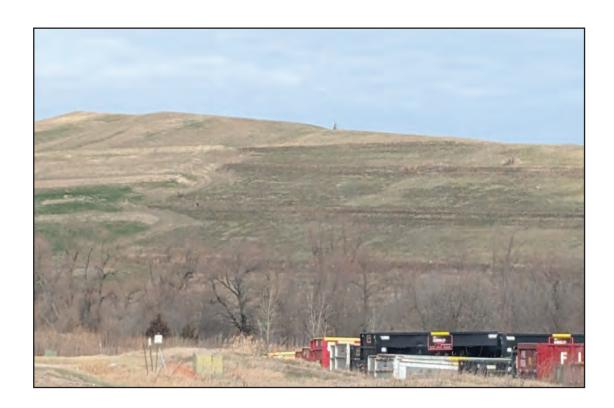
West slope of cap project, vegetation is developing quickly

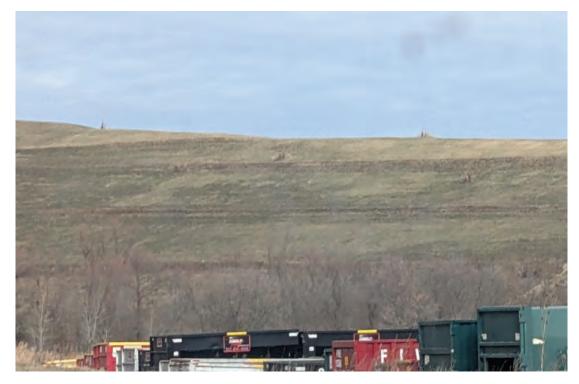
West slope of cap project, vegetation is developing quickly

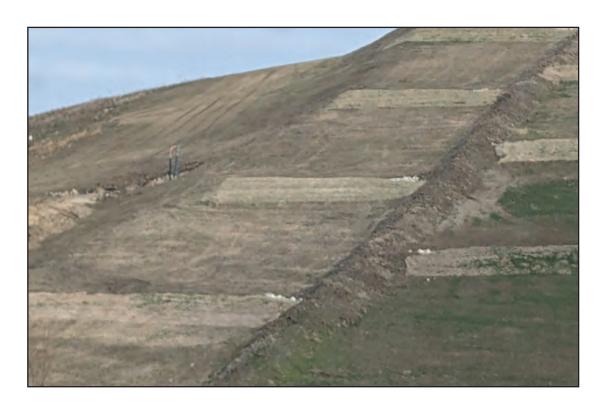
Transition of cap to capless of Phase 3

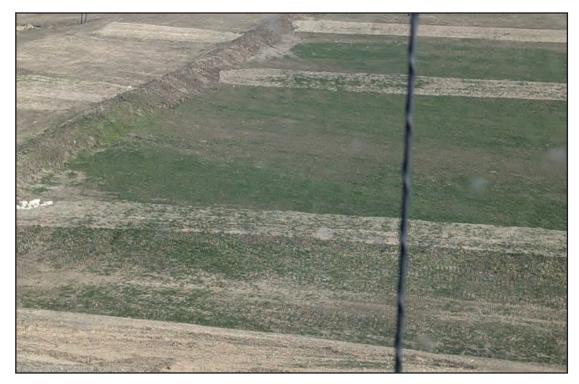
Cap project greening rapidly

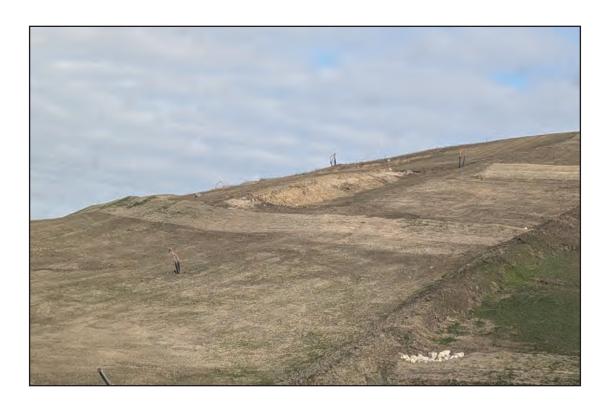
Northwest corner of Phase 3, slow to green

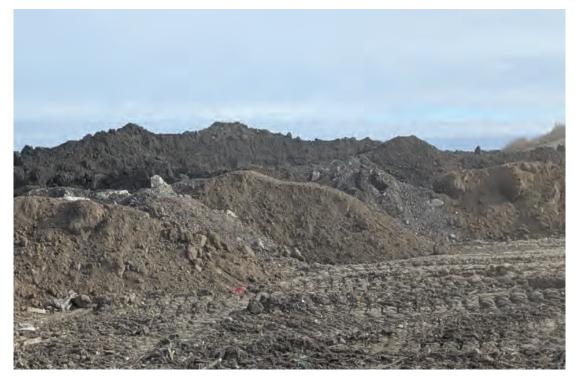
Plethora of soils tipped in Phase 4 for cover

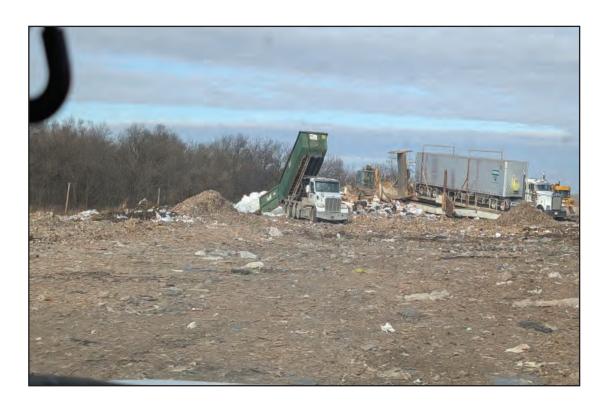
Truck tipping into working face in Northwest corner of Phase 4

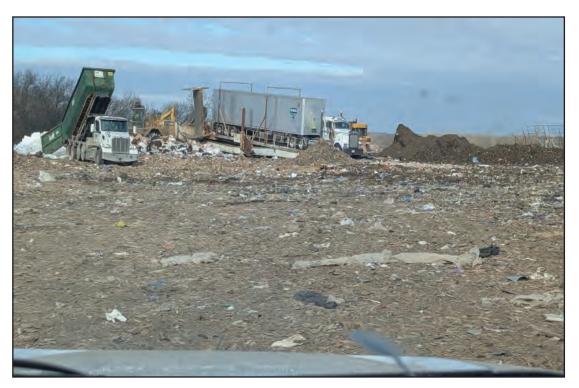
Tipper with stockpiling of cover on East side

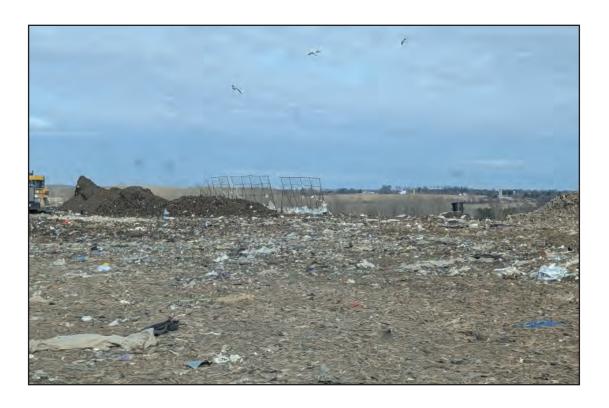
Active area in Phase 4

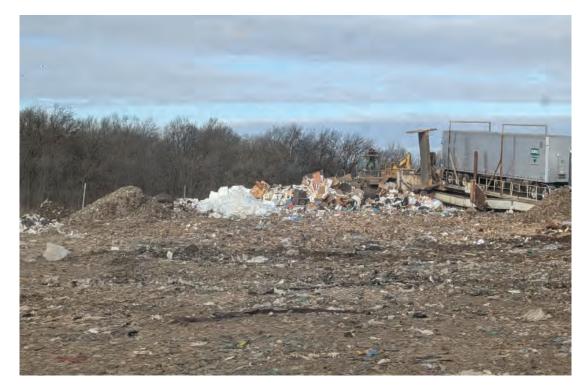
Tipper aimed into Northwest corner of Phase 4

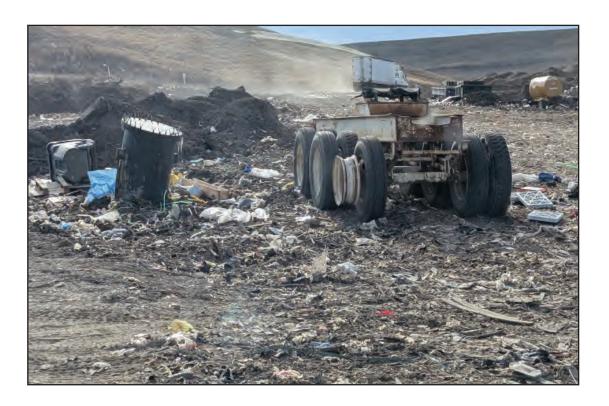
Tipper carrier placed adjacent to gas well to protect it
