WMWI – METRO LANDFILL  
LANDFILL OPERATIONS AUDIT FORM  
CITY OF FRANKLIN

PROJECT NO. 1036.10056

DATE May 28, 2026

# WMWI - Metro Landfill, *AUDIT PHOTOS*

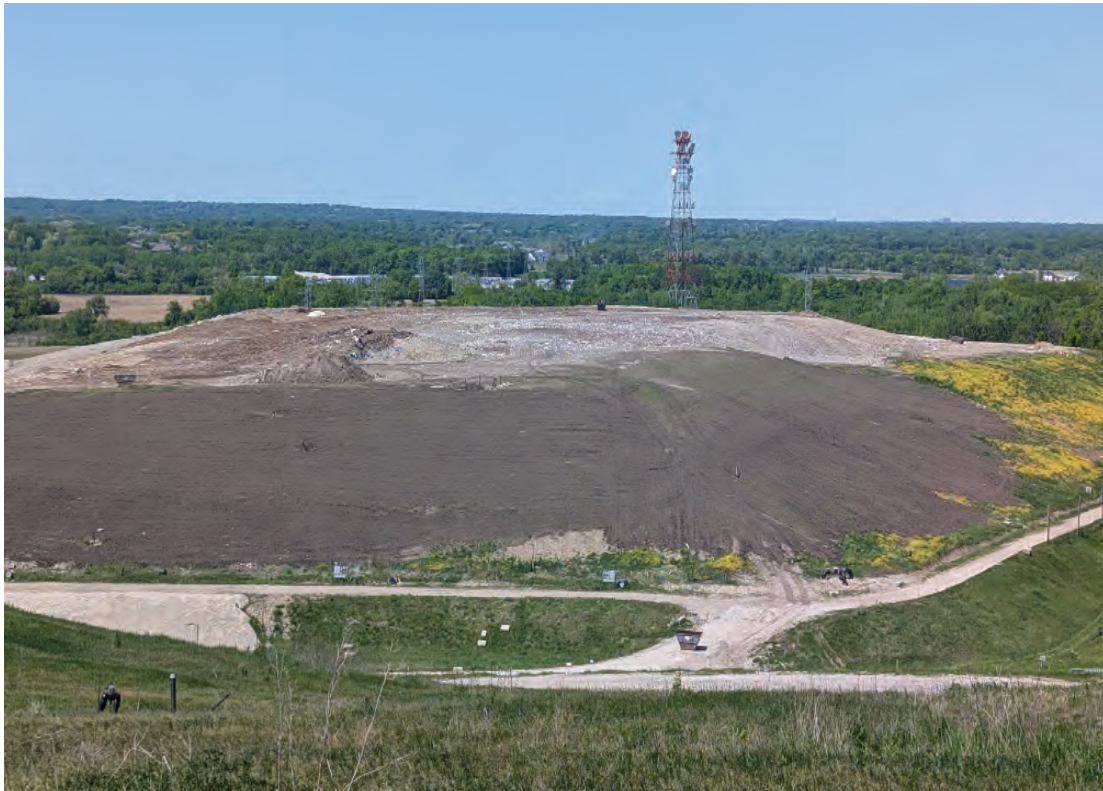
Top soil on North Expansion West; vegetation starting to show

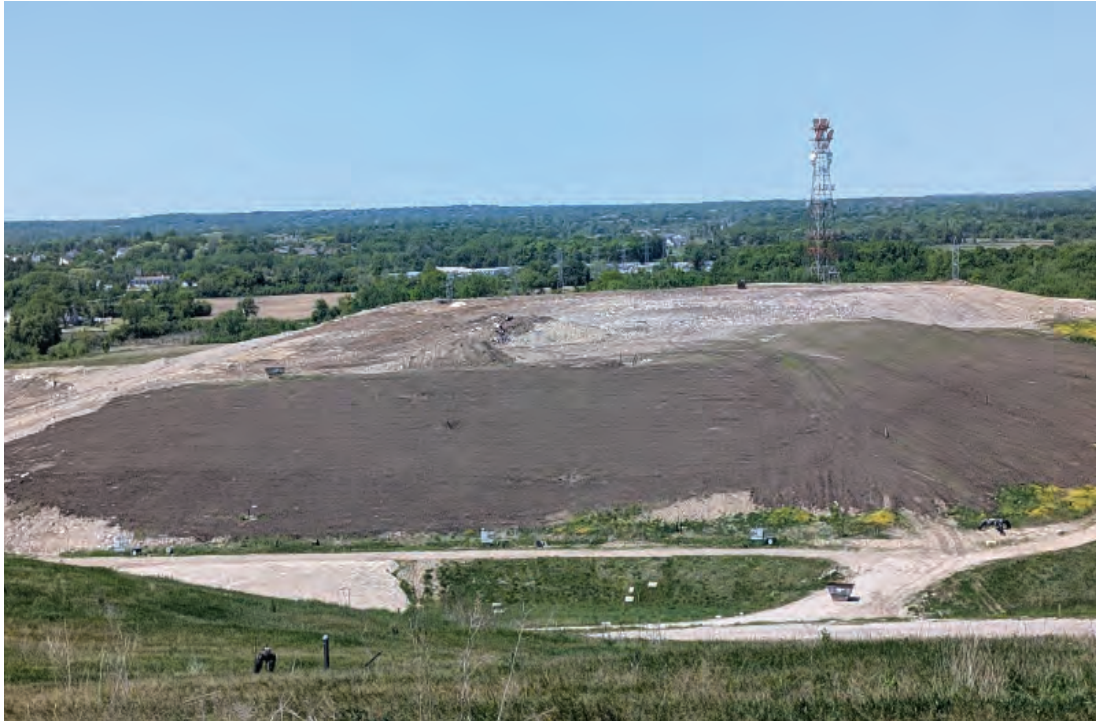
Top soil on North Expansion West, some vegetation starting to show

\* Phase 1 thru three have had their cover of top soil backdragged and graded

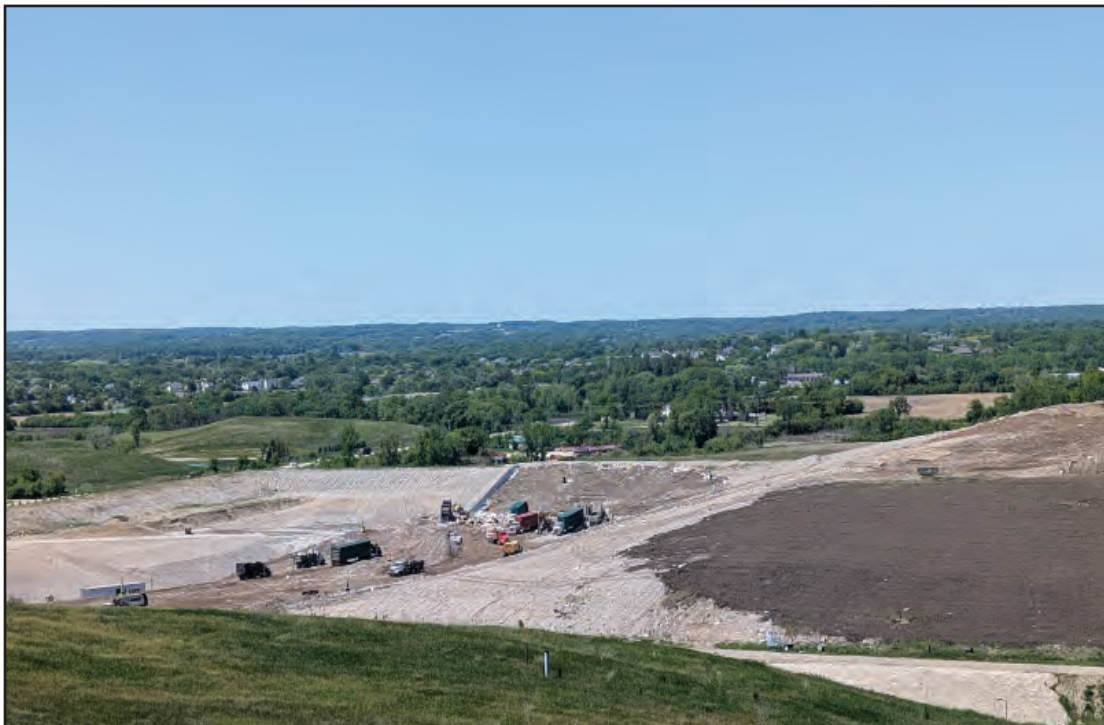
Overview of Phase 4

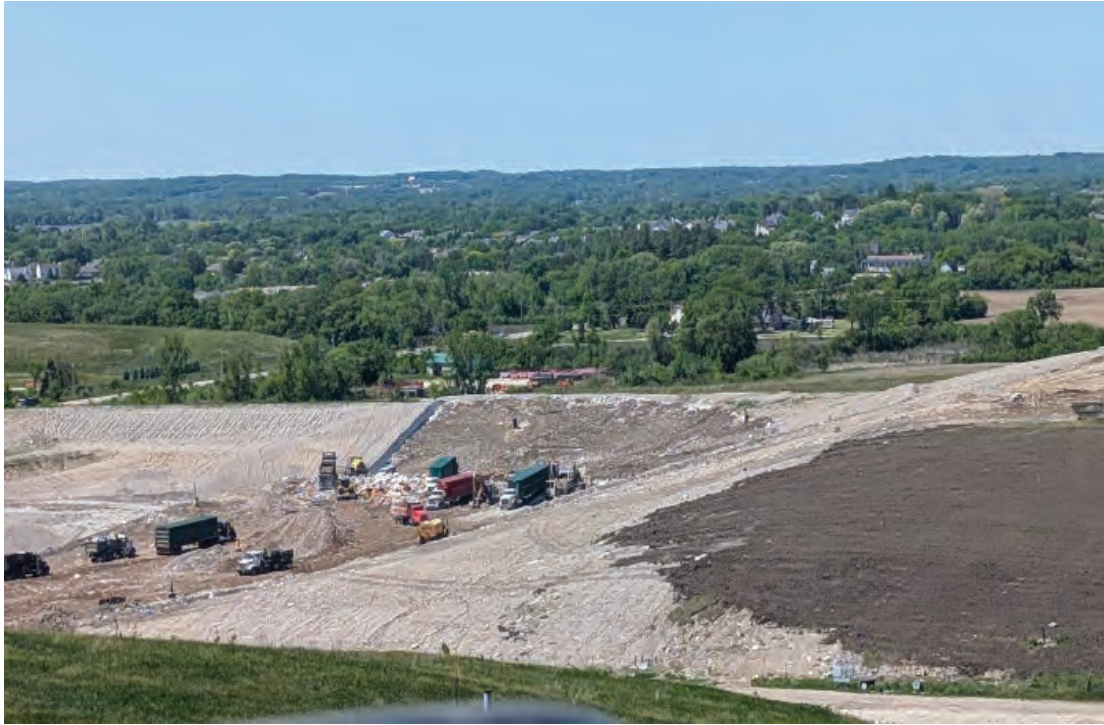
Working face in Phase 4 at Northern end, lift headed North. One more lift before active area will

crest.

North end of Phase 4, current working face

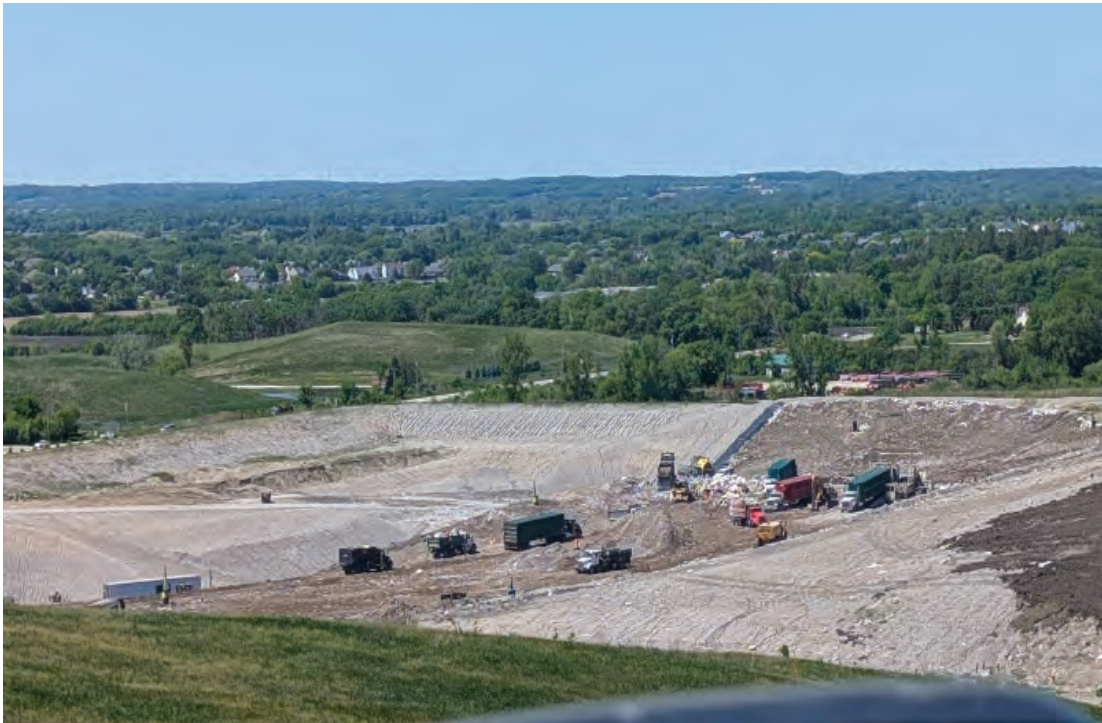
Phase 4 viewed from the Sout

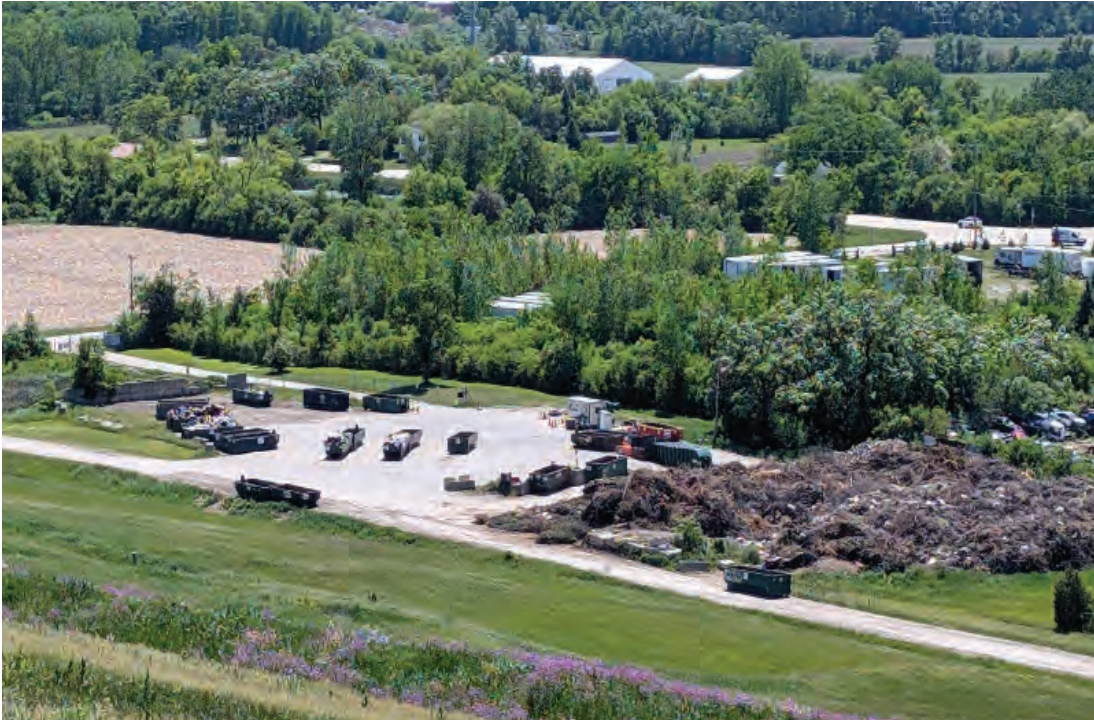
Drop off clean, boxes filling, but not over flowed. Site ready for operations tomorrow

Resi-drop-off, some boxes full, some empty the green waste volume is up

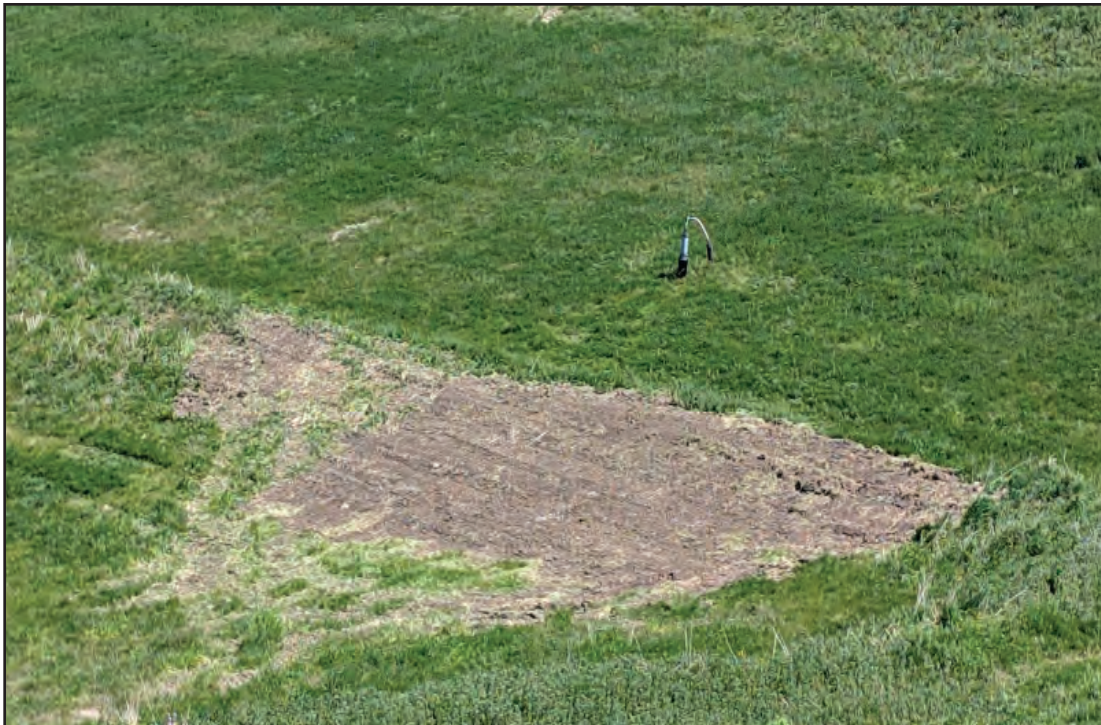
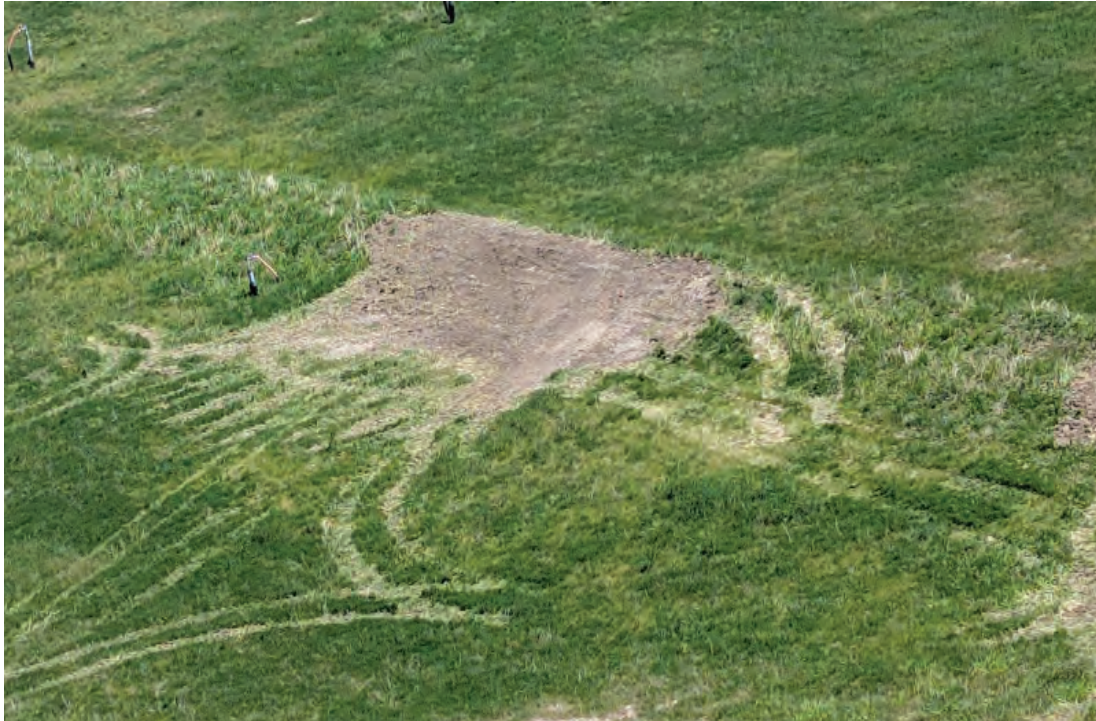
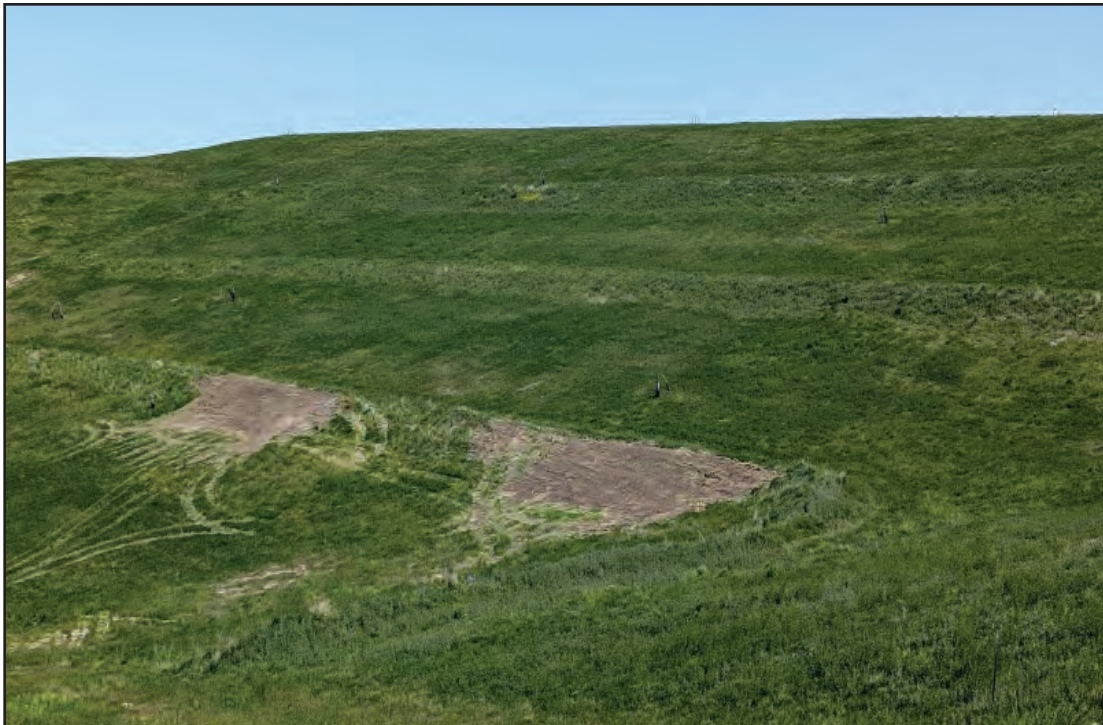
Erosion repair to berm on South slope of Phase 6

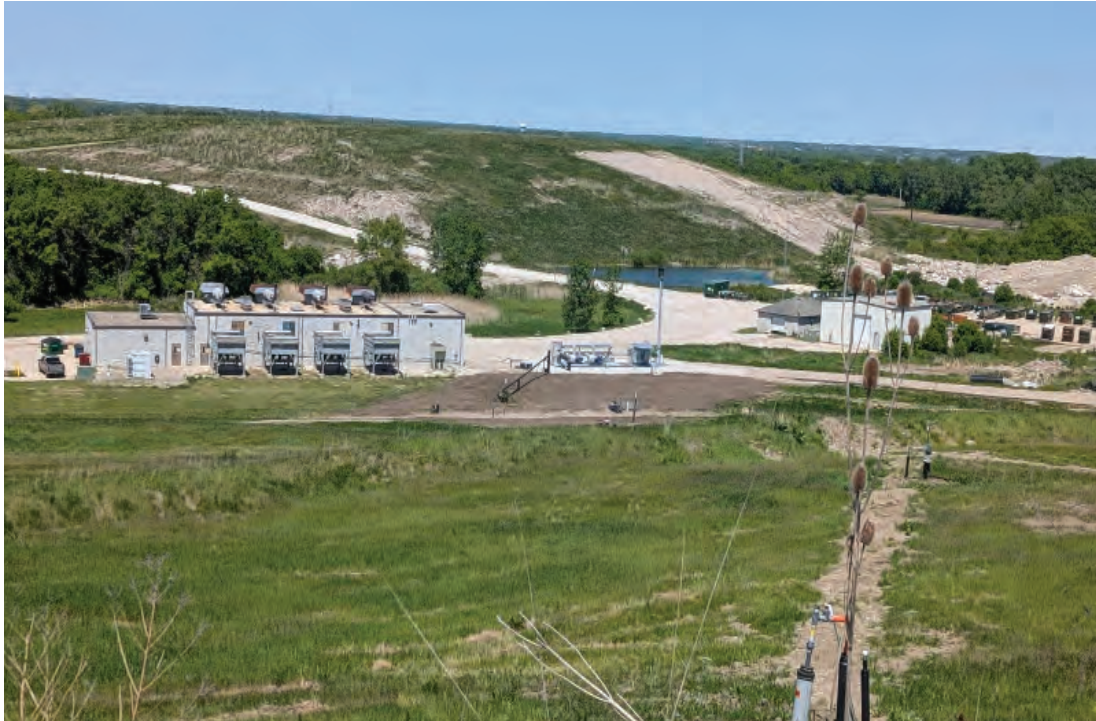
New flare lit and maintaining steady draw on gas fields. Gas destruction value consistent and constant.

No shutdowns since new flare implemented

New flare!

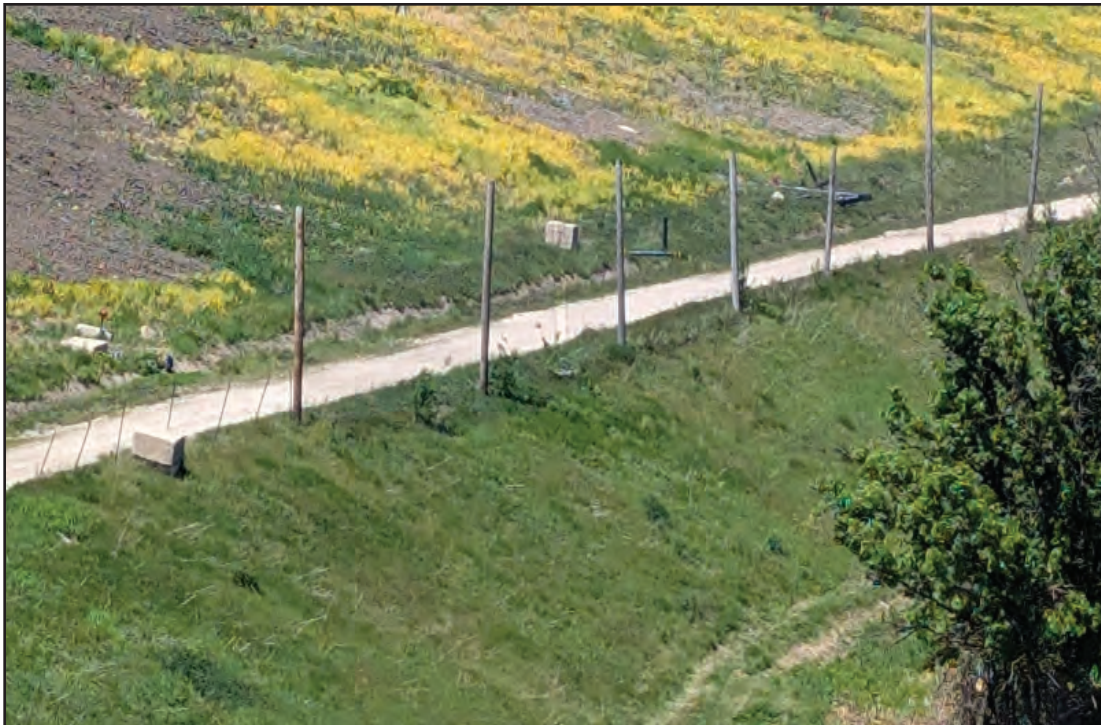
\* Tall litter fence under construction South of North Expansion West

Post for tall fence being placed East of North Expansion West

Off site litter well controlled. On site litter control being improved by installation of a tall fence along East boundary
