WMWI – METRO LANDFILL
LANDFILL OPERATIONS AUDIT FORM
CITY OF FRANKLIN

PROJECT NO. 1036.10056

DATE August 14, 2026 TIME 1:00 PM

WMWI - Metro Landfill,
AUDIT PHOTOS

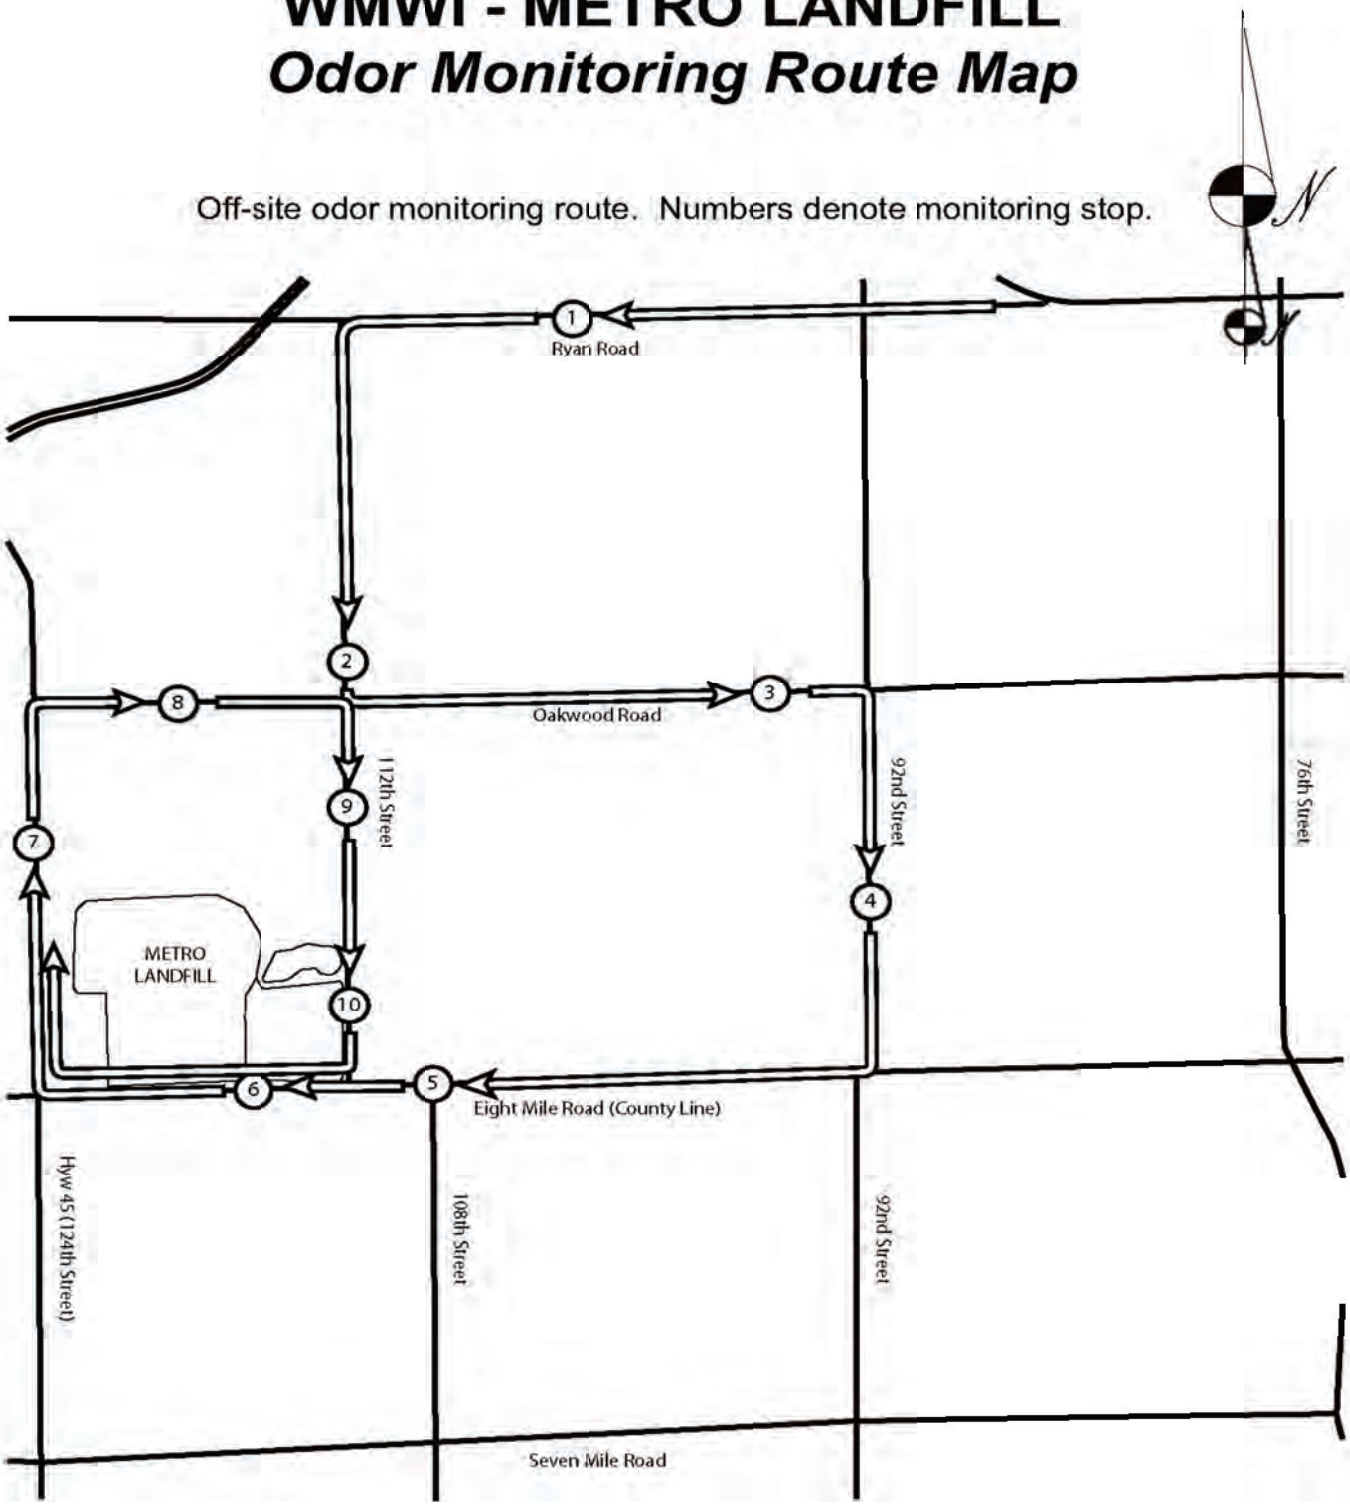
WMWI - METRO LANDFILL
Odor Monitoring Route Map

Off-site odor monitoring route. Numbers denote monitoring stop.
