2020 Year End Summary of Audits of the Emerald Park Landfill

Prepared For:
City of Muskego
Green For Life Emerald Park Landfill Standing Committee

2020 Green For Life Emerald Park Landfill Year End Compliance Officer Report and Audit Summary

TO: Advanced Disposal Services Emerald Park Standing Committee
FROM: Jo-Walter Spear, Jr., P.E.
COPIES: File
DATE: 03/29/2021
PROJECT NUMBER: 1012.10030

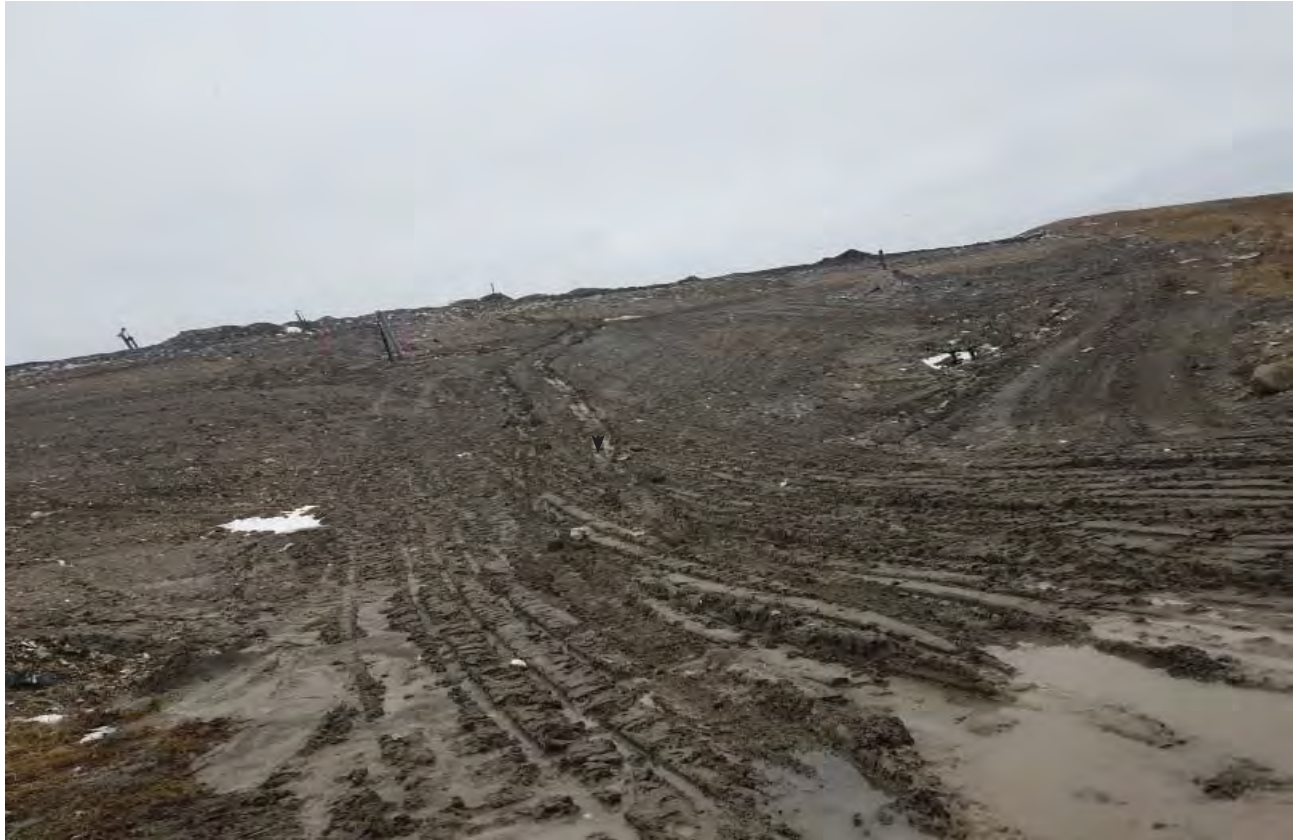
South slope of Phase 7 South, two new wells and well to be abandoned.

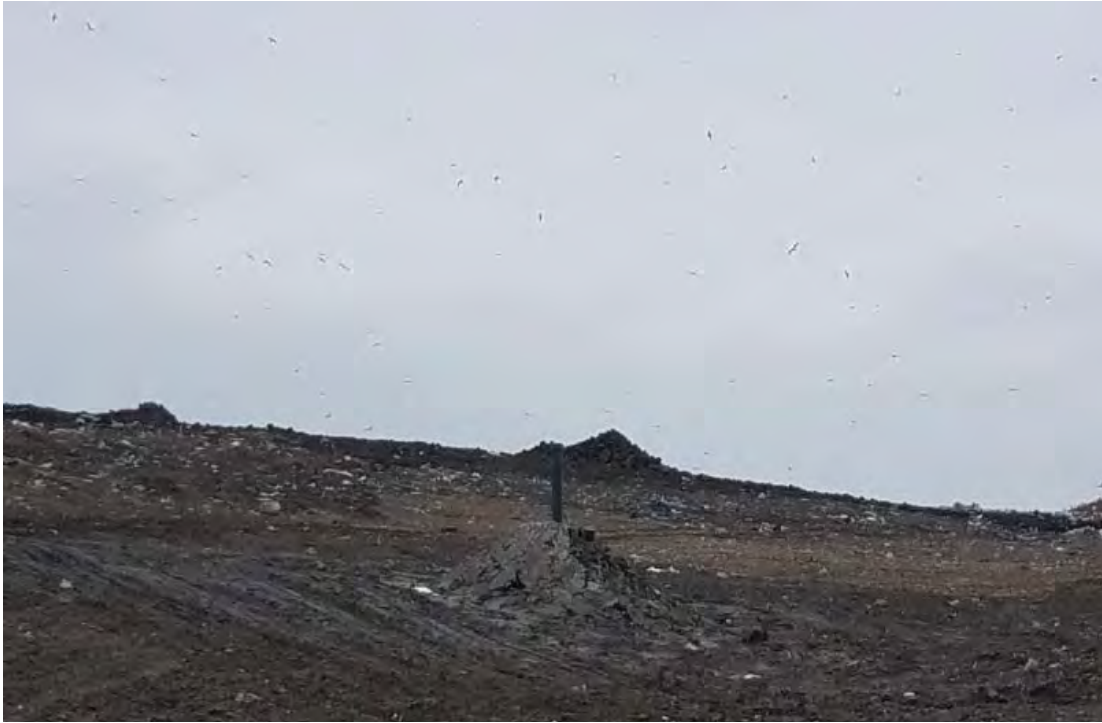
New well installed on Phase 7 South, South slope

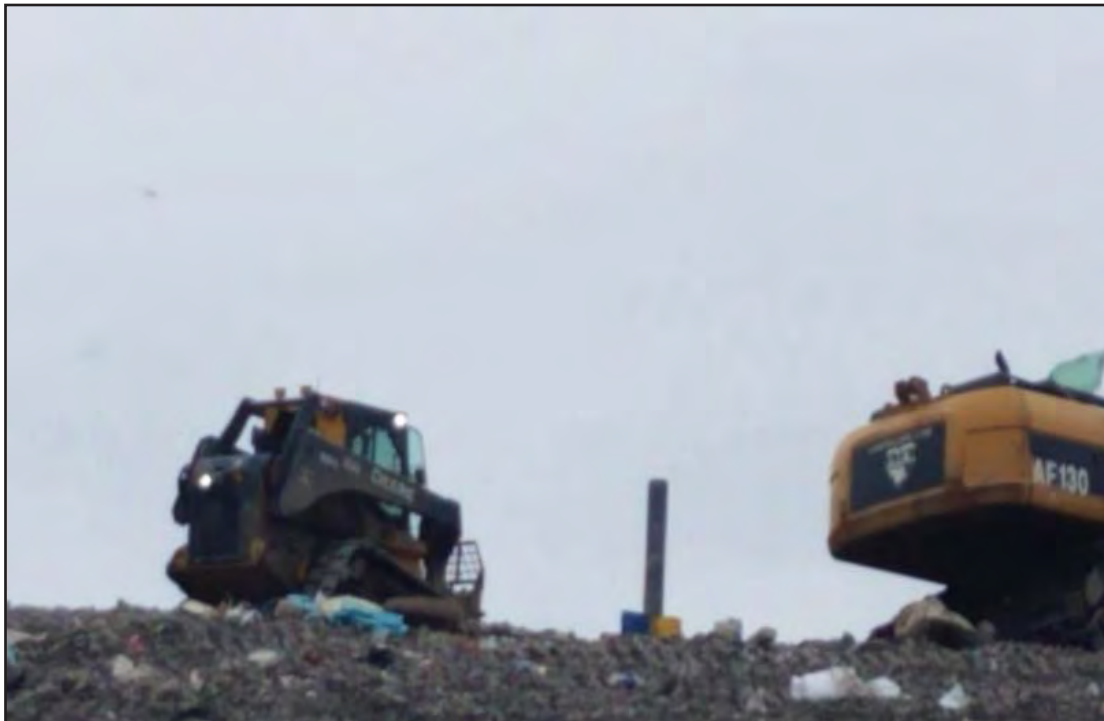
New well, last well to drill, being installed near Southwest corner of Phase 7 South

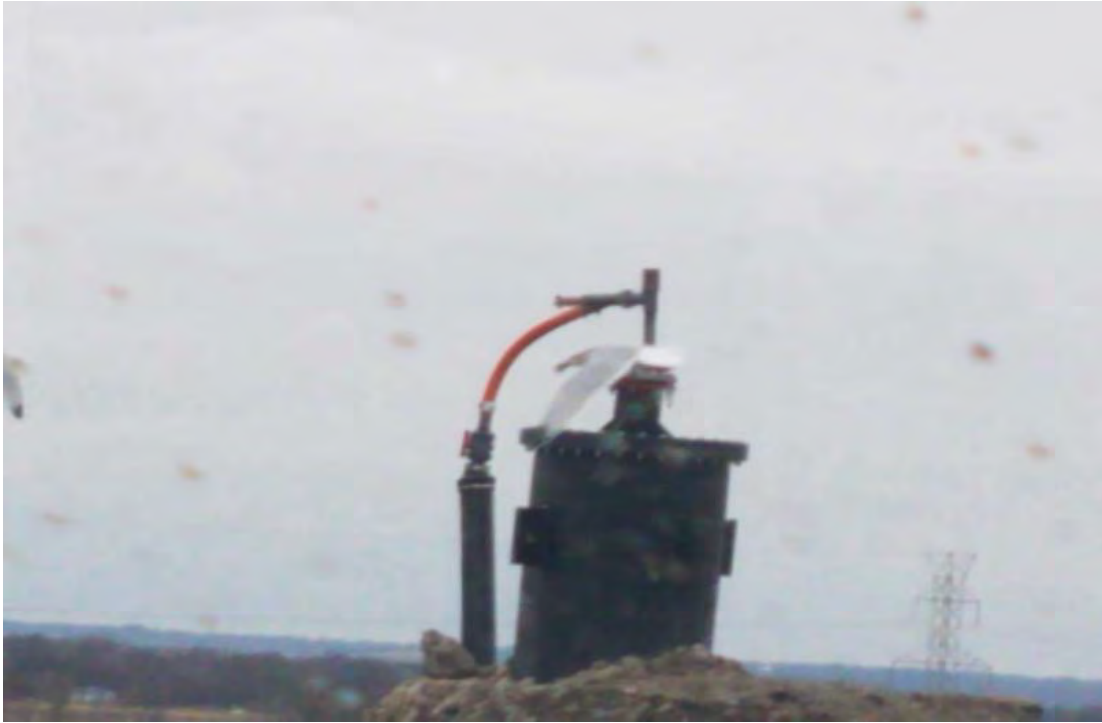
Cason well attached to gas collection system

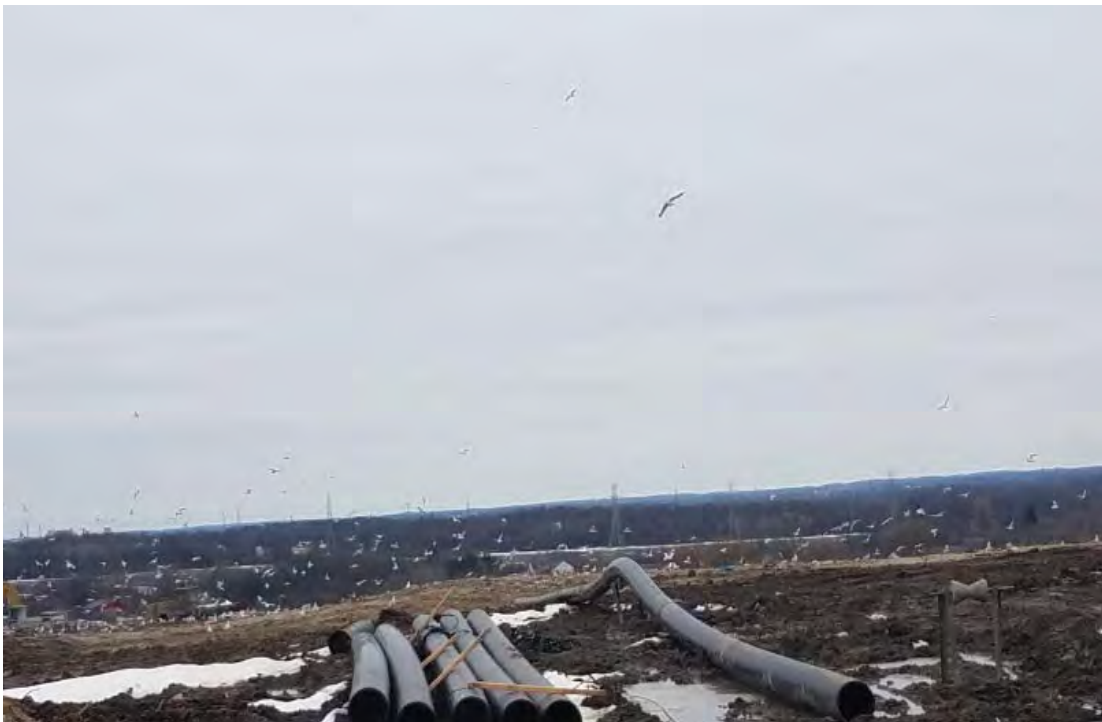
Phase 7 North, intermediate cover and pipe awaiting welding and use in gas collection system

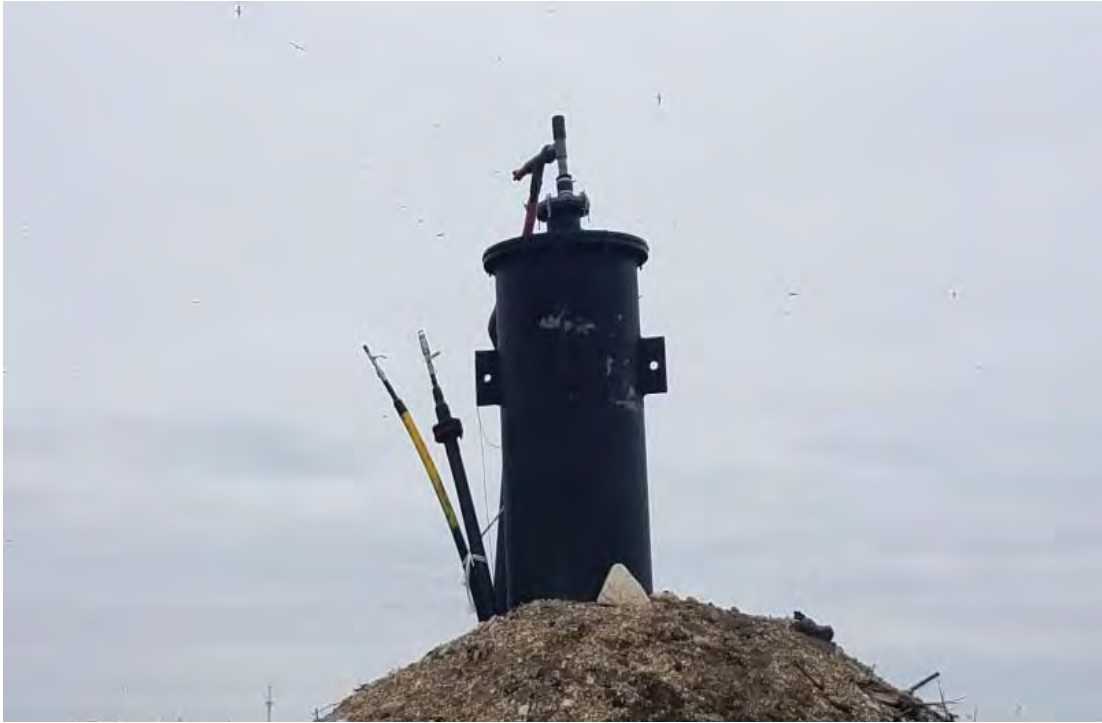
Existing cason well in Phase 7 North

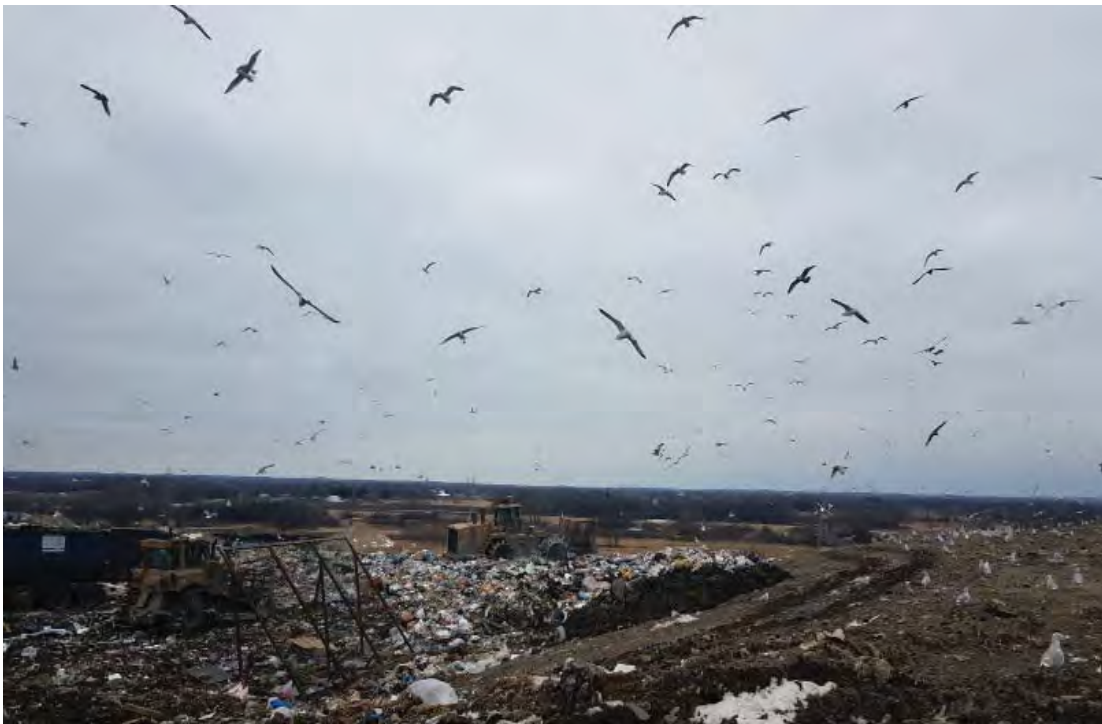
Active area viewed from the North

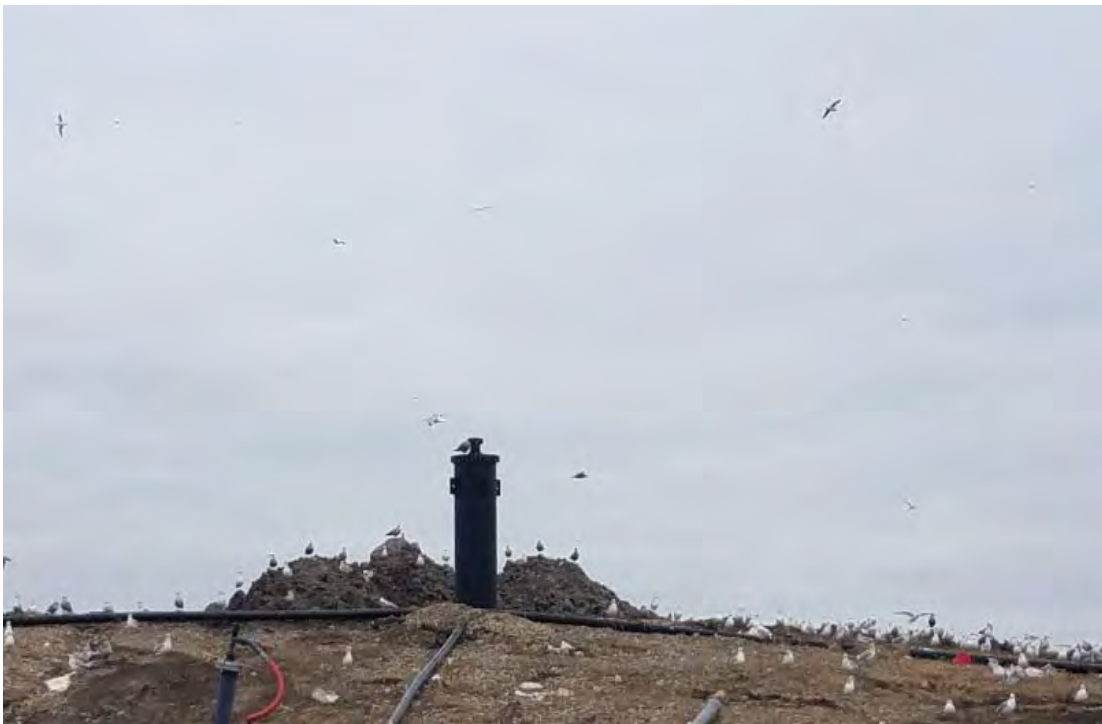
New gas well on top of Phase 5

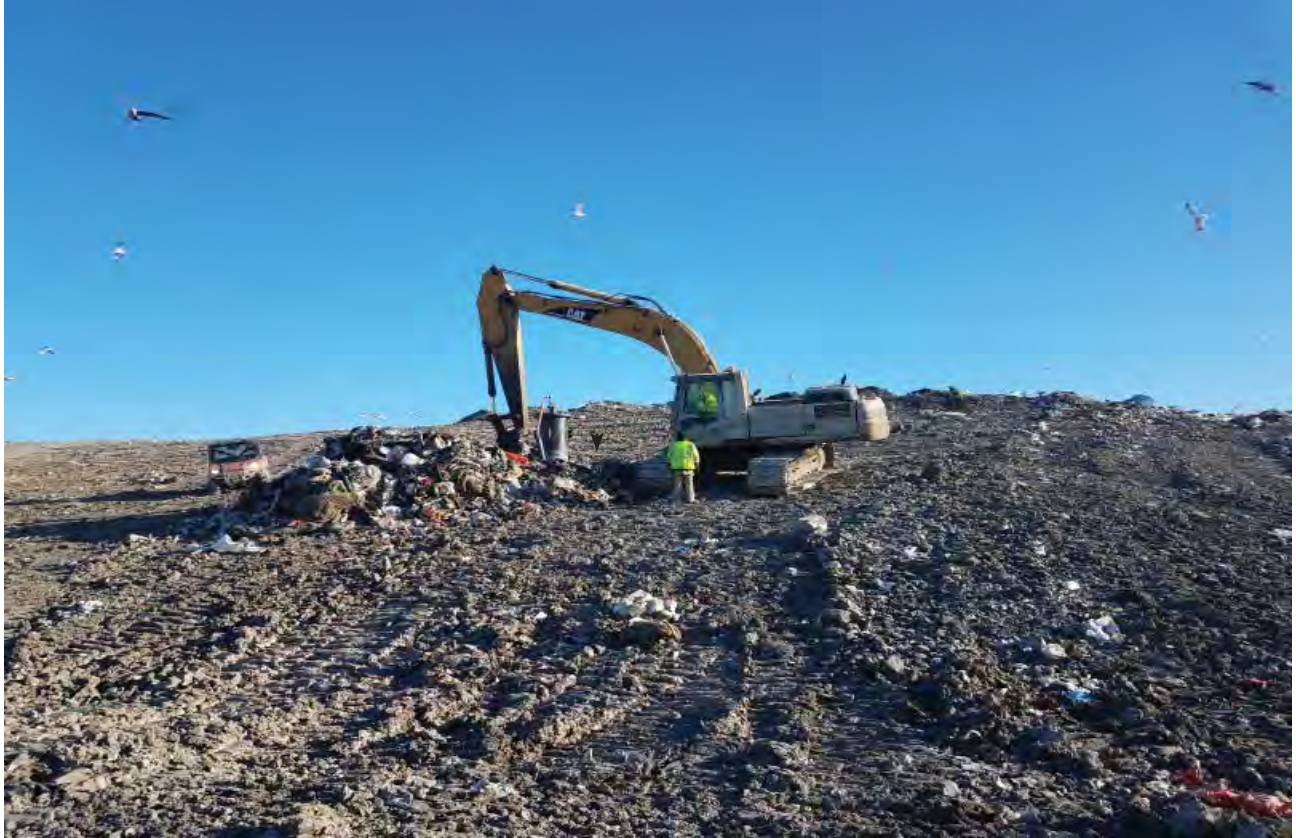
Site employees investigating location of possible oxygen intrusion to gas collection system

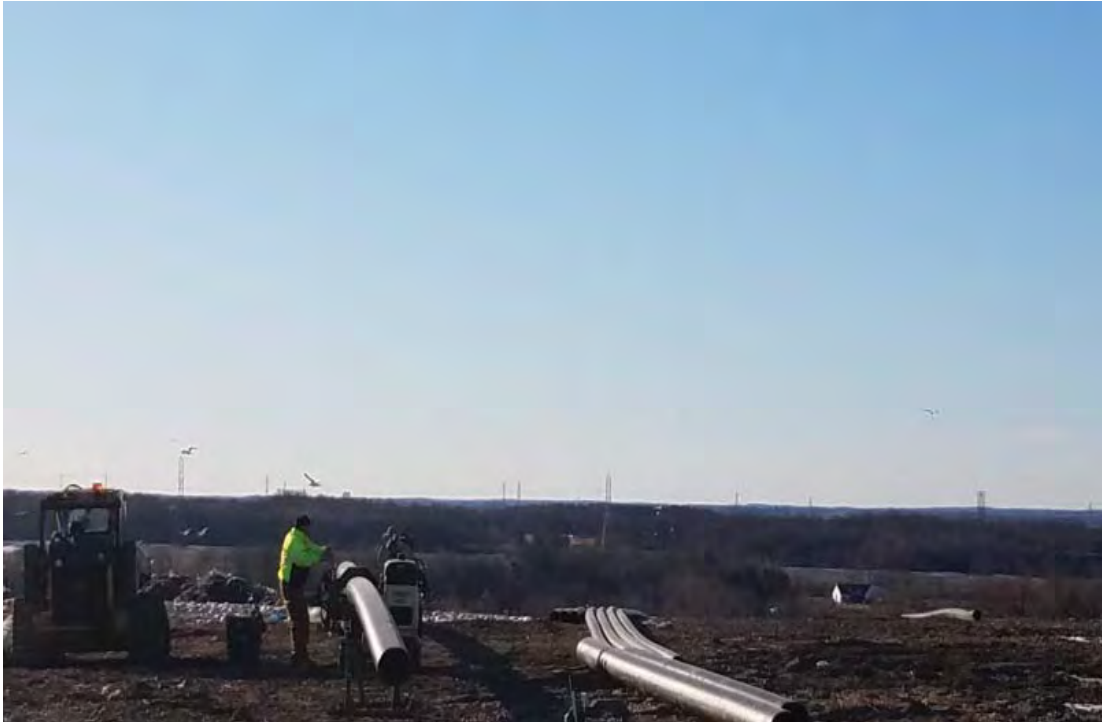
12" HDPE pipe welding, ongoing, to connect gas system to wells

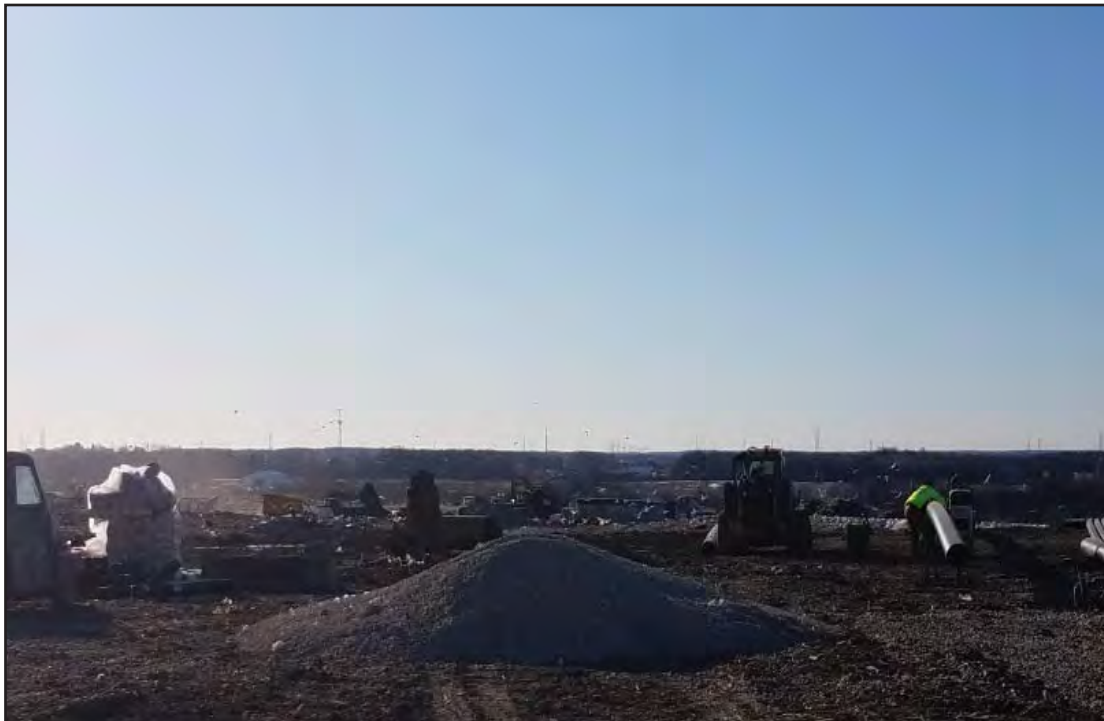
Contractor staging area on Phase 7 North

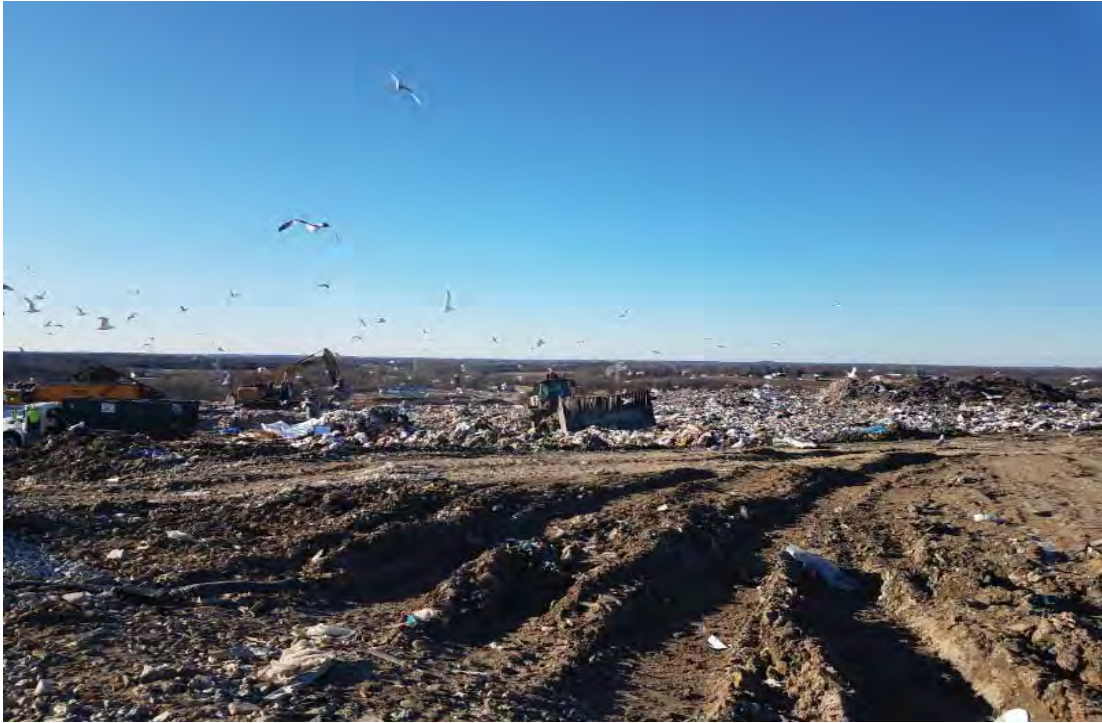
Working face in Northwest corner of Phase 7 South viewed from the North

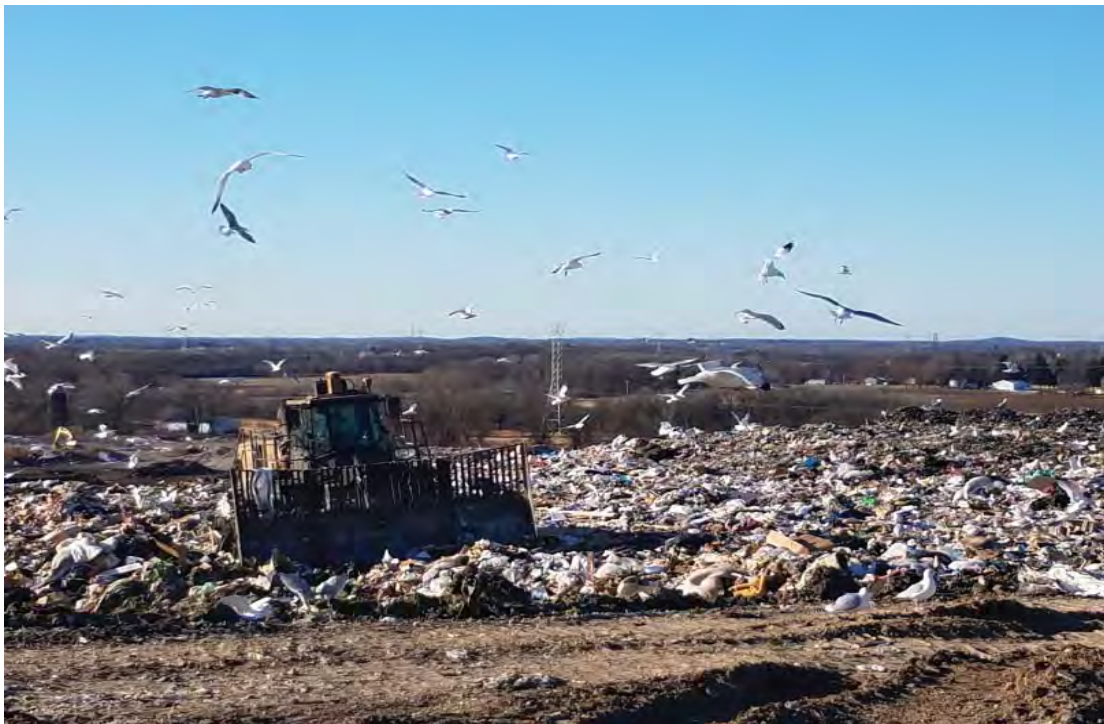
Compactor working in Phase 7 South, against Phase 7 North, nearly same elevation

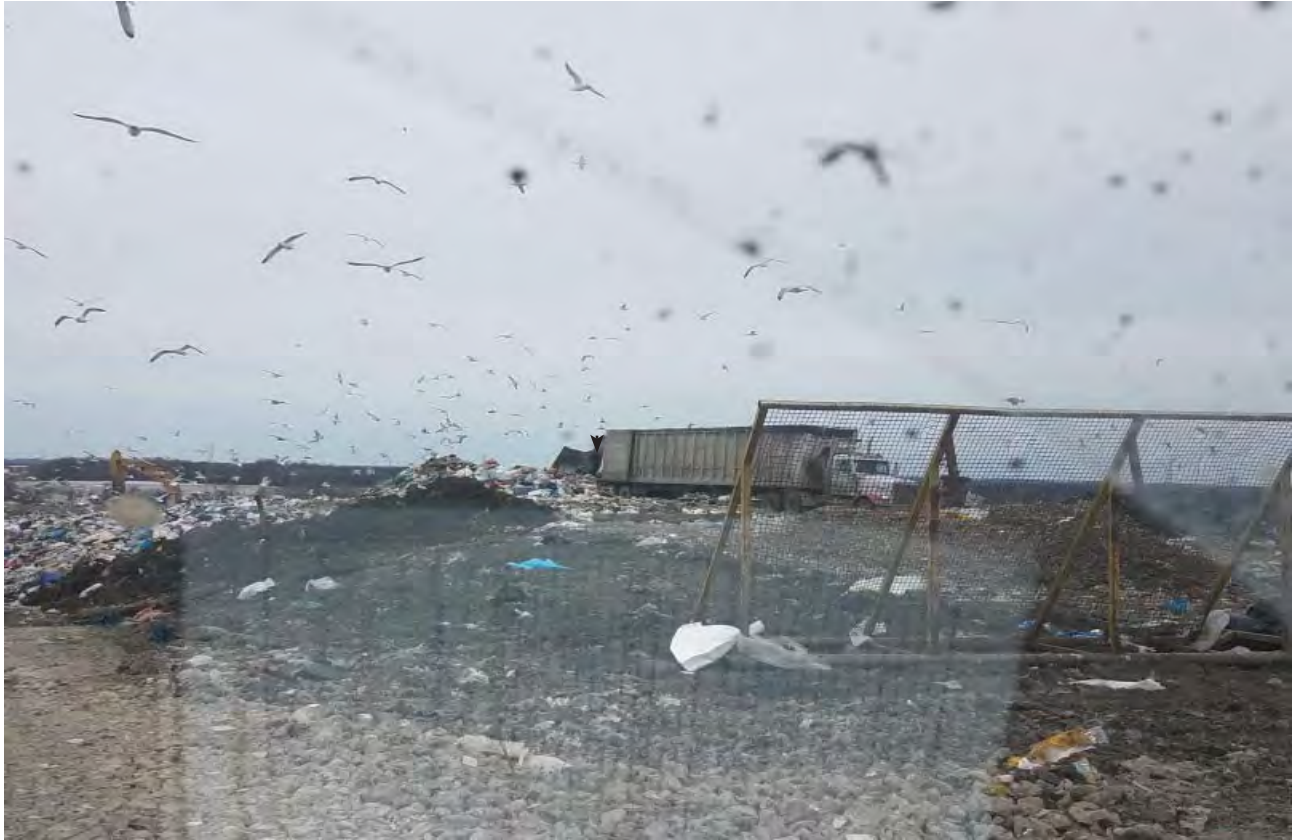
Working face viewed from the North, no good access point to take pictures during this audit

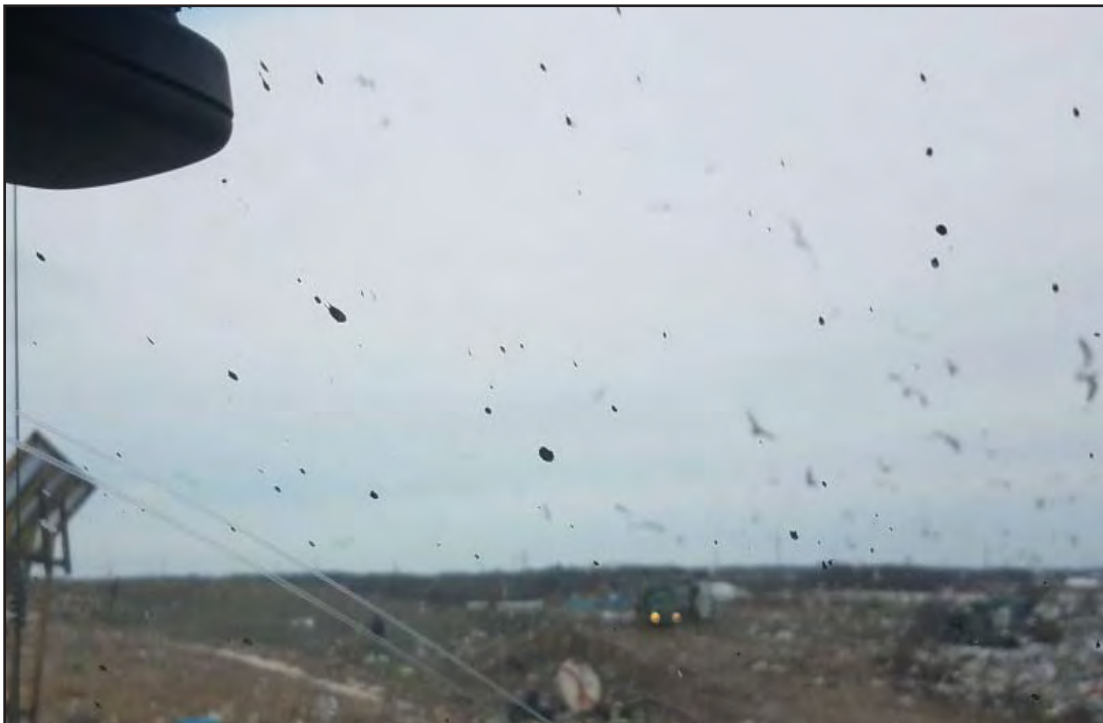
Active area viewed from the North

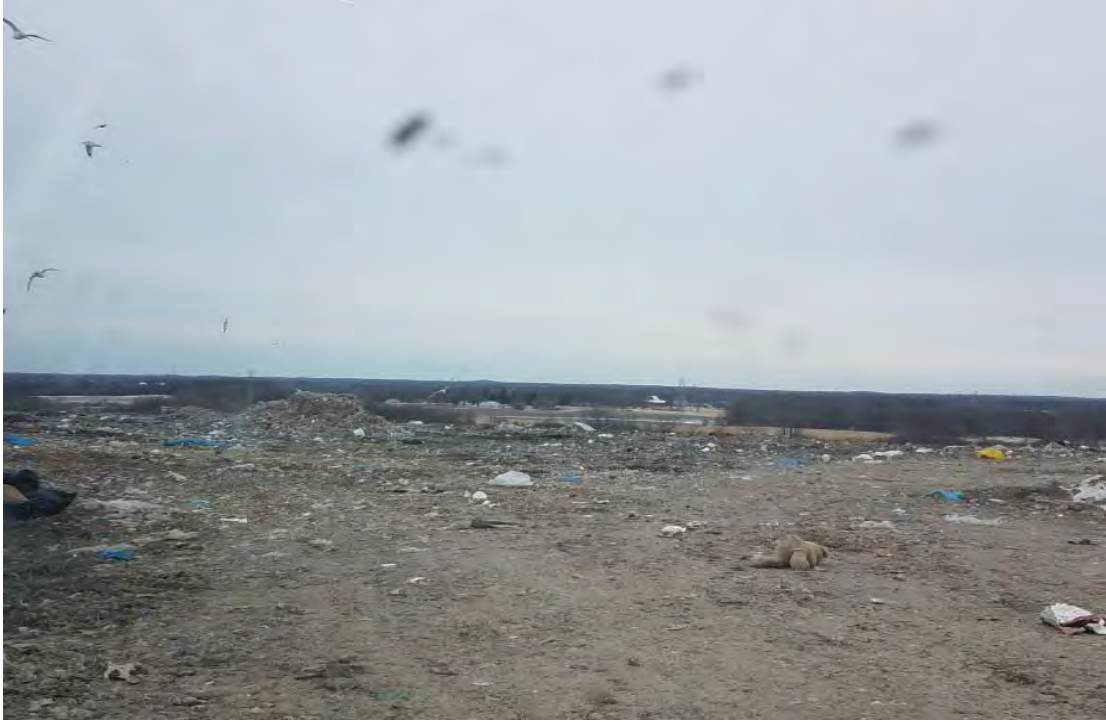
Daily cover stockpile in Phase 7 South viewed from the North

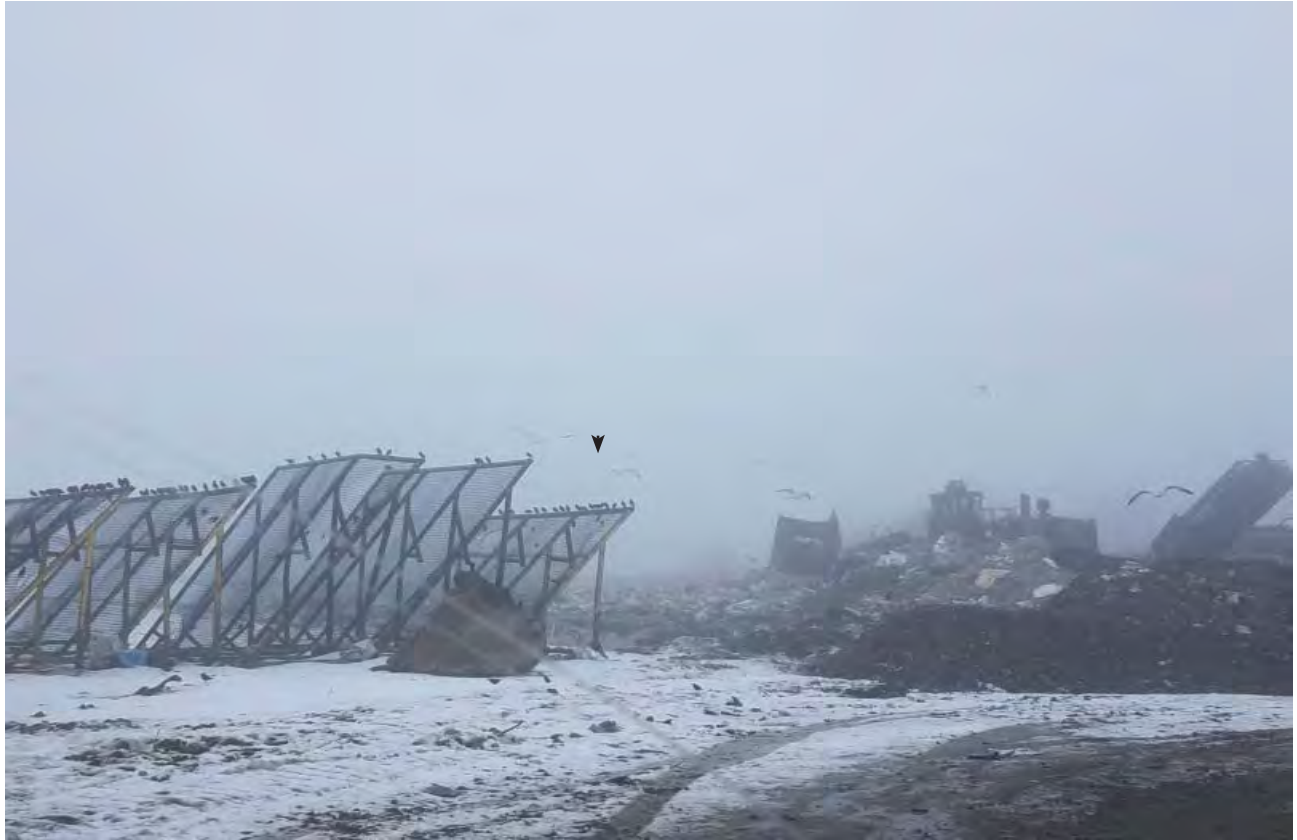
Working face viewed from the North. Cover stockpile to left

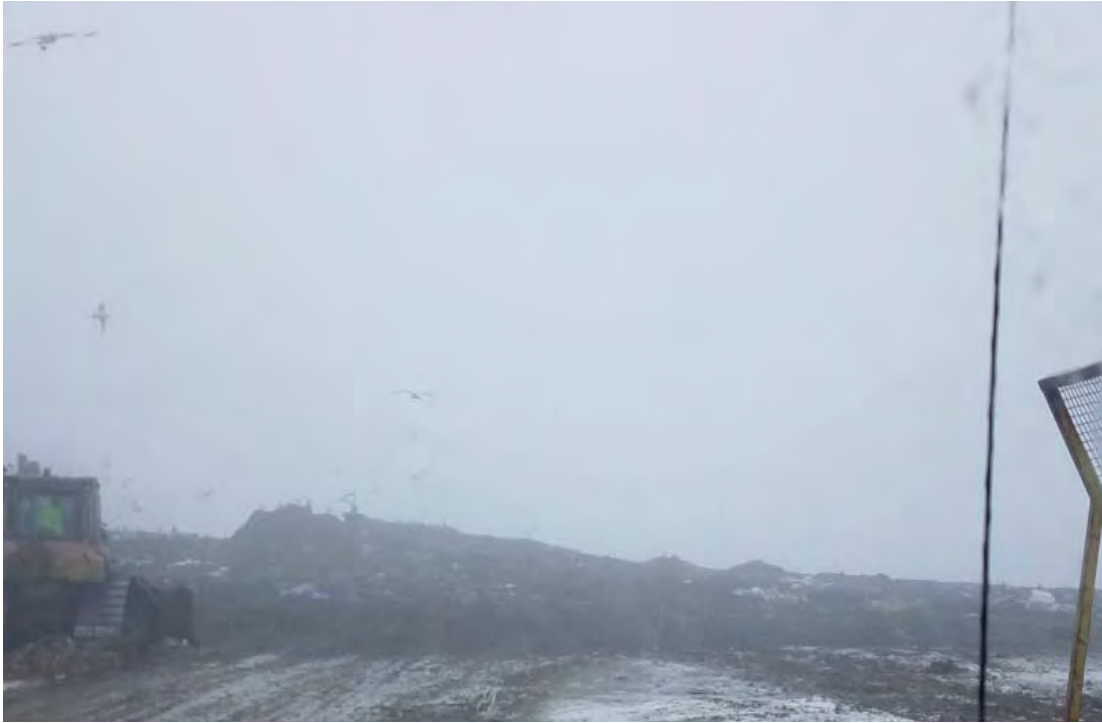
Mixed alternative daily cover (ADC) stockpiled for future cover

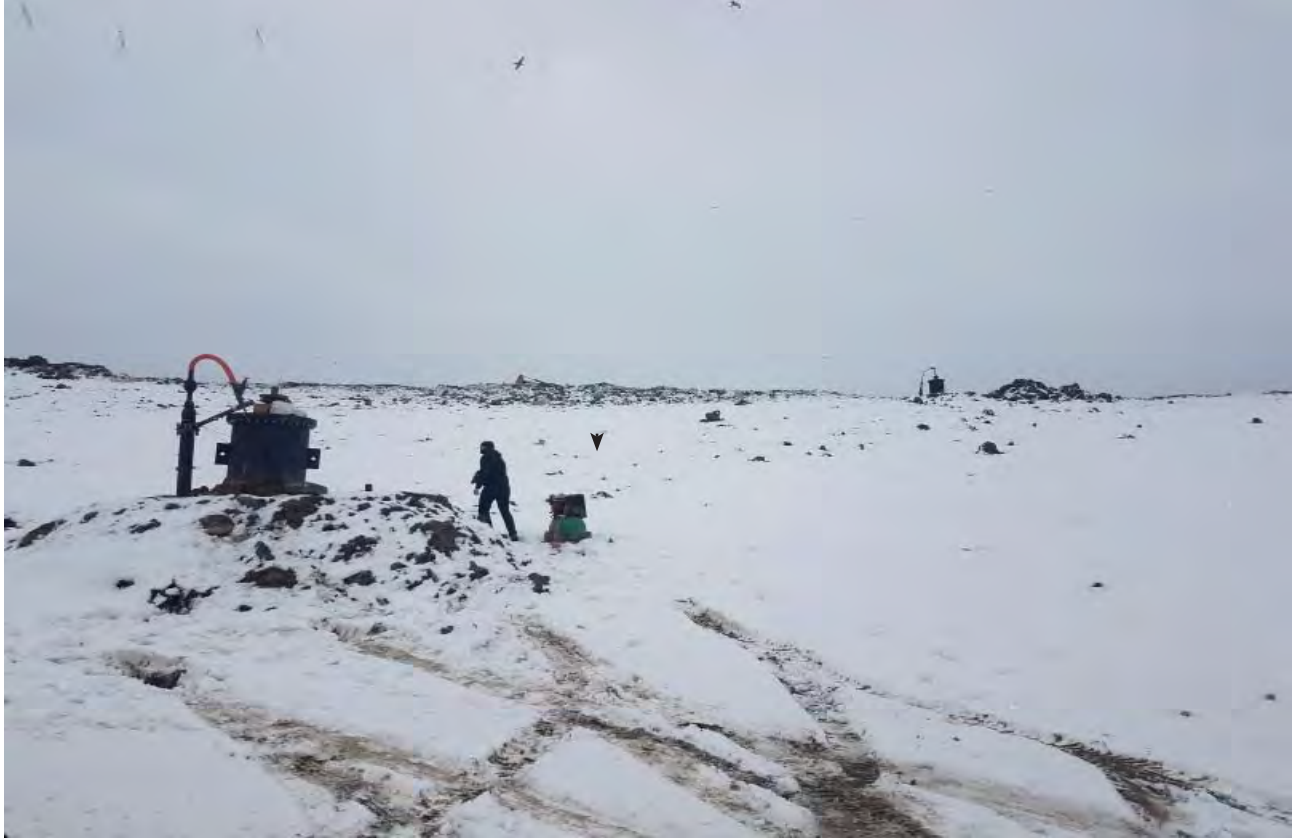
Well in West slope of Phase 7 South, well actively being pumped to remove water and allow gas collection

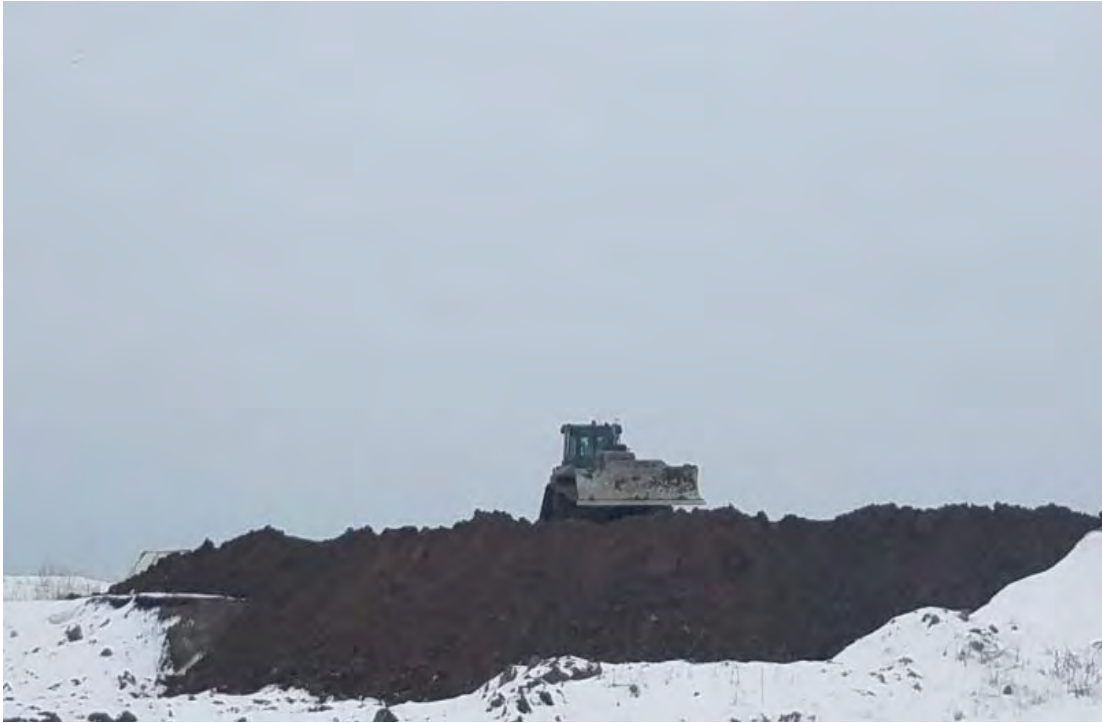
Tipped soil being stockpiled on Phase 3 for future use

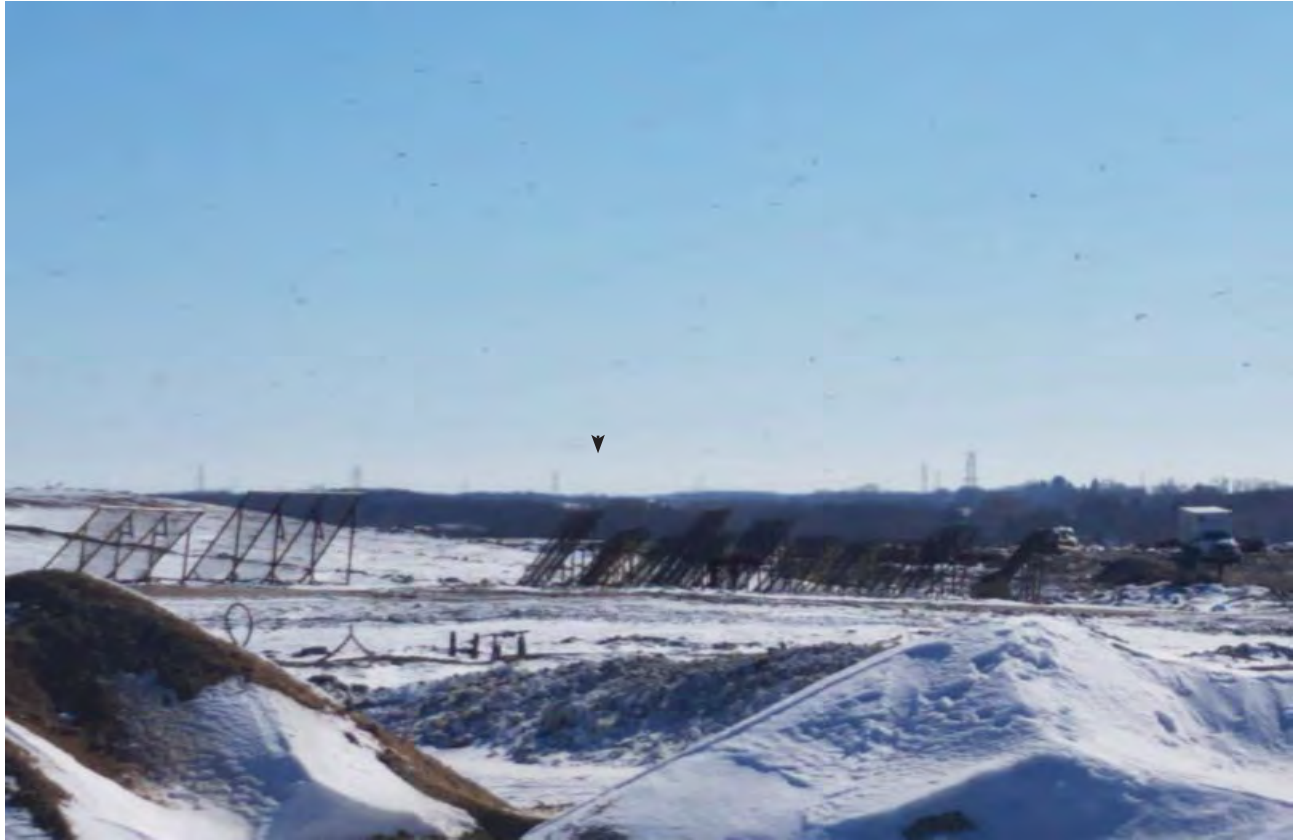
Fences placed to account for high winds

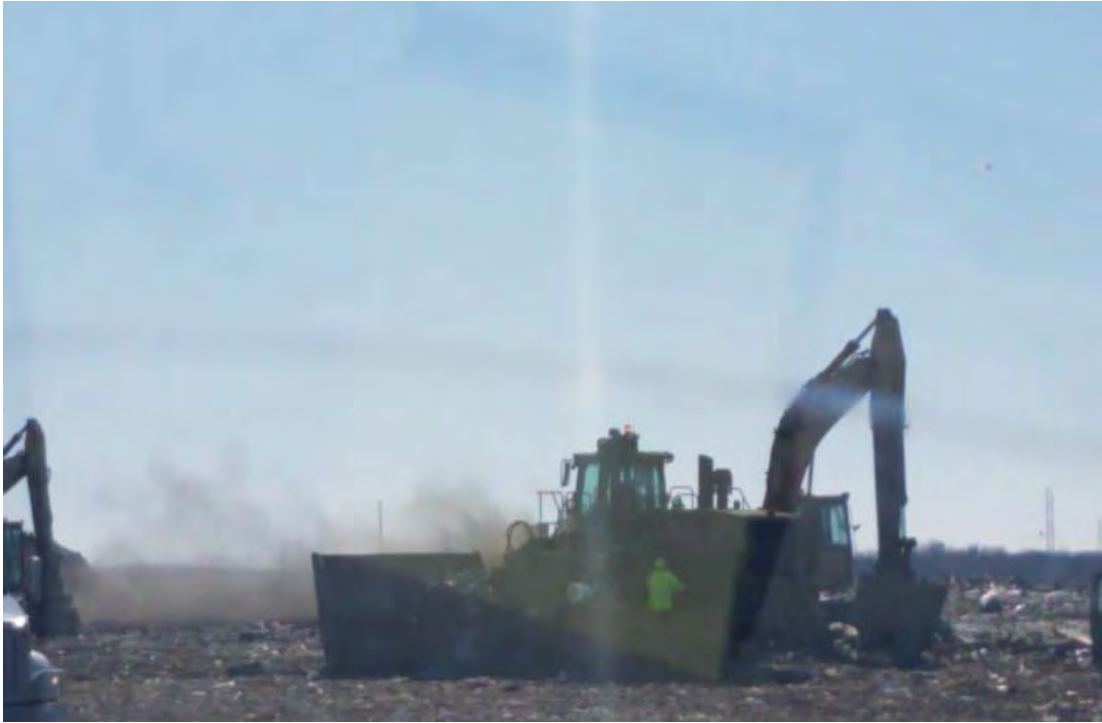
Compactor being cleaned out after dusty loads

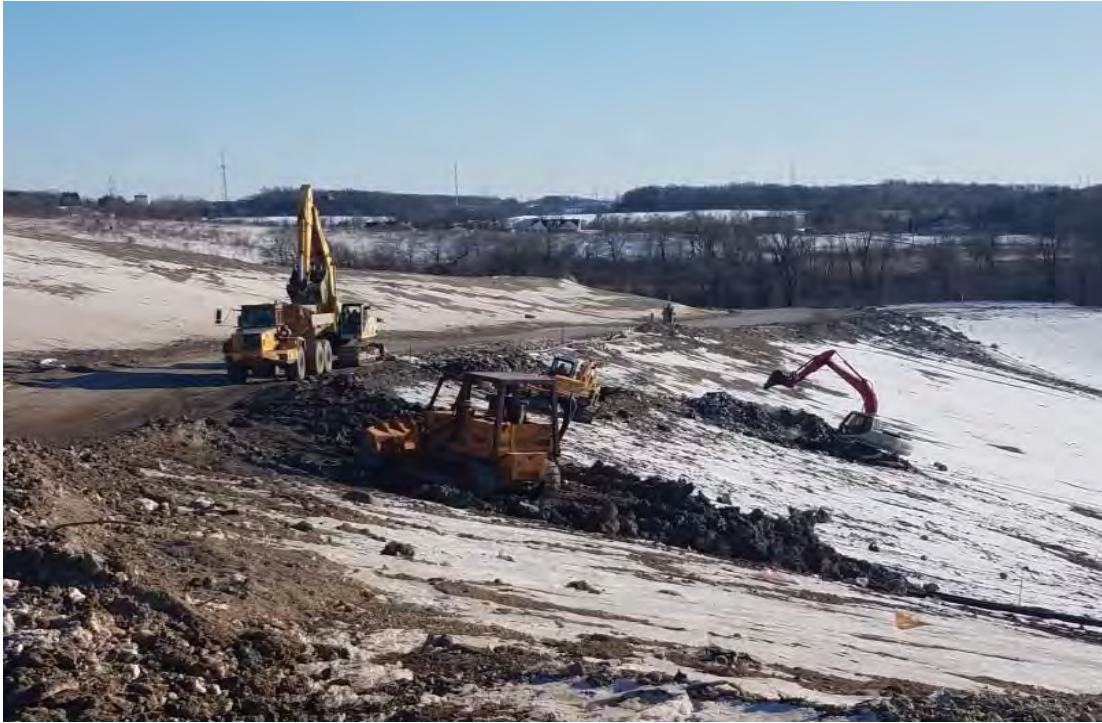
Seep repair and horizontal gas extraction trench construction on West slope of Phase 7; West of access road

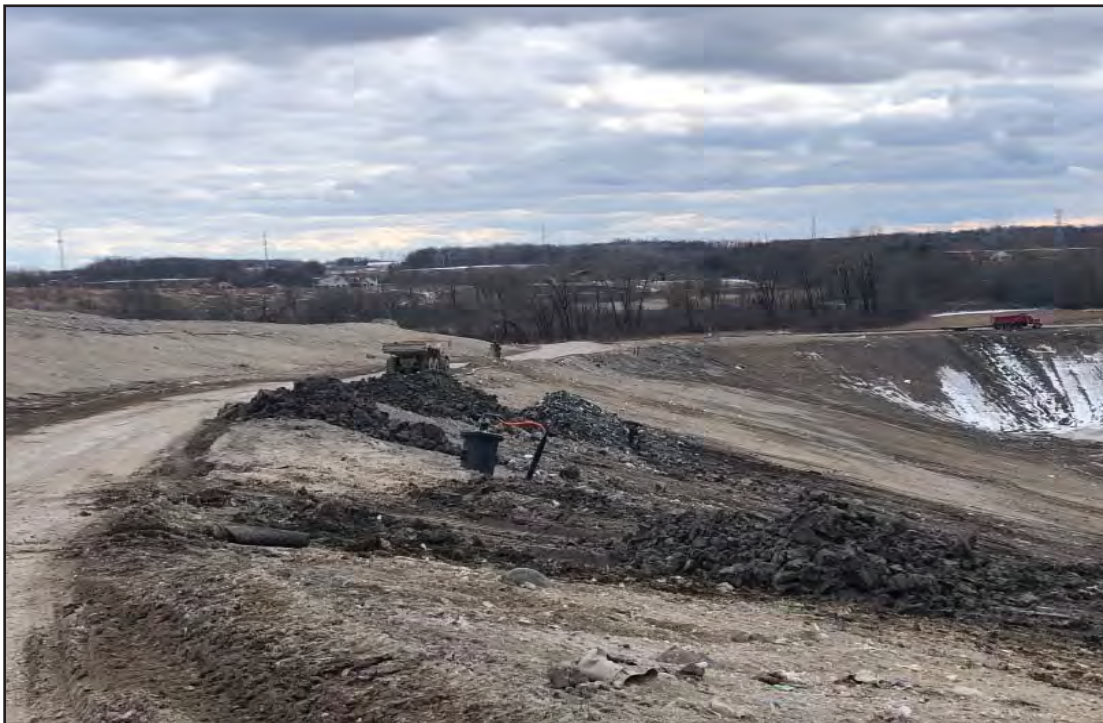
West slope of Phase 7 with completed horizontal wells and air supply

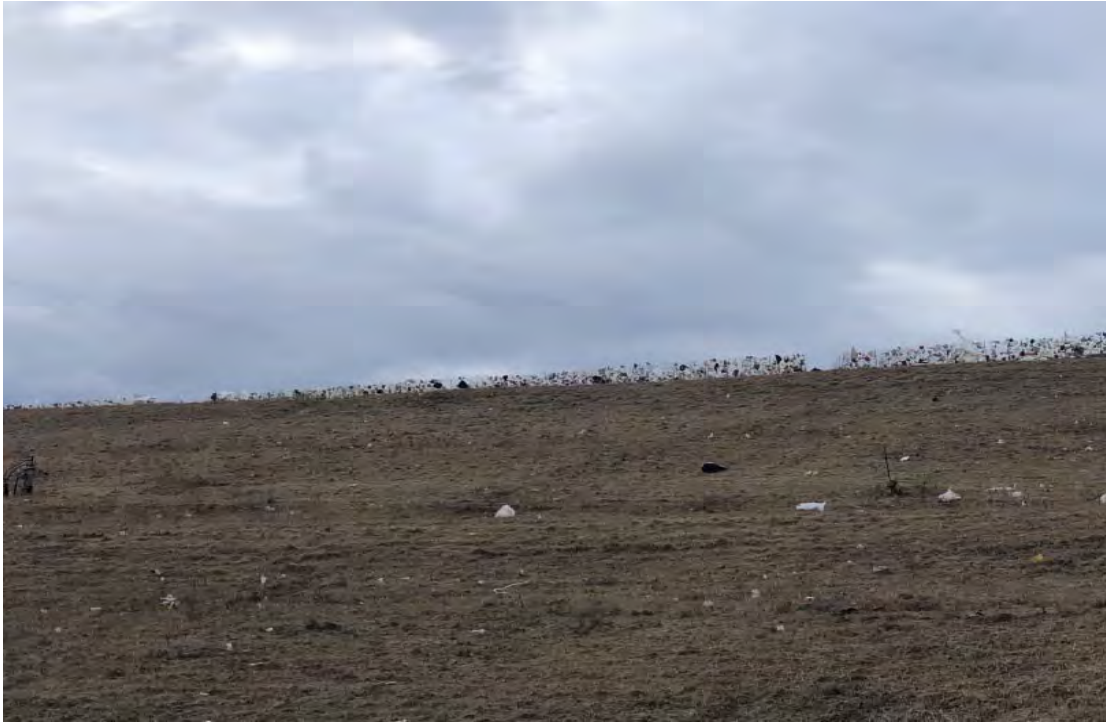
Capped slope with minor litter

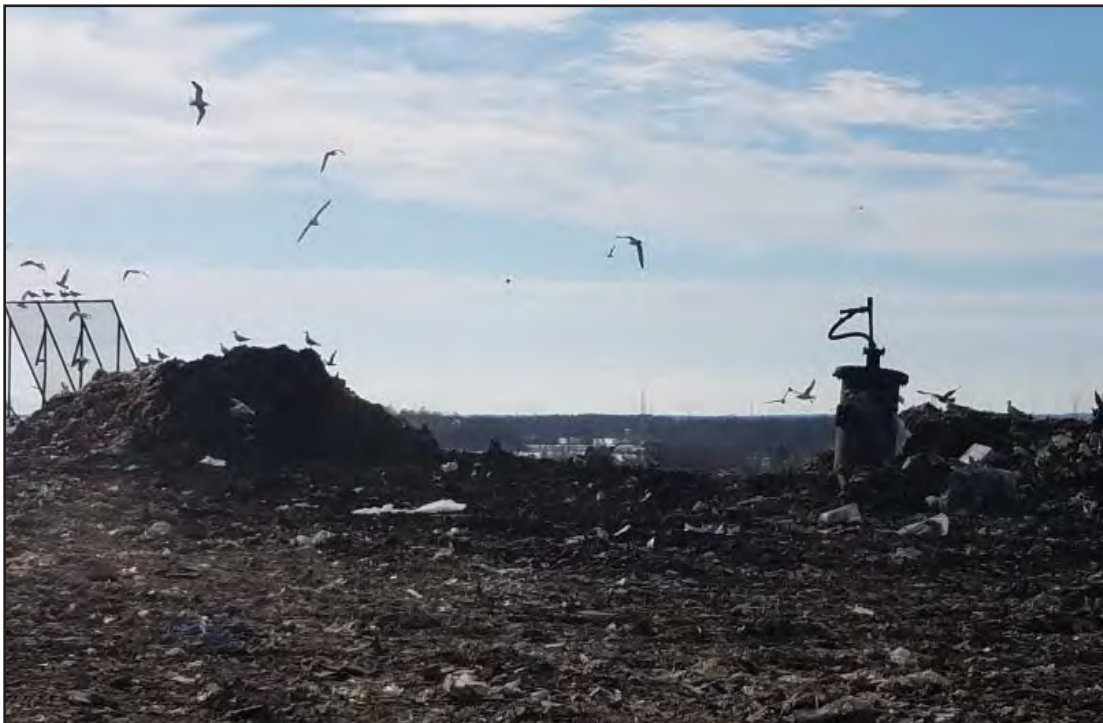
West edge of Phase 7 South, new well and ADC stockpile
