2020 Year End Summary of Audits of the Emerald Park Landfill

Prepared For:
City of Muskego
Green For Life Emerald Park Landfill Standing Committee

2020 Green For Life Emerald Park Landfill Year End Compliance Officer Report and Audit Summary

TO: Advanced Disposal Services Emerald Park Standing Committee
FROM: Jo-Walter Spear, Jr., P.E.
COPIES: File
DATE: 03/29/2021
PROJECT NUMBER: 1012.10030

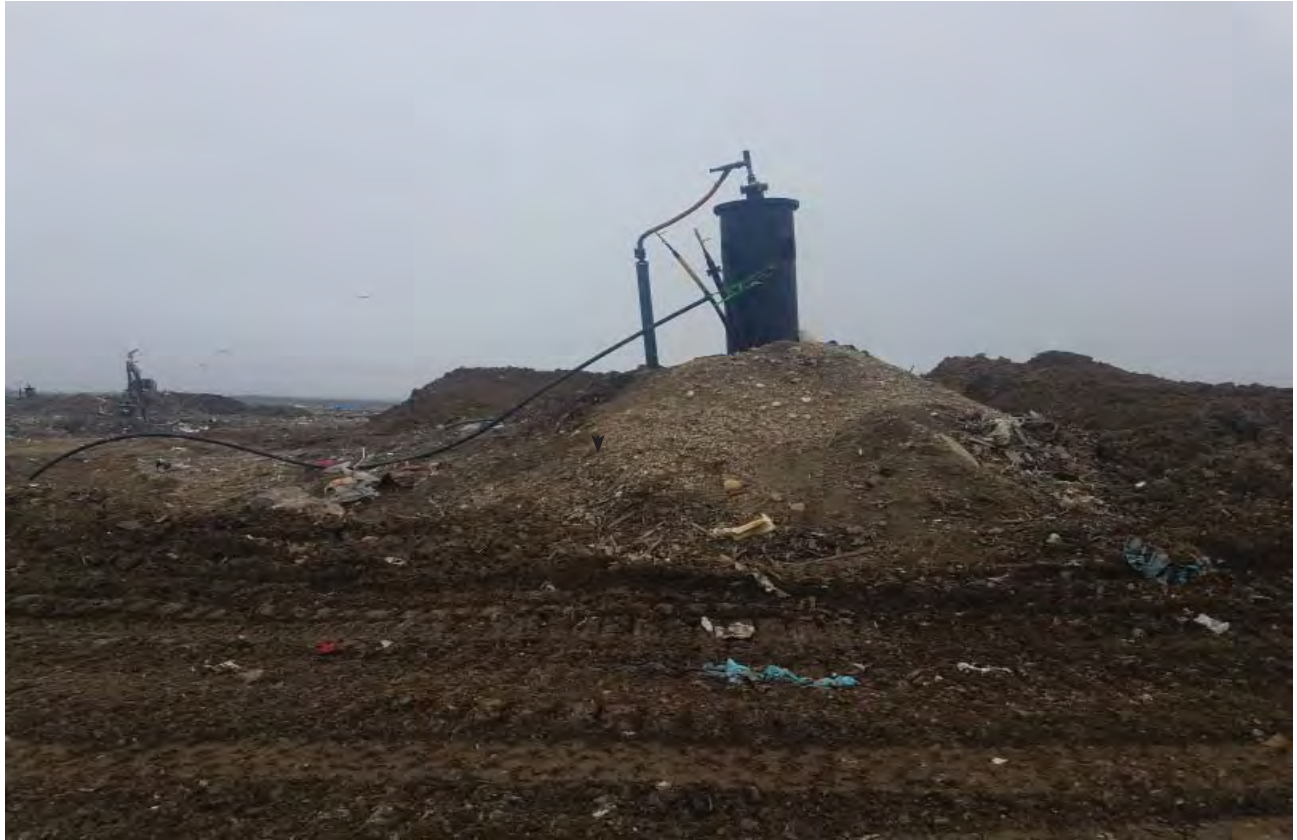
Raised well in Phase 7 North

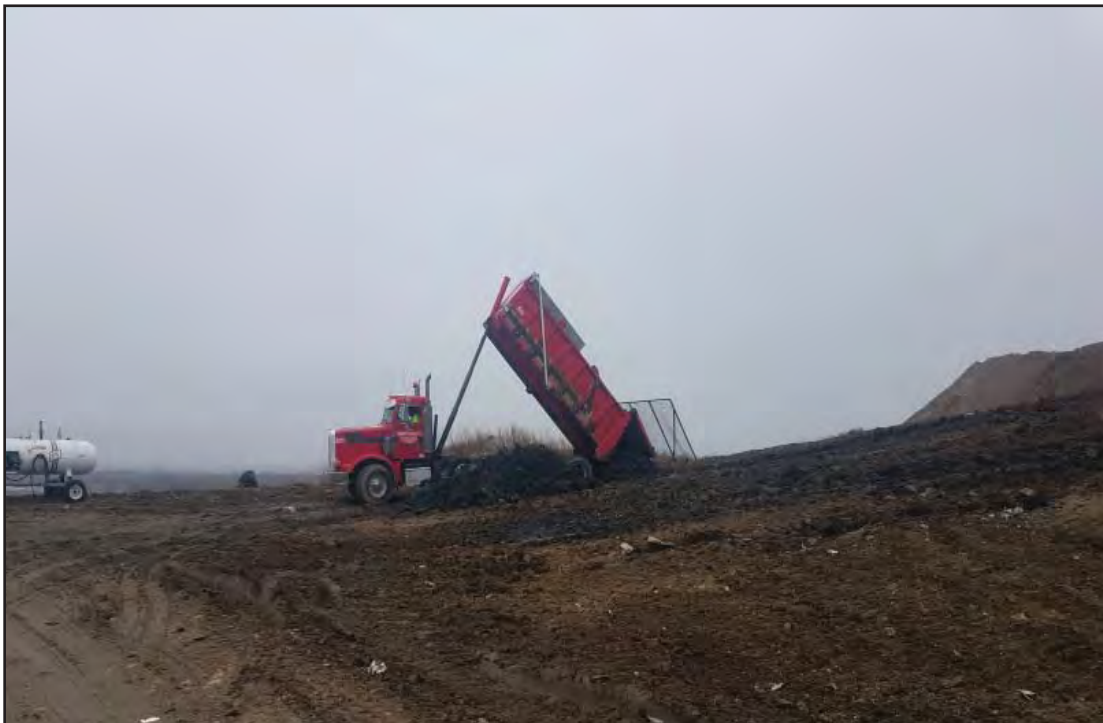
Soils tipping at North end of Phase 7

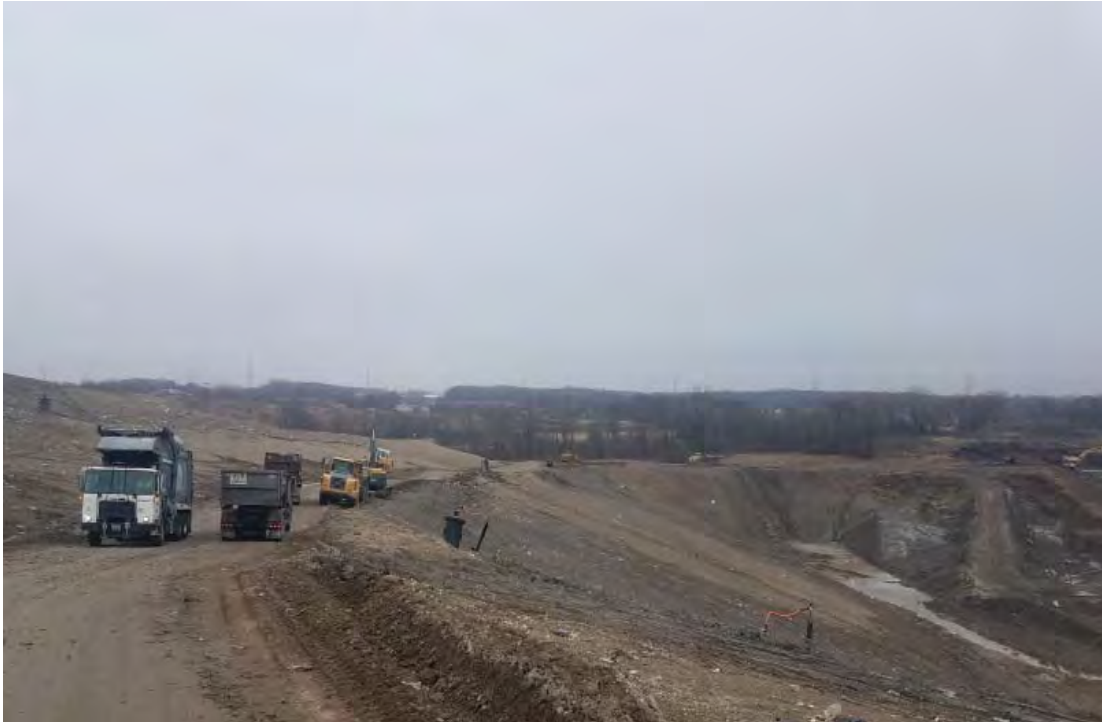
Installation of air line and force main by trenching and backfilling along West slope of Phase 7

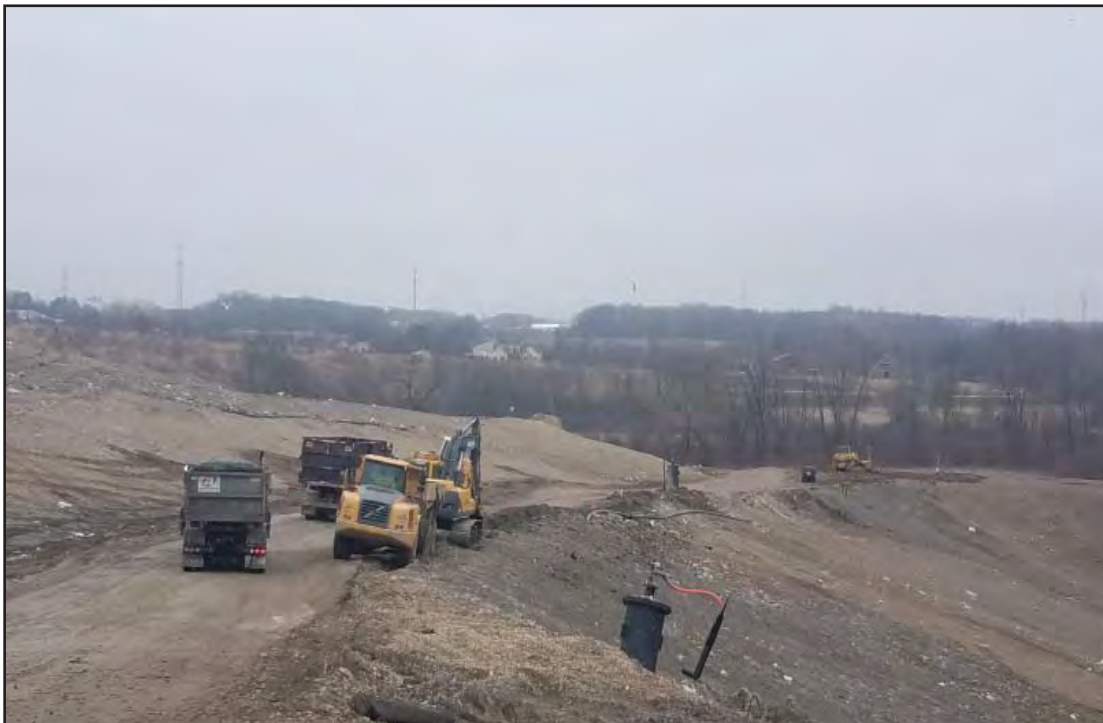
Installation of air line and force main by trenching and backfilling

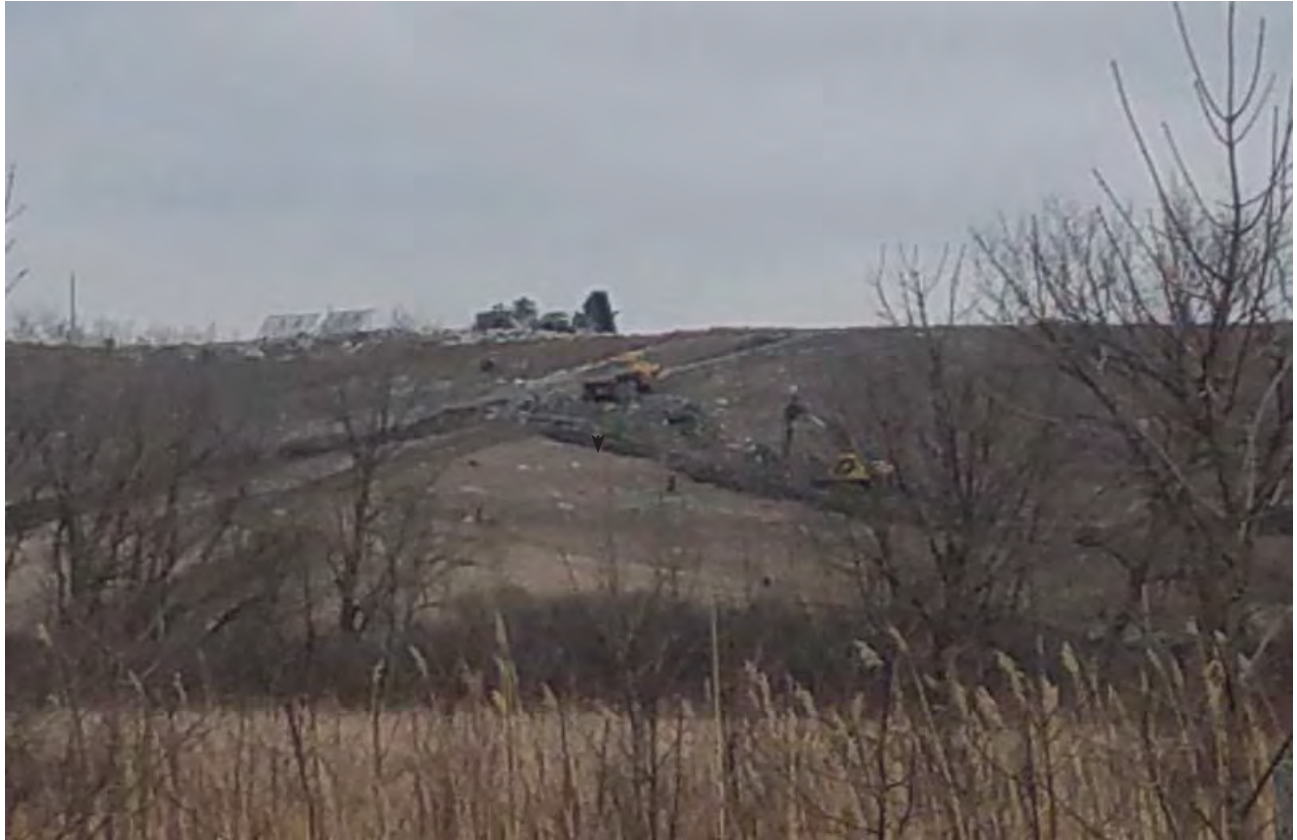
Trenching on Phase 7 slopes for the installation of air and force main lines

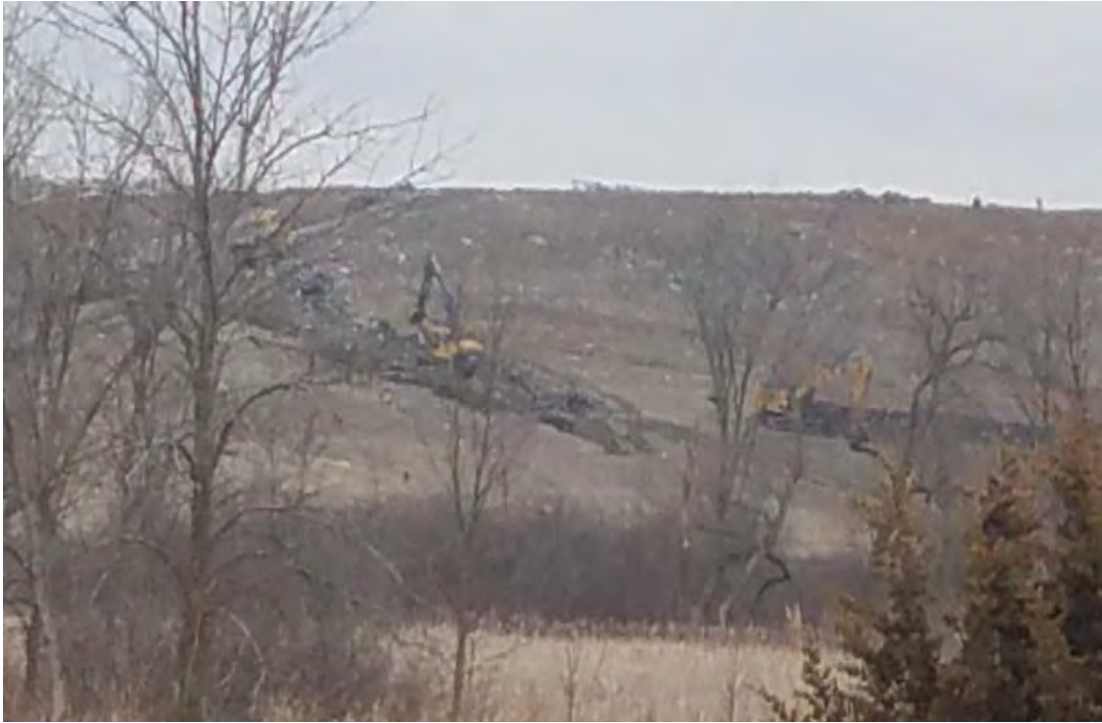
Trenching on Phase 7 slopes for the installation of air and force main lines

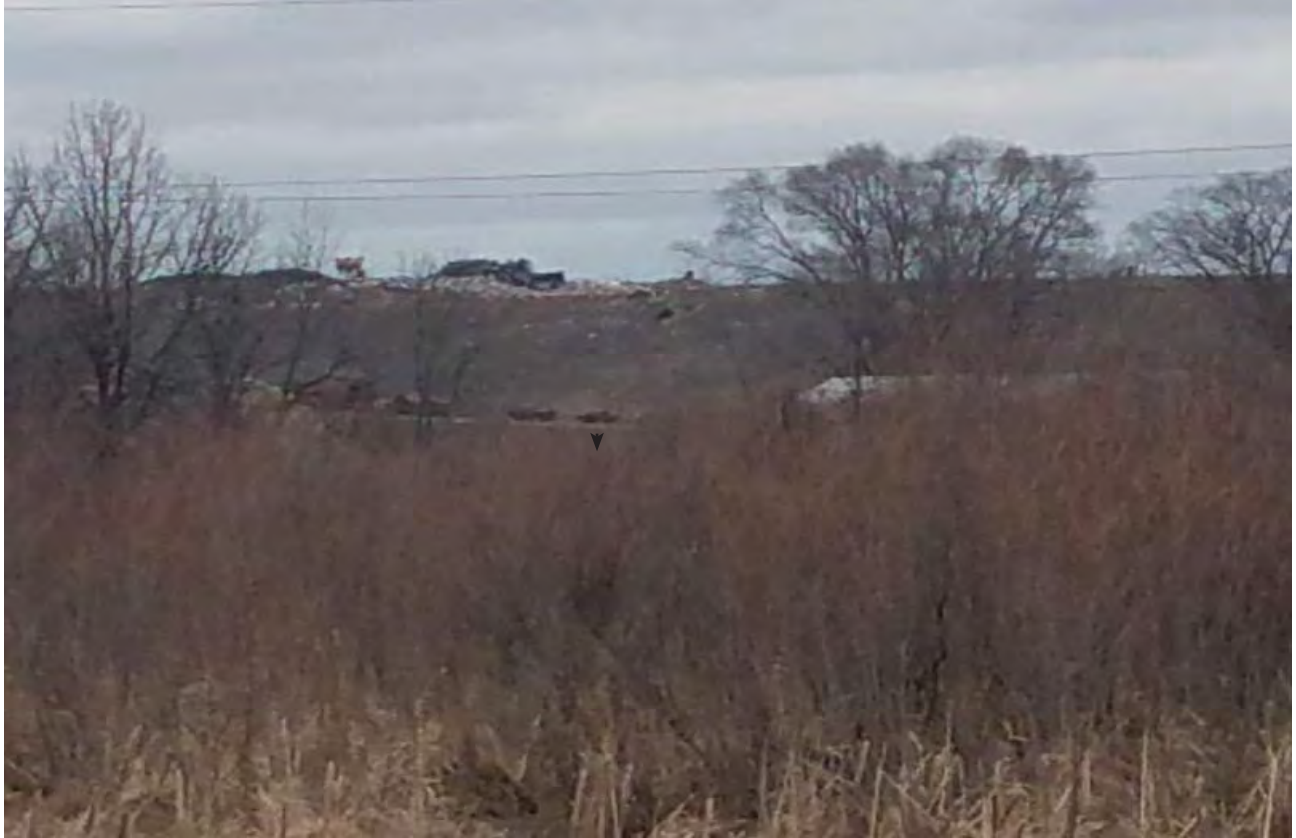
Working face and trenching project viewed from Union Church Road from the South

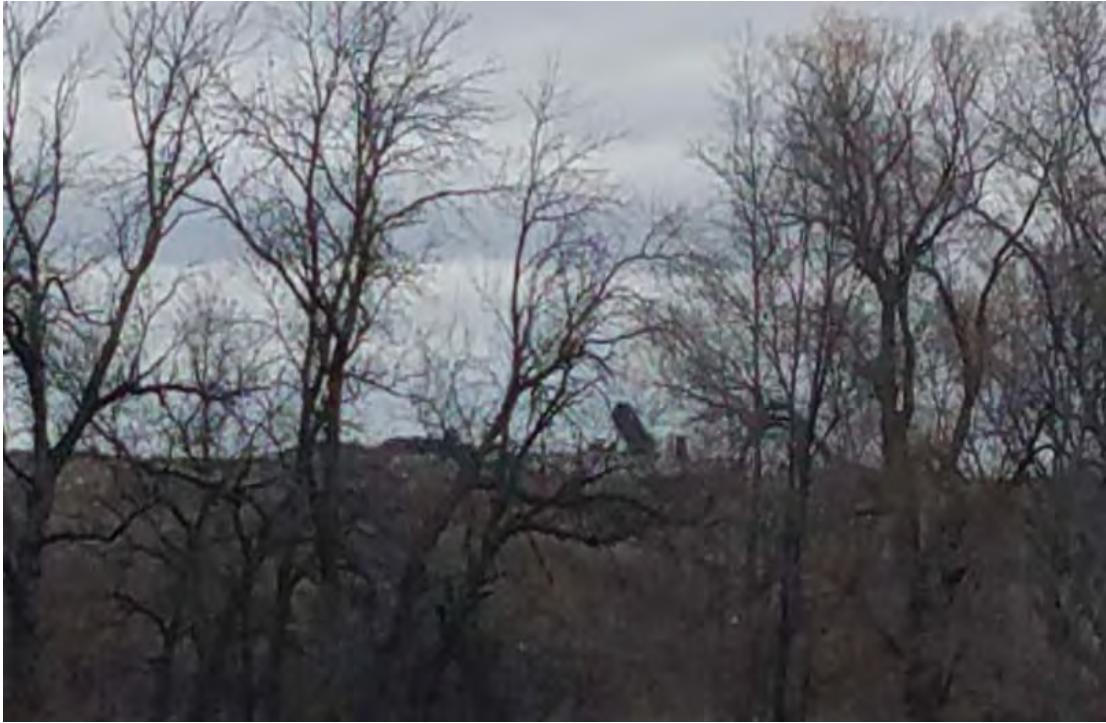
Working face on top of Phase 7 South

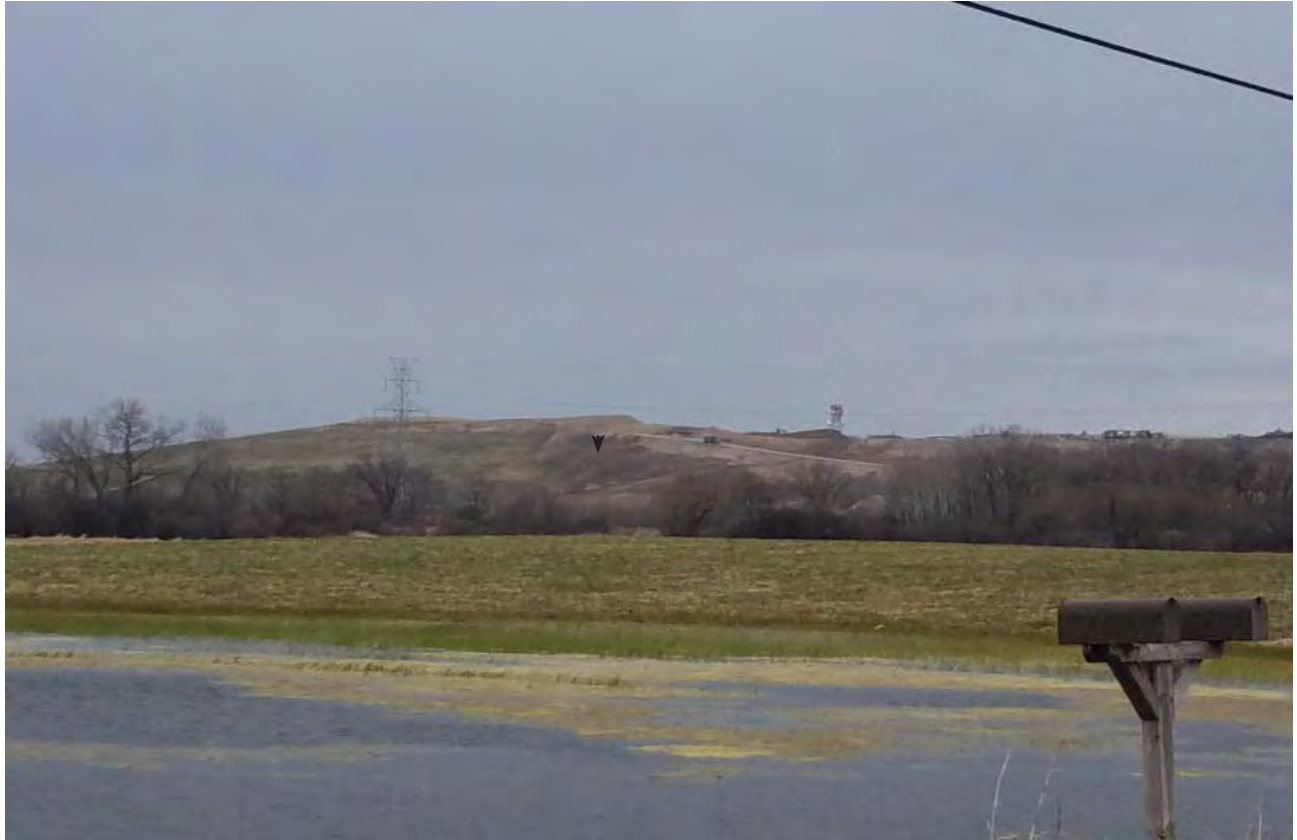
Working face viewed from Union Church Road from the South. Trenching project on South slopes blocked by trees

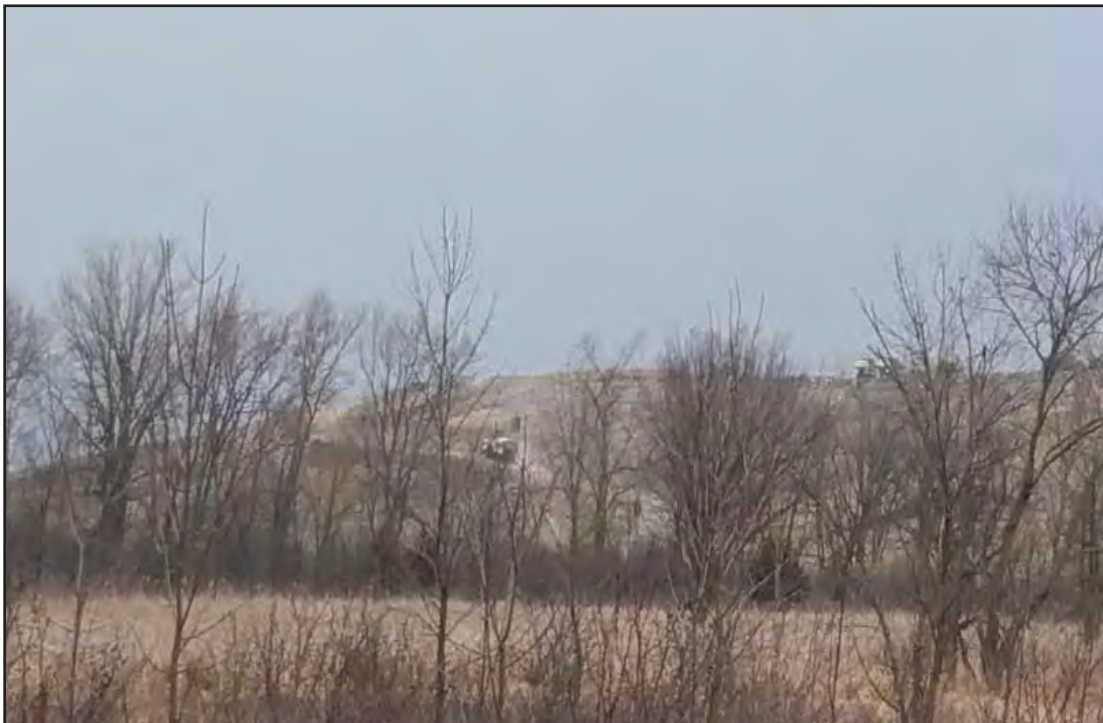
Trenching complete on West slopes

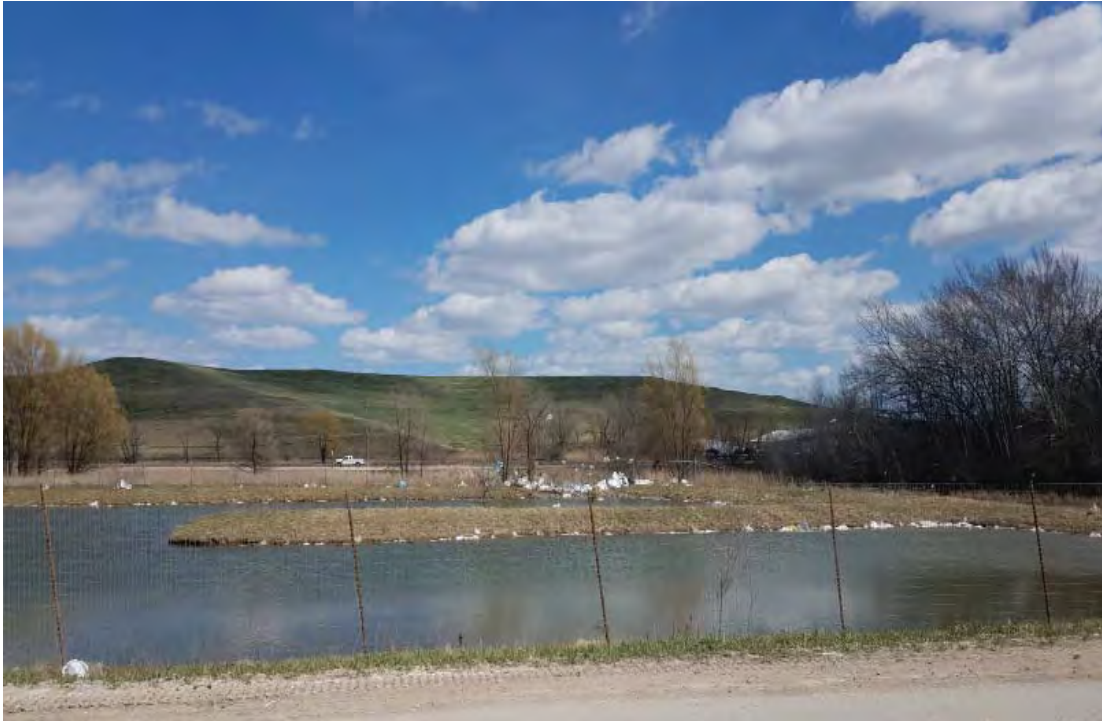
Litter around basin, but still on site

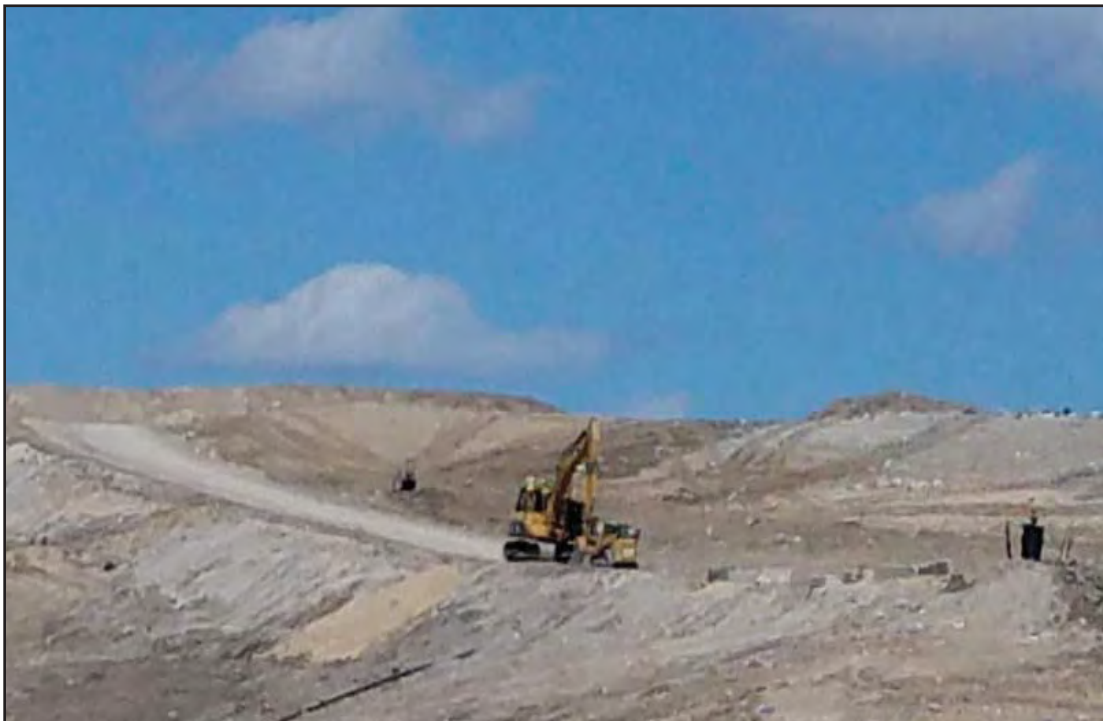
Basins are draining and site slope repairs ongoing where trenching occurred.

Trenching complete on West slopes and slope patched

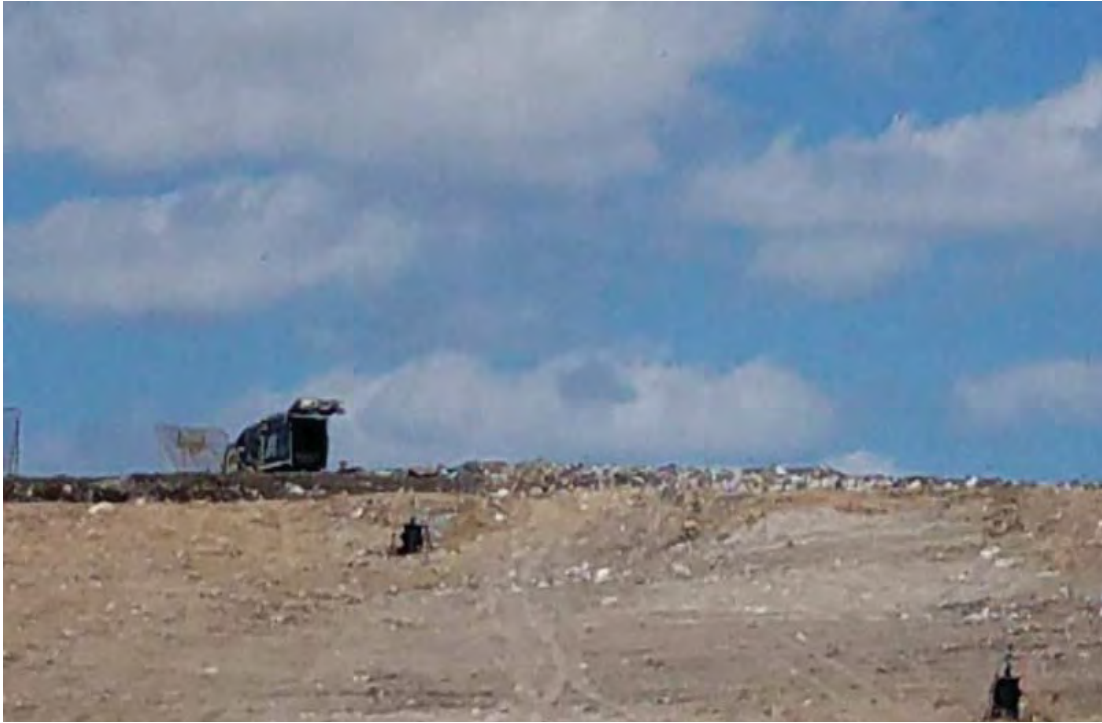
Previously placed waste, compacted and awaiting cover

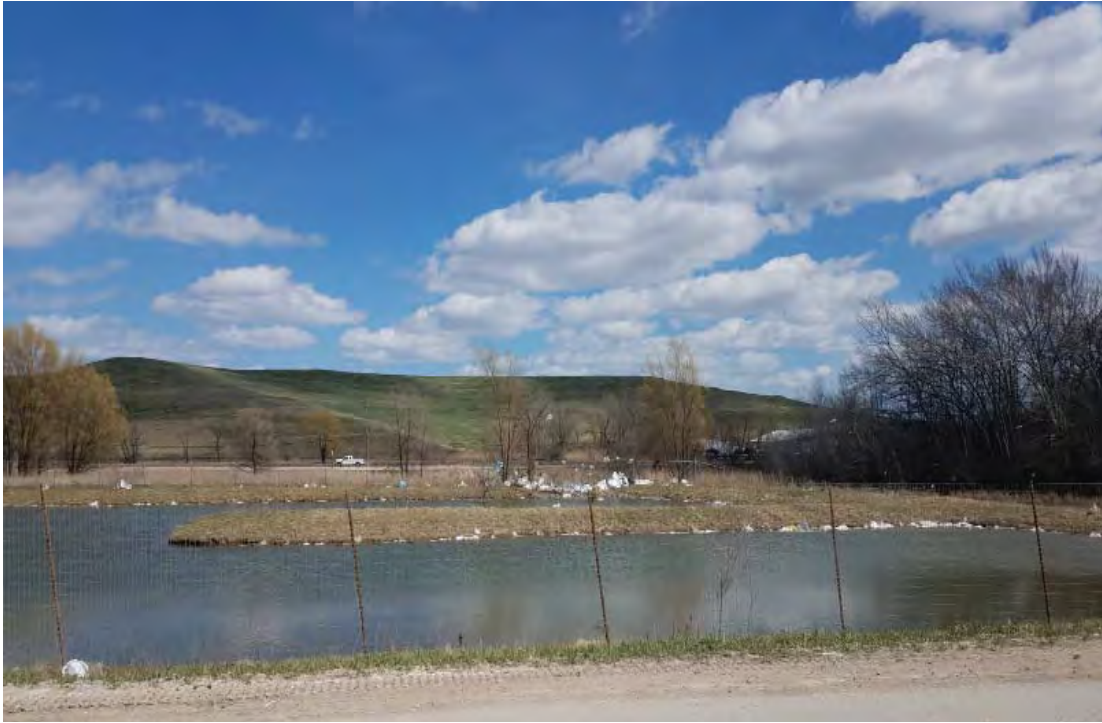
Litter around basin, but still on site

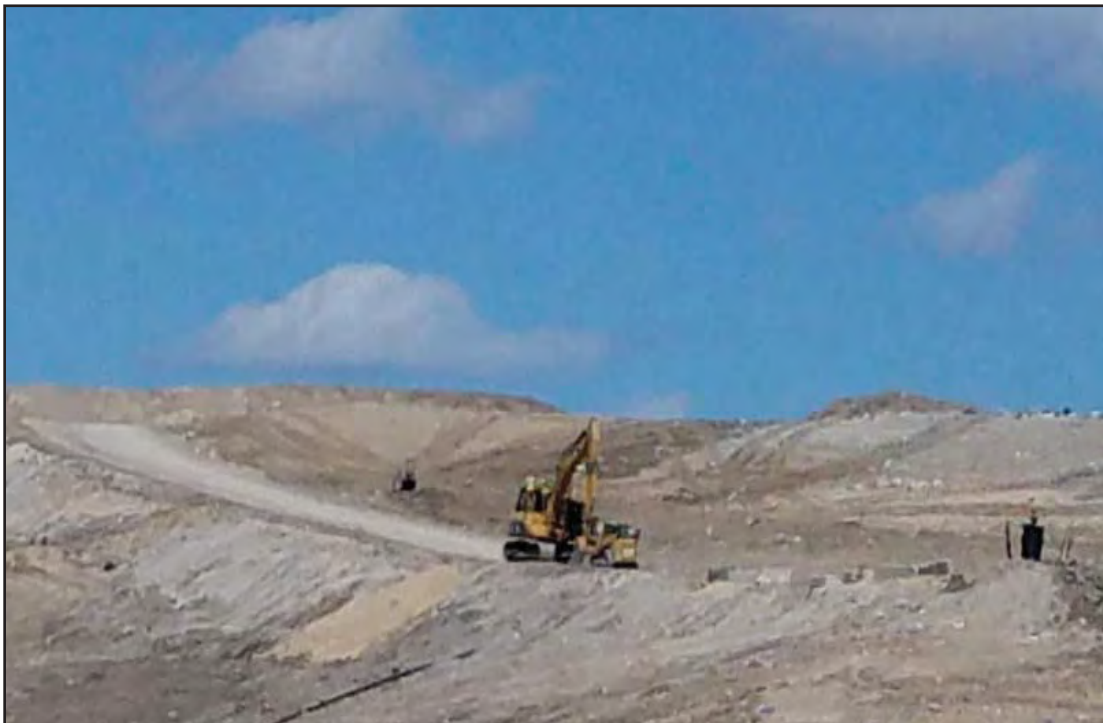
Trenching complete on West slopes and slope patched

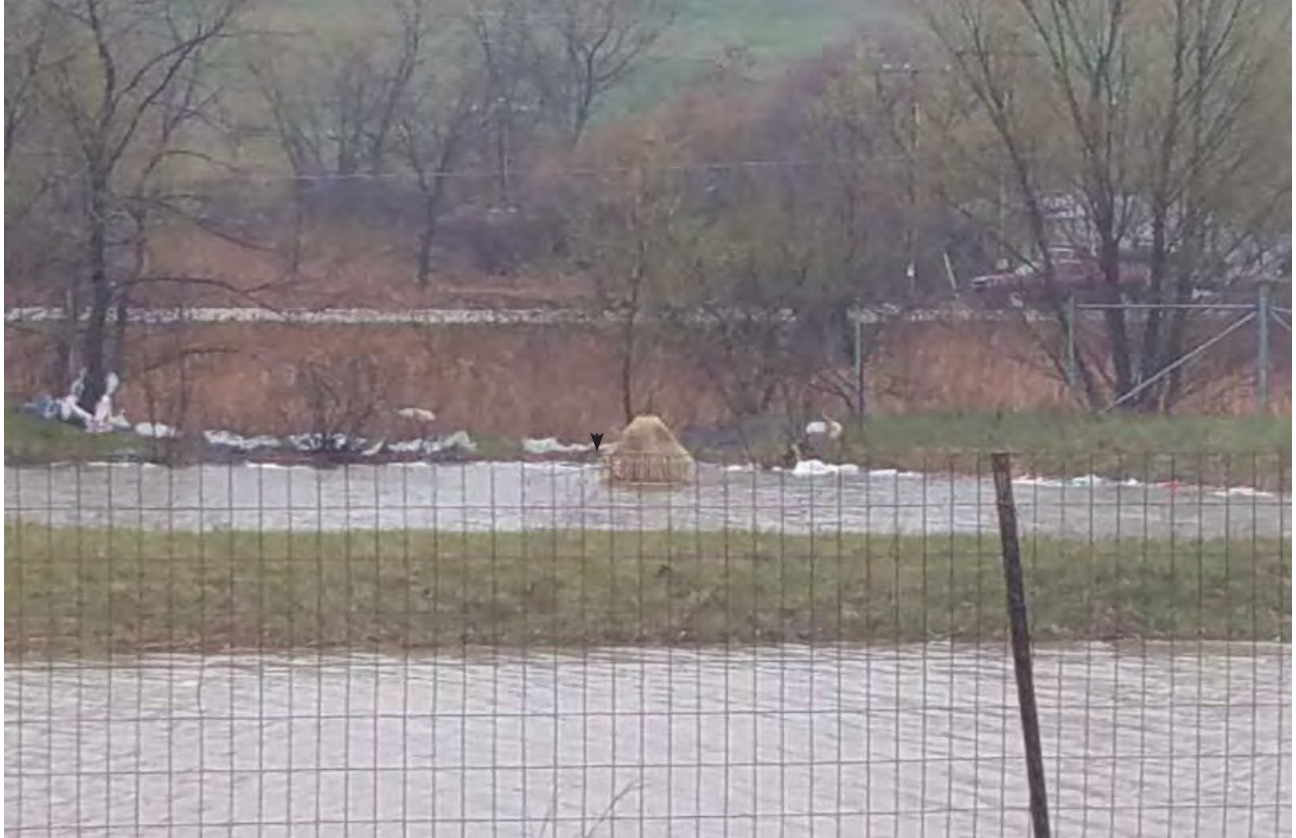
Control structure of Basin 3, litter greatly reduced. Tree growing from control structure

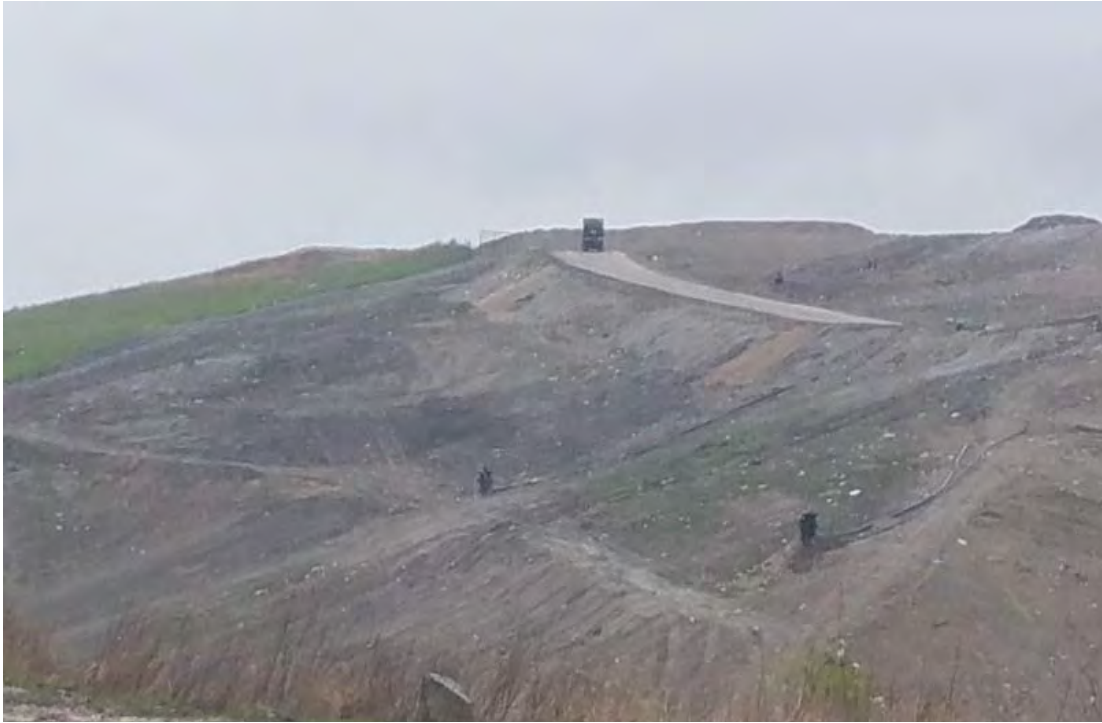
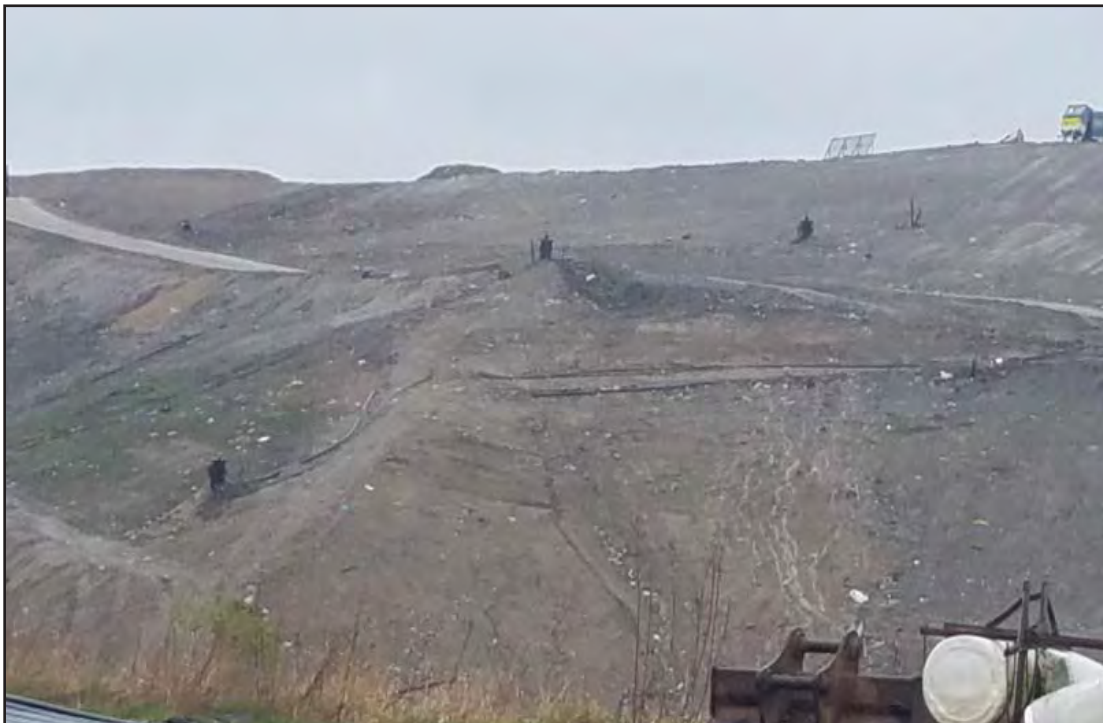
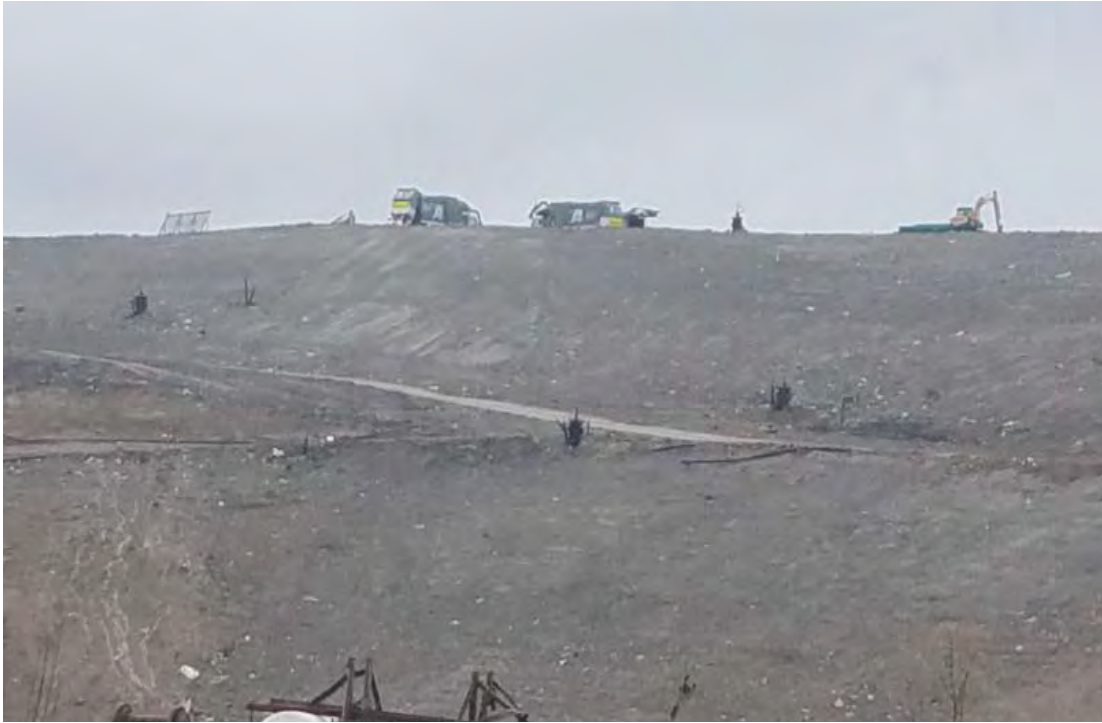
West slopes restored after trenching

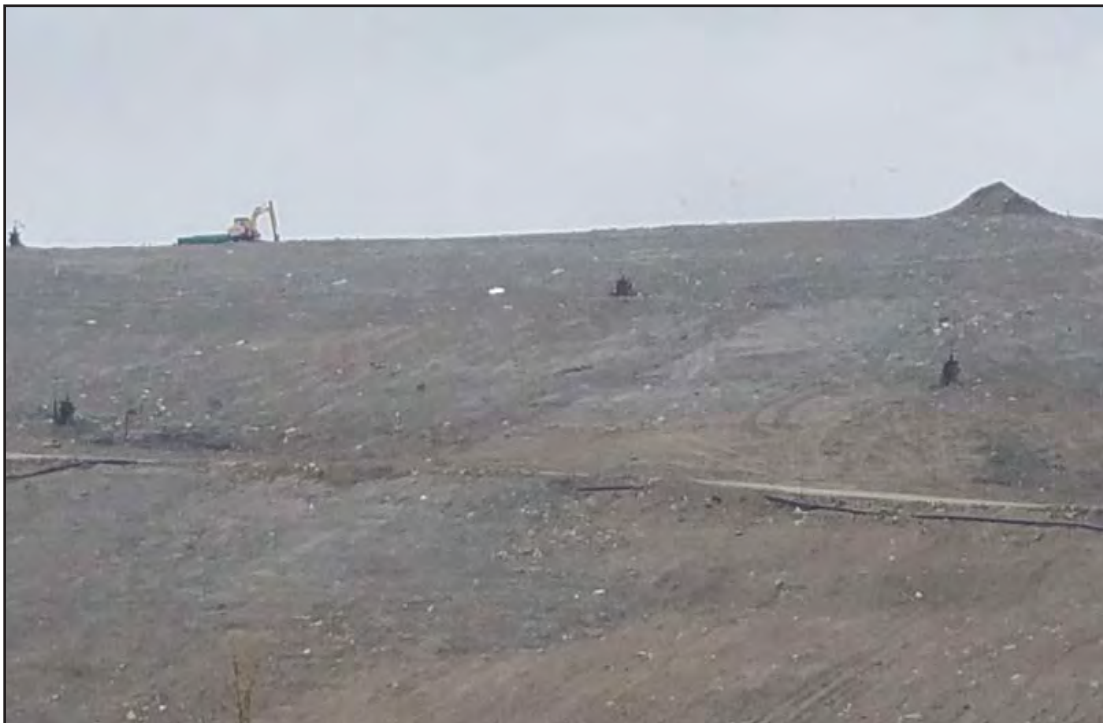
- Repairing slopes and grading areas impacted by trenching
 - Three possible seeps on West slope of Phase 7, manager agrees and will address seeps

No evidence of seeps on West slope

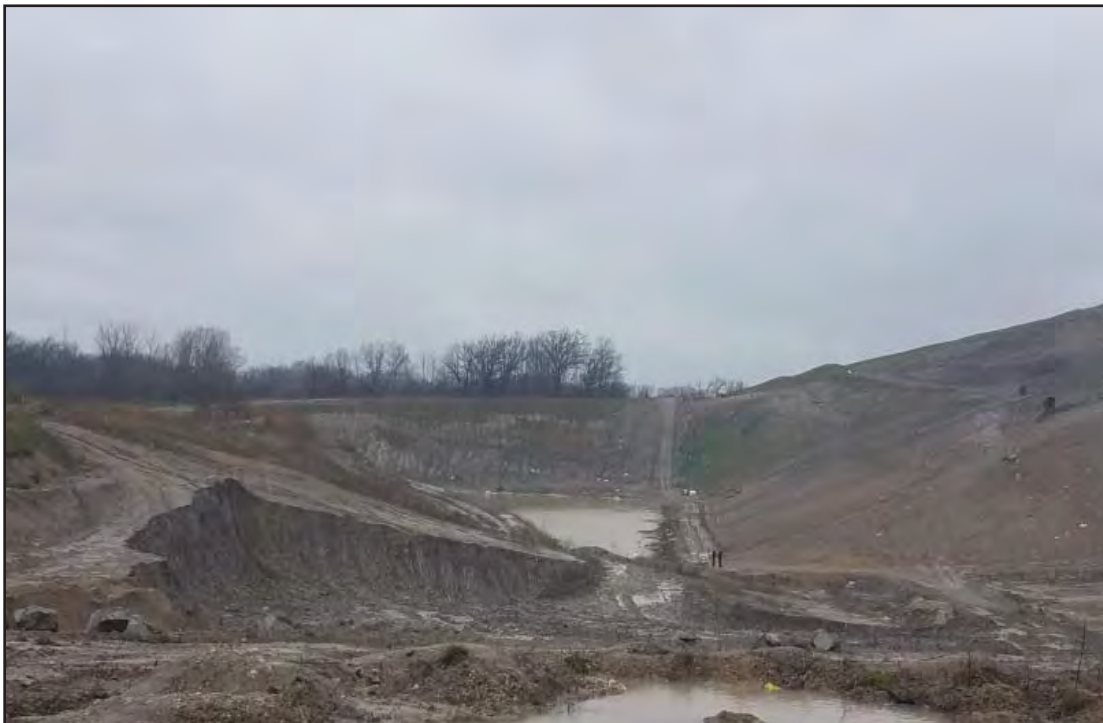
Temp. Sed Pond well pumped

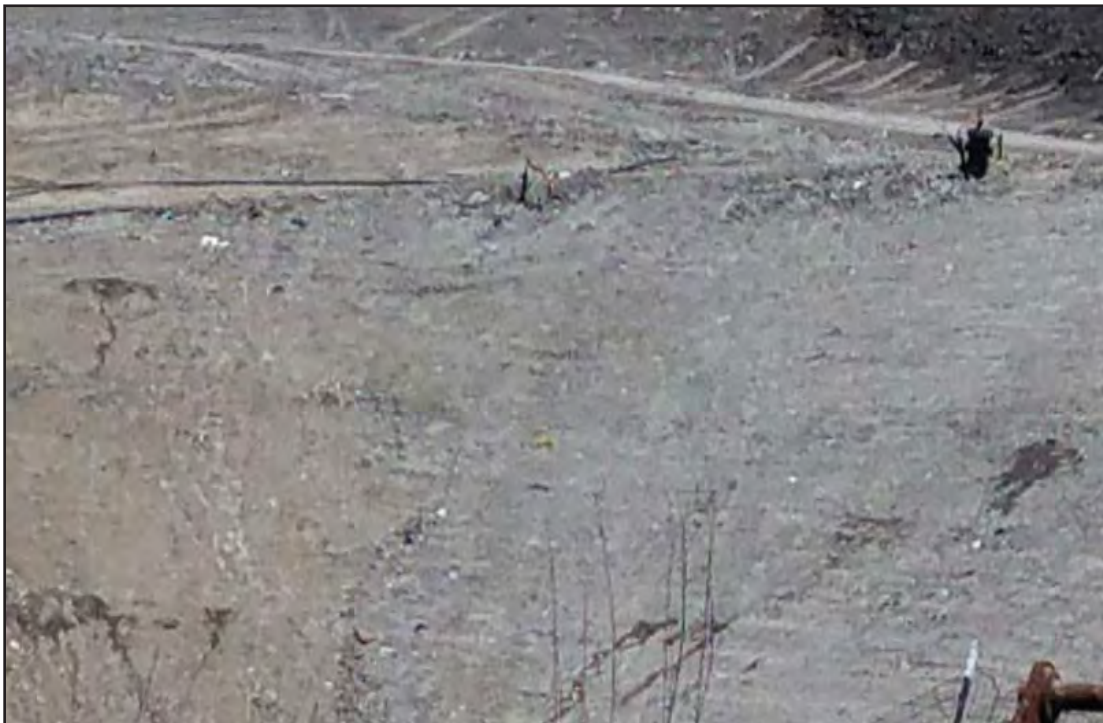
West slope of Phase 7 South, small seeps have appeared, self cured, and then reappeared

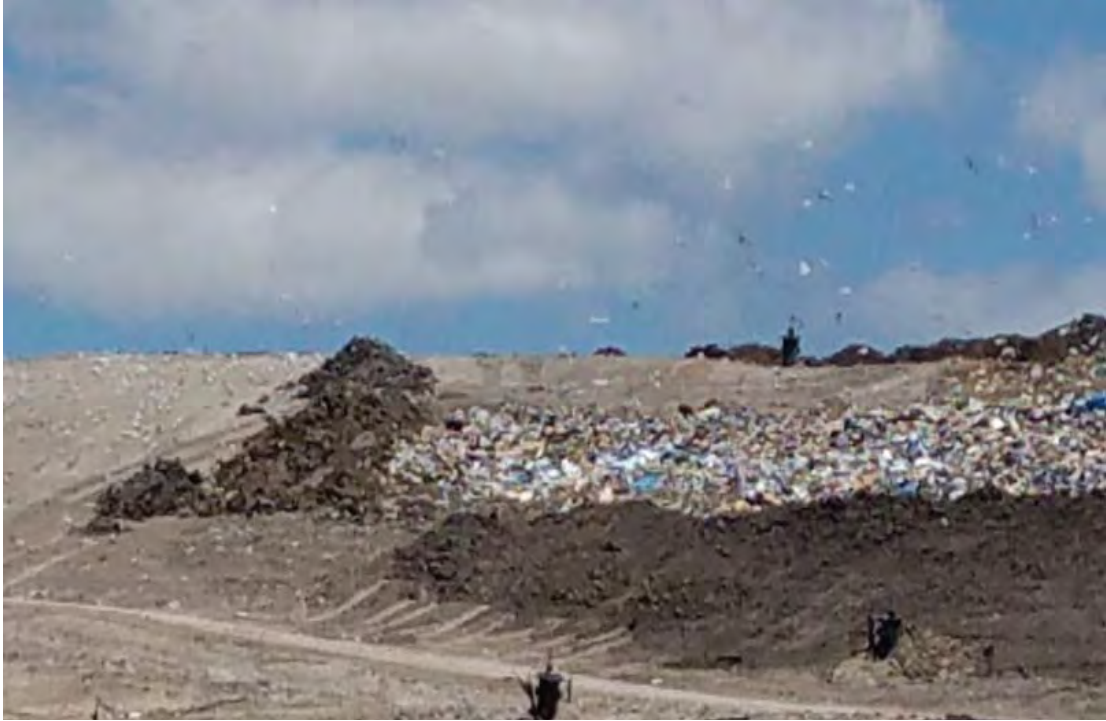
Phase 7 viewed from the West

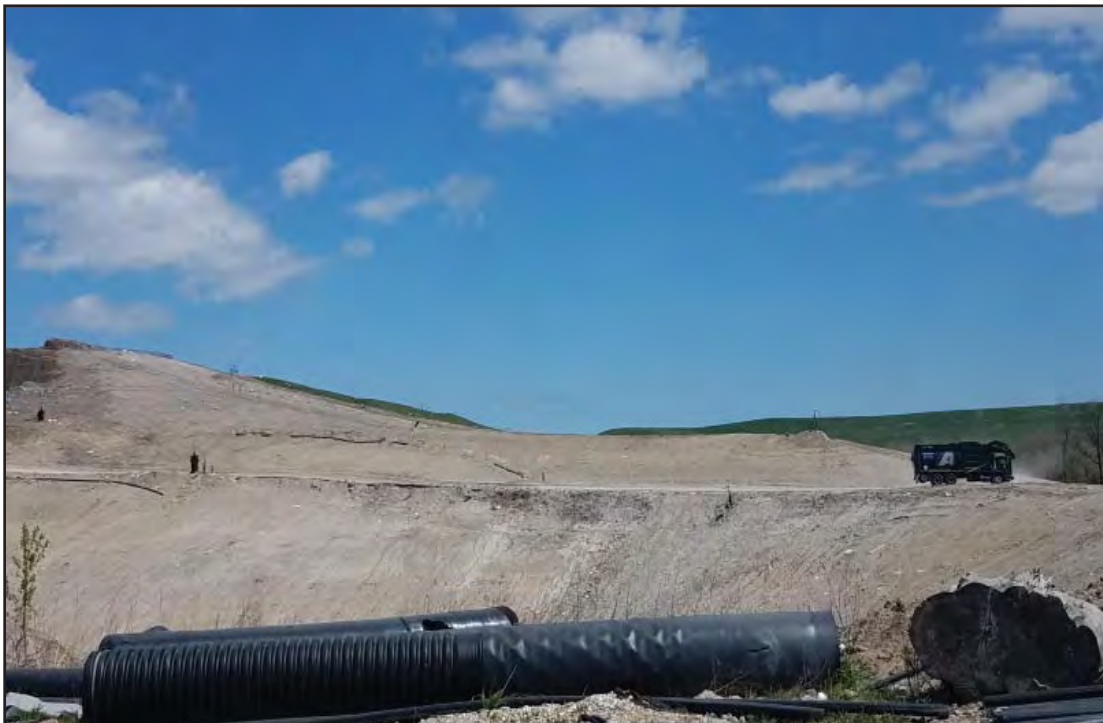
South edge of footprint viewed from West

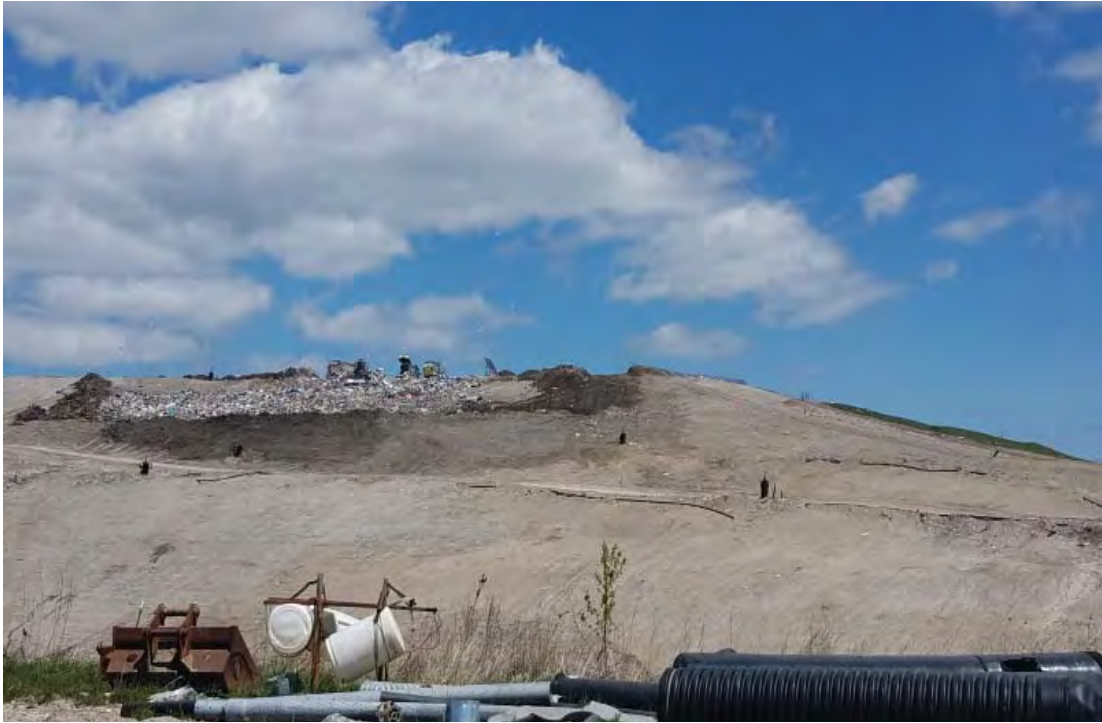
Phase 7 South, Southwest corner

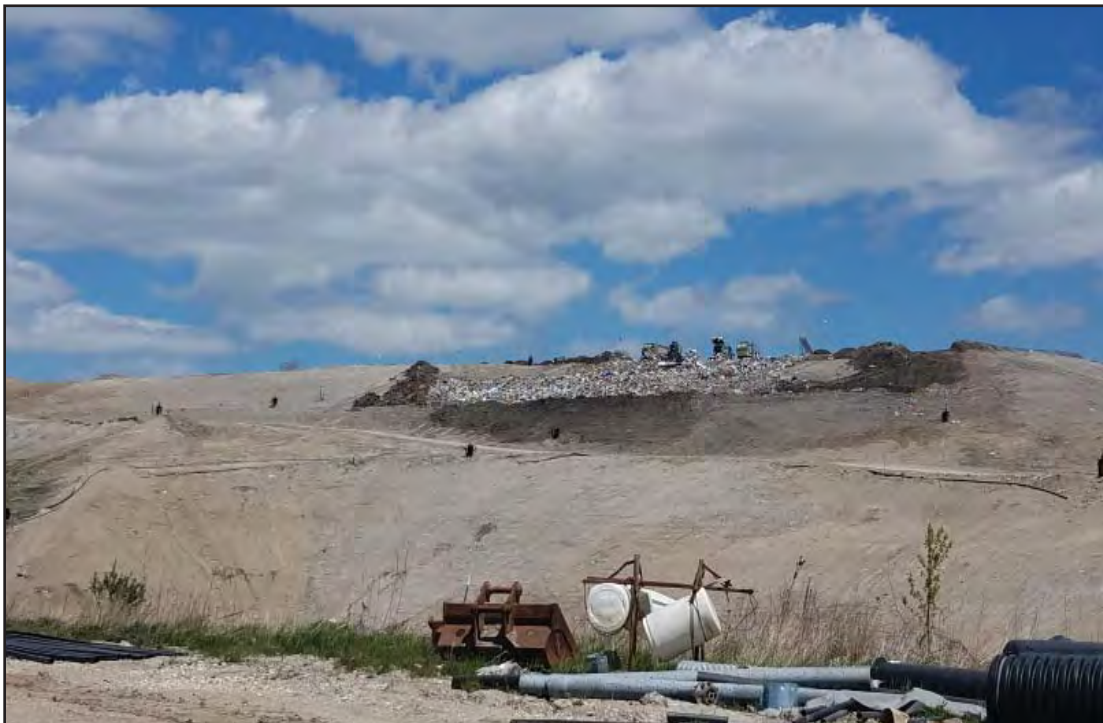
Phase 7 South, West slope, small seeps evident
