2020 Year End Summary of Audits of the Emerald Park Landfill

Prepared For:
City of Muskego
Green For Life Emerald Park Landfill Standing Committee

2020 Green For Life Emerald Park Landfill Year End Compliance Officer Report and Audit Summary

TO: Advanced Disposal Services Emerald Park Standing Committee
FROM: Jo-Walter Spear, Jr., P.E.
COPIES: File
DATE: 03/29/2021
PROJECT NUMBER: 1012.10030

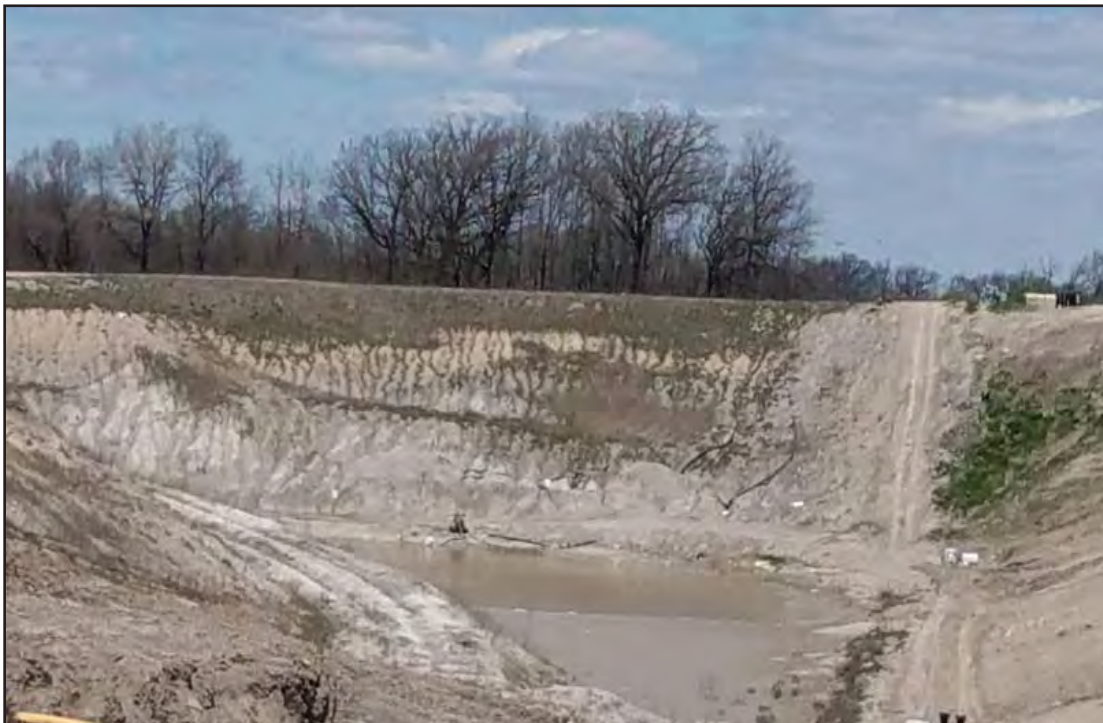
Temp. Sed Pond well pumped

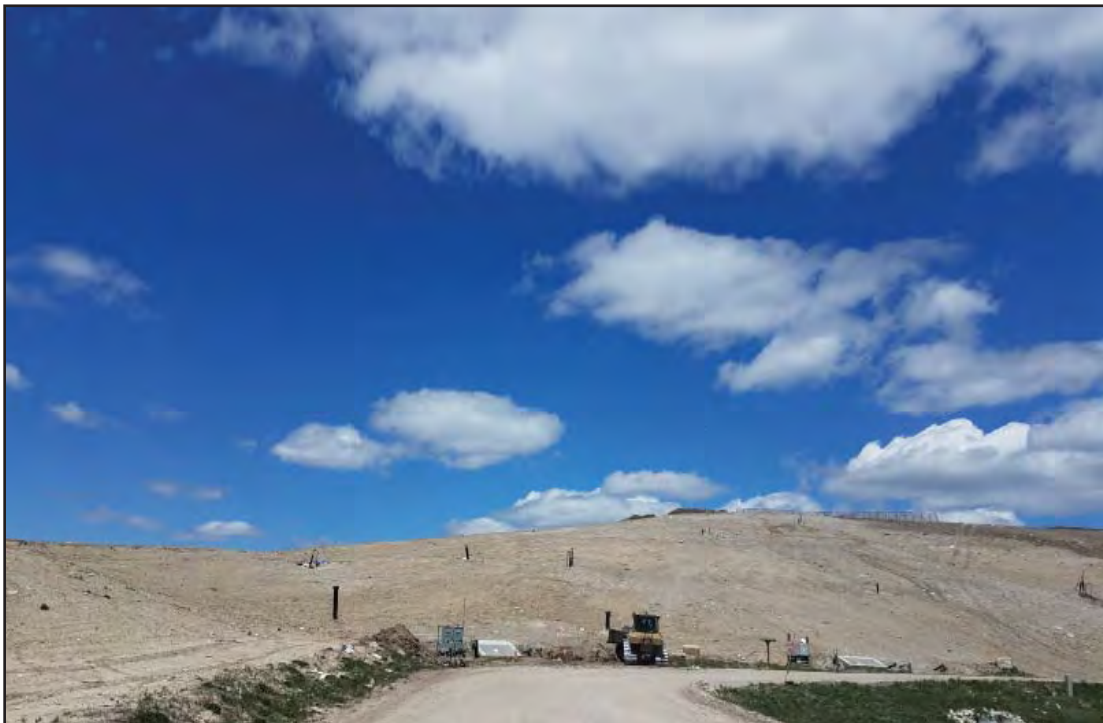
Dozer grading soils excavated for pipe repairs

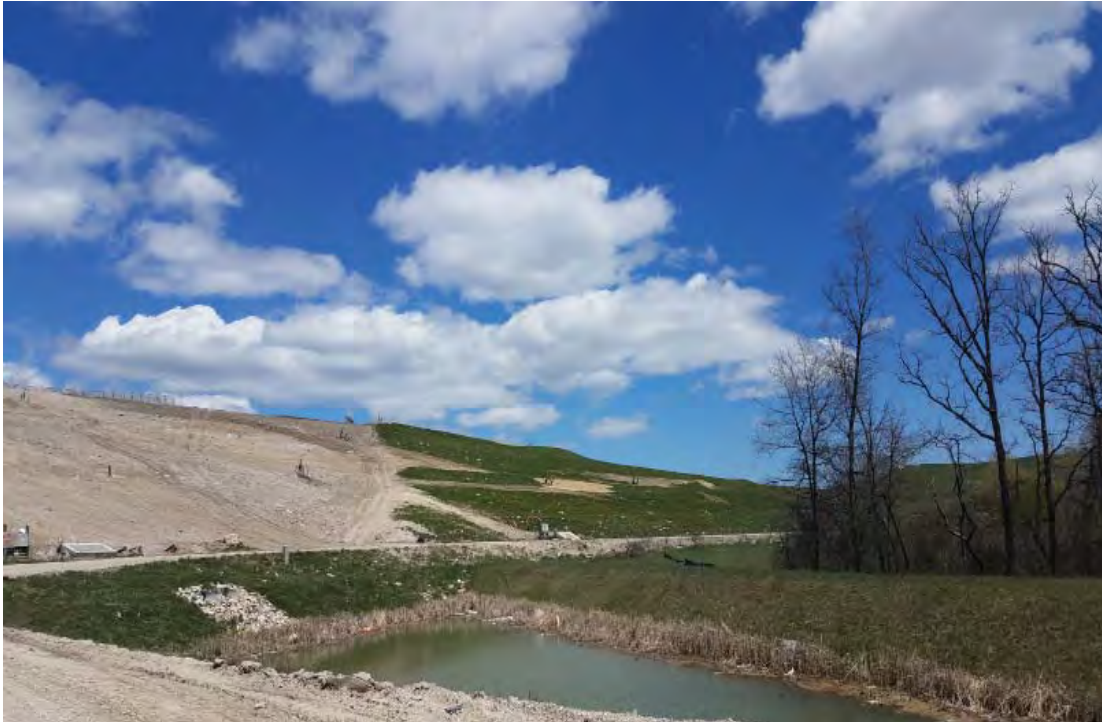
South slope, litter trapped in grasses on capped areas

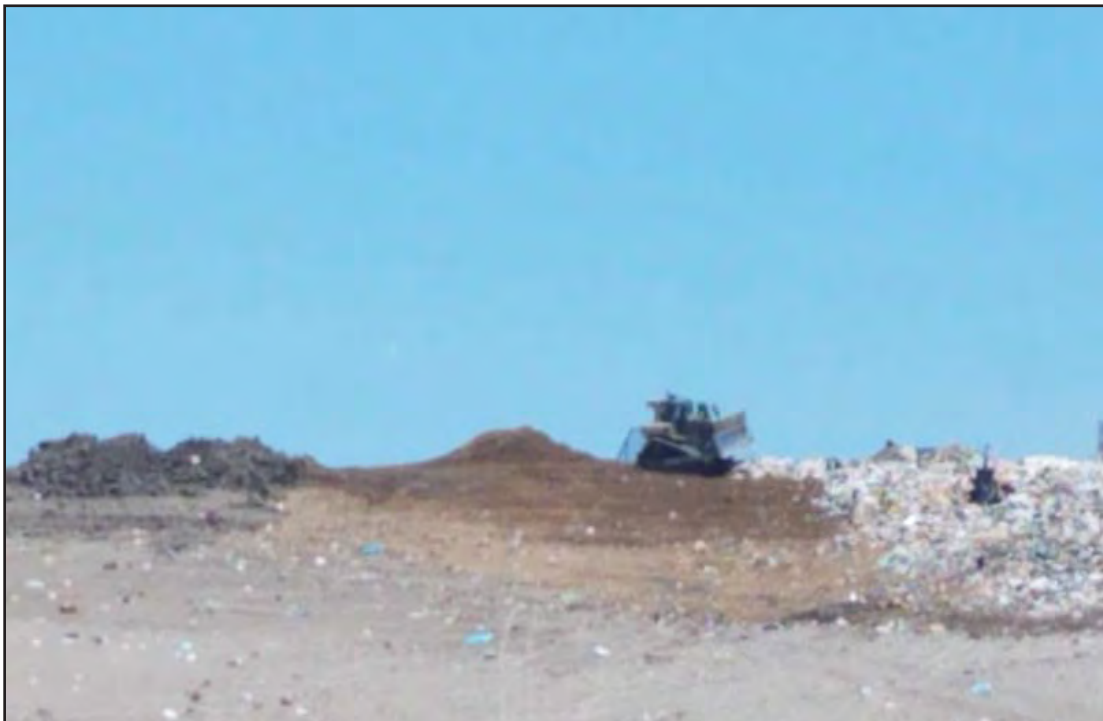
Dozer placing cover as slope elevations are reached

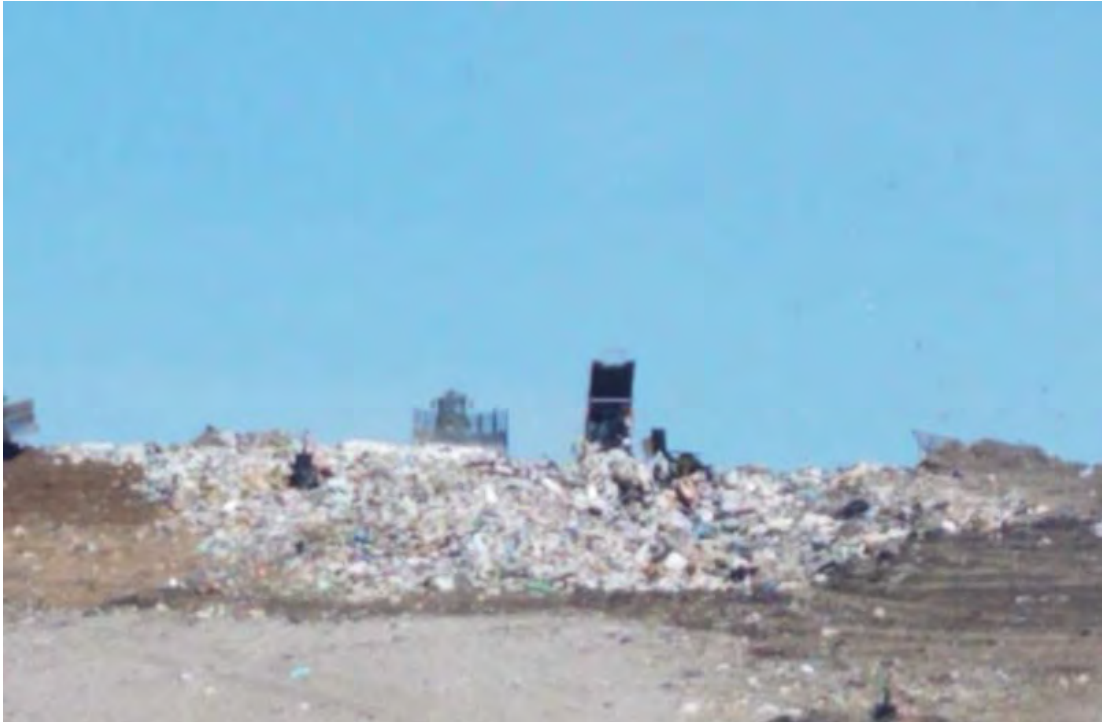
Working face viewed from the West

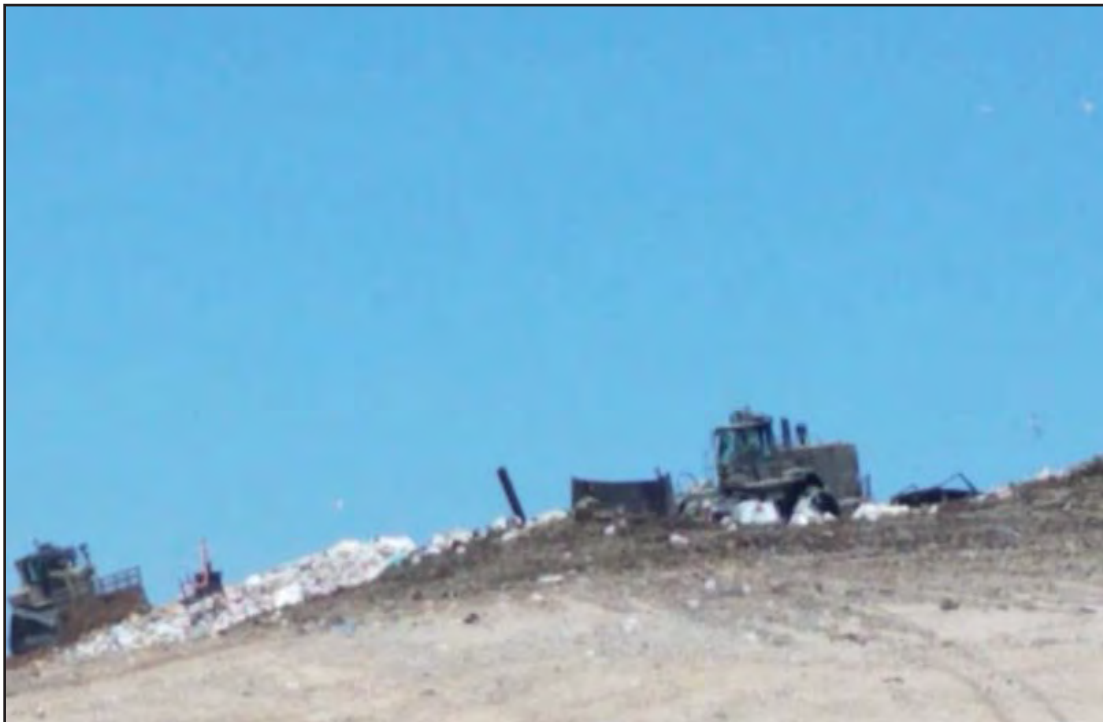
Compactor active at Working Face

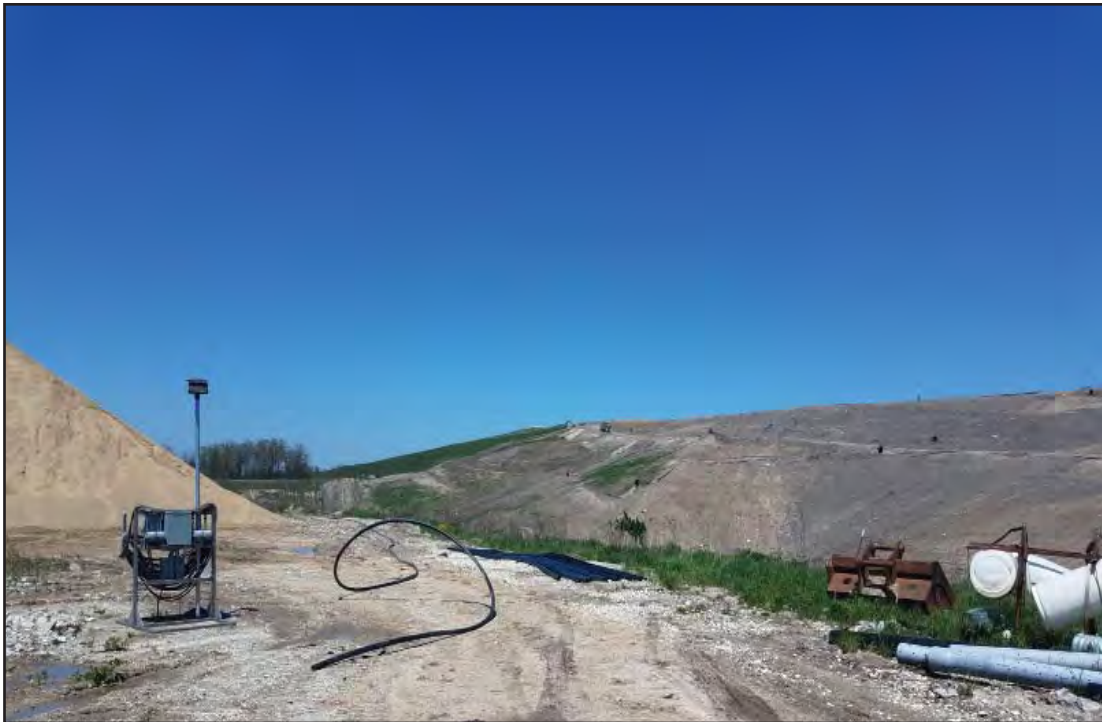
West slope of Phase 7 North

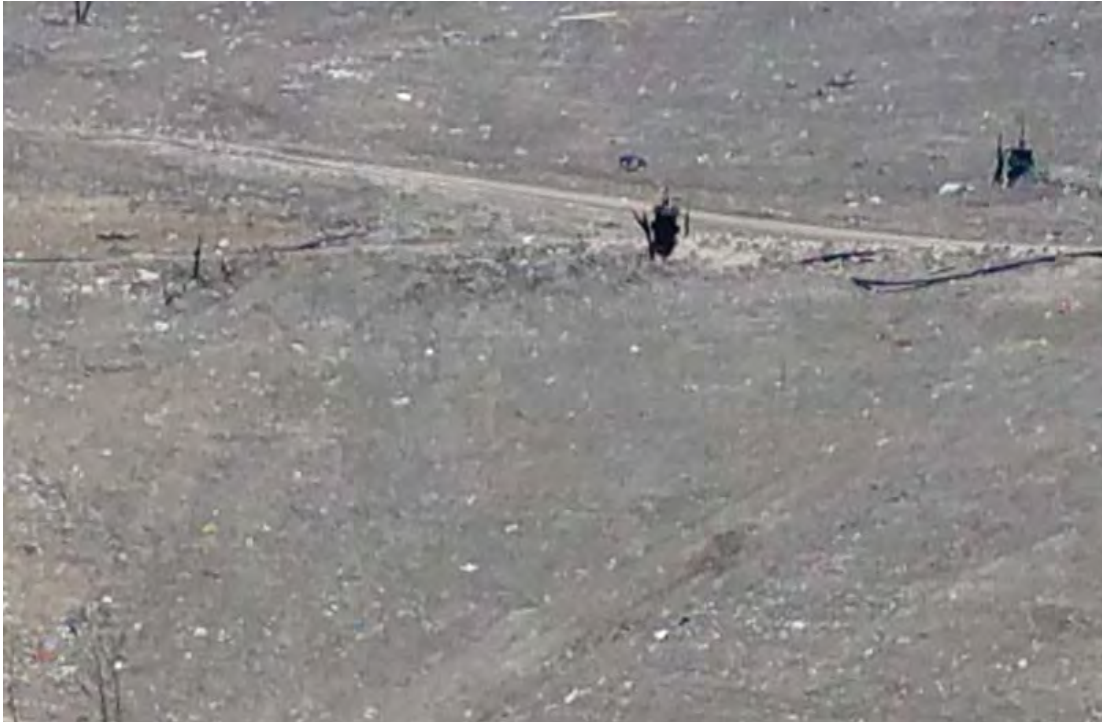
Small seep on Phase 7 South West slope

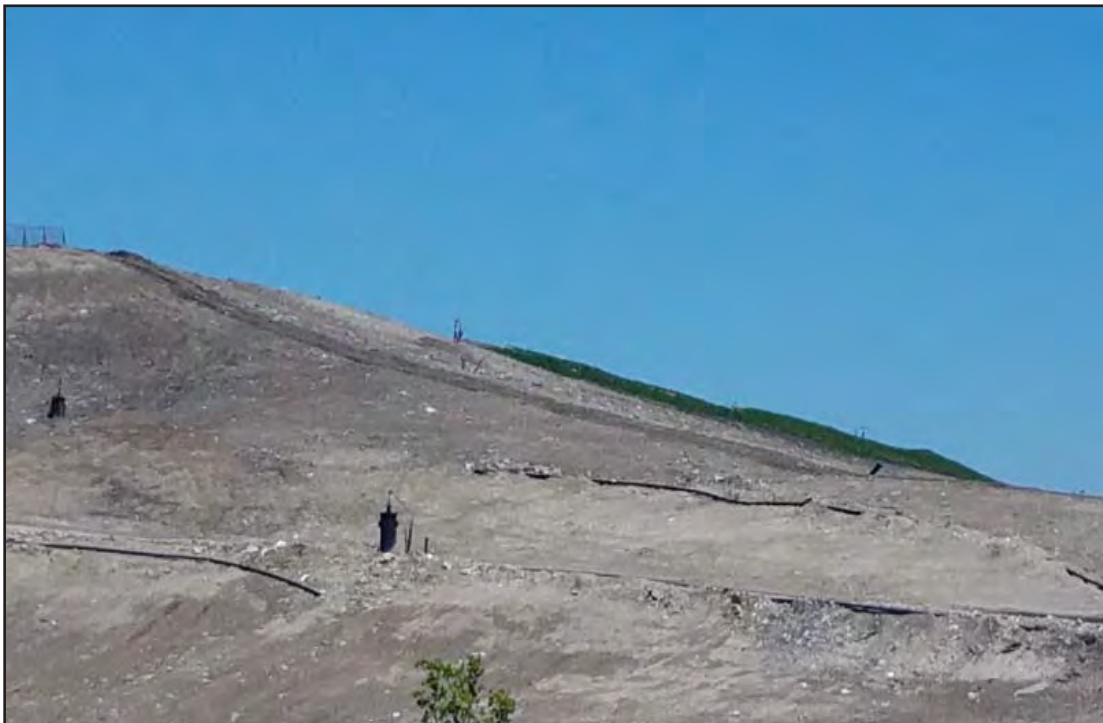
South slope of Phase 7 South, viewed from West

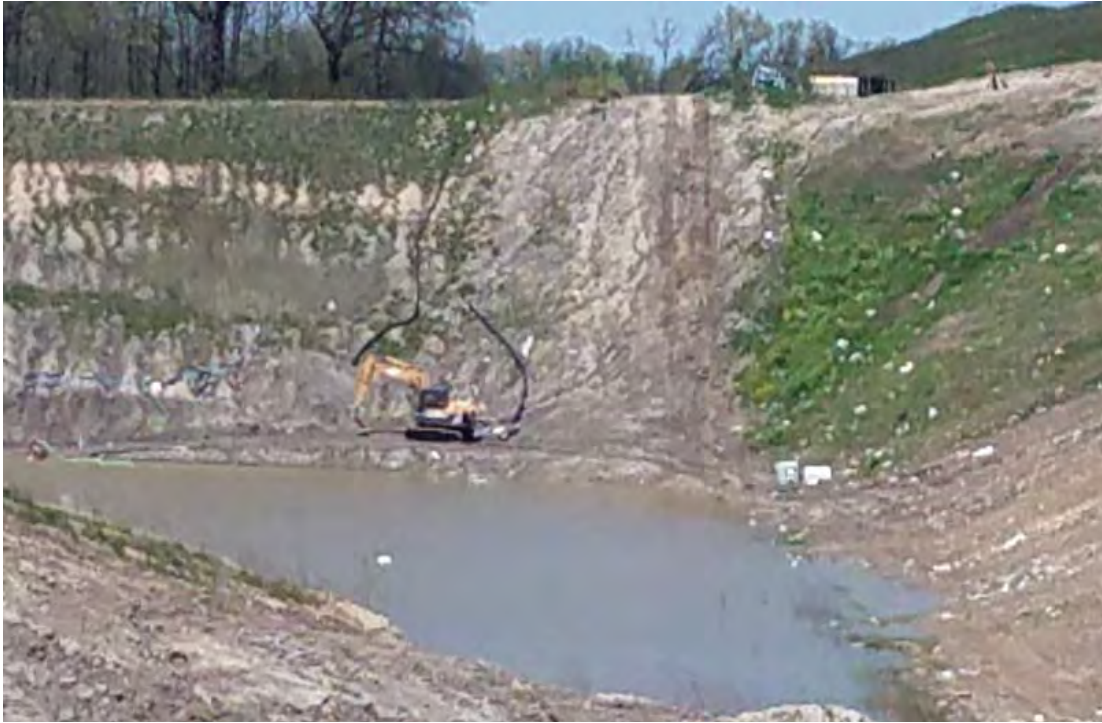
Temp sed basin, well pumped down

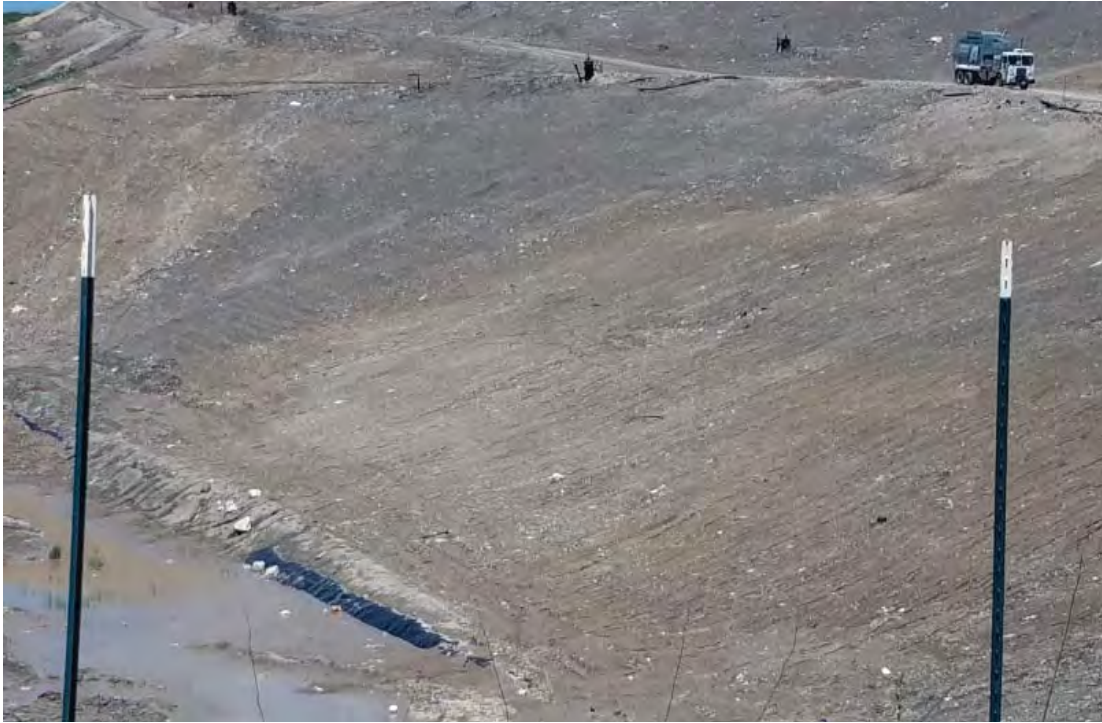
South portion of Temp Sed Basin, adjacent to Phase 7 South

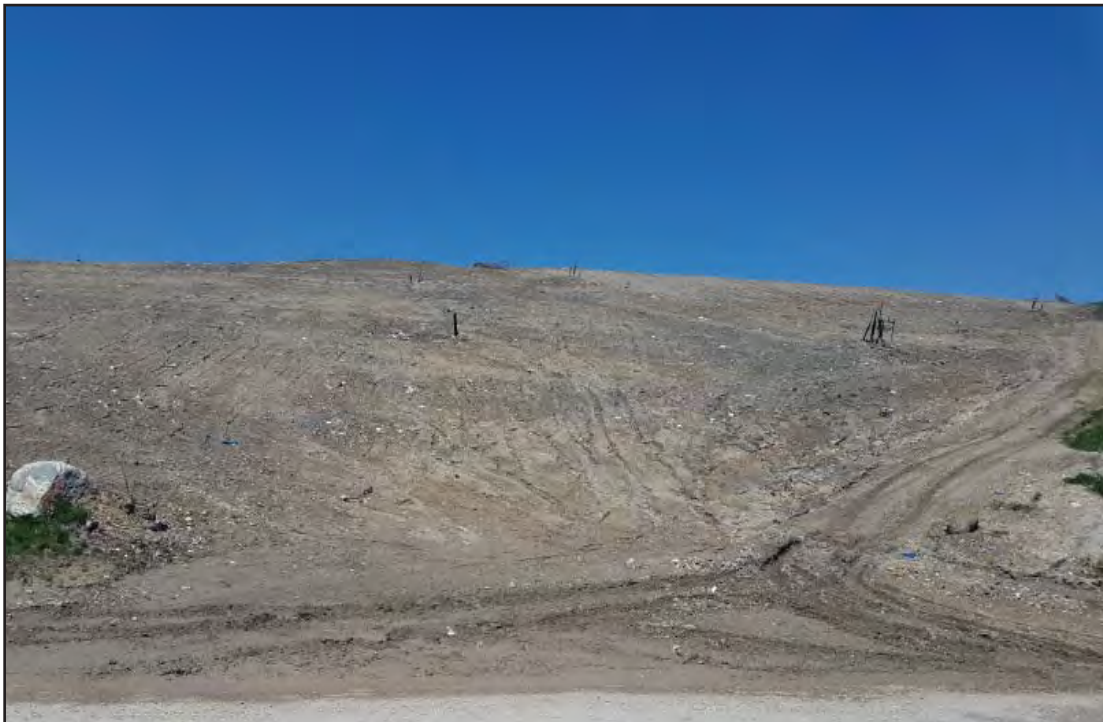
South slope with some erosion after two days of storms

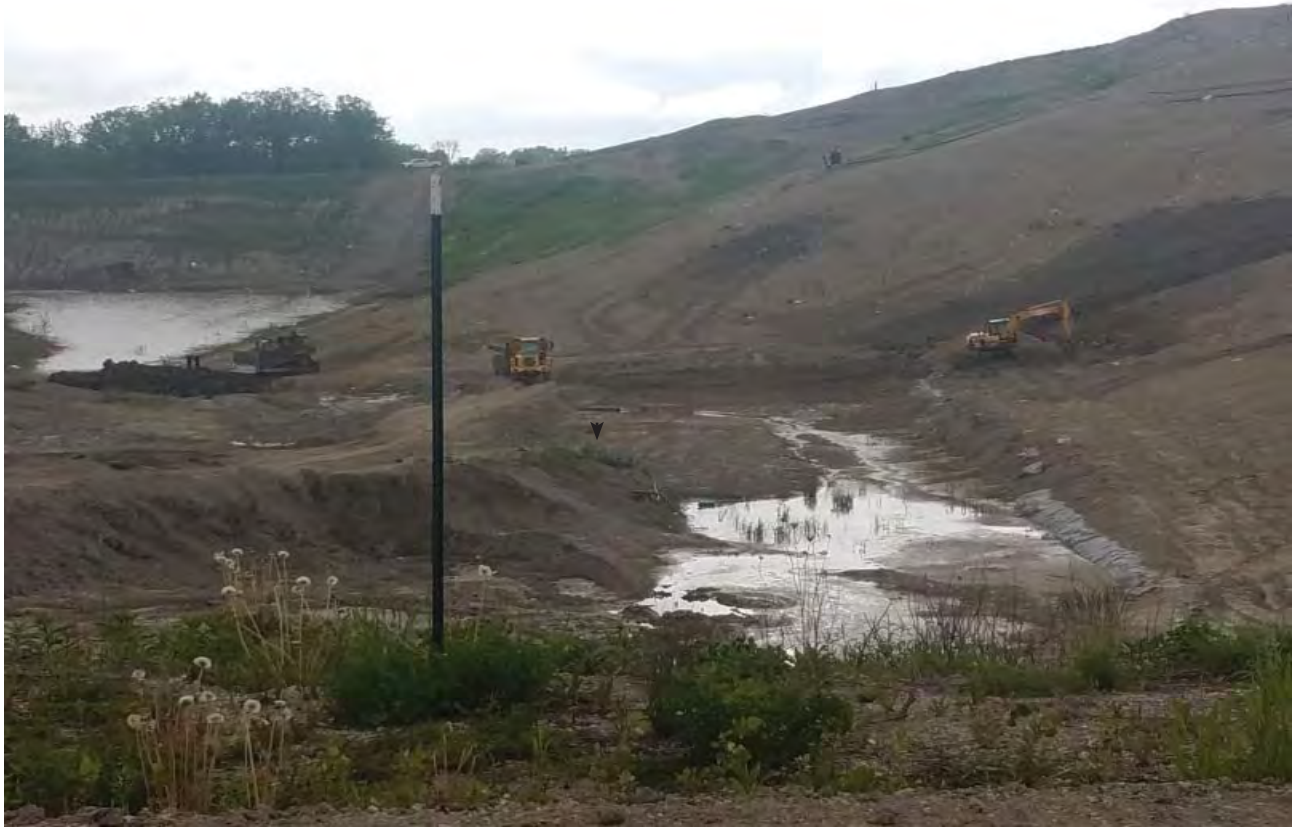
1. Temp sed basin forebay

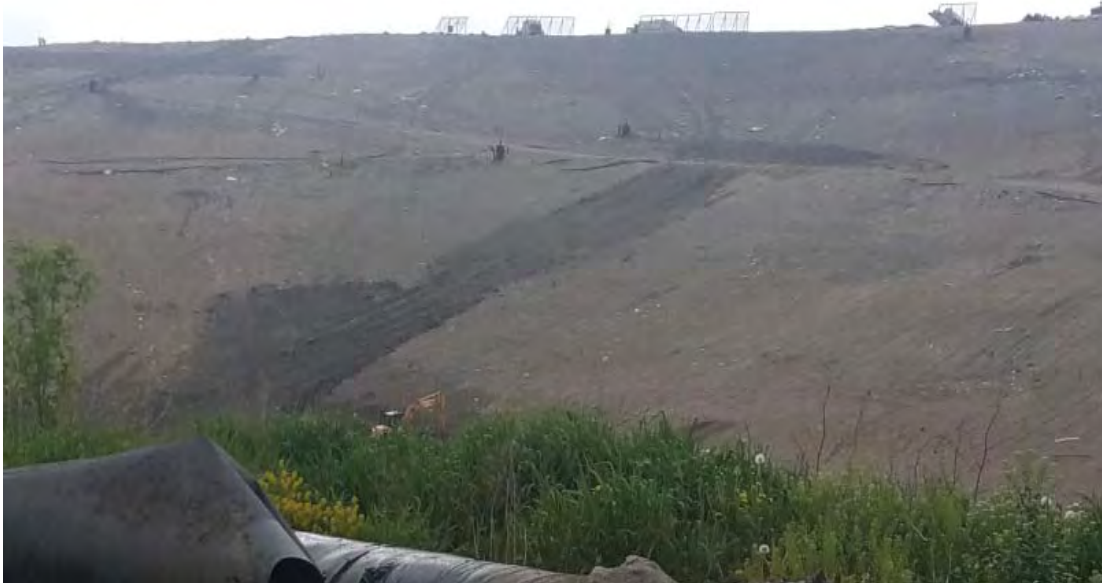
2. West slope of Phase 7 South, seep repairs by placement of soil cover

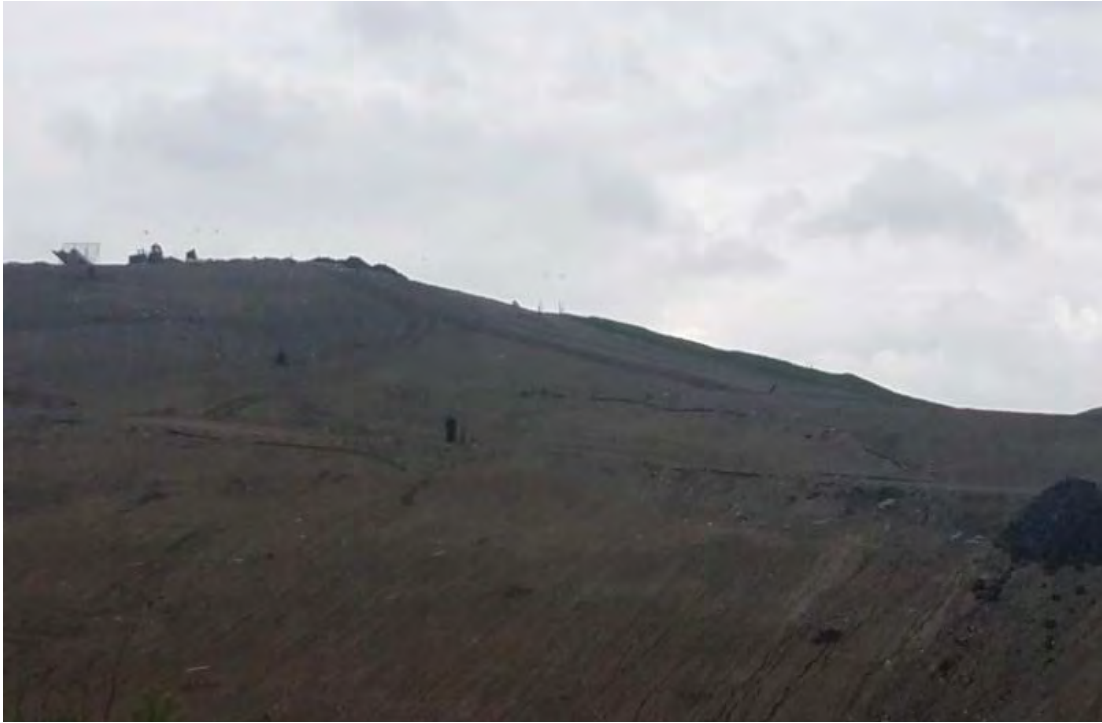
4. Southwest corner of Phase 7 South

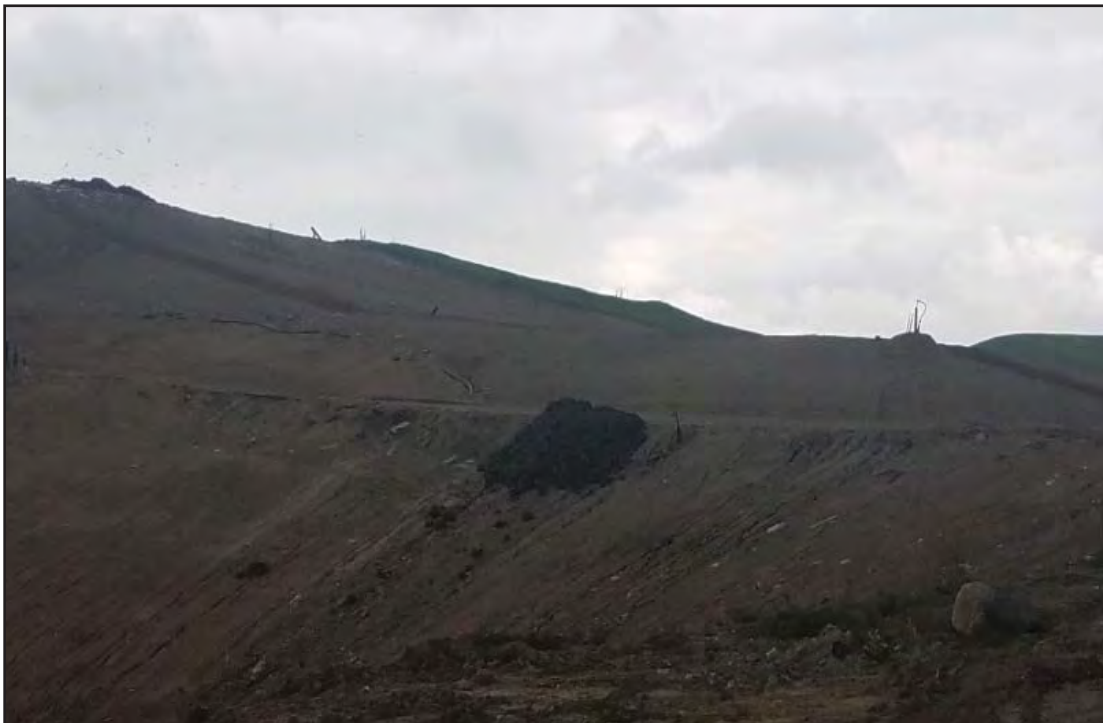
5. Soil stockpile to add to cover for seeps or emissions

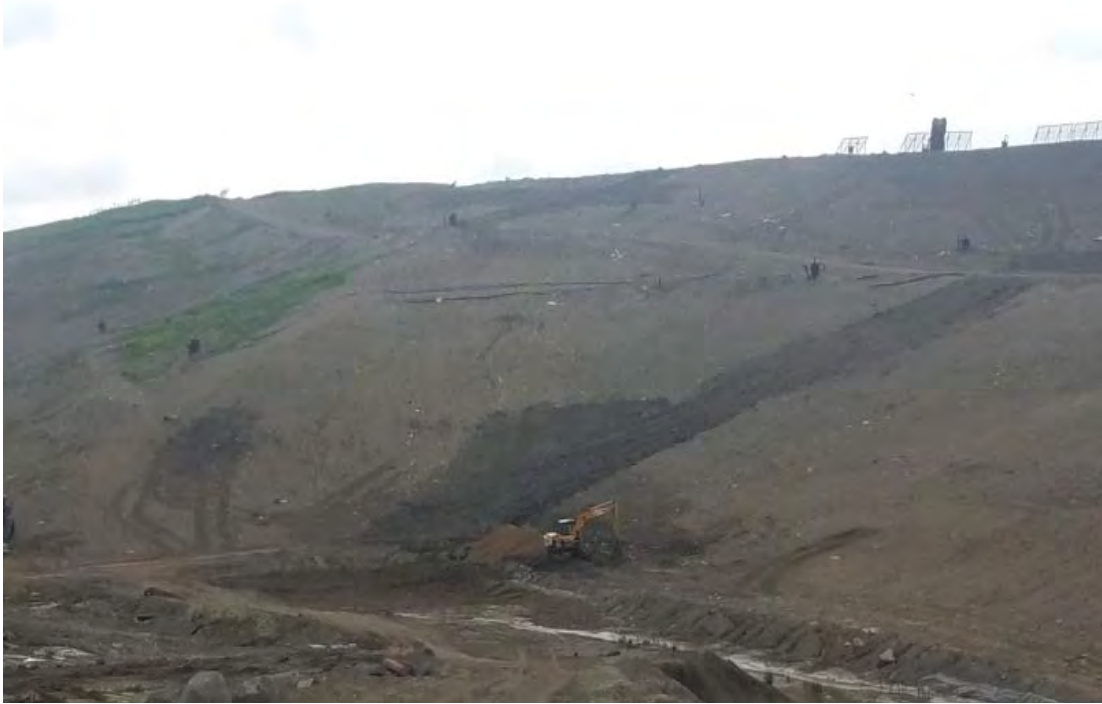
6. Excavator performing slope repairs for Emissions and/or seeps

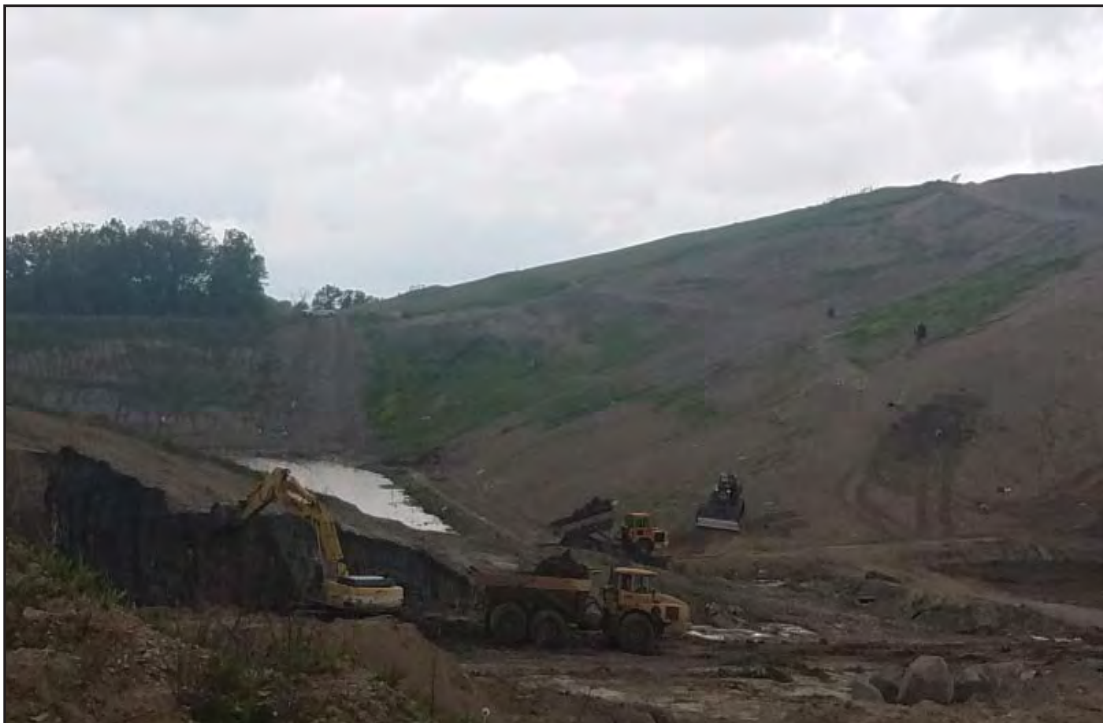
7. Excavation of future Phase 8, soil being used in the back ground at South end of Temp Sed Basin

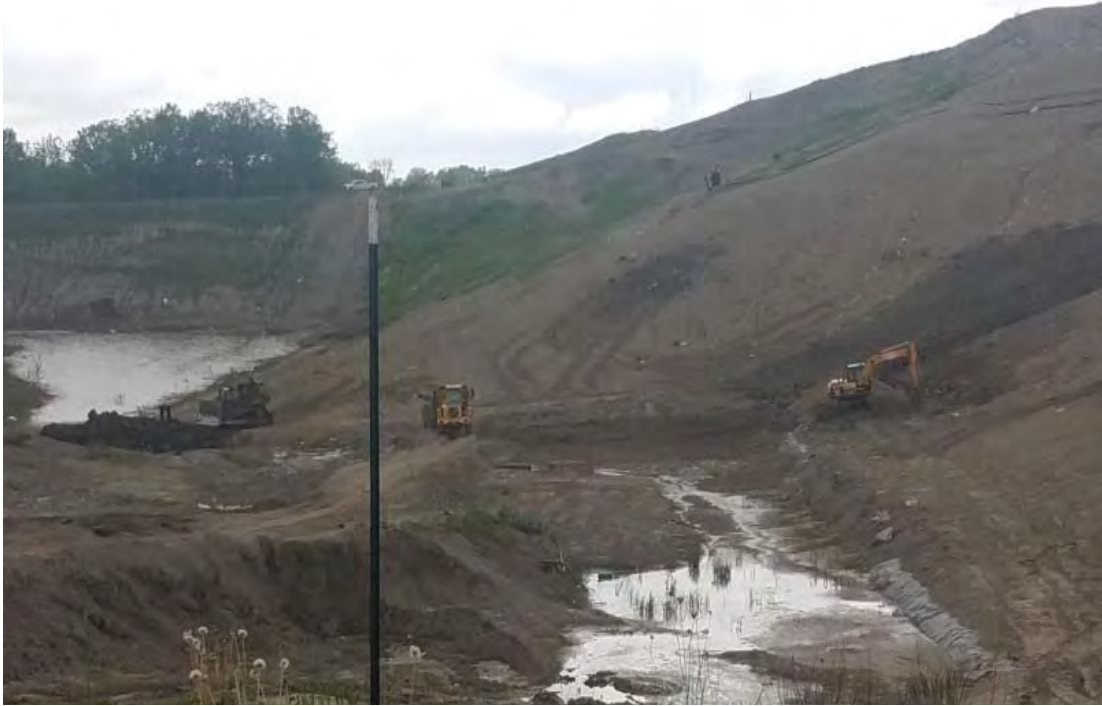
8. Temp Sed Basin Forebay, some cleaning appears to have been done for silt

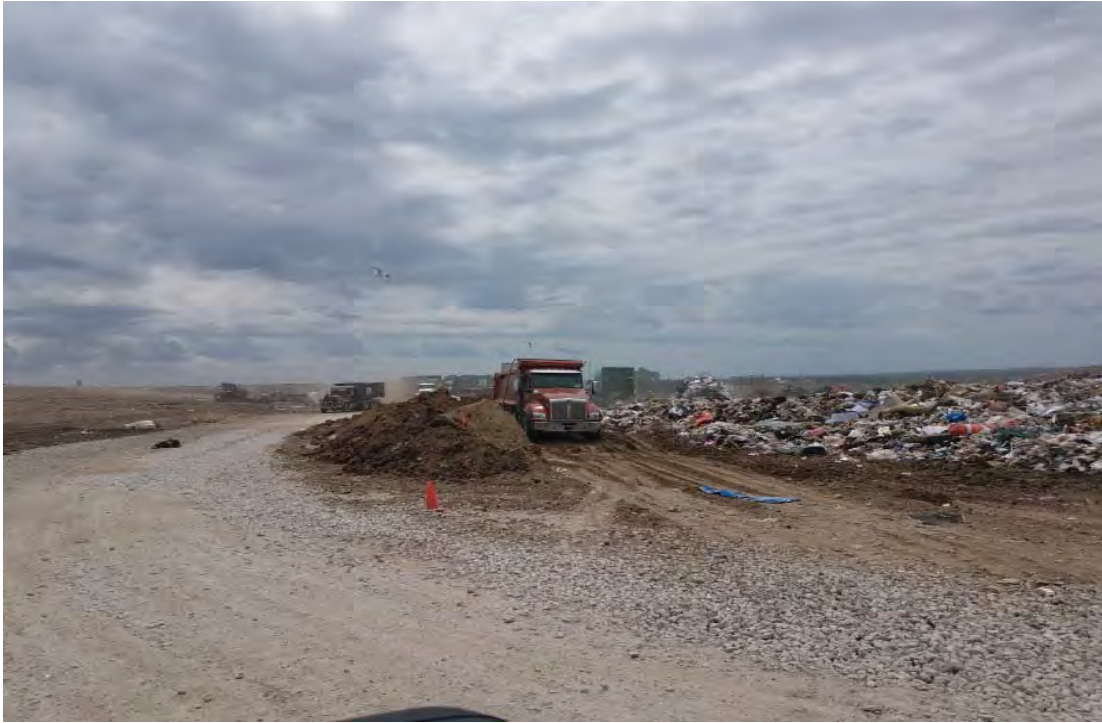
Working face in Northwest corner of Phase 7 South

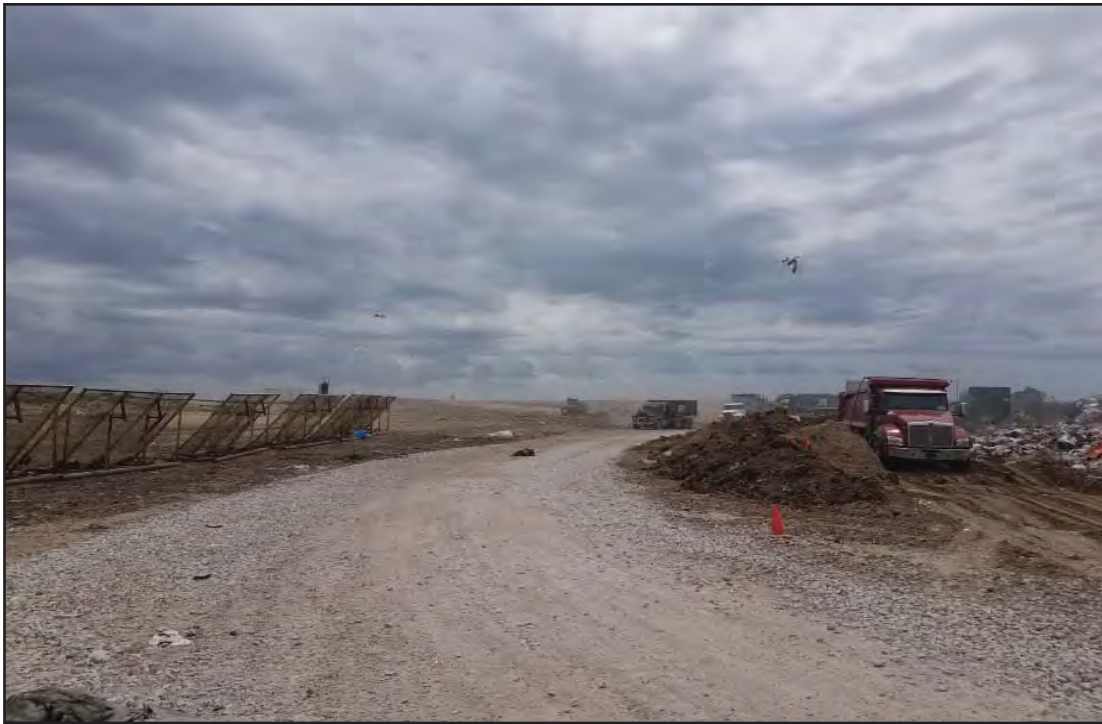
Working face and access to previous faces

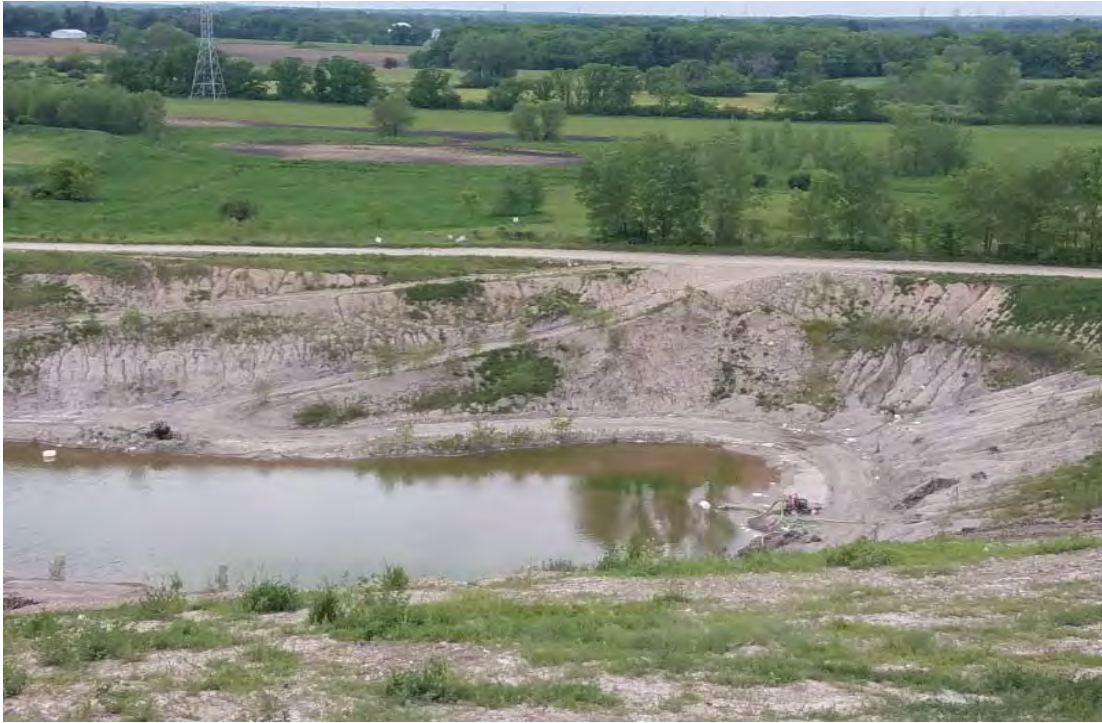
- Contractor on site aiding in erosion, seep, and gas field repairs
 - Action Item - A large breach or seep occurred on May 28, 2020 discharging leachate from Phase 7 South into the temp sed basin forebay. Advanced has corrected the seep and will be cleaning the impacted area over the month of June

Temp sed basin, contaminated with leachate from seep in Phase 7 South

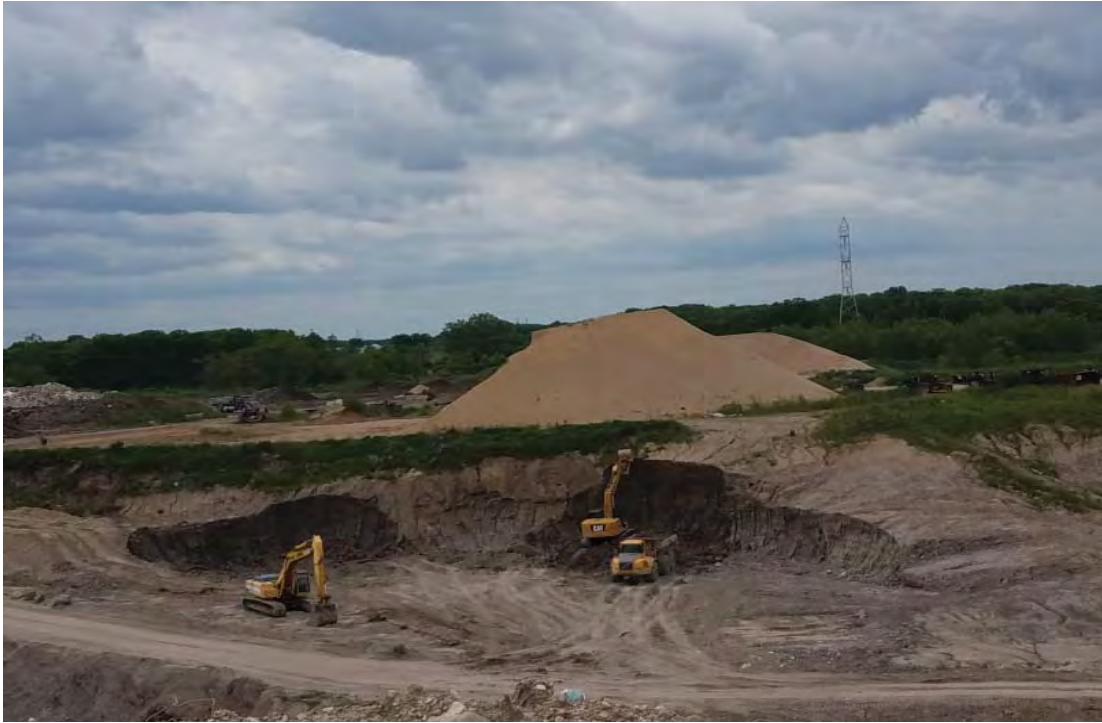
Excavation of future Phase 8

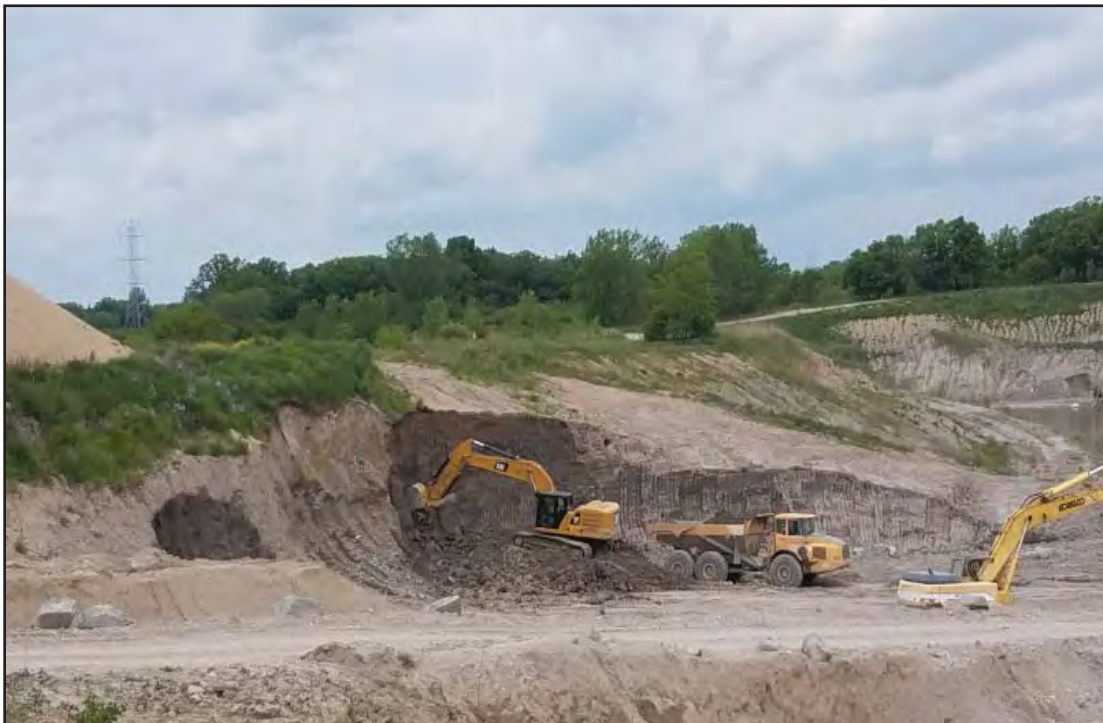
Excavation of future Phase 8, soil being used in seep repairs

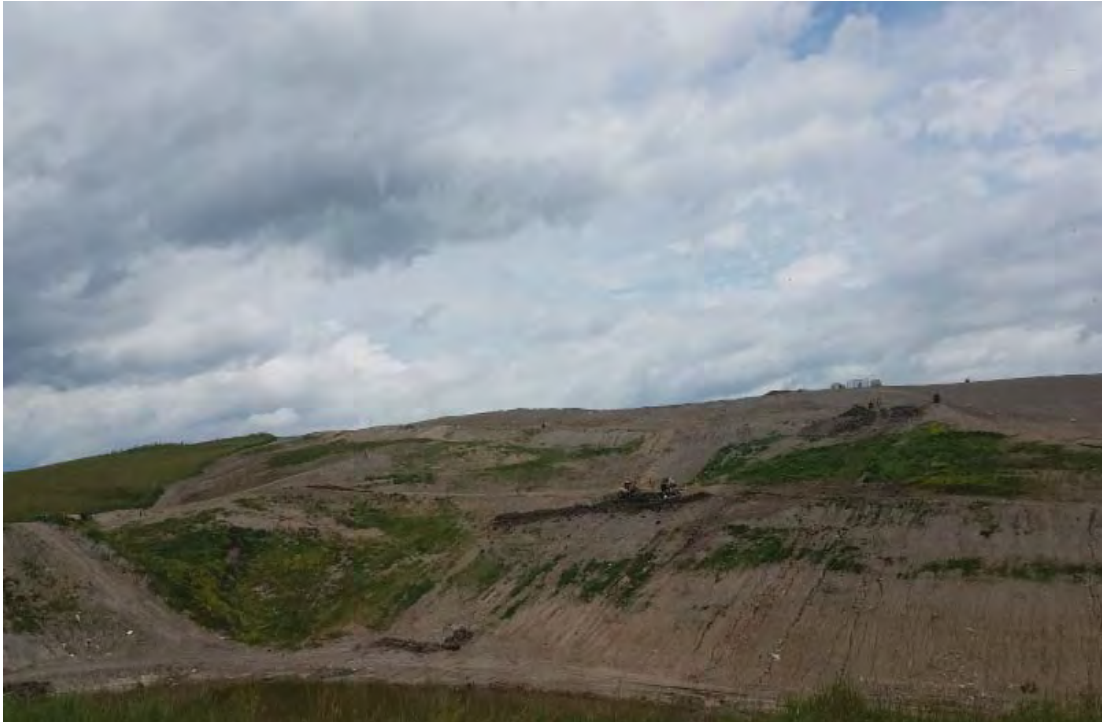
West slope of Phase 7 North, some seep repairs evident

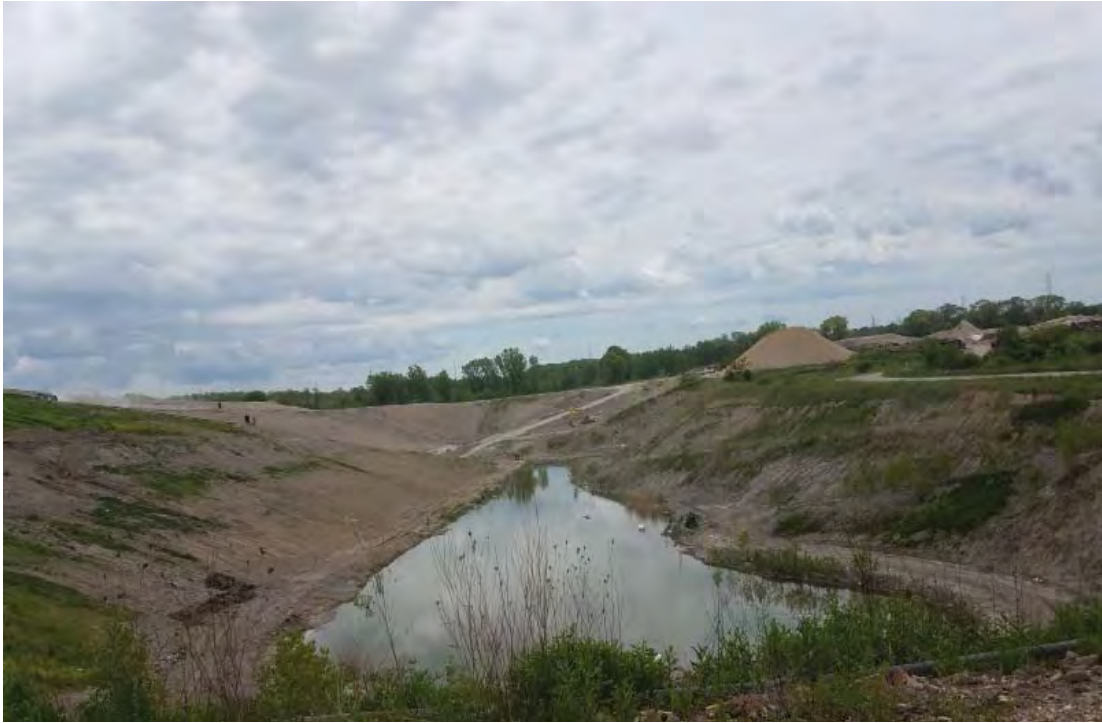
Temp sed basin viewed from the North, closed off at the South end until cleaned and graded

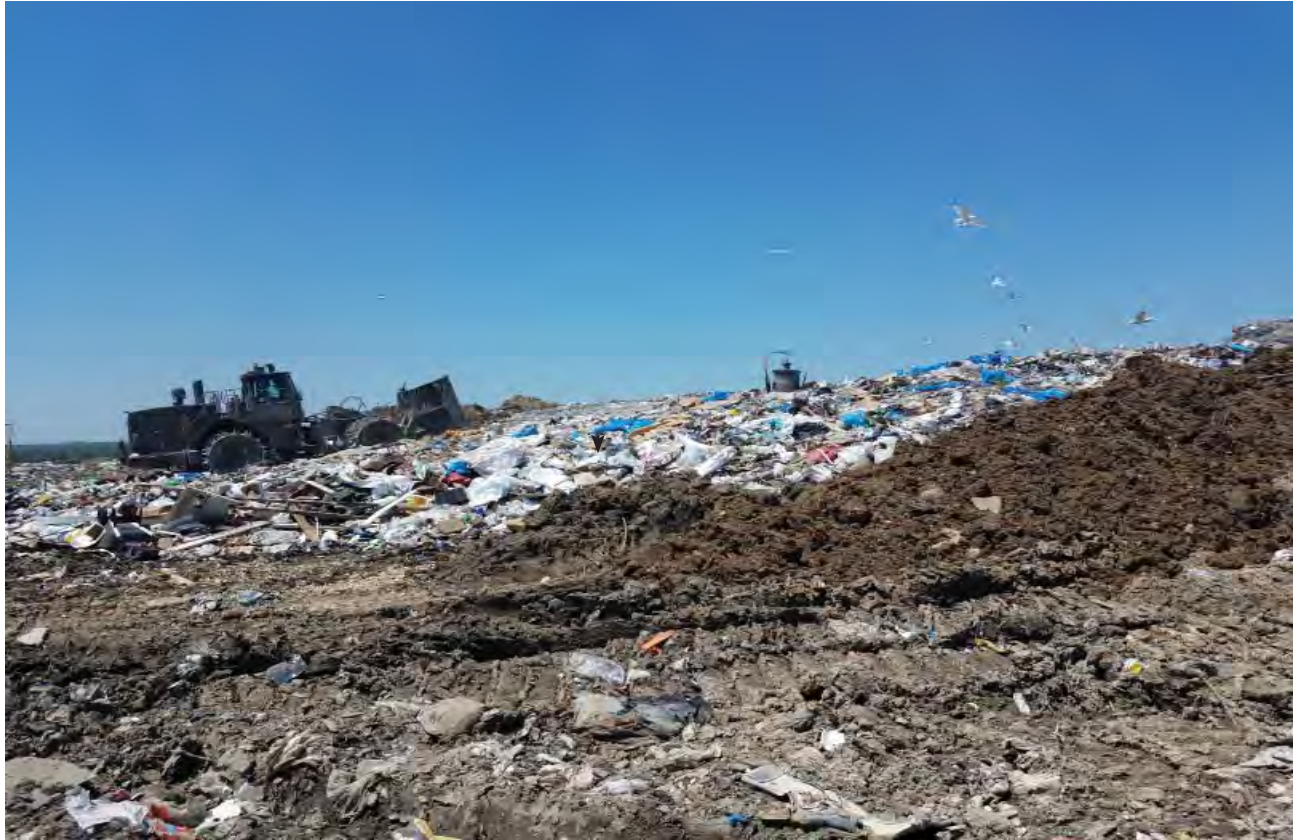
Working face with daily cover stockpiled about edges

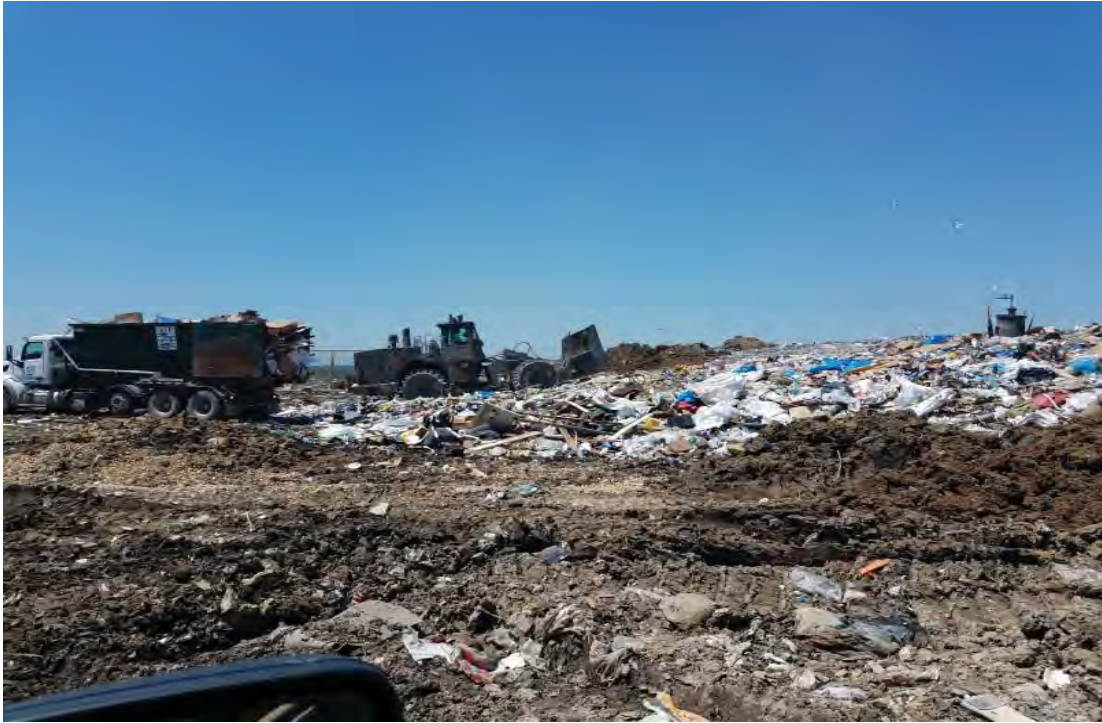
Working face on West edge of Phase 7 South
