2020 Year End Summary of Audits of the Emerald Park Landfill

Prepared For:
City of Muskego
Green For Life Emerald Park Landfill Standing Committee

2020 Green For Life Emerald Park Landfill Year End Compliance Officer Report and Audit Summary

TO: Advanced Disposal Services Emerald Park Standing Committee
FROM: Jo-Walter Spear, Jr., P.E.
COPIES: File
DATE: 03/29/2021
PROJECT NUMBER: 1012.10030

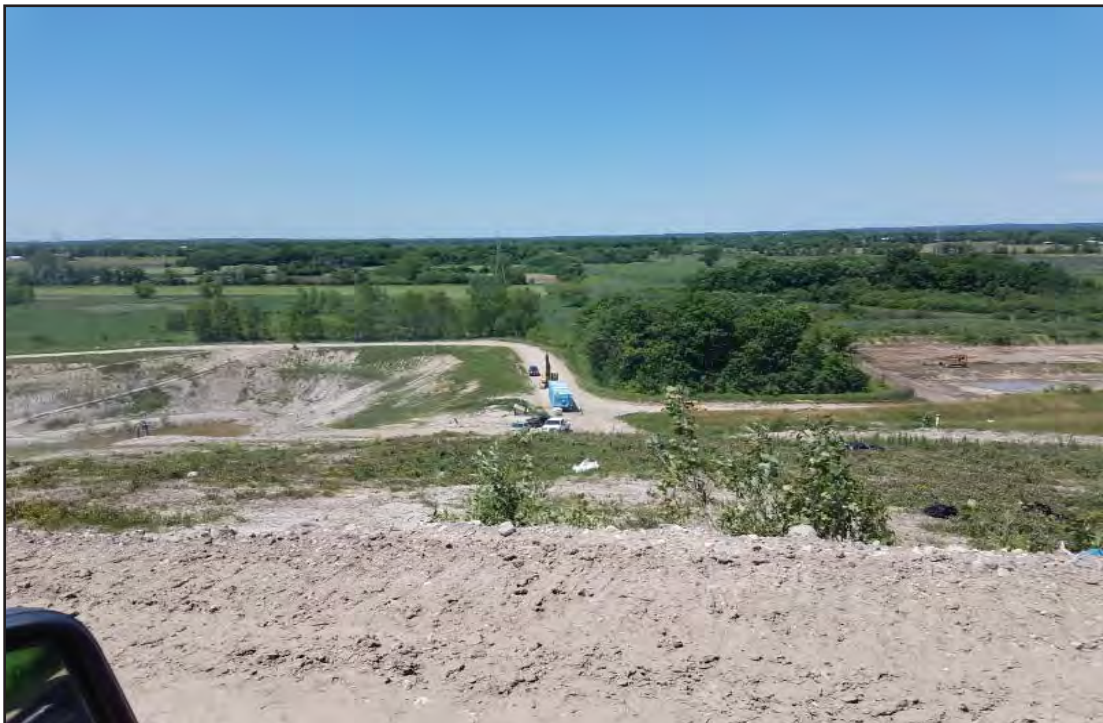
Filter trailer for removing sediment from Temp Sed Basin leachate clean up

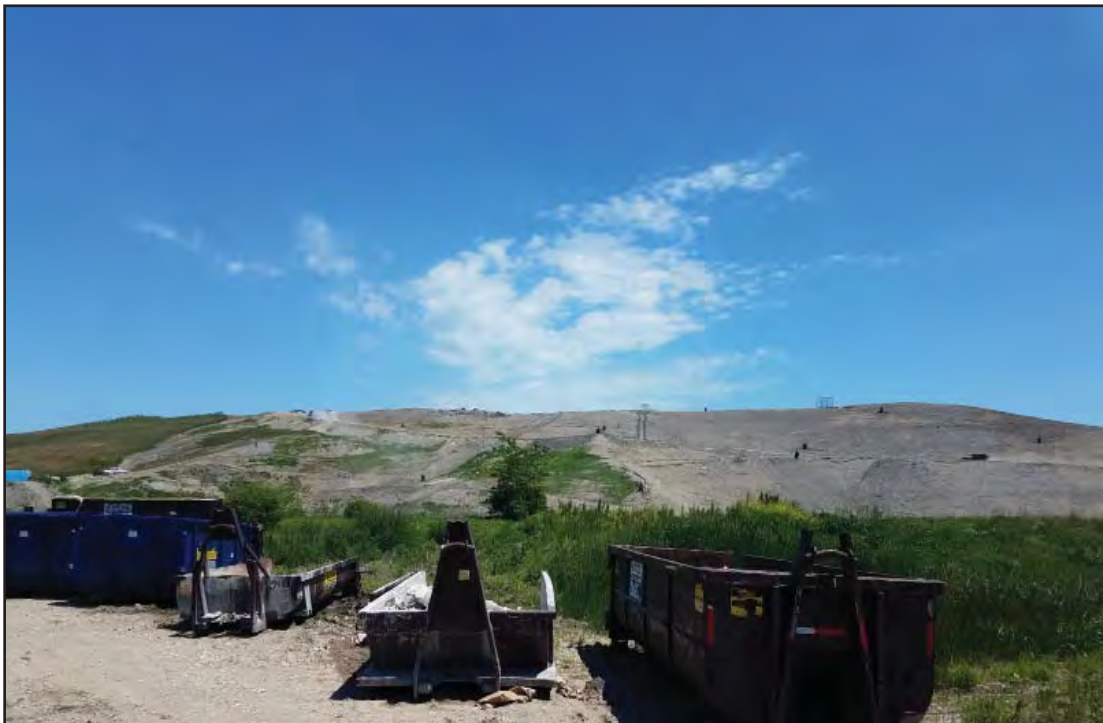
Overview of West slope of Phase 7

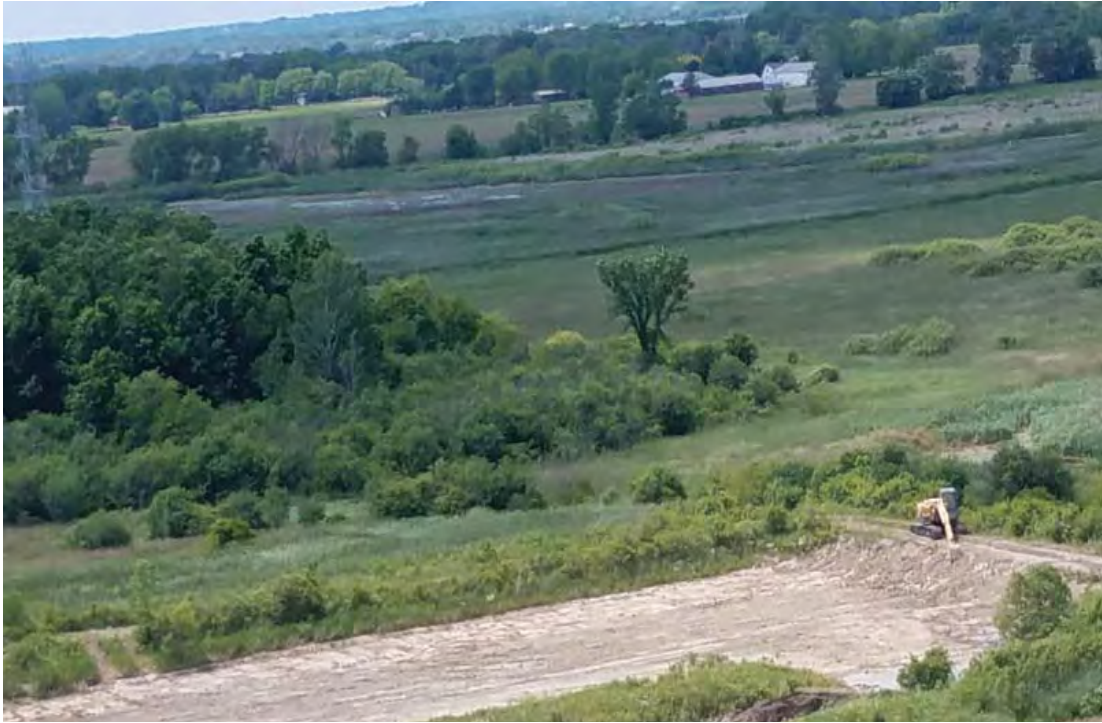
Basin #1 cleaned and restored, new control structure being installed

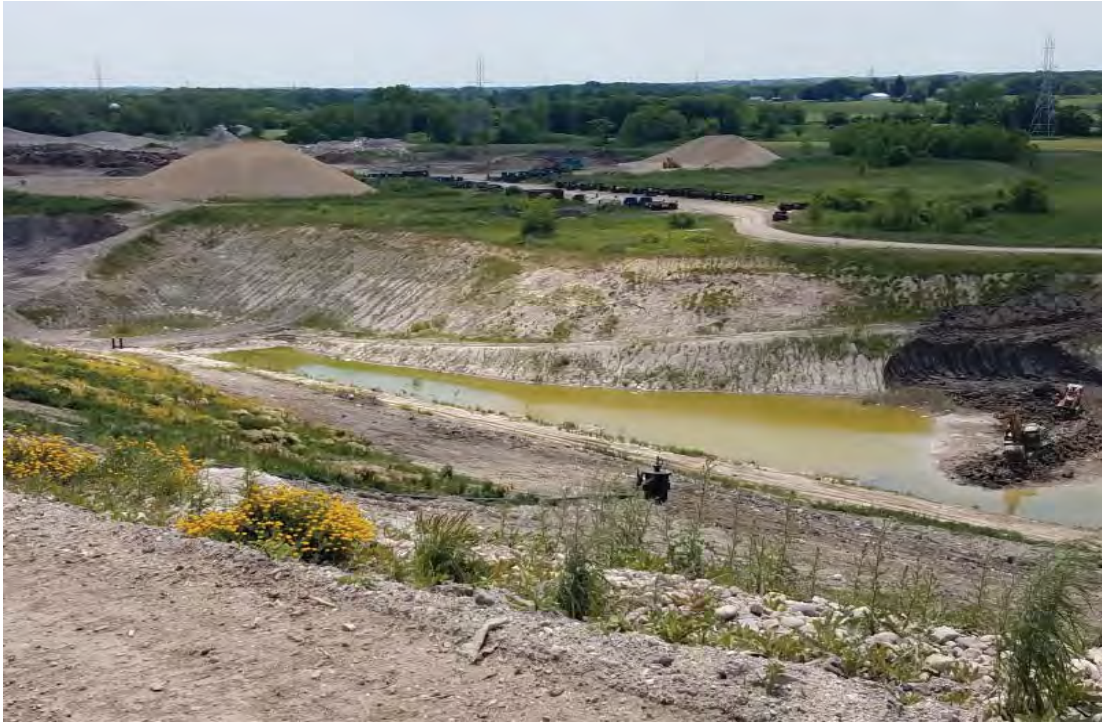
North end of temp sed basin, pumping from this area to tanker

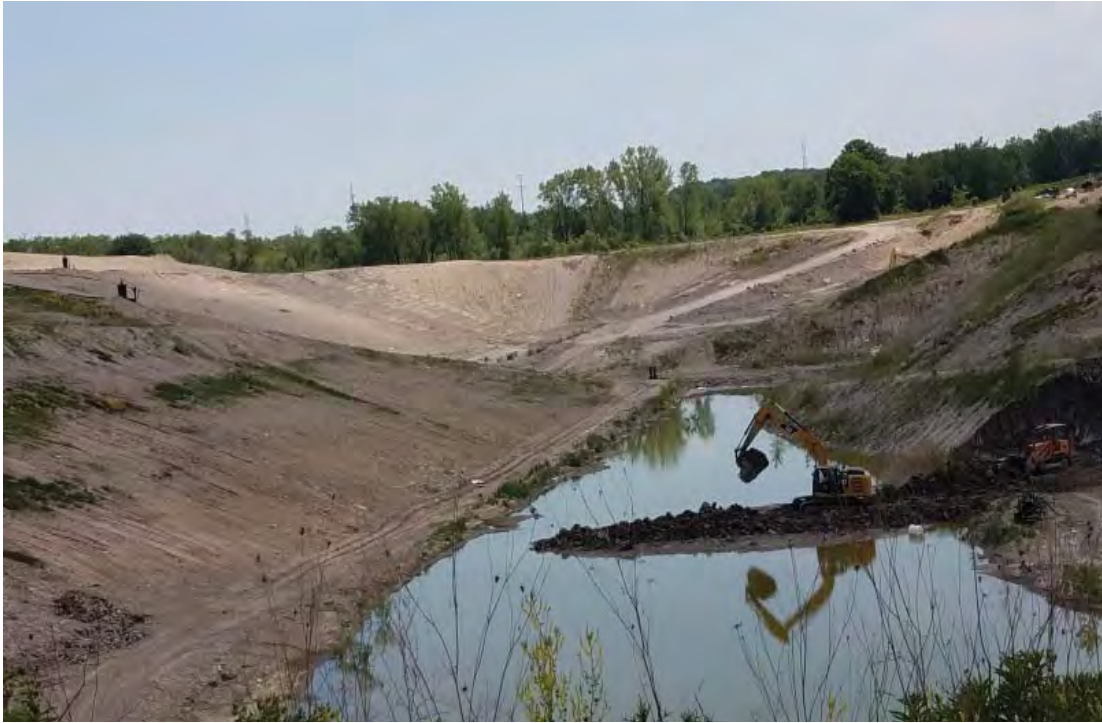
West slope of Phase 7, soils at top of slope for daily cover

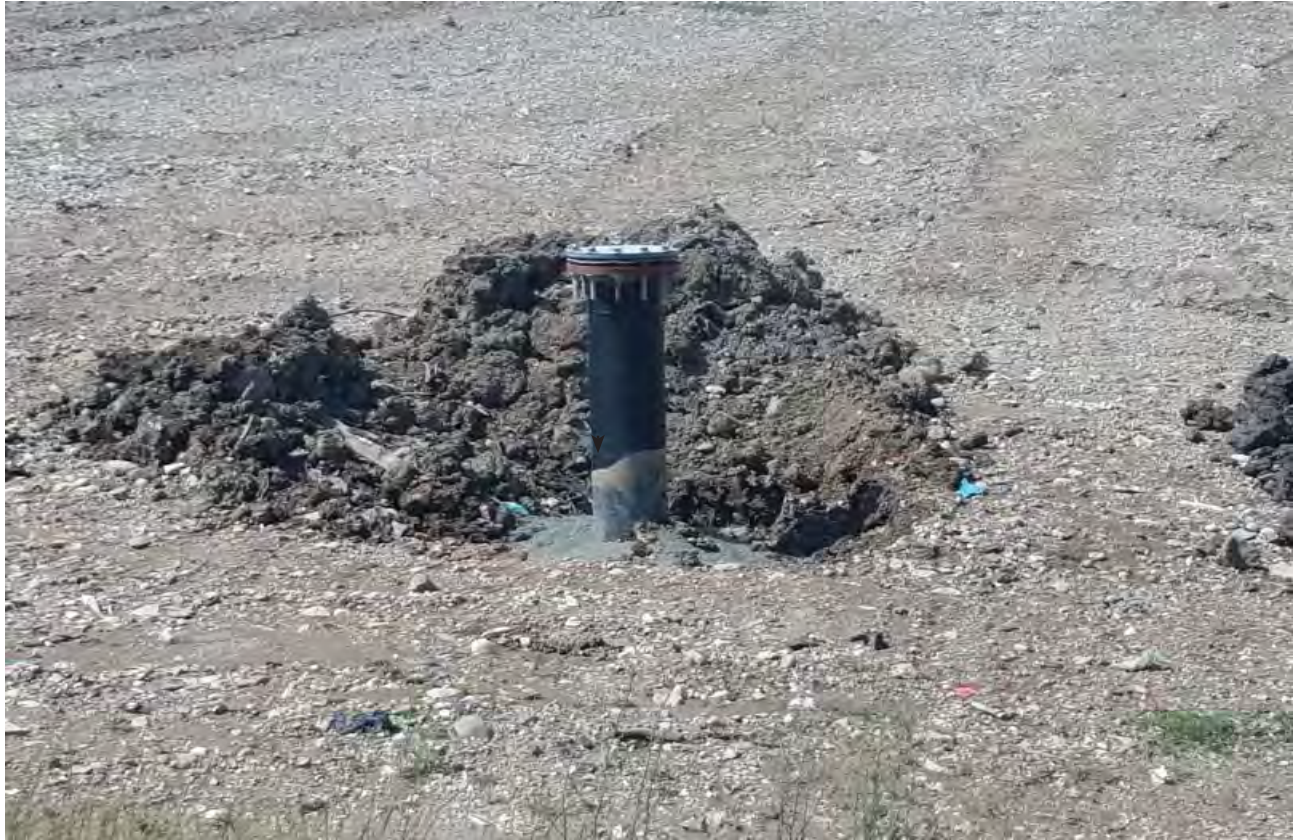
Bentonite and clay sealing about well heads

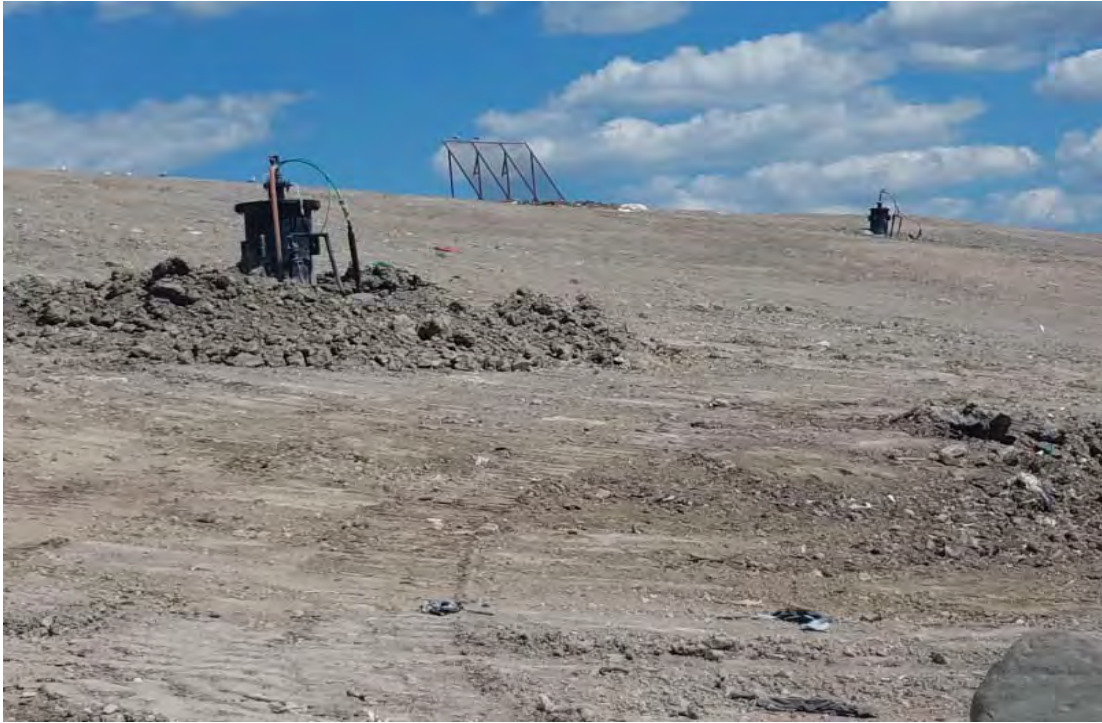
Bentonite and clay sealing about well heads

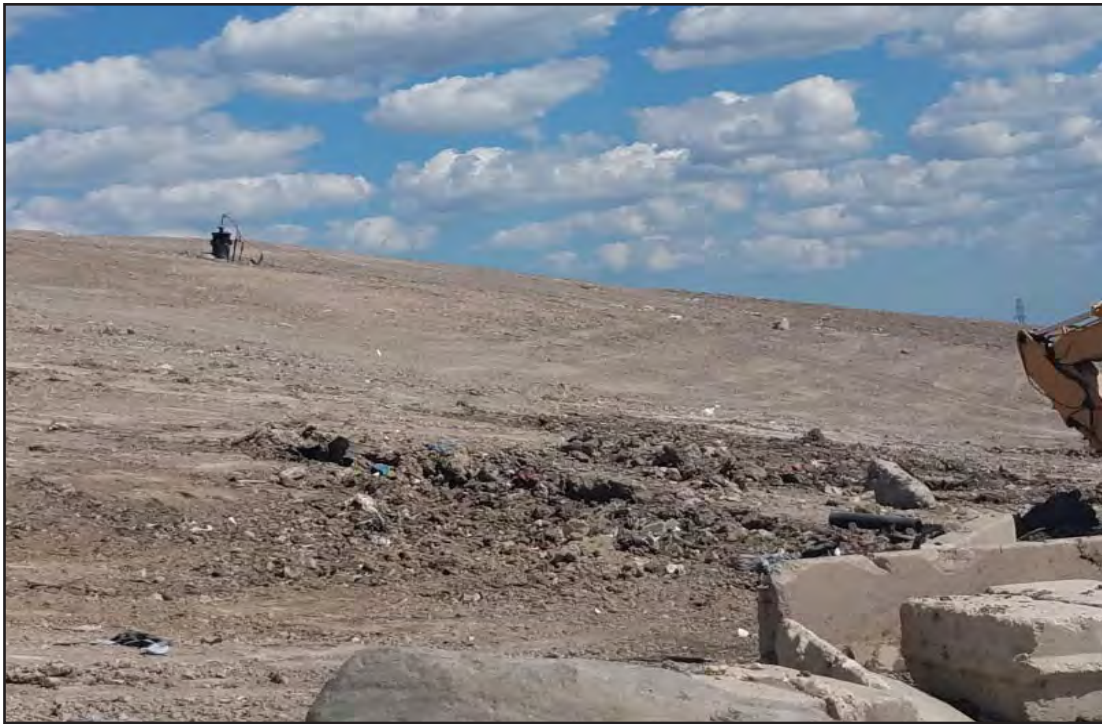
Excavation upslope of access road to address seeps and gas emissions.
May not be capped by end of day, but will be by 6/26/2020

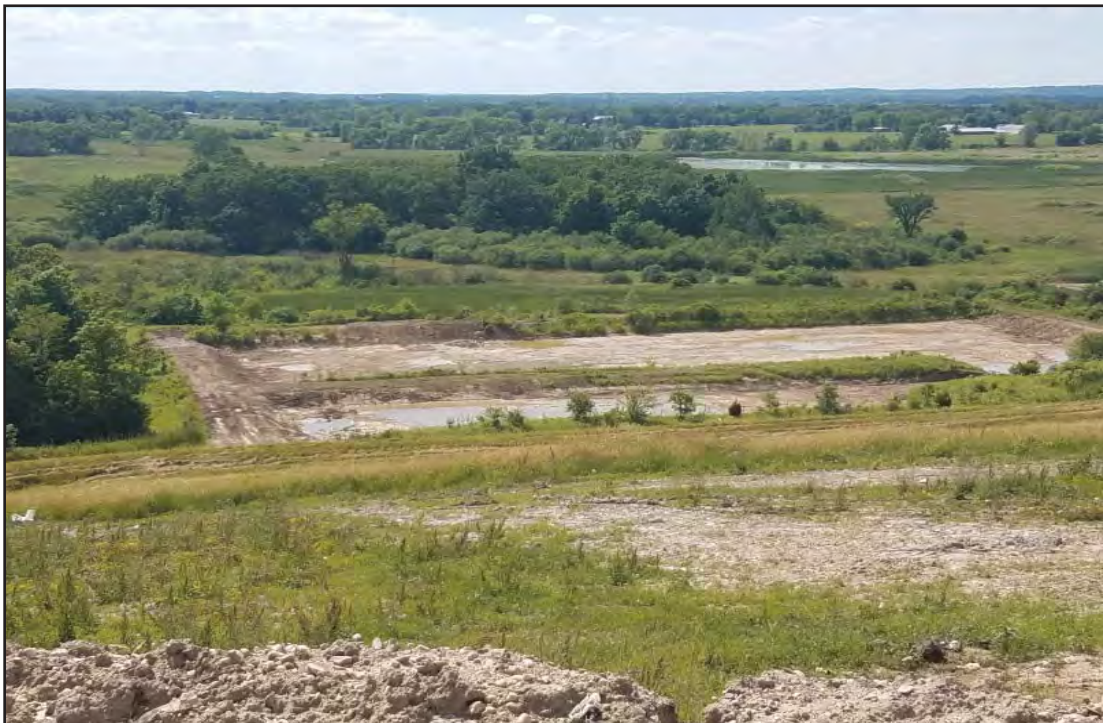
Work in cleaning and restoring basin #1 complete

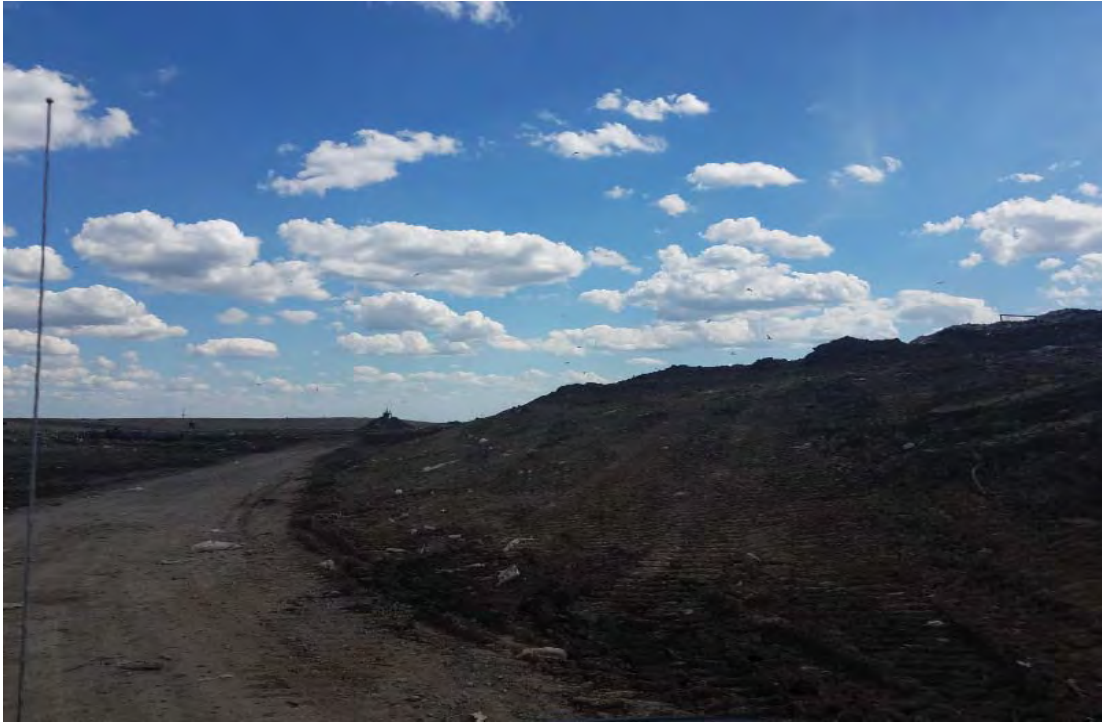
Access road up to Phase 7, area of recurring odors

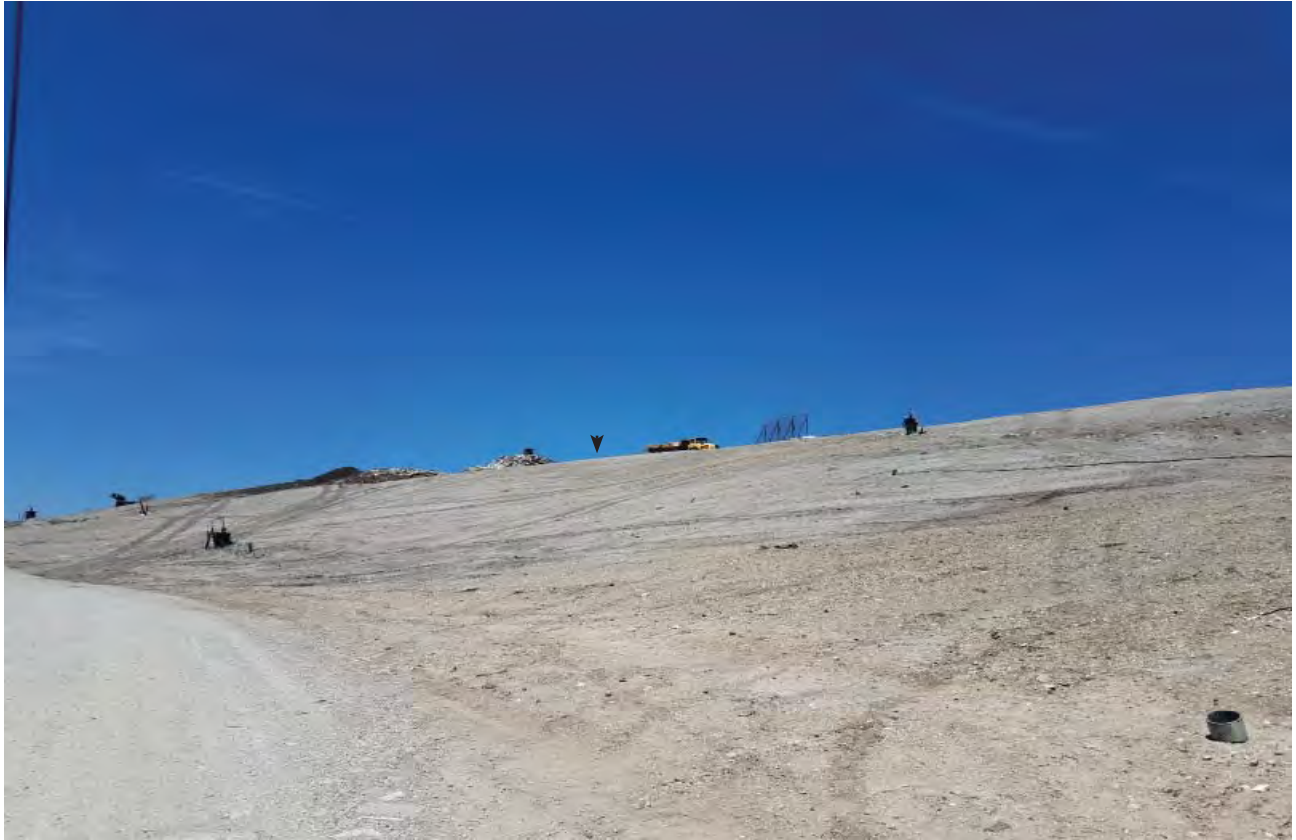
West slope on approach to working face in Phase 7

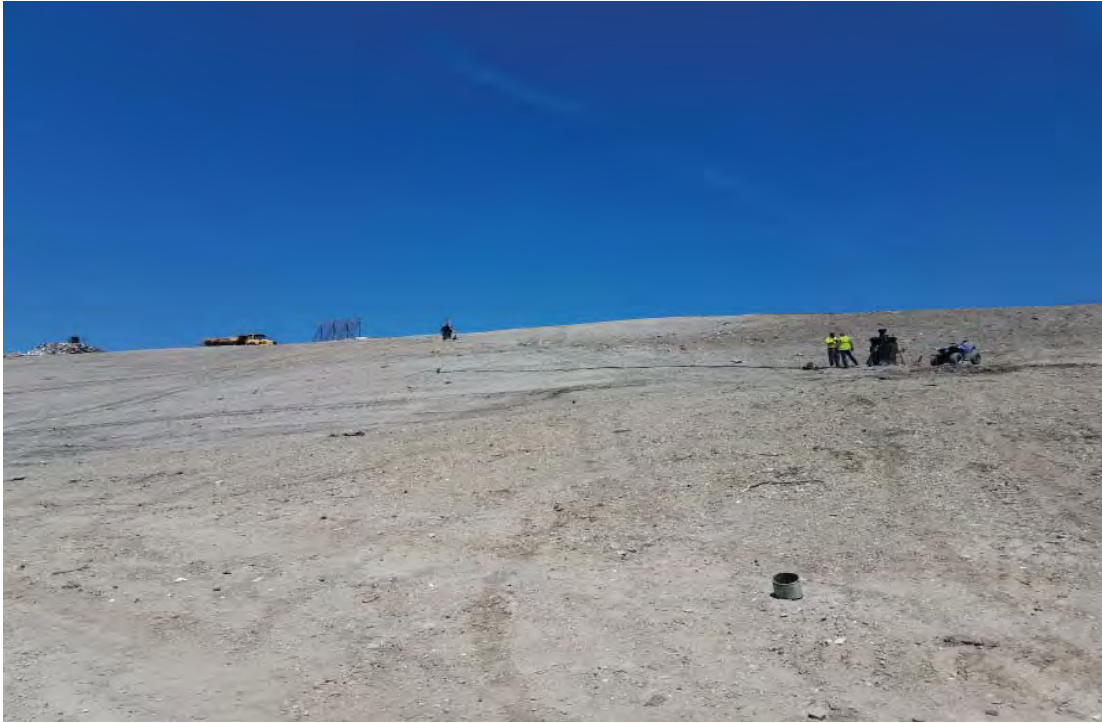
West slope of Phase 7 above access road

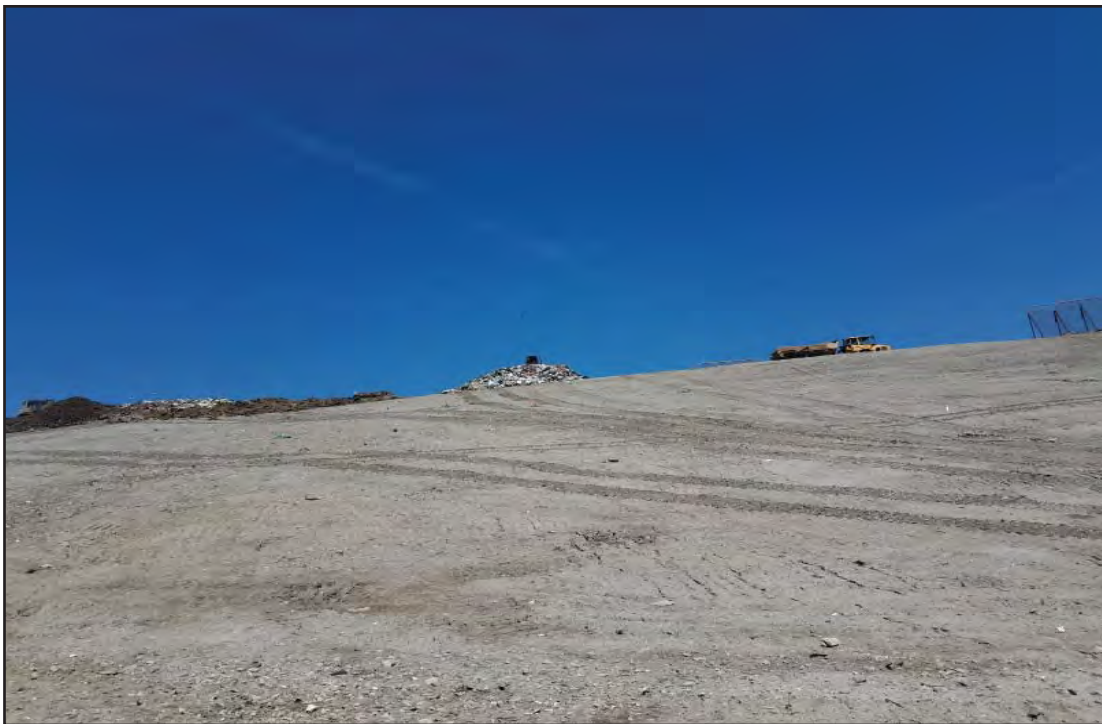
West slope of Phase 7 above access road

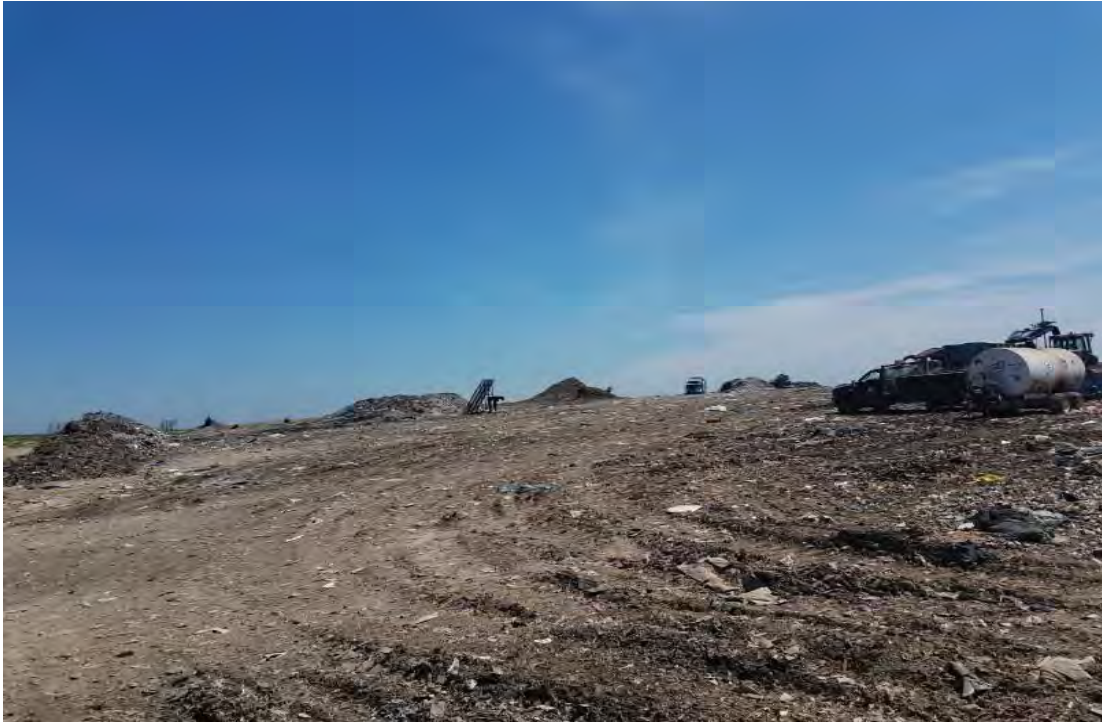
Current surface conditions about working face in Phase 7

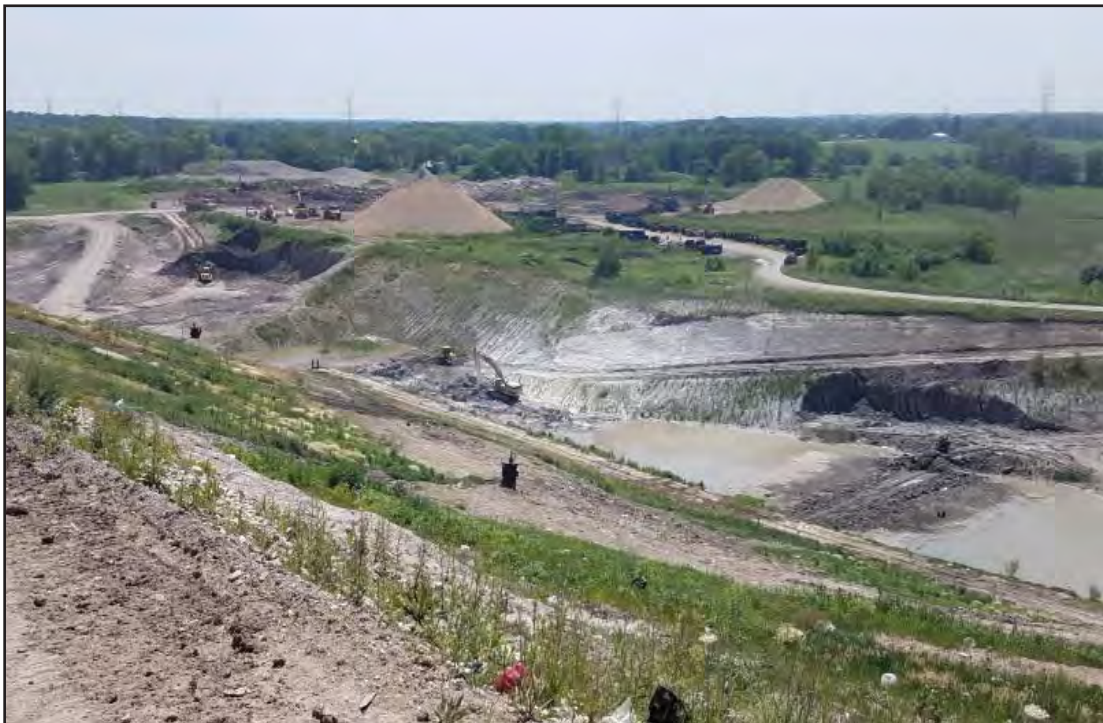
Temp sed basin being separated to manage leachate contamination

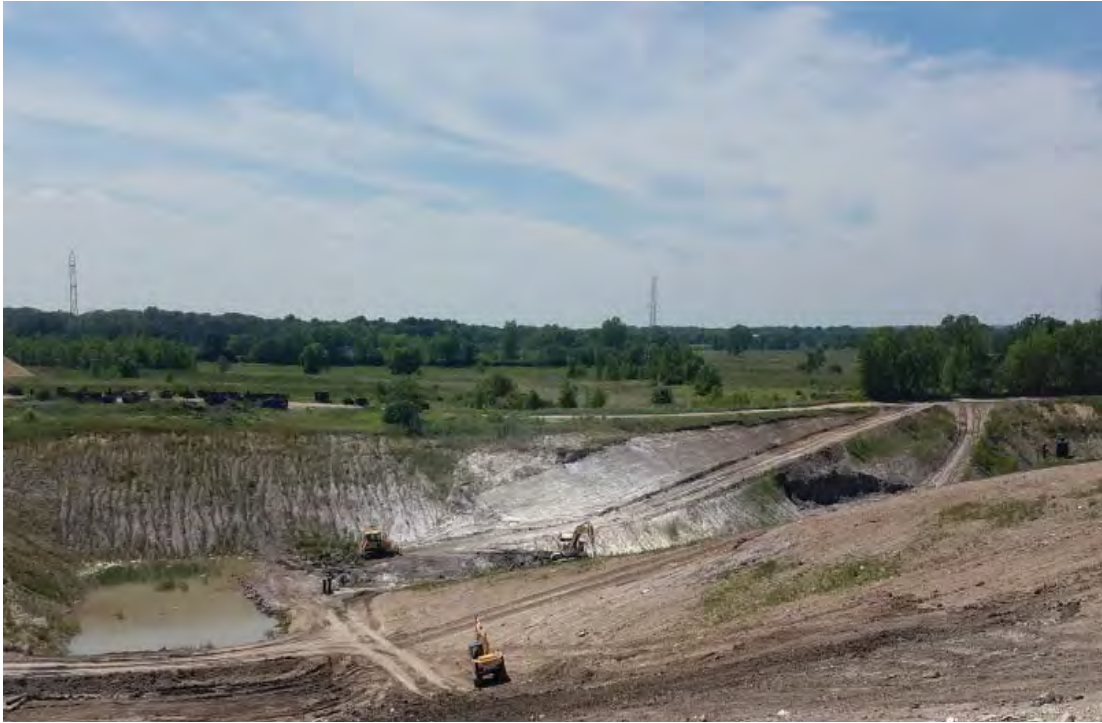
View across temp sed basin, East to West

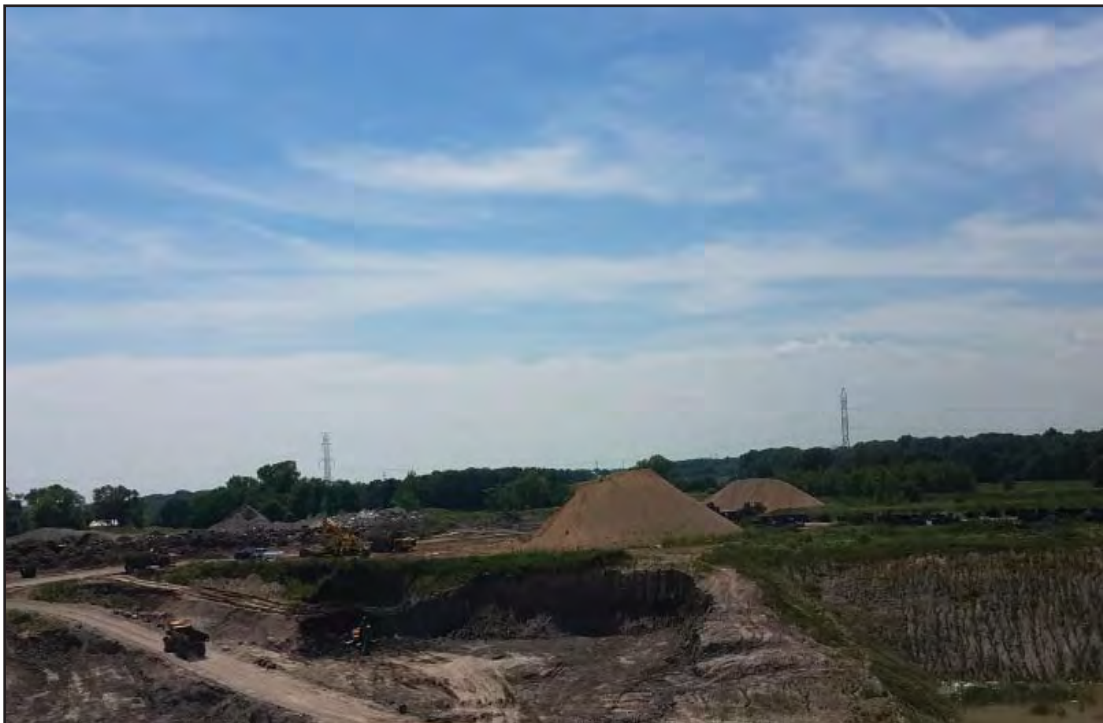
View into future Phase 8 excavation from the East

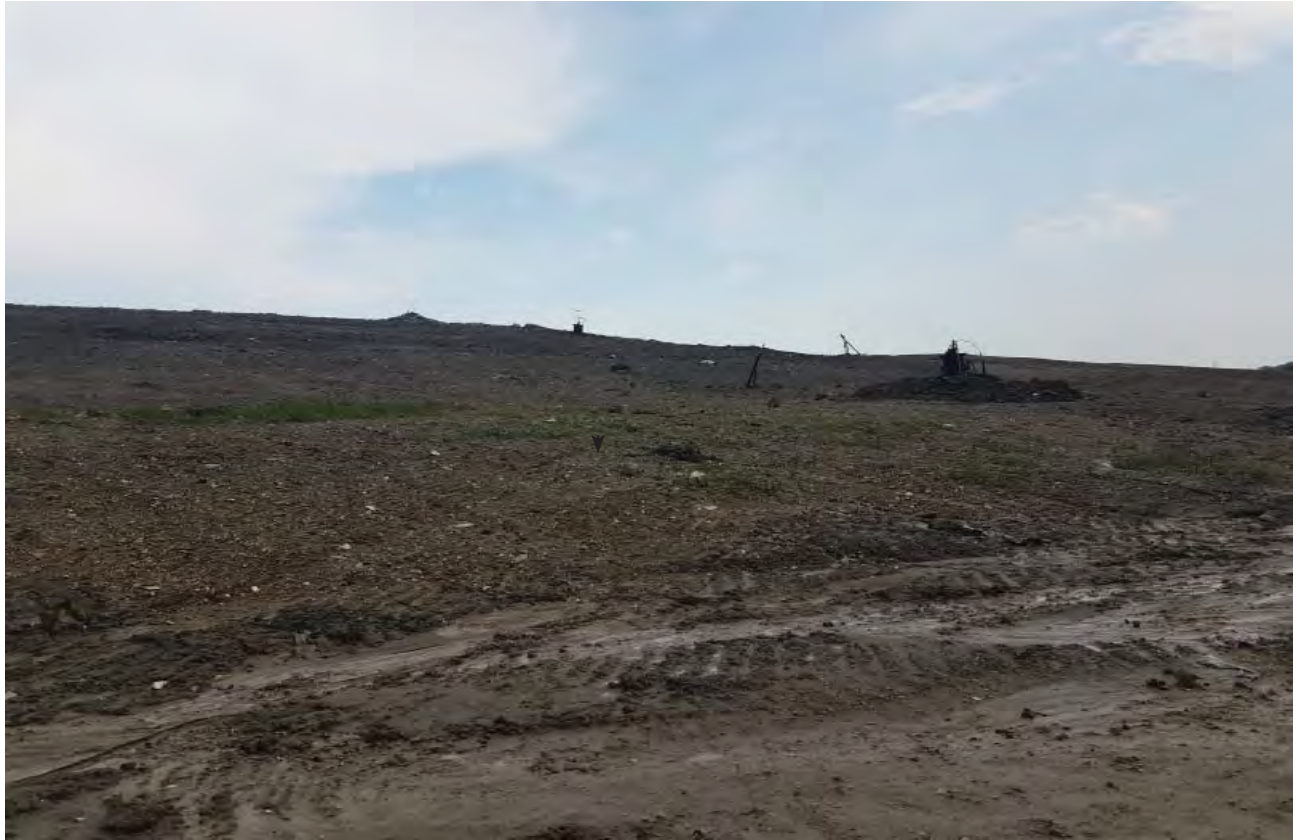
Site slopes wet, but not eroded

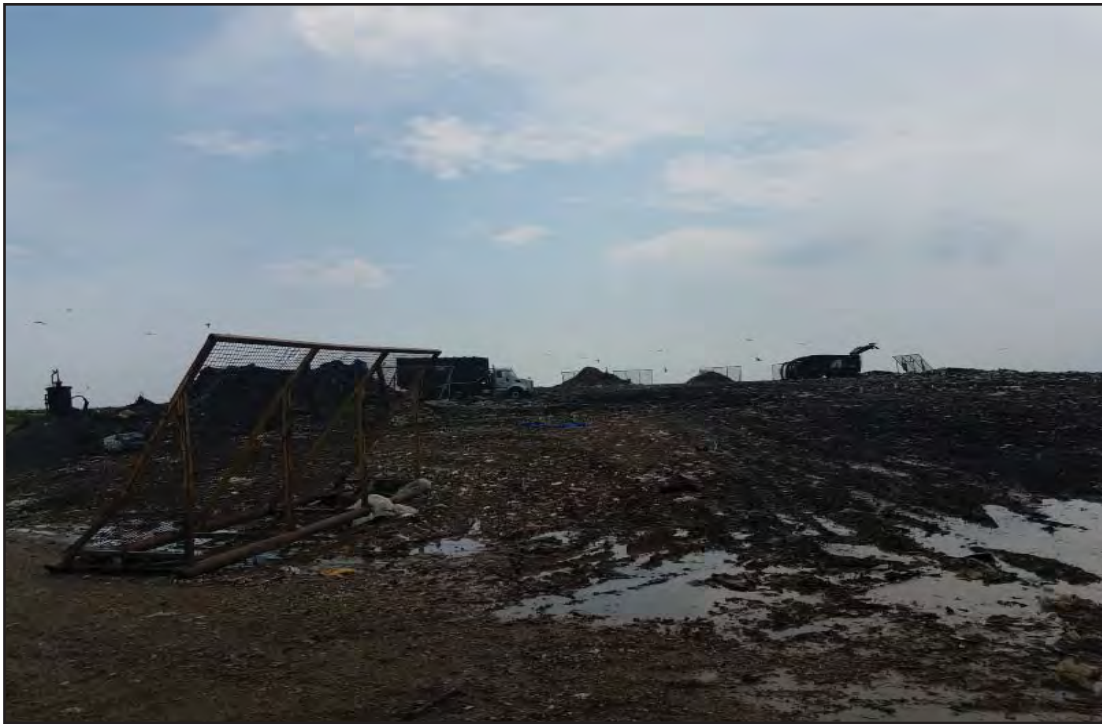
Water pooled about active area

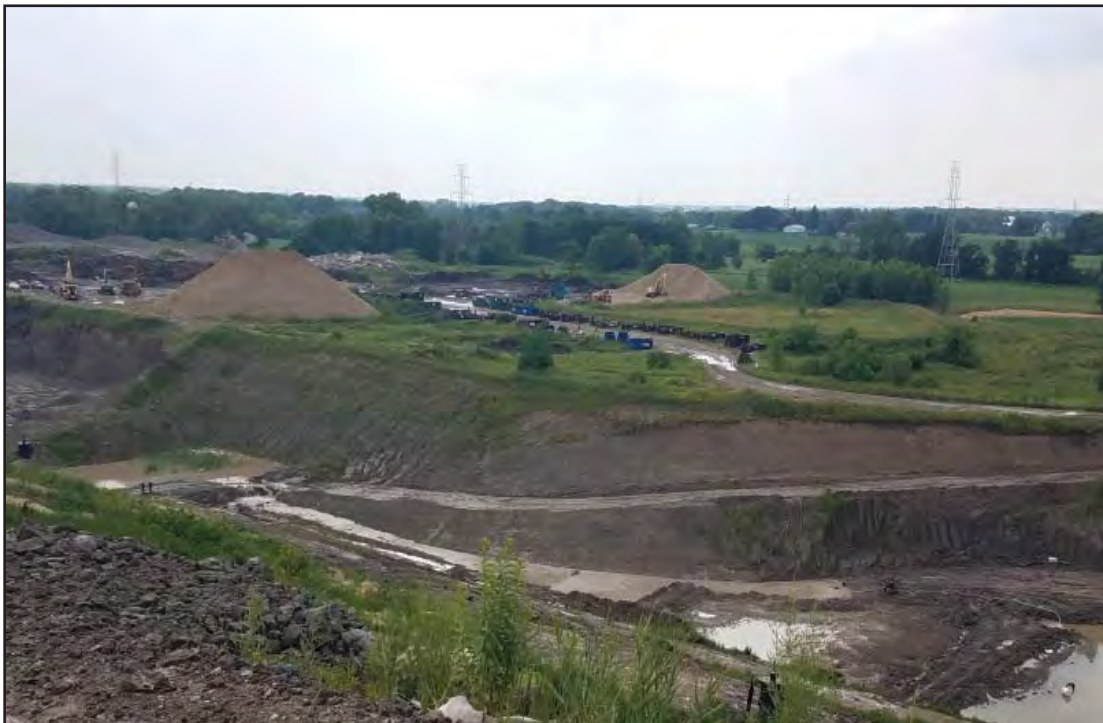
Temp sed basin laid out, prepped for leachate removal and dredging

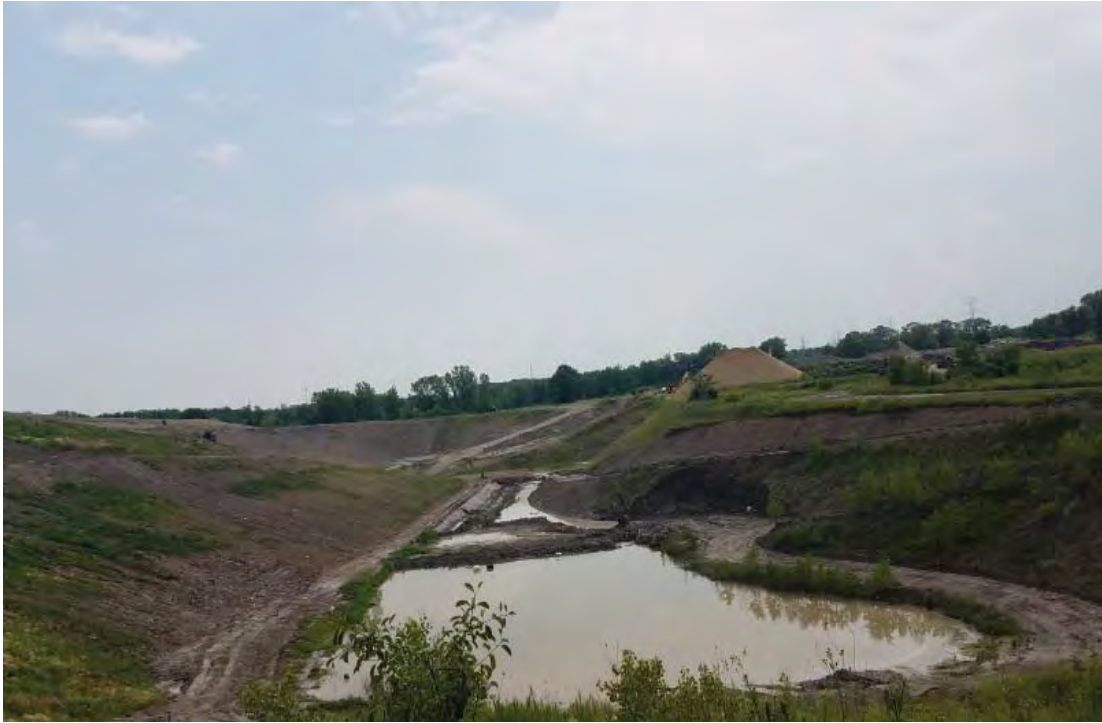
Temp sed basin, cleaning and dredging continue.

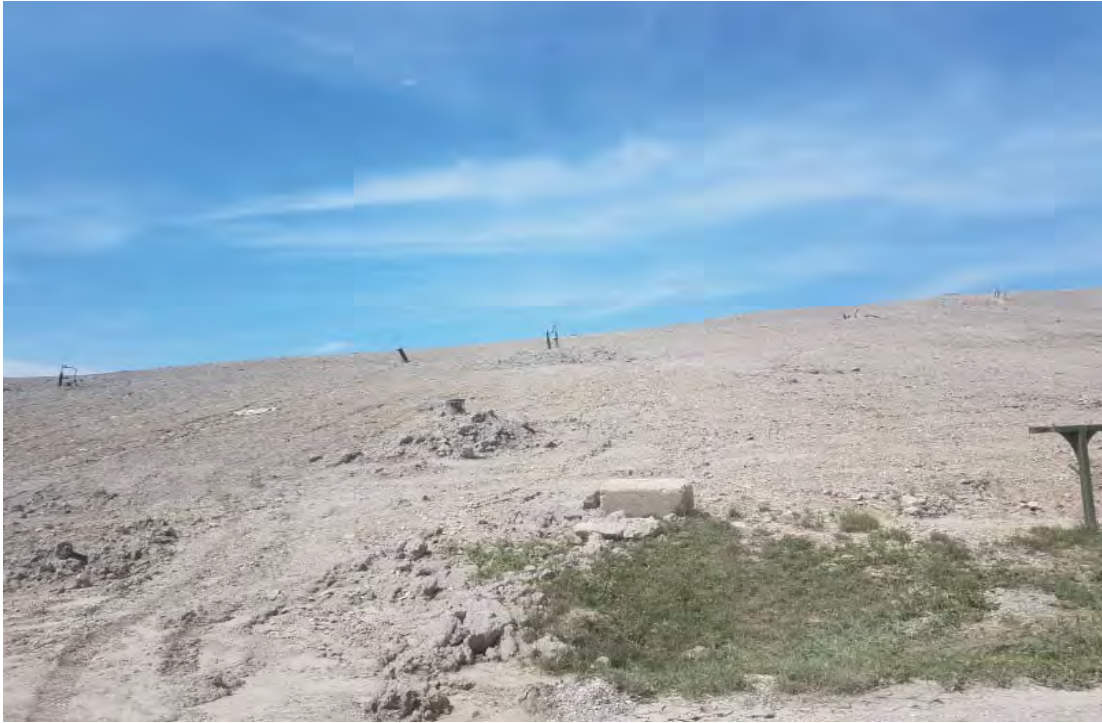
West edge of South slope of Phase 7 South

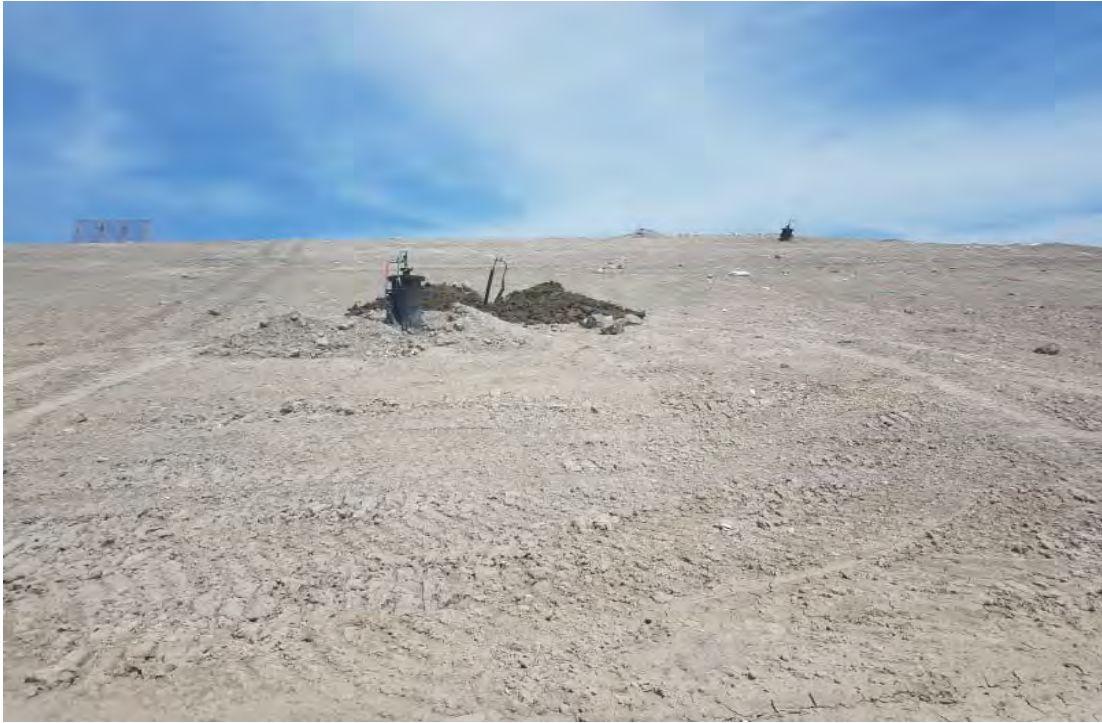
South slope of Phase 7 South, well being backfilled after placement of bentonite

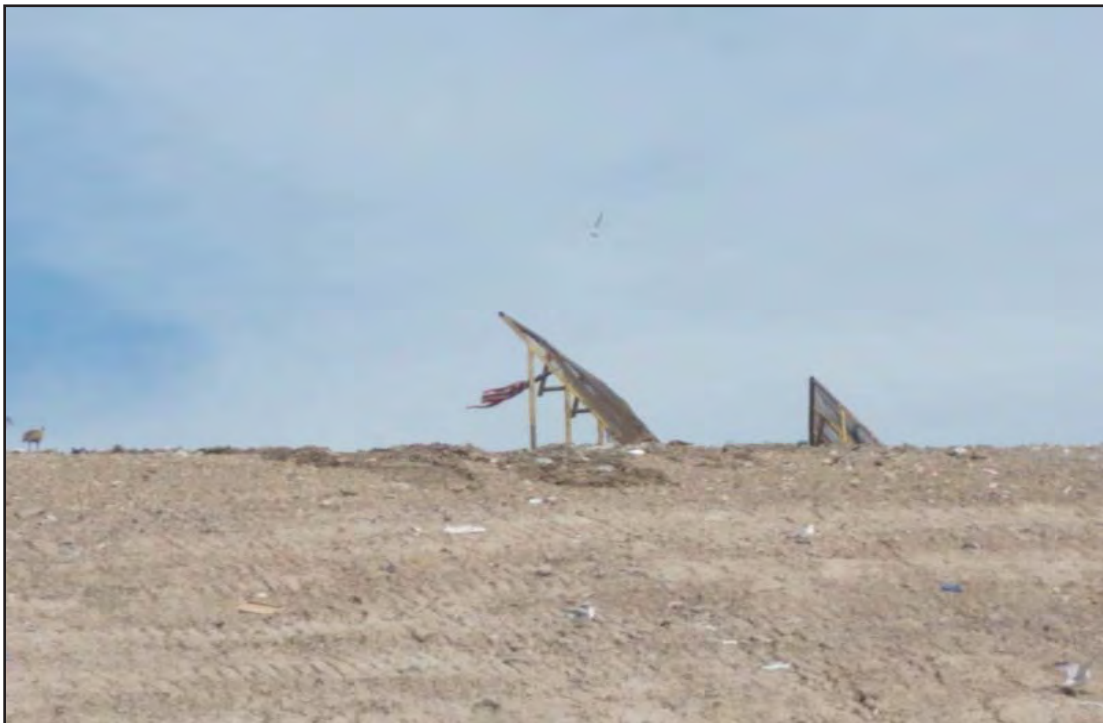
Top of slope, Phase 7, some stockpiling placed for cover

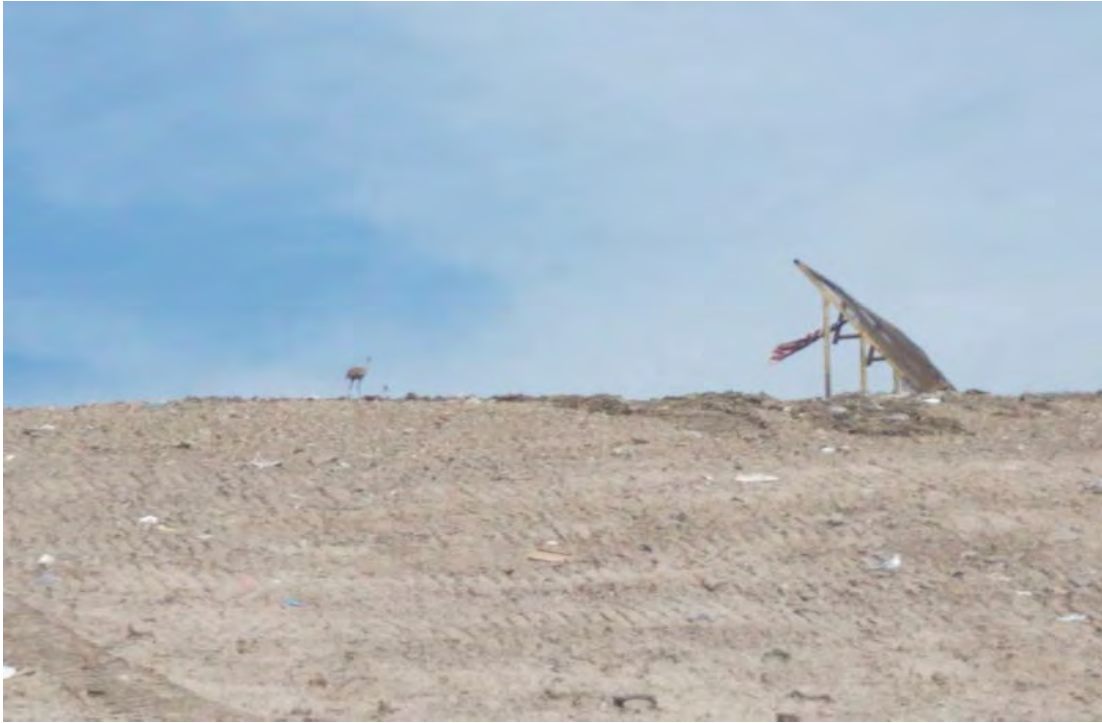
West slope, at top, of Phase 7

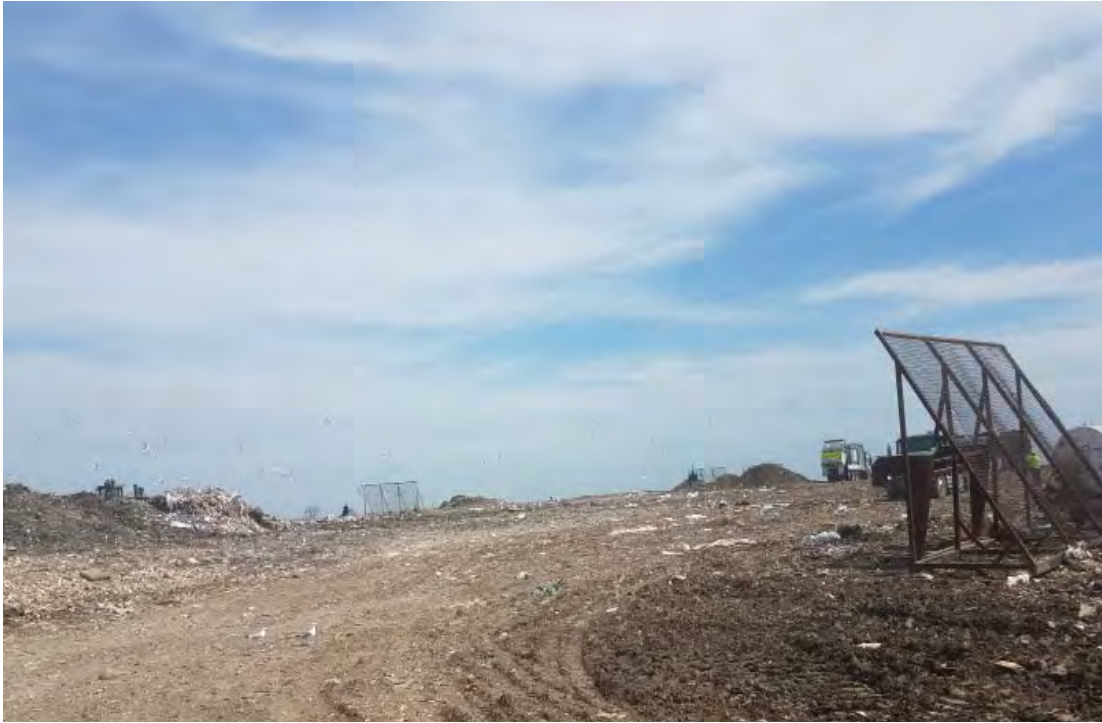
Access across active area viewing South

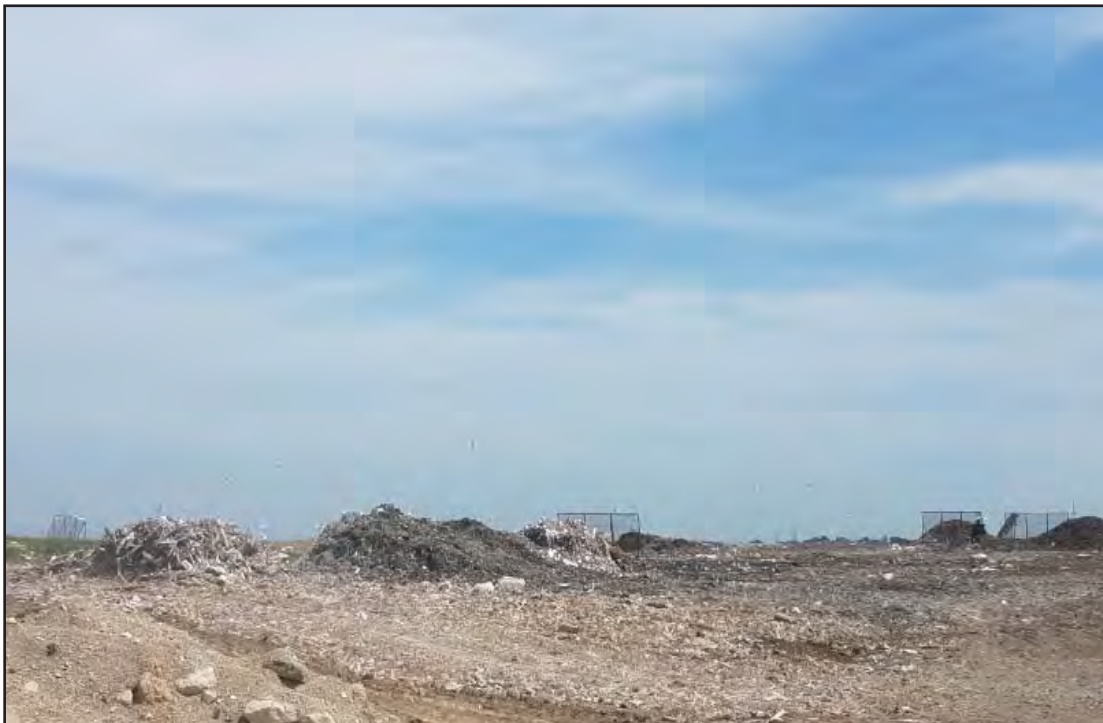
Phase 7 view to the South
