2020 Year End Summary of Audits of the Emerald Park Landfill

Prepared For:
City of Muskego
Green For Life Emerald Park Landfill Standing Committee

2020 Green For Life Emerald Park Landfill Year End Compliance Officer Report and Audit Summary

TO: Advanced Disposal Services Emerald Park Standing Committee
FROM: Jo-Walter Spear, Jr., P.E.
COPIES: File
DATE: 03/29/2021
PROJECT NUMBER: 1012.10030

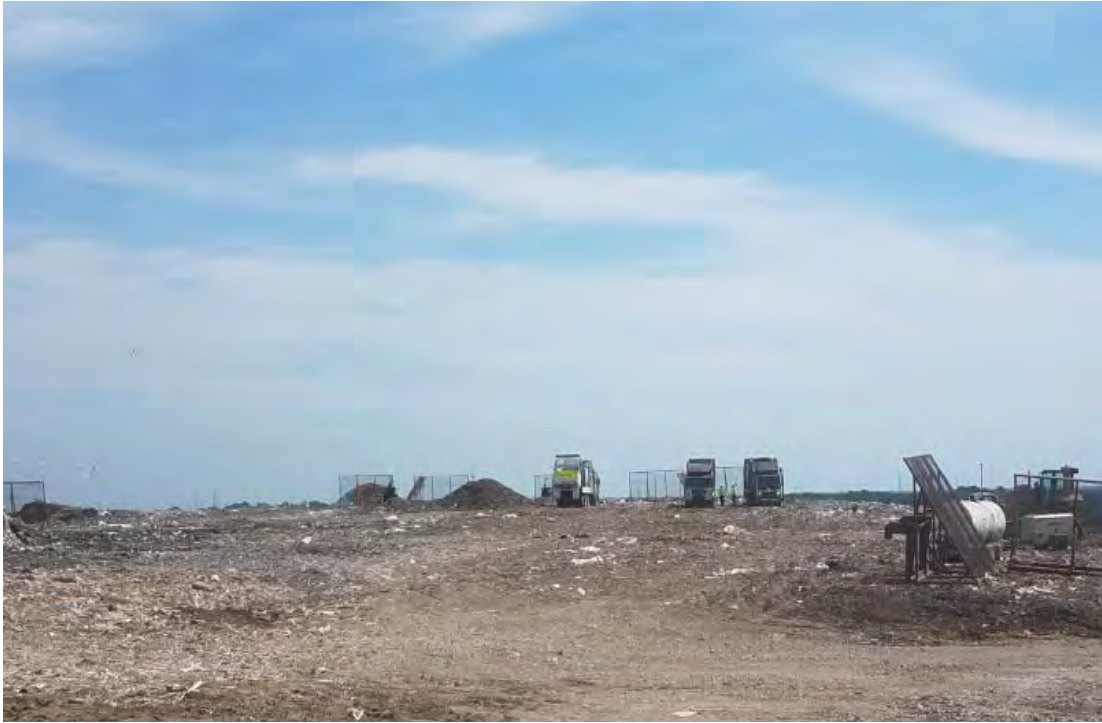
New lift moving West across Phase 7

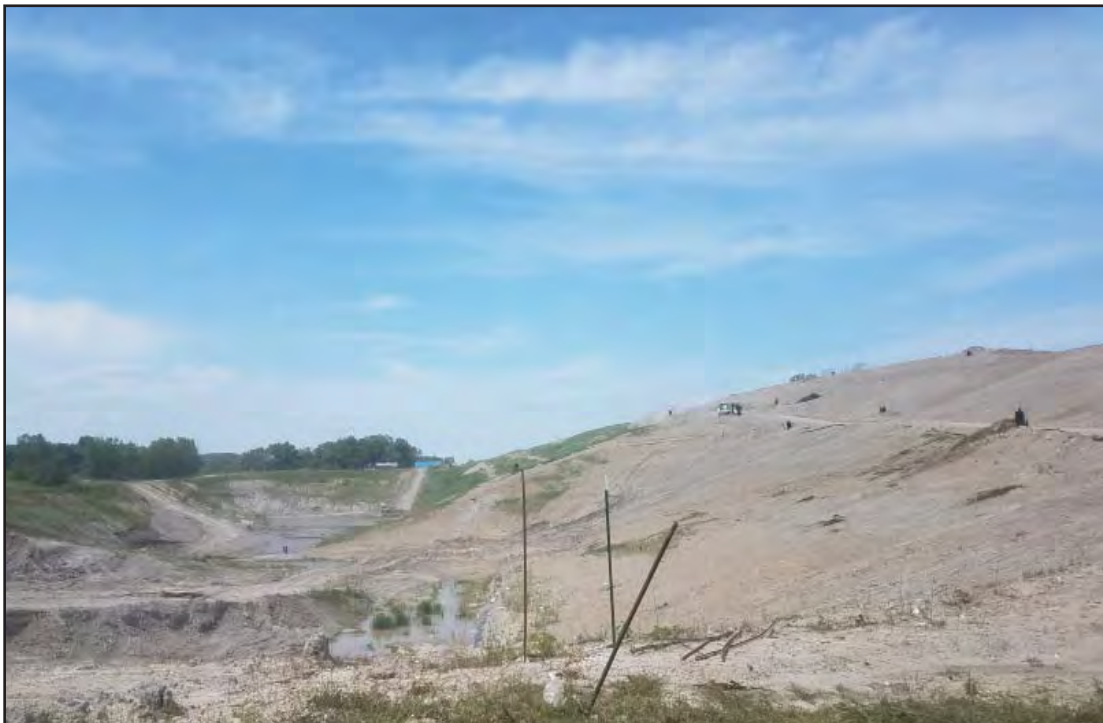
West slope of Phase 7 viewed from the South

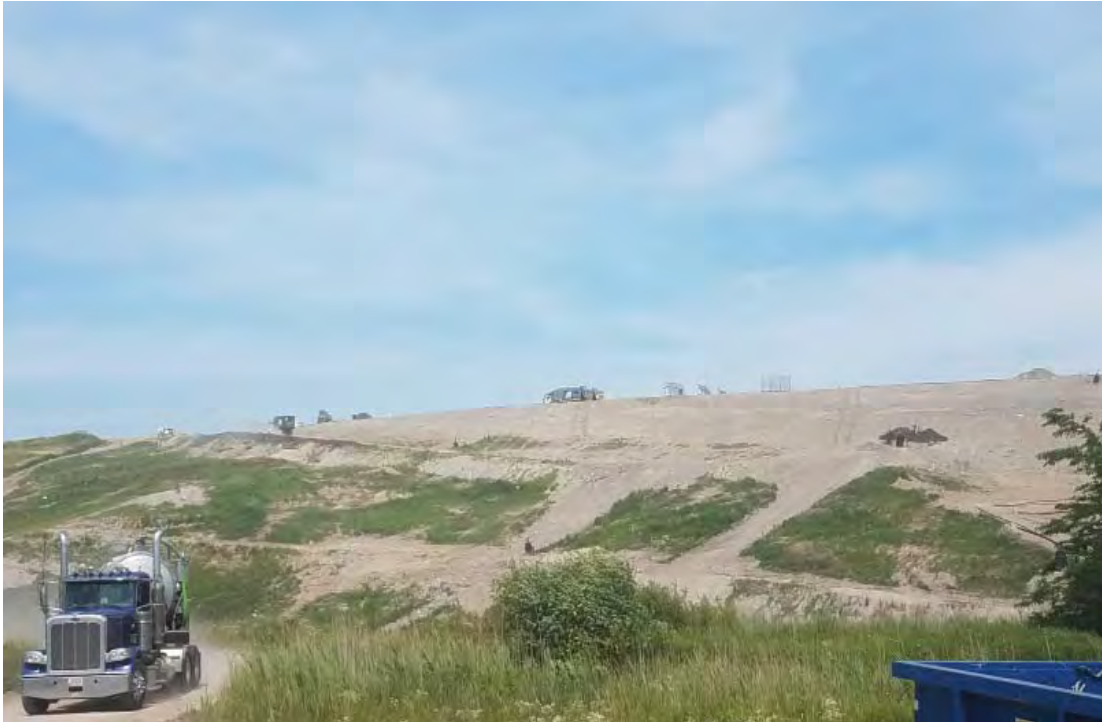
West slope of Phase 7, tanker truck leaving with a load from temp sed basin

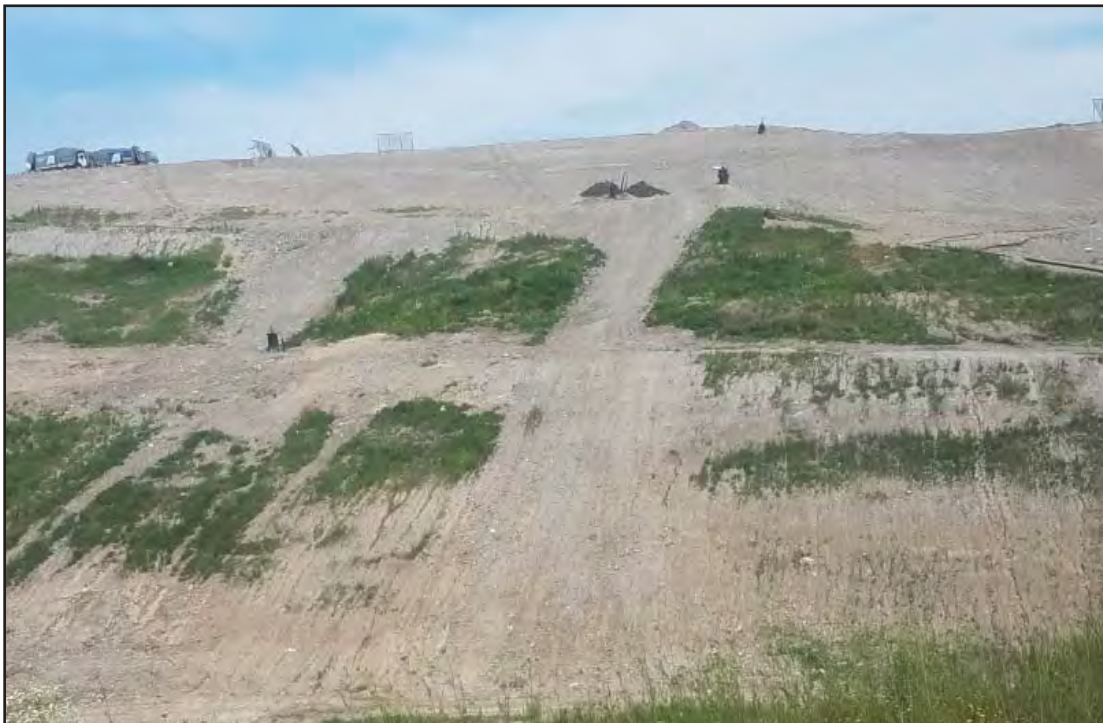
West slope of Phase 7, no evident seeps

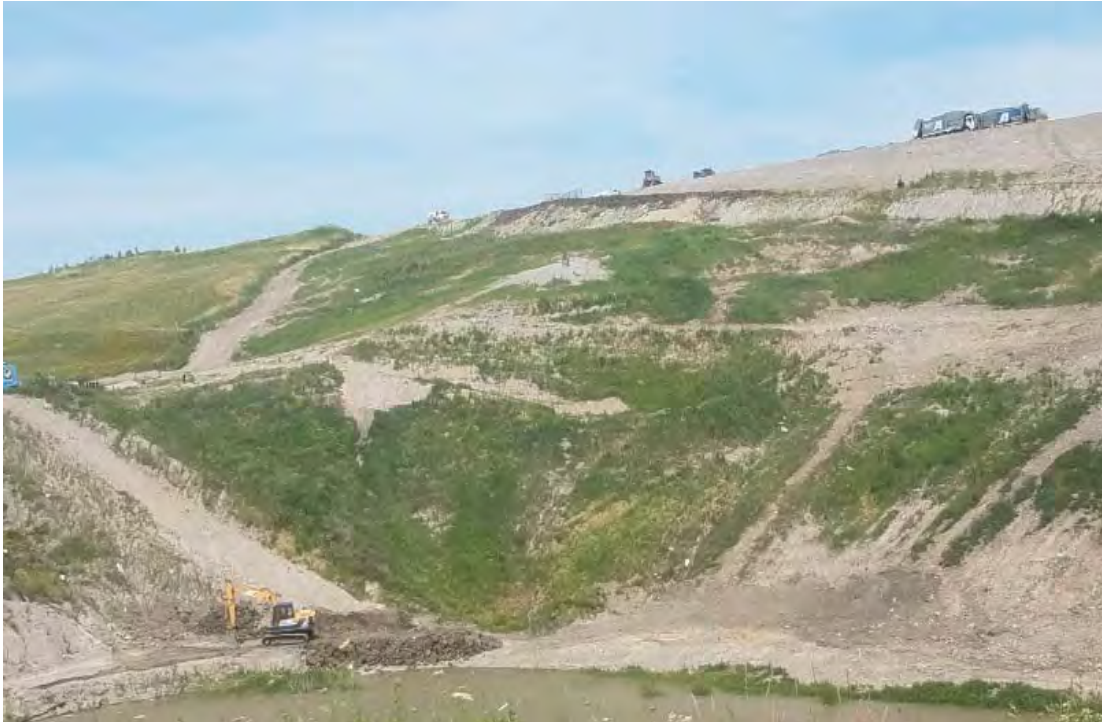
West slope above temp sed basin, excavator making repairs and access improvements

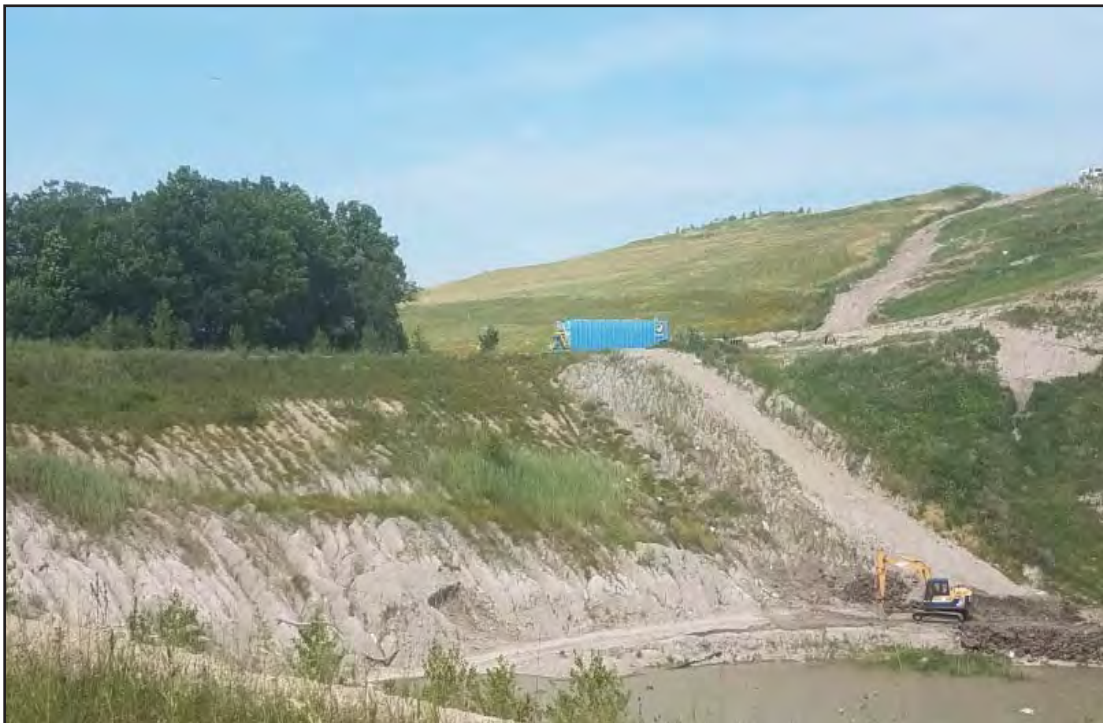
North slope out of temp sed basin, contaminated runoff pumped through filter tailer into tankers

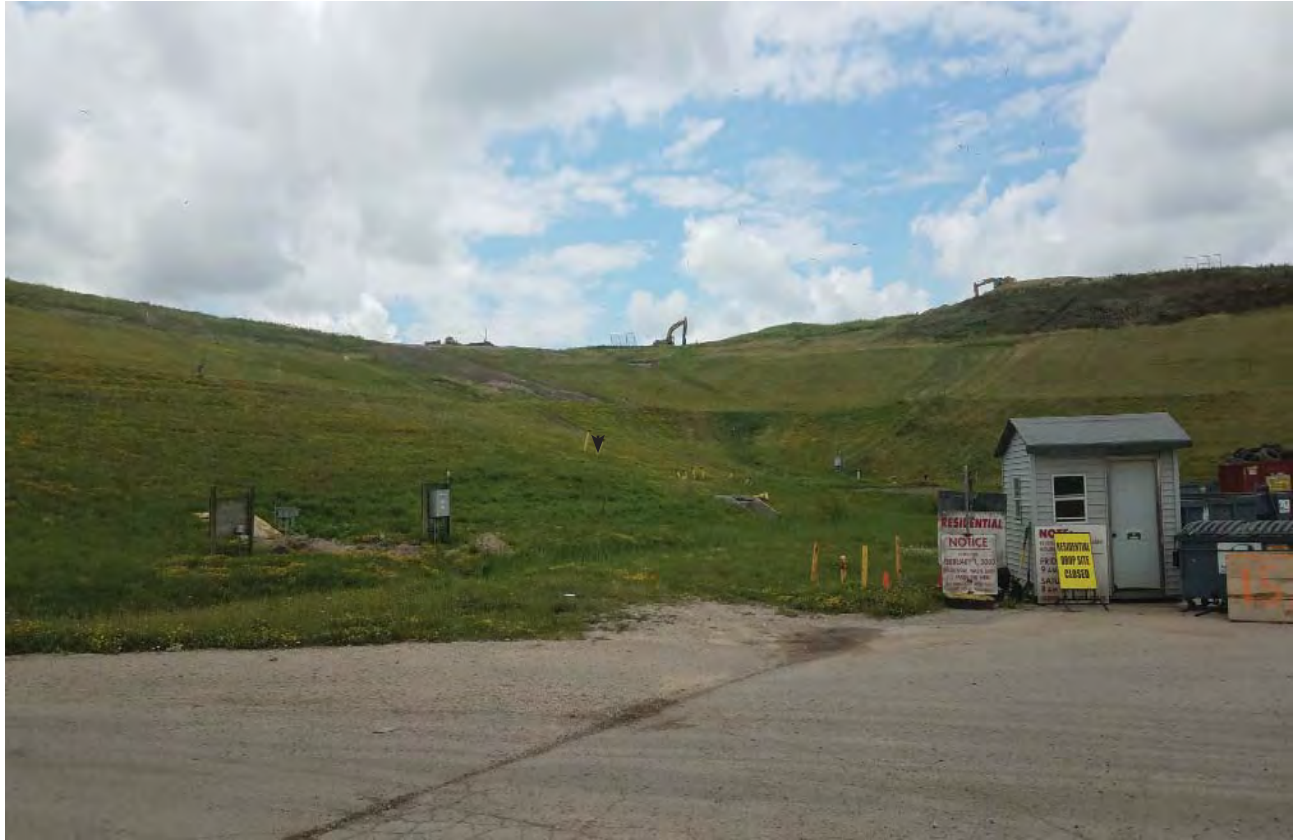
Slope repair on North slope of Phase 4, upper middle of Photo

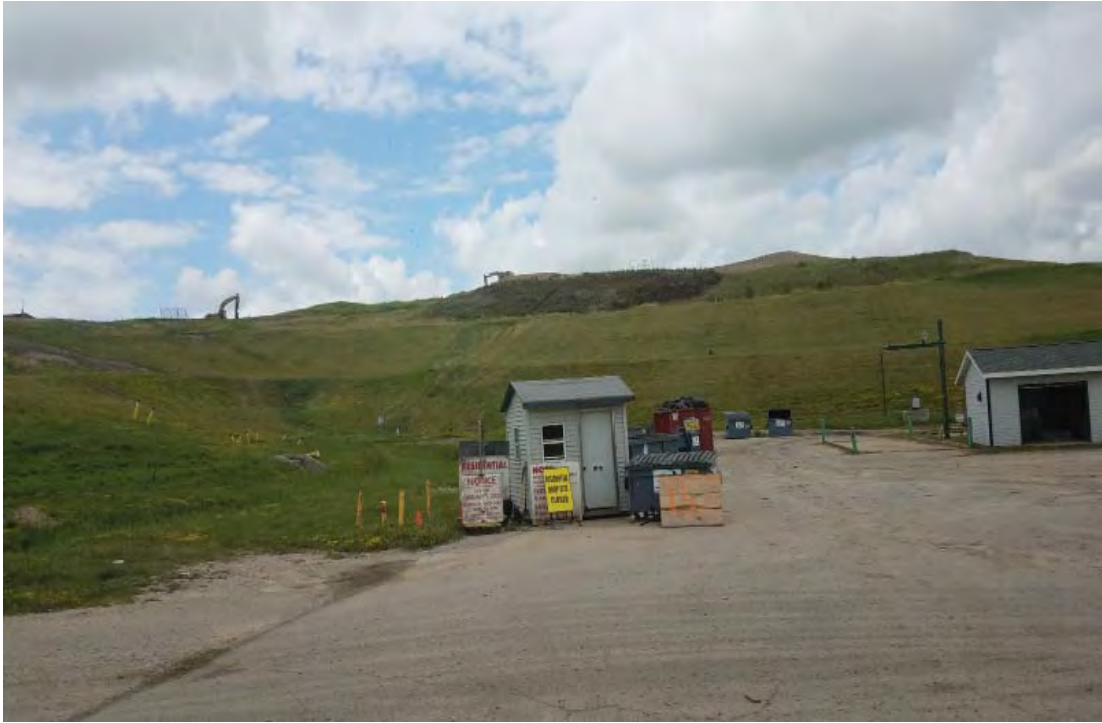
Phases 4 and 3, soil being excavated from on top of Phase 3 for cover

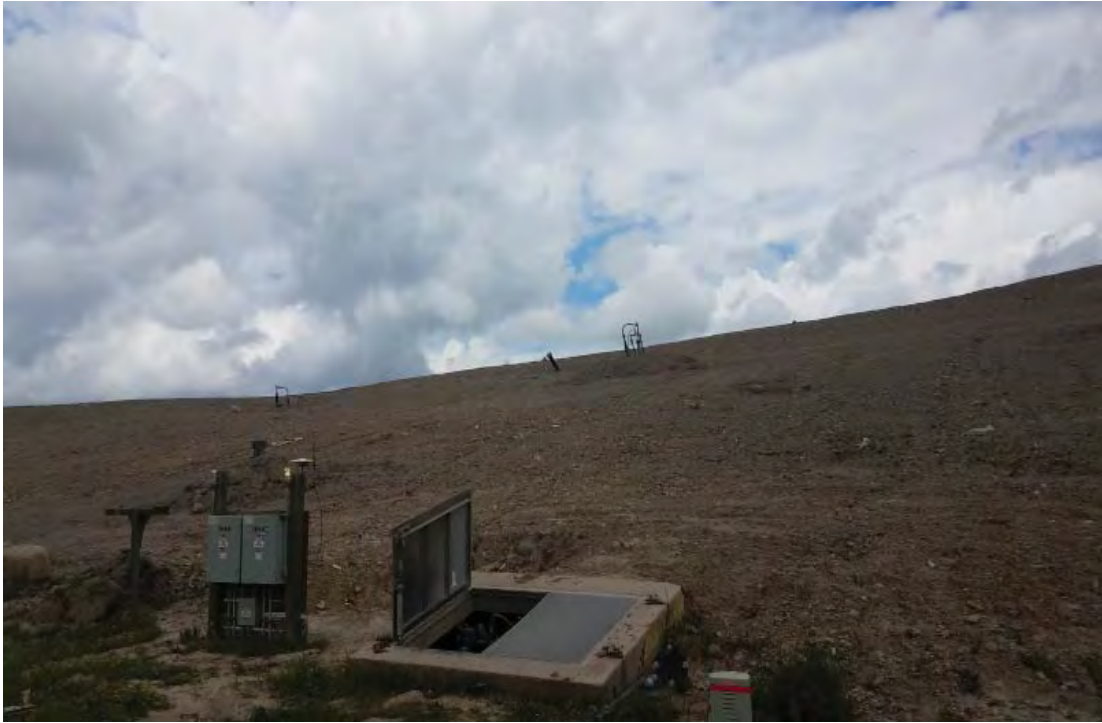
Vault at toe of Phase 7 South slope

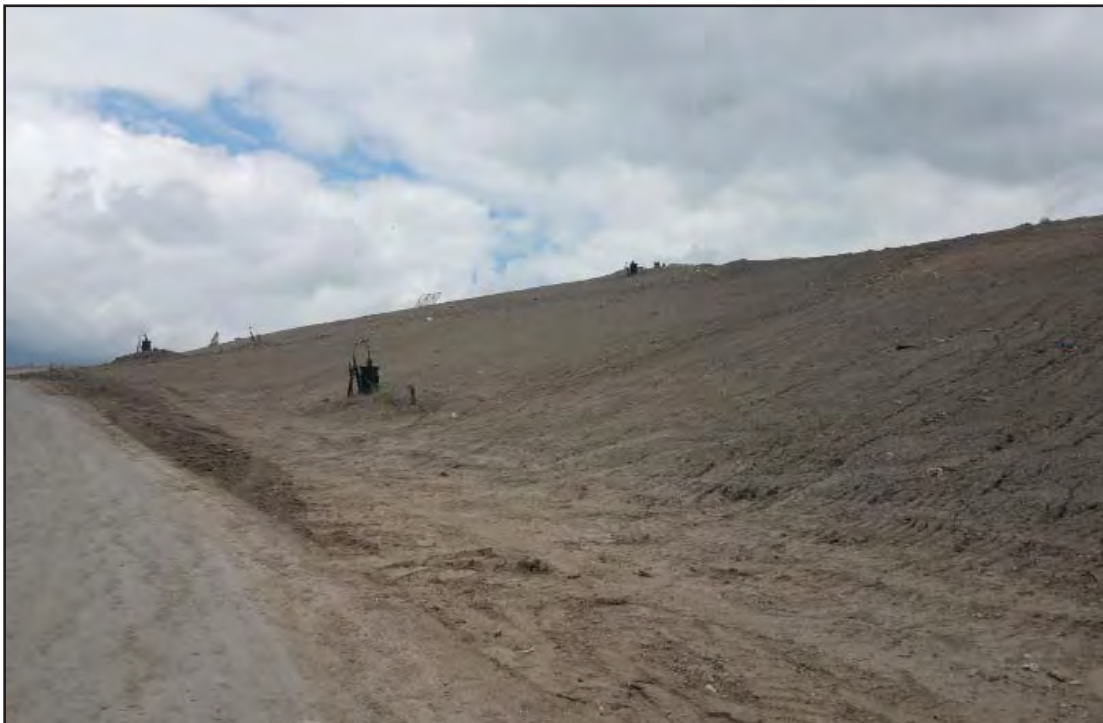
Access road headed North, potential area of odor release and where the most odors are encountered

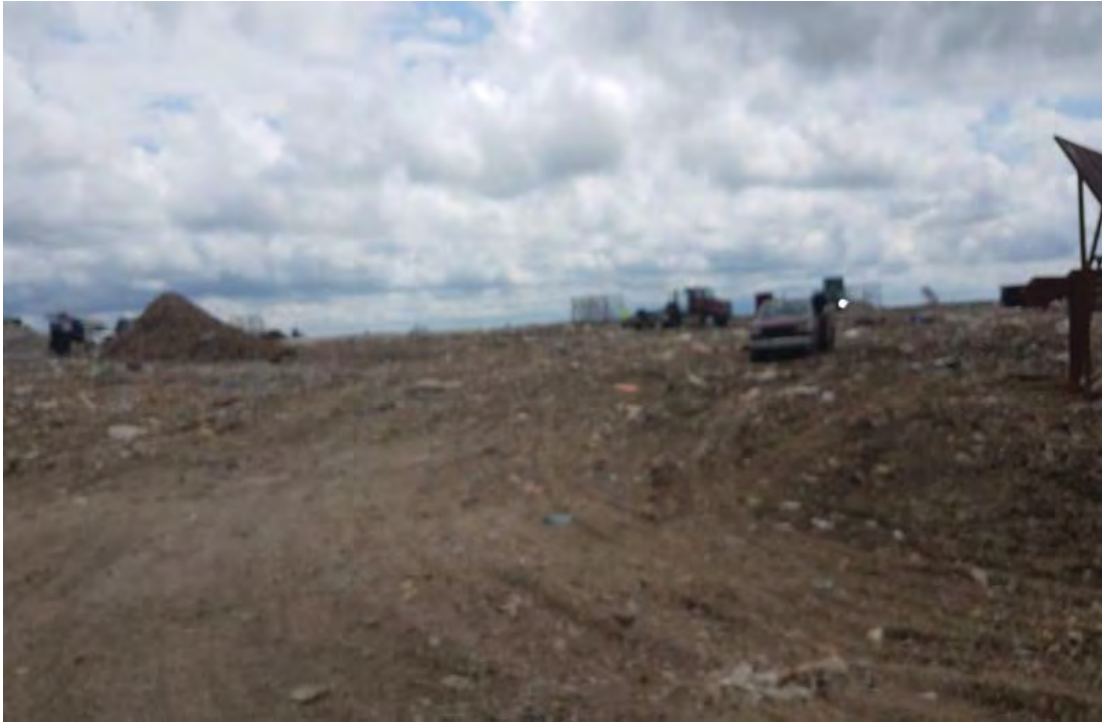
Phase 7 viewed from the North

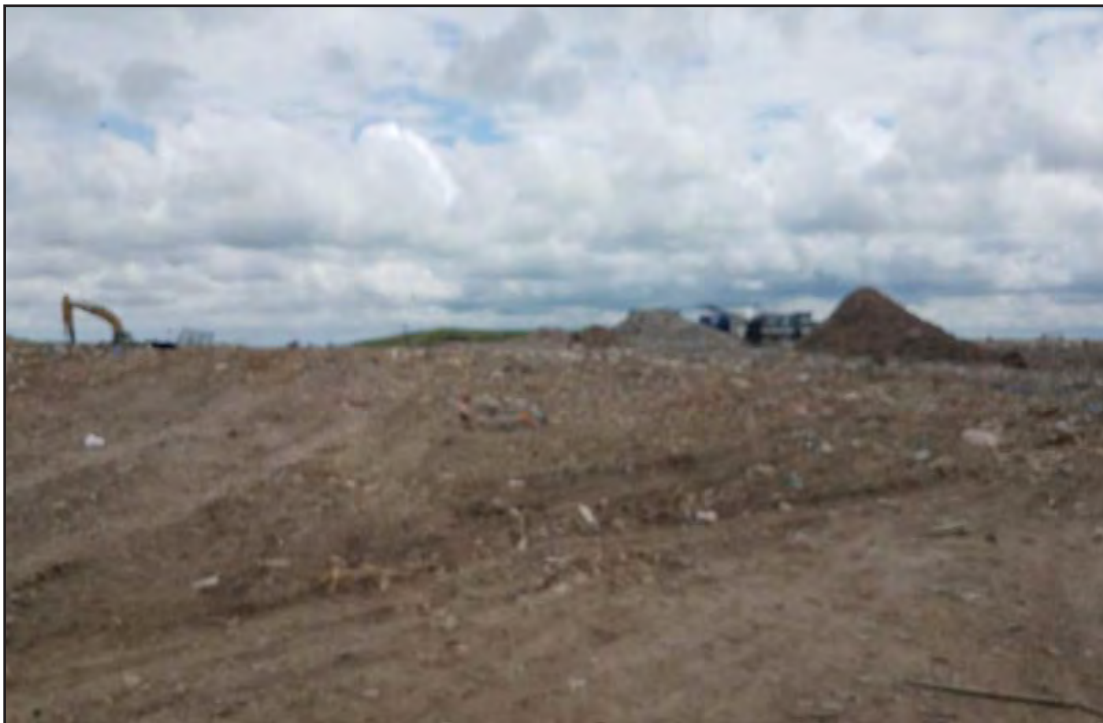
View across Phase 7

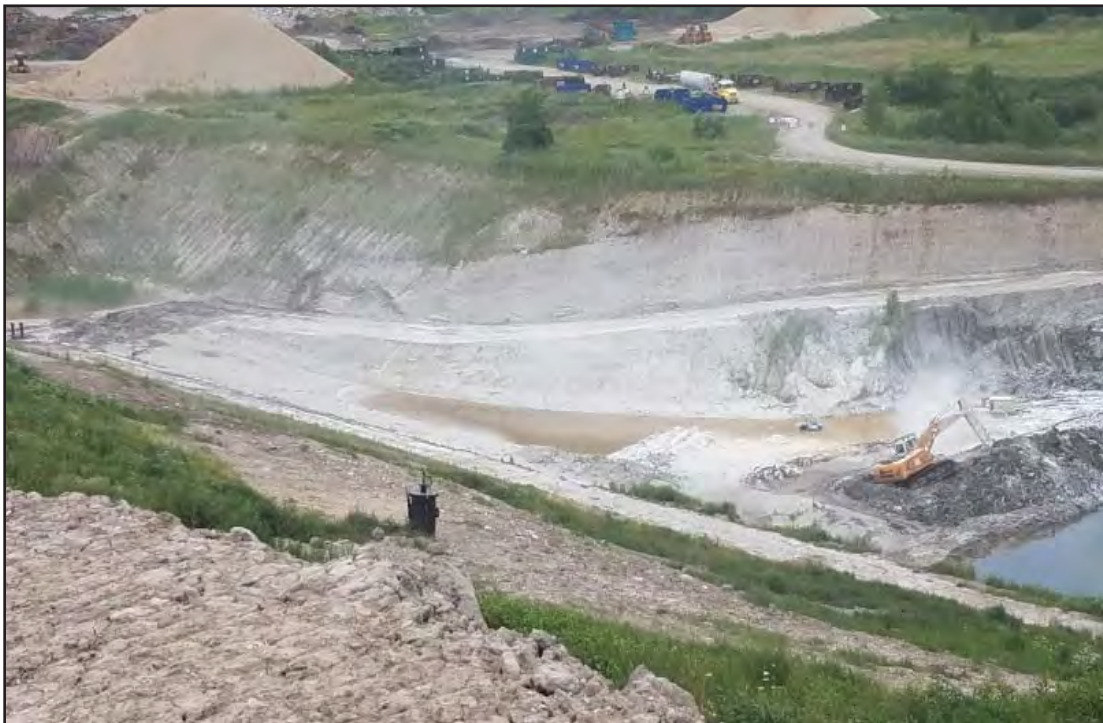
South end of temp basin, certified clean

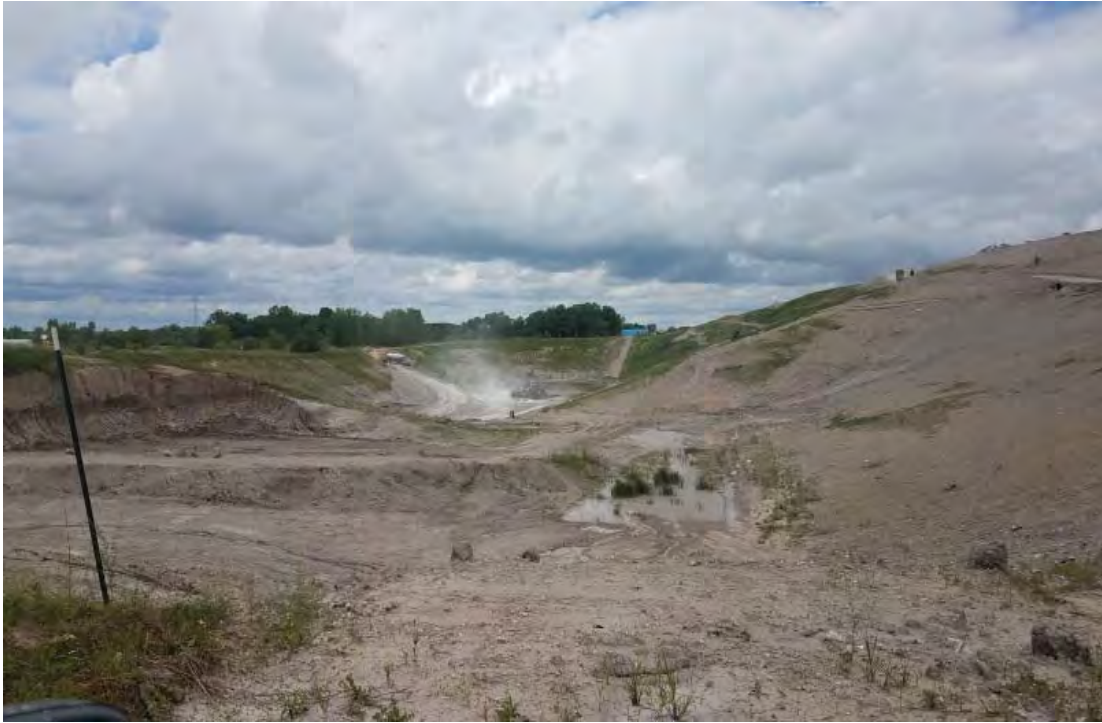
View across temp sed basin, South to North

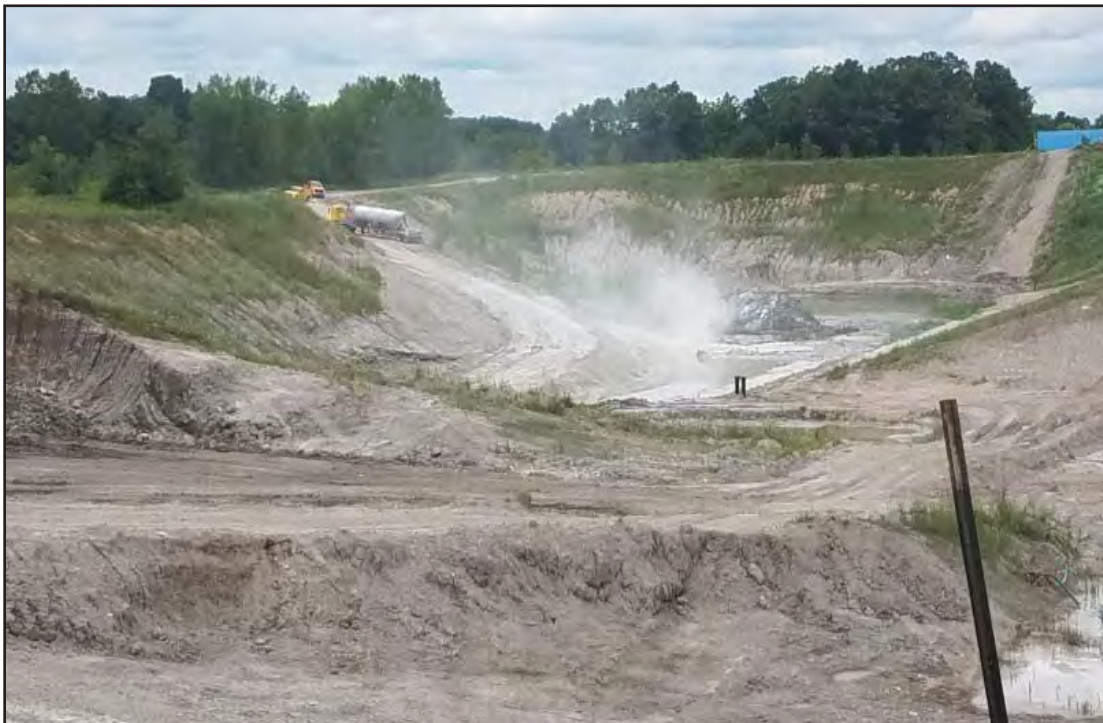
Temp Sed Basin receiving Lye to solidify basin for cleaning

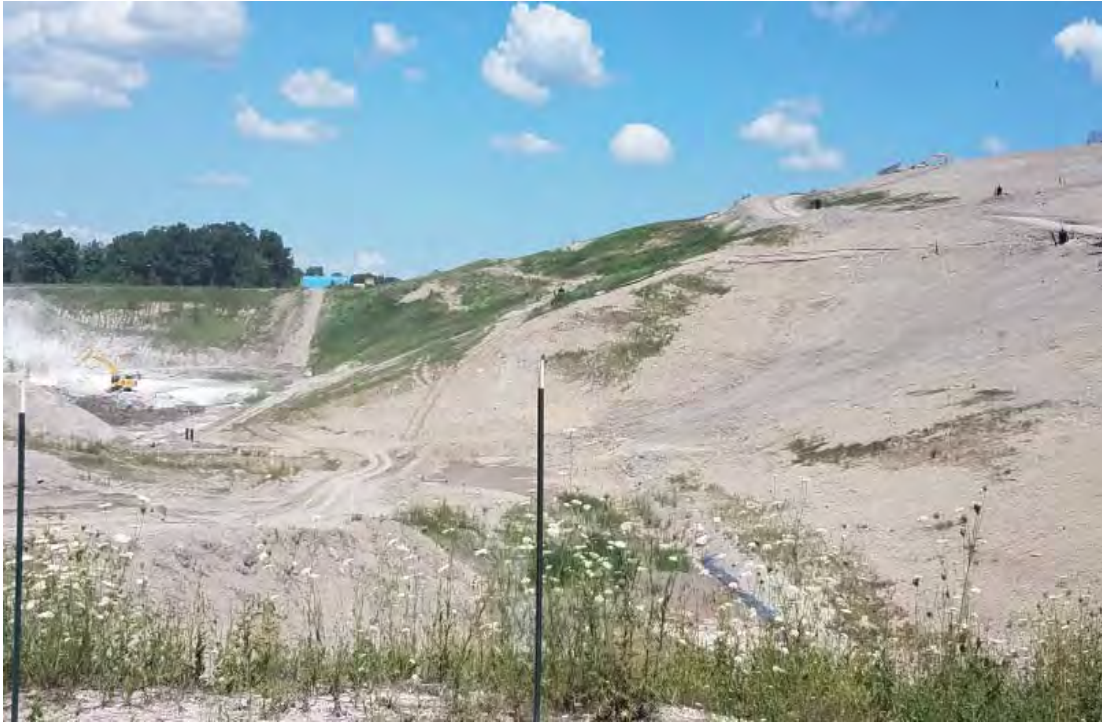
West, outboard slope, of Phase 7 South

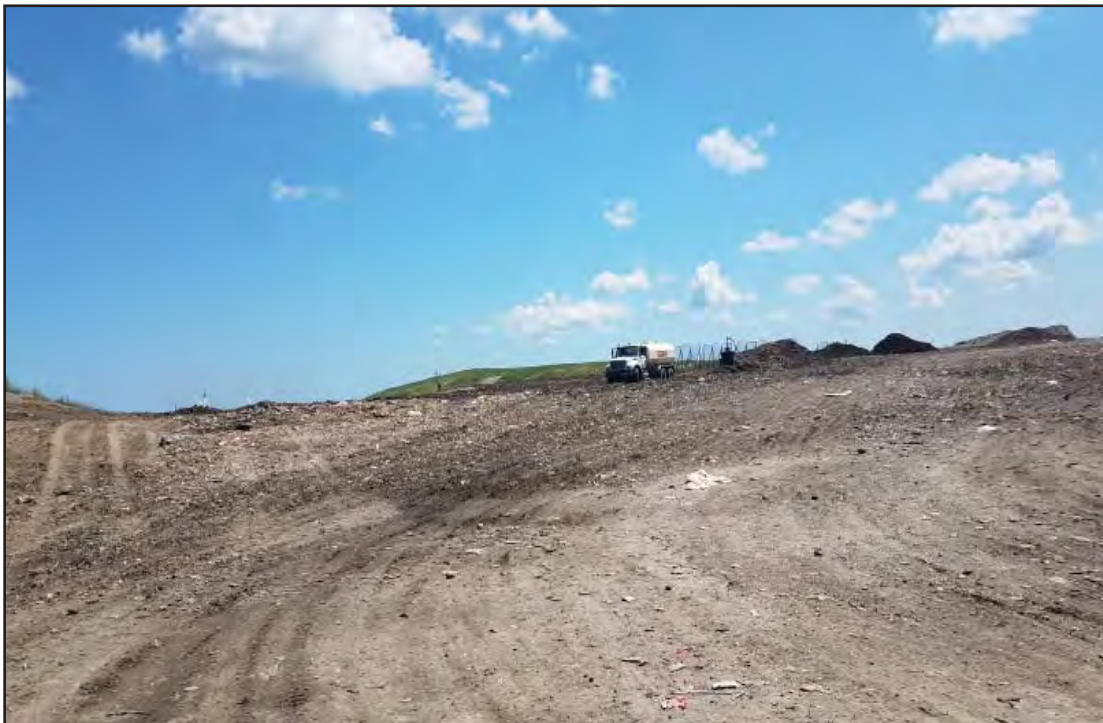
Working face in Phase 7 North/South boundary

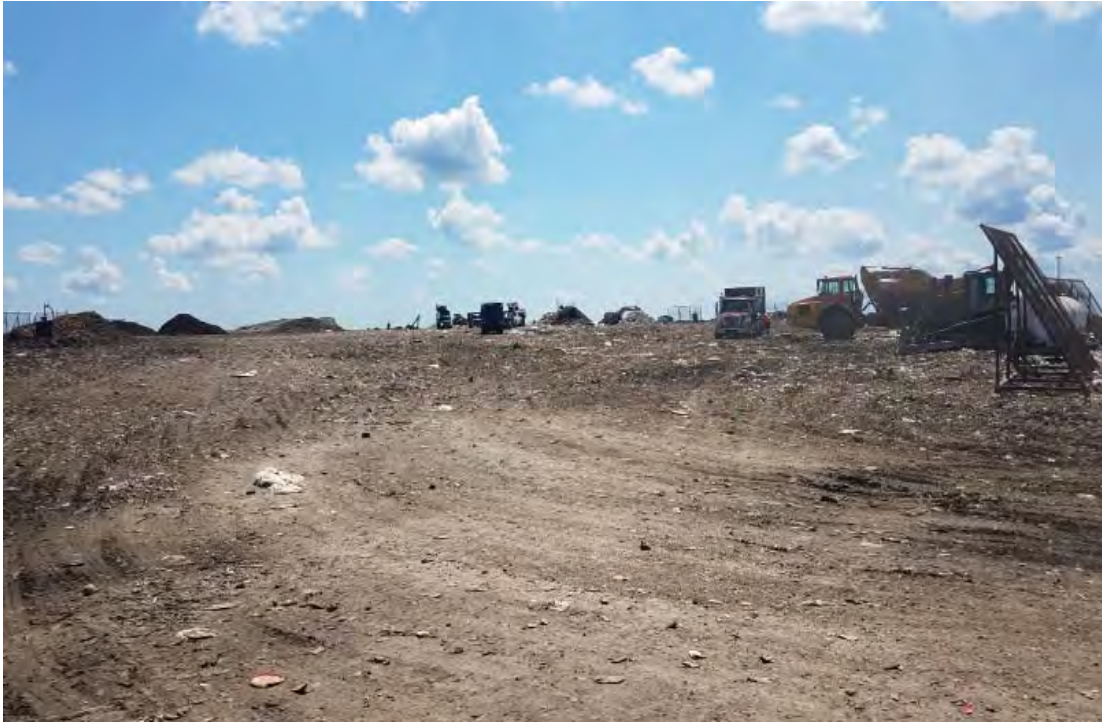
Phase 7 viewed from the North

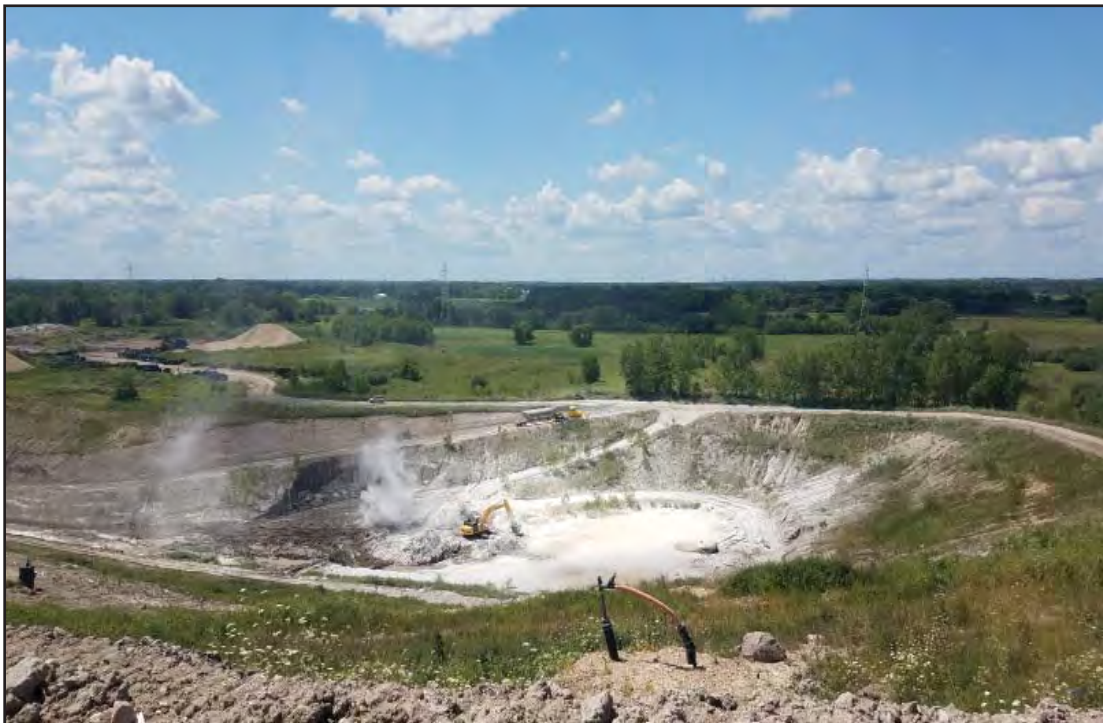
Overview of Temp Sed basin cleanup

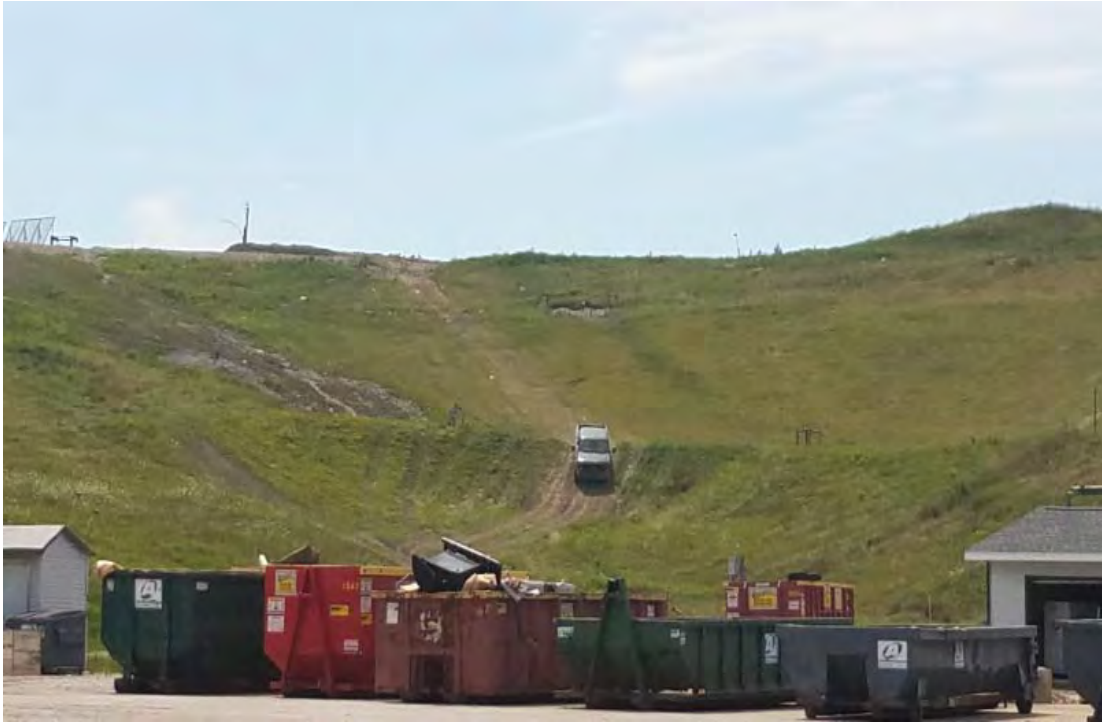
South slope of Phase 7 South, at junction with Phase 6

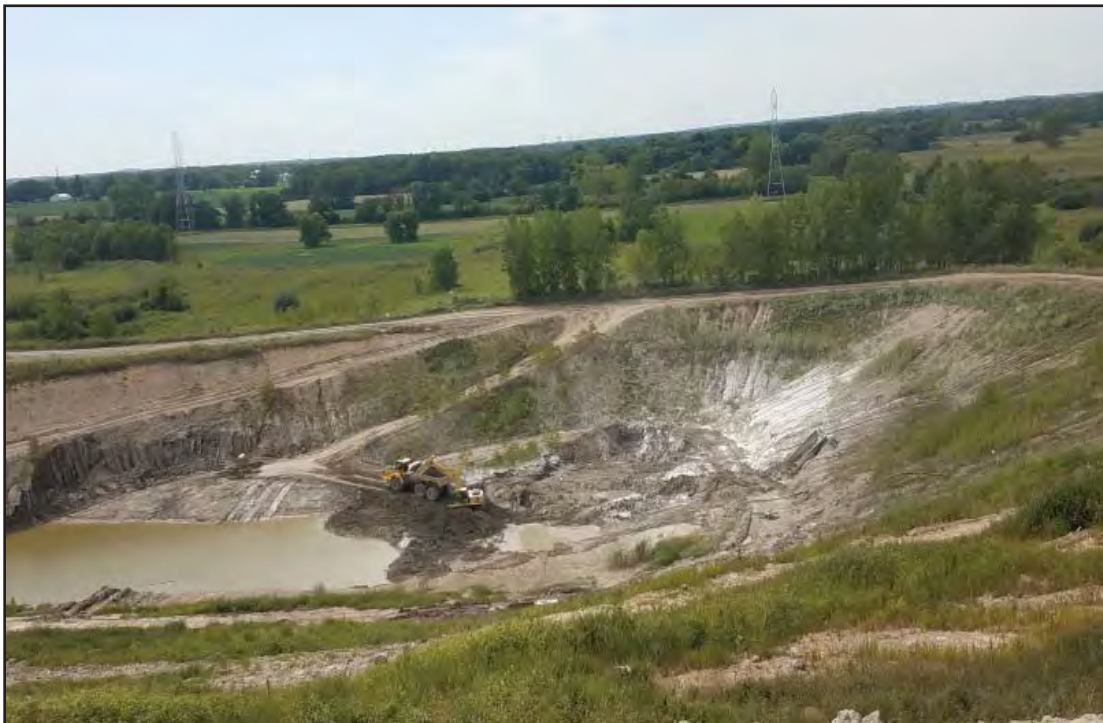
Lost portion of Temp Sed Basin being cleaned of sil, contaminated by leach-
ate

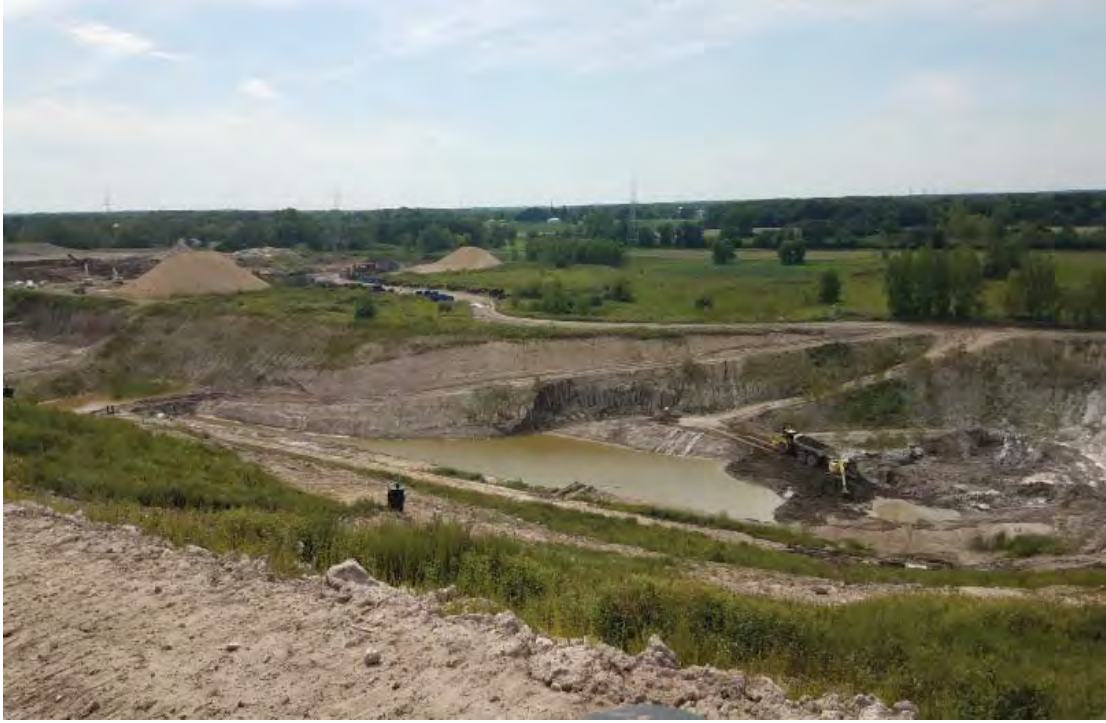
Overview of Temp Sed Basin, mostly cleared and cleaned

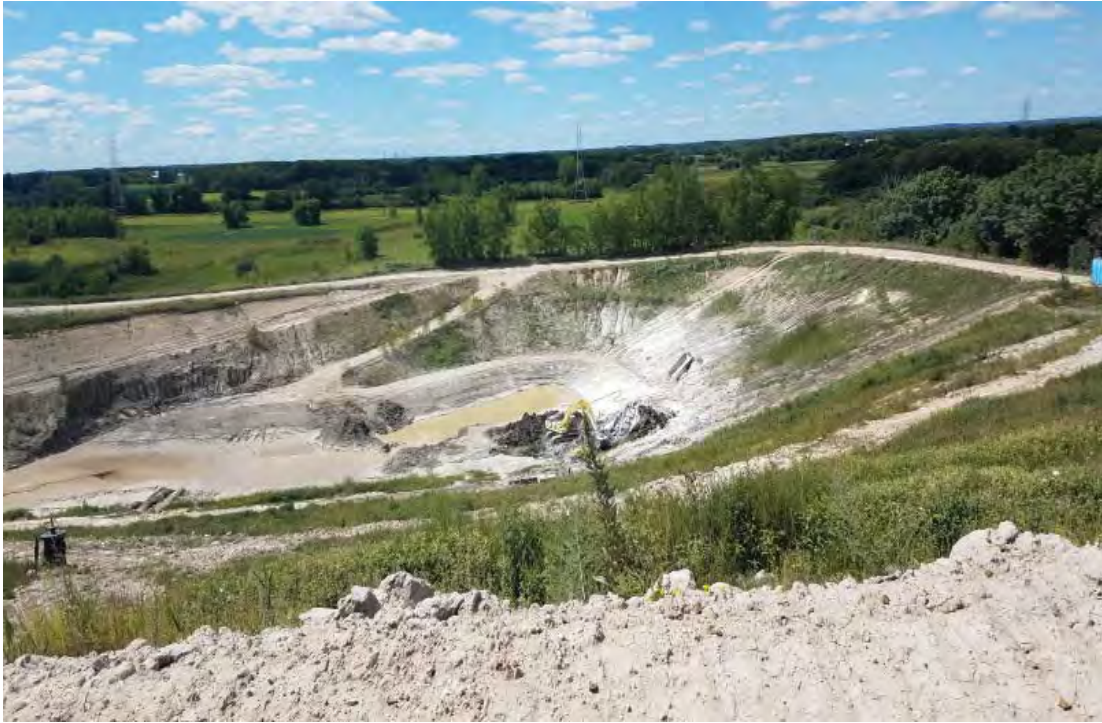
Temp sed basin viewed from Phase 7, not seep in sed basin in the South portion

* Seep into Temp Sed basin, identified last week, being repaired by contractor during audit today. Additionally excavated soils to expose rain flap and seep fixed in Phase 3 haul trucks rutting West slope at Phase 3/7 junction

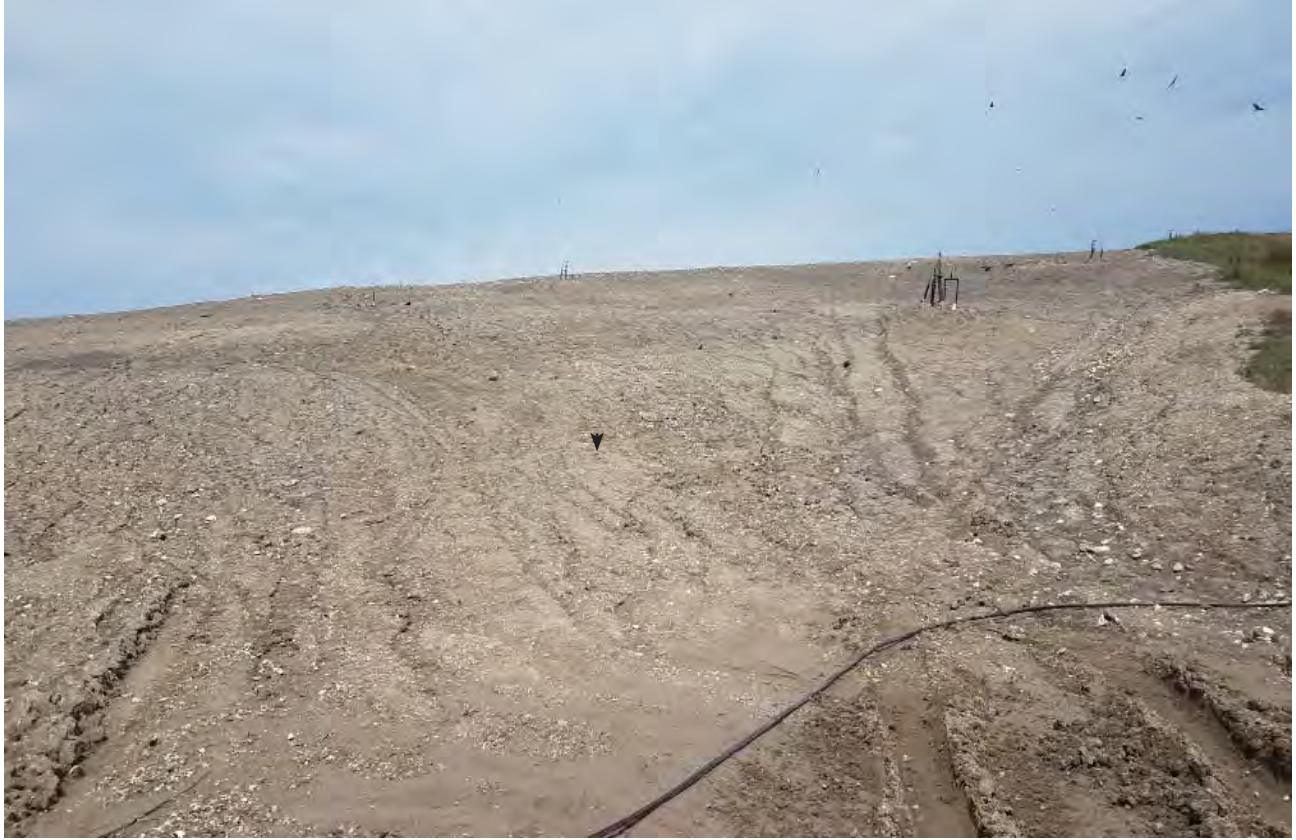
South slope of Phase 7 South, erosion developing

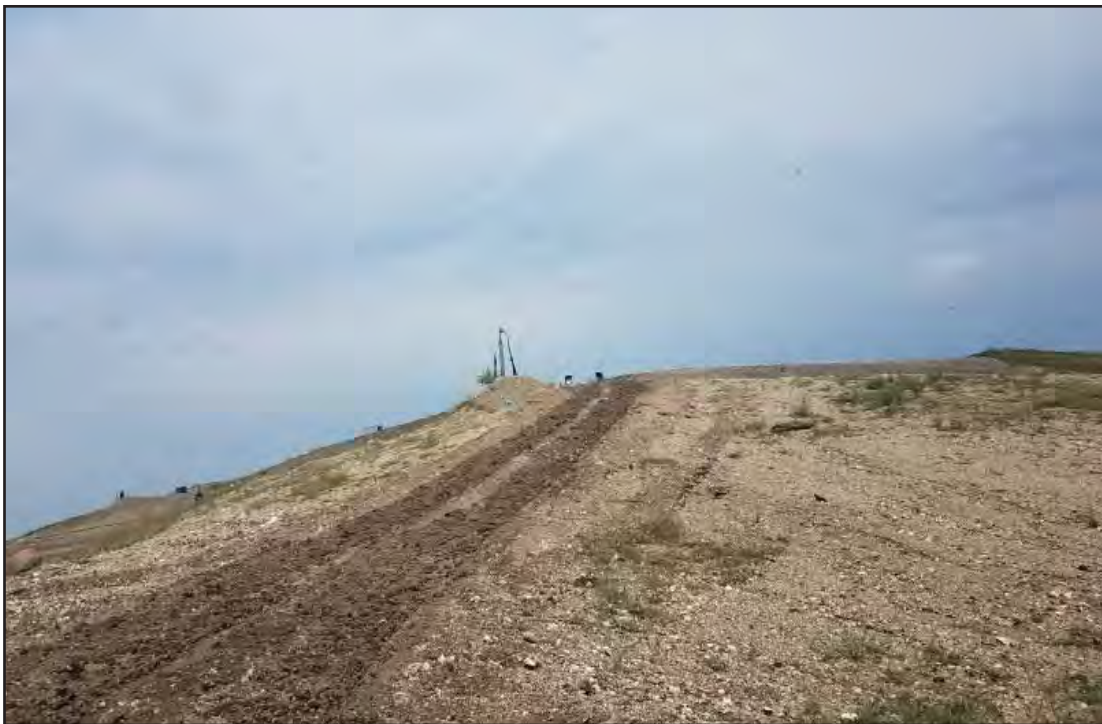
Southwest corner, South side of Phase 7 South. Heavy rutting by travel of gas techs

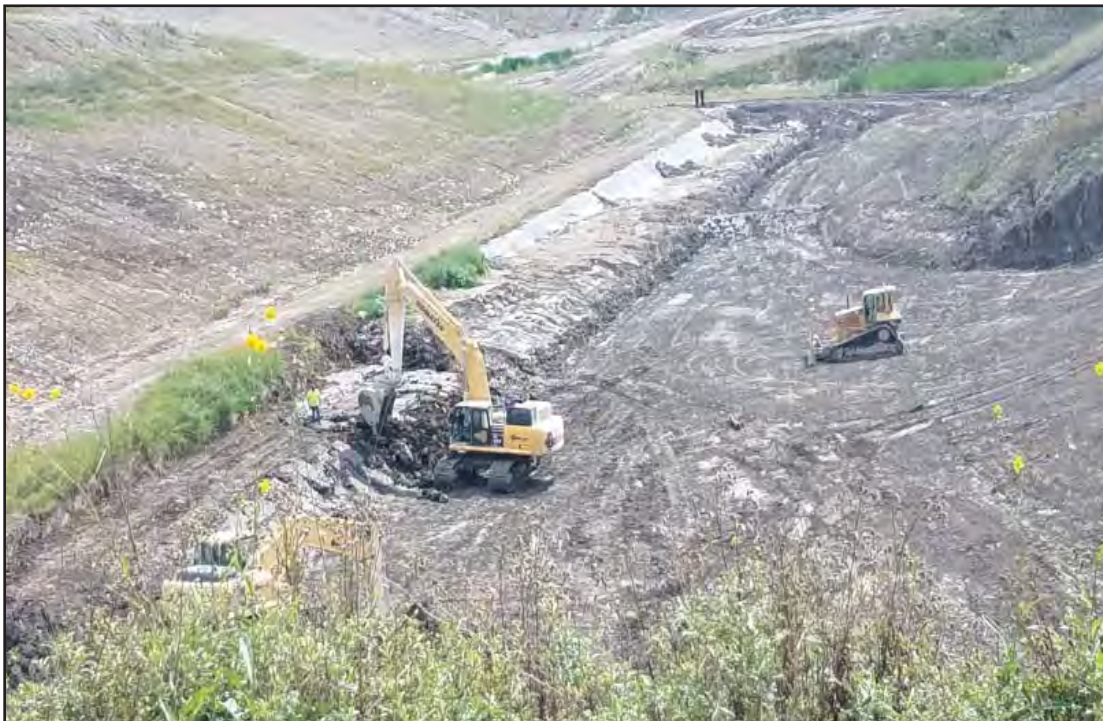
Excavator clearing rain flap to access seep

* Temp Sed Basin cleaning to repair rain flap deep ongoing

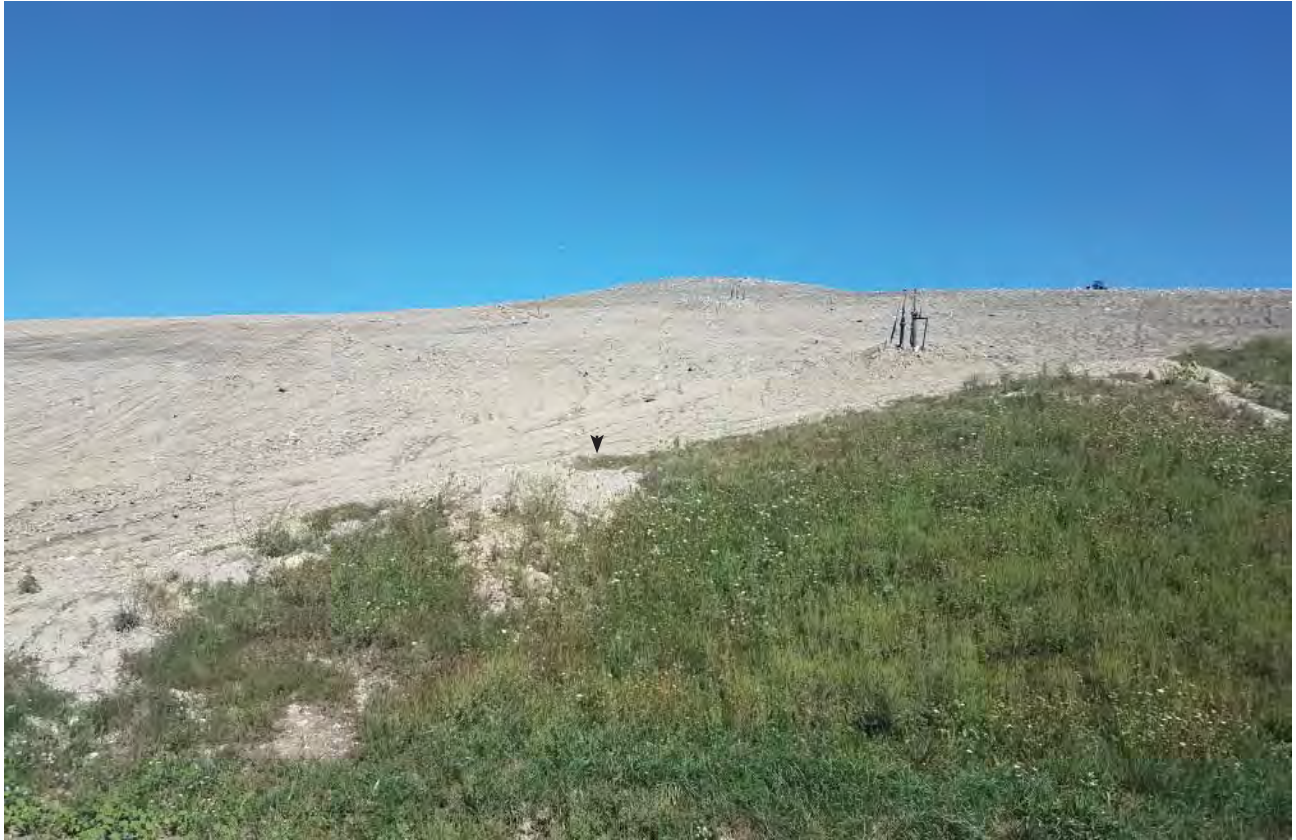
Top of Phase 7 South slope, at Phase 6 junction
