2020 Year End Summary of Audits of the Emerald Park Landfill

Prepared For:
City of Muskego
Green For Life Emerald Park Landfill Standing Committee

2020 Green For Life Emerald Park Landfill Year End Compliance Officer Report and Audit Summary

TO: Advanced Disposal Services Emerald Park Standing Committee
FROM: Jo-Walter Spear, Jr., P.E.
COPIES: File
DATE: 03/29/2021
PROJECT NUMBER: 1012.10030

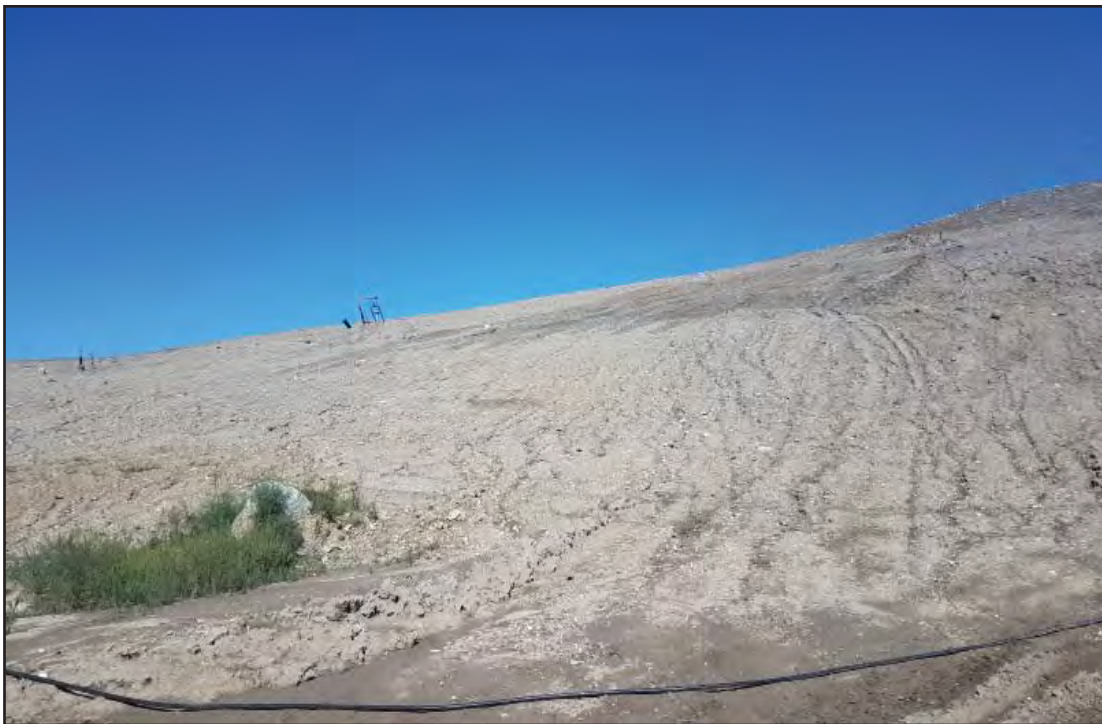
South slope of Phase 7 South showing some erosion

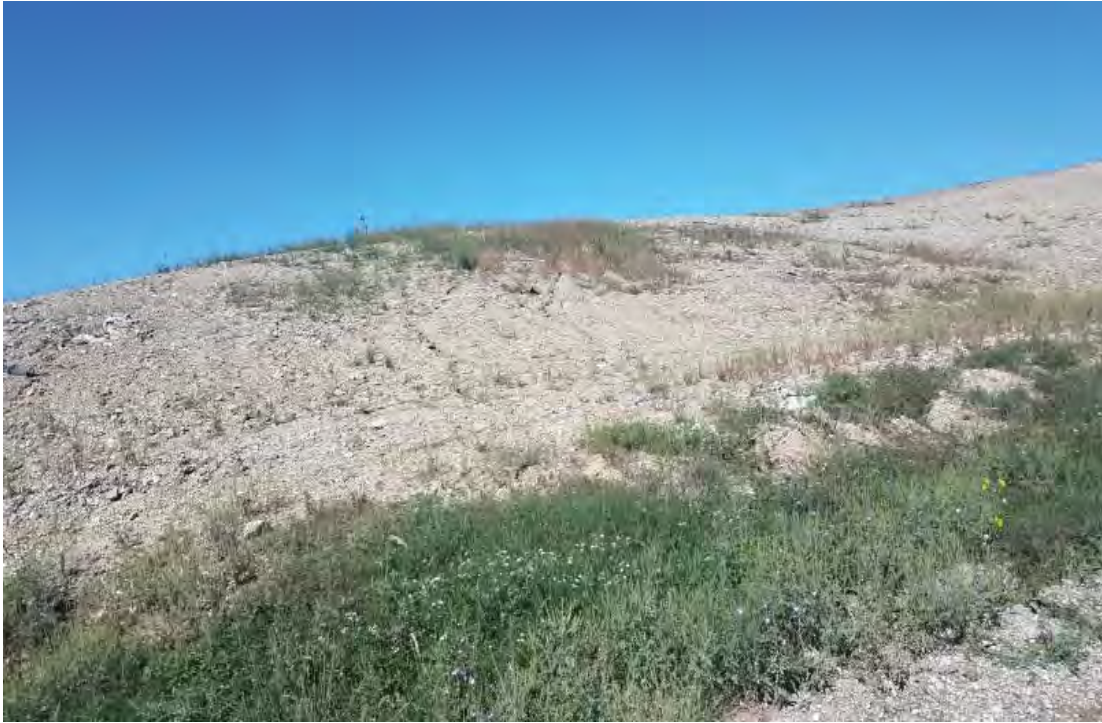
South slope of Phase 6 & 7 junction

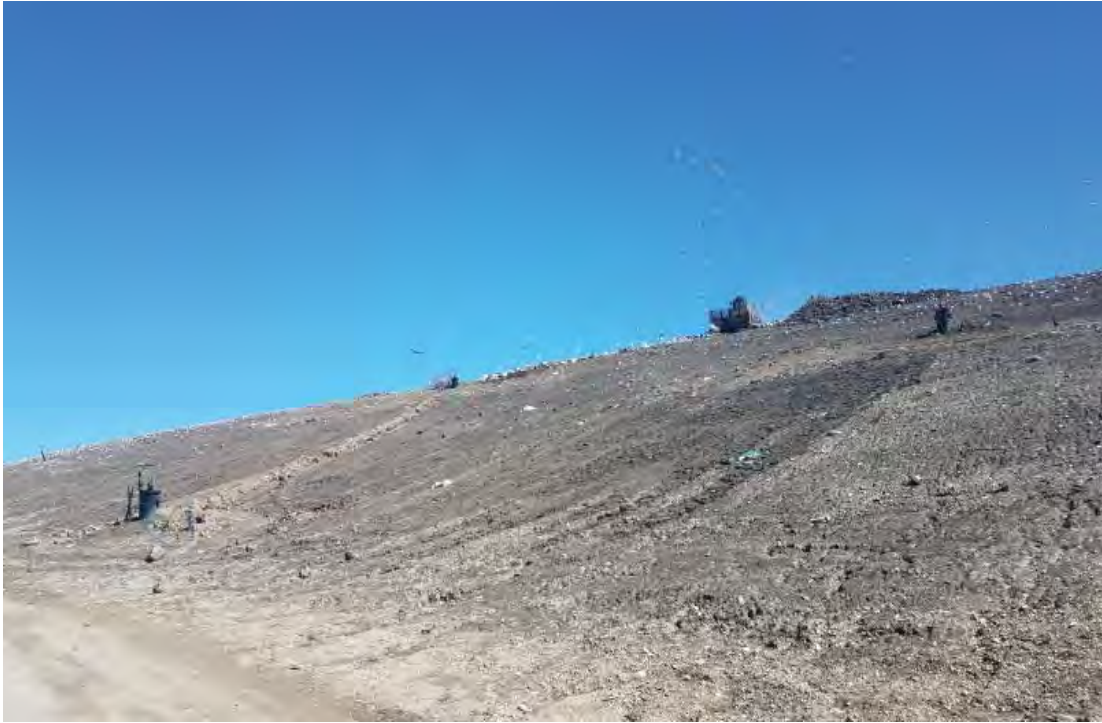
View across Phase 6

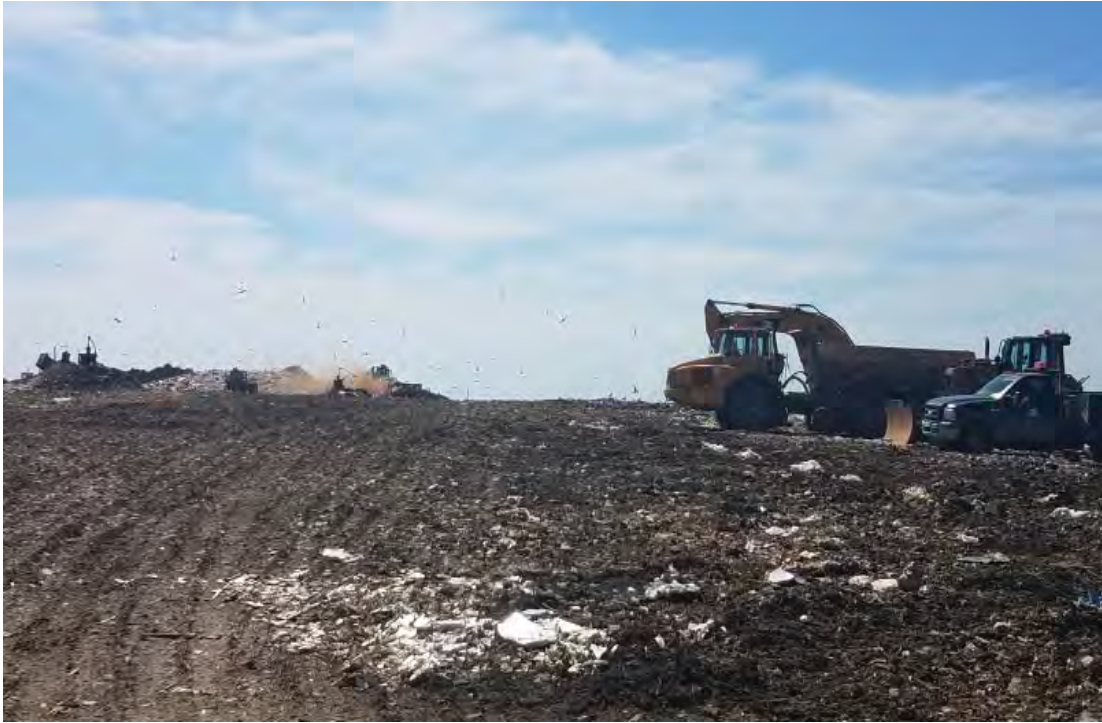
Phase 7 viewed from the North

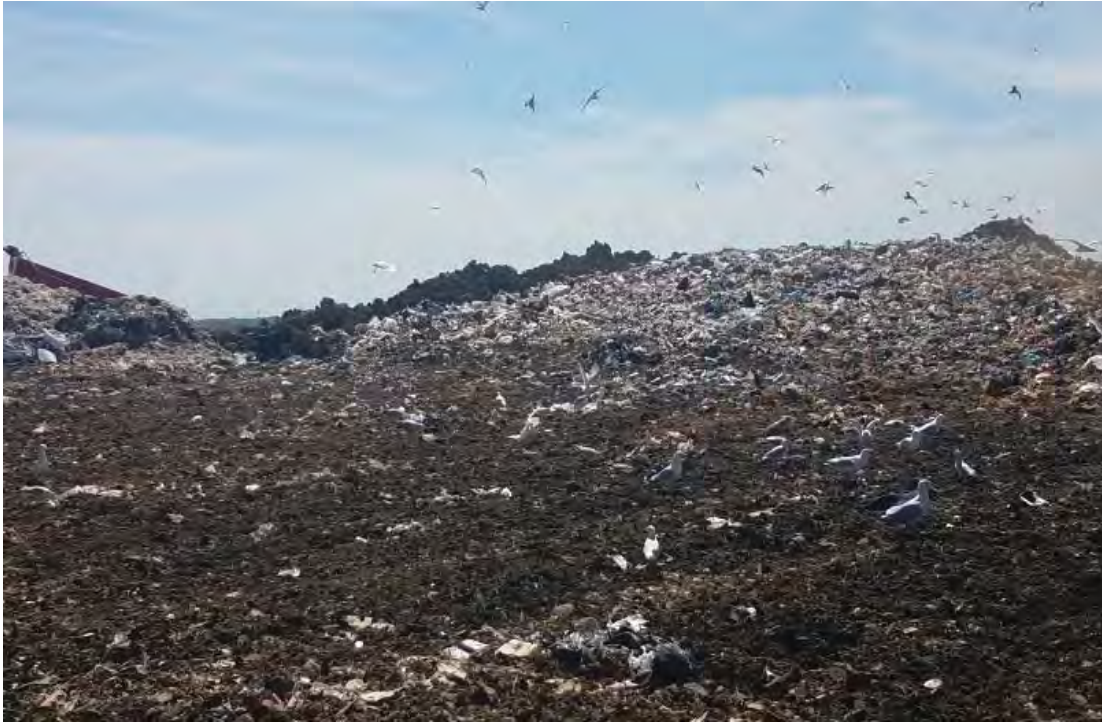
Working face, new lift starting at South end of Phase 7 South

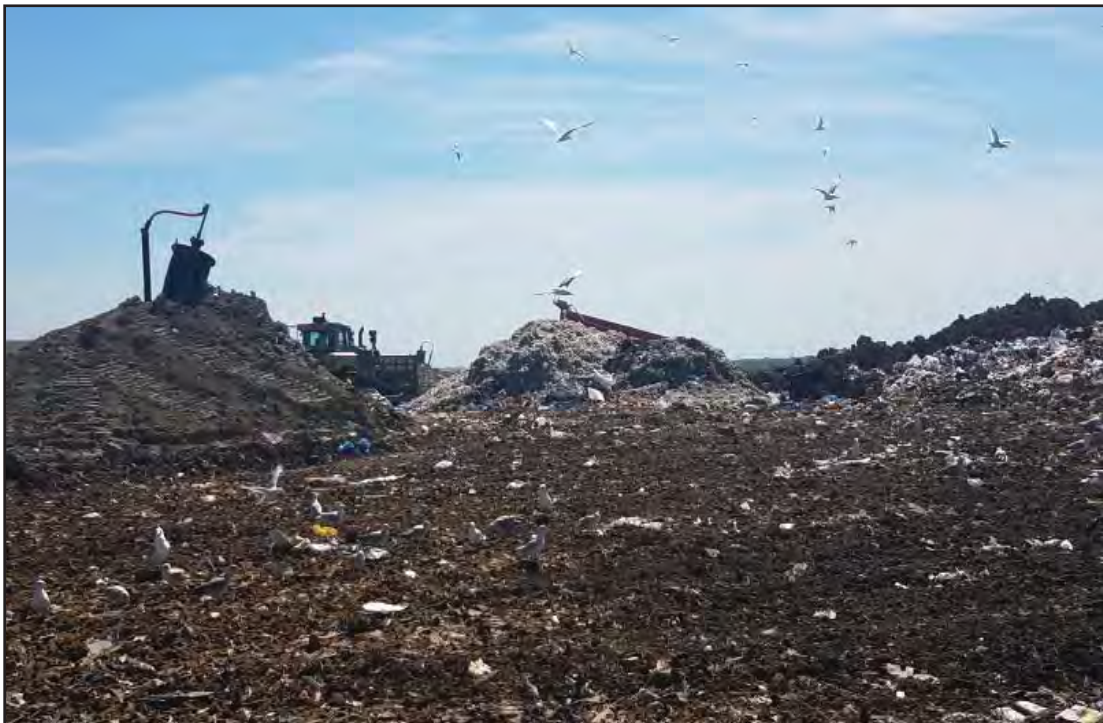
Protected wells and working face, well on left to be redrilled

- Well redrill scheduled for end of month, includes horizontal gas collection trench installation
 - Liner repair on rainflap to occur when liner crew finishes at other sites

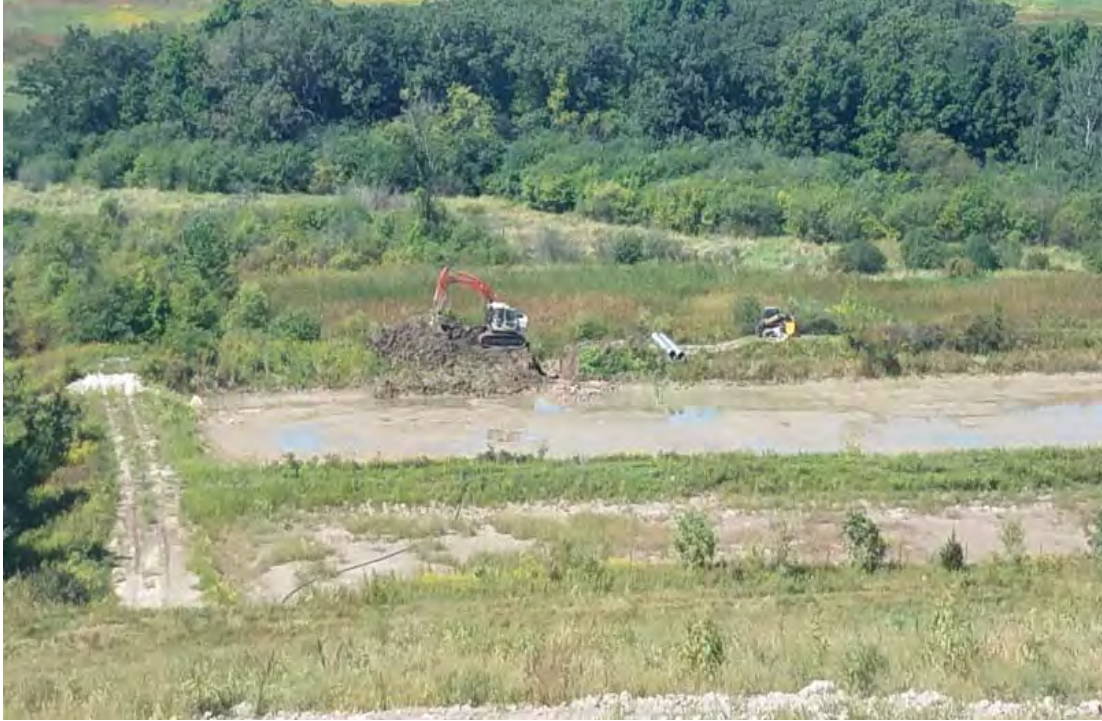
Construction of new outfall for Basin #1

- D) Surface Water Management
 - Storms have occurred throughout the last week.
 - Basins have freeboard
 - Basin #1 repairs now complete
 - Erosion minimal, no noticeable increase

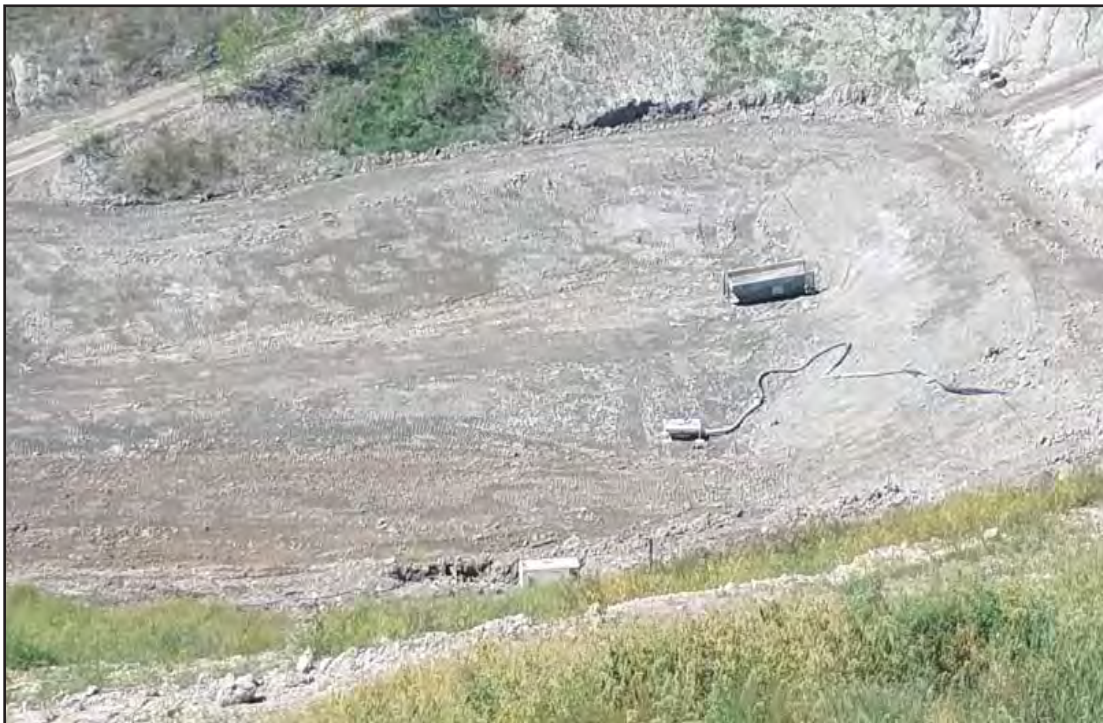
Temp Sed Basin, cleaned and drained

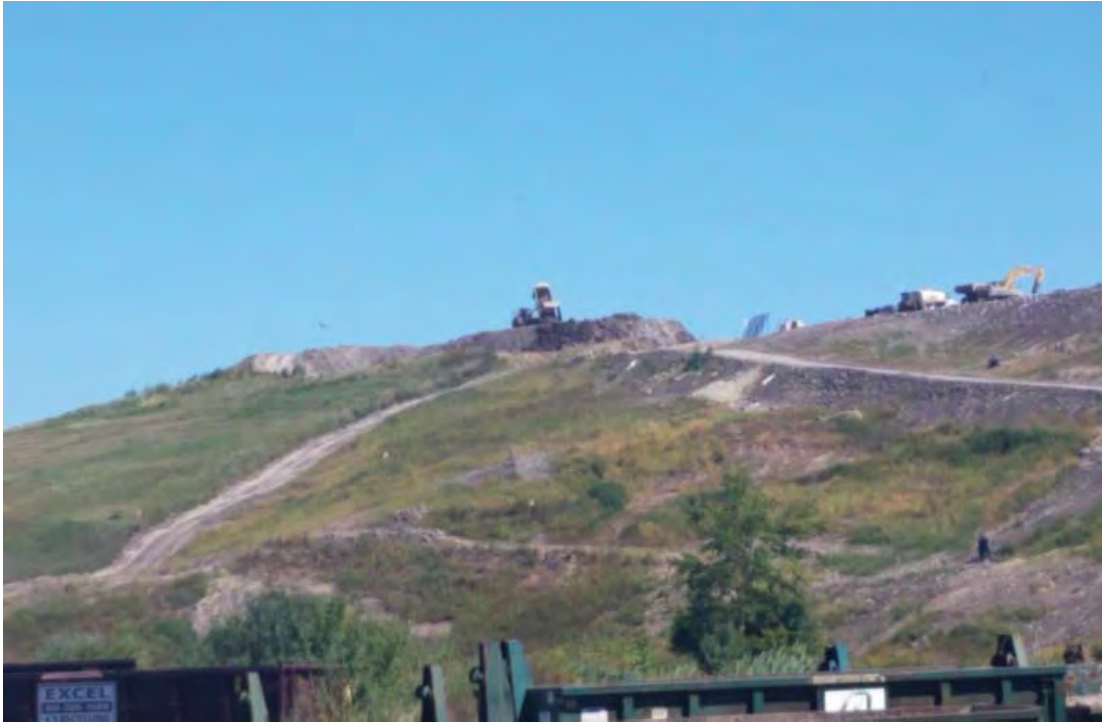
Stockpiling of soils from Temp Sed Basin on Phase 3

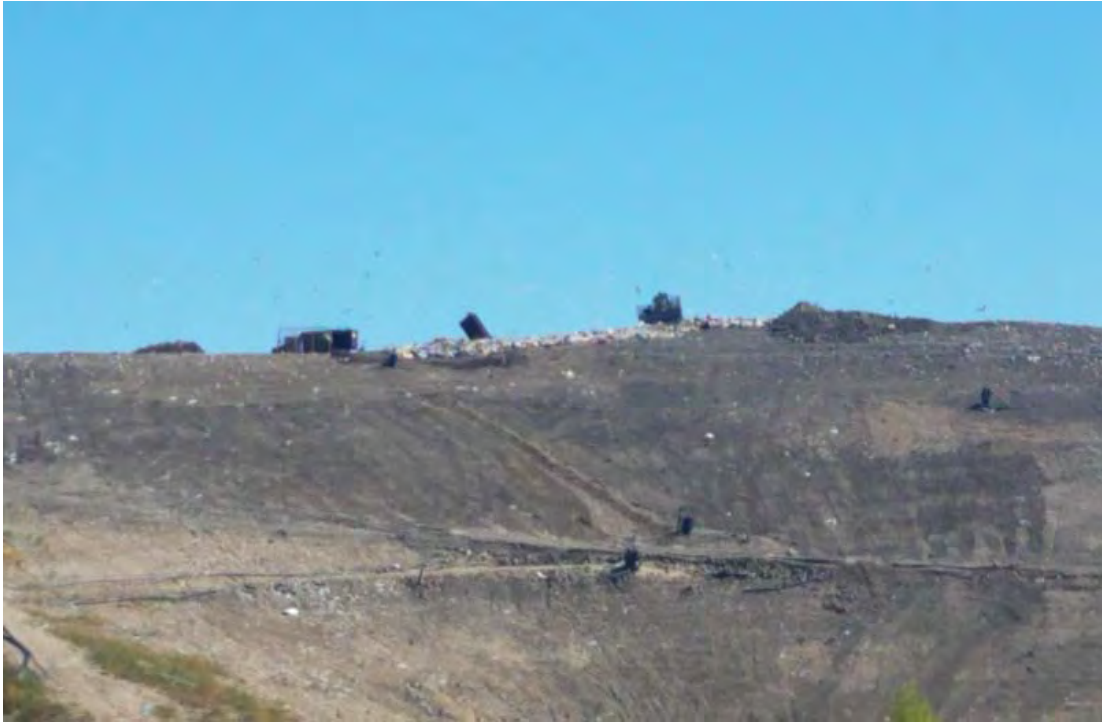
West slope of Phase 7 South, edge of working face visible

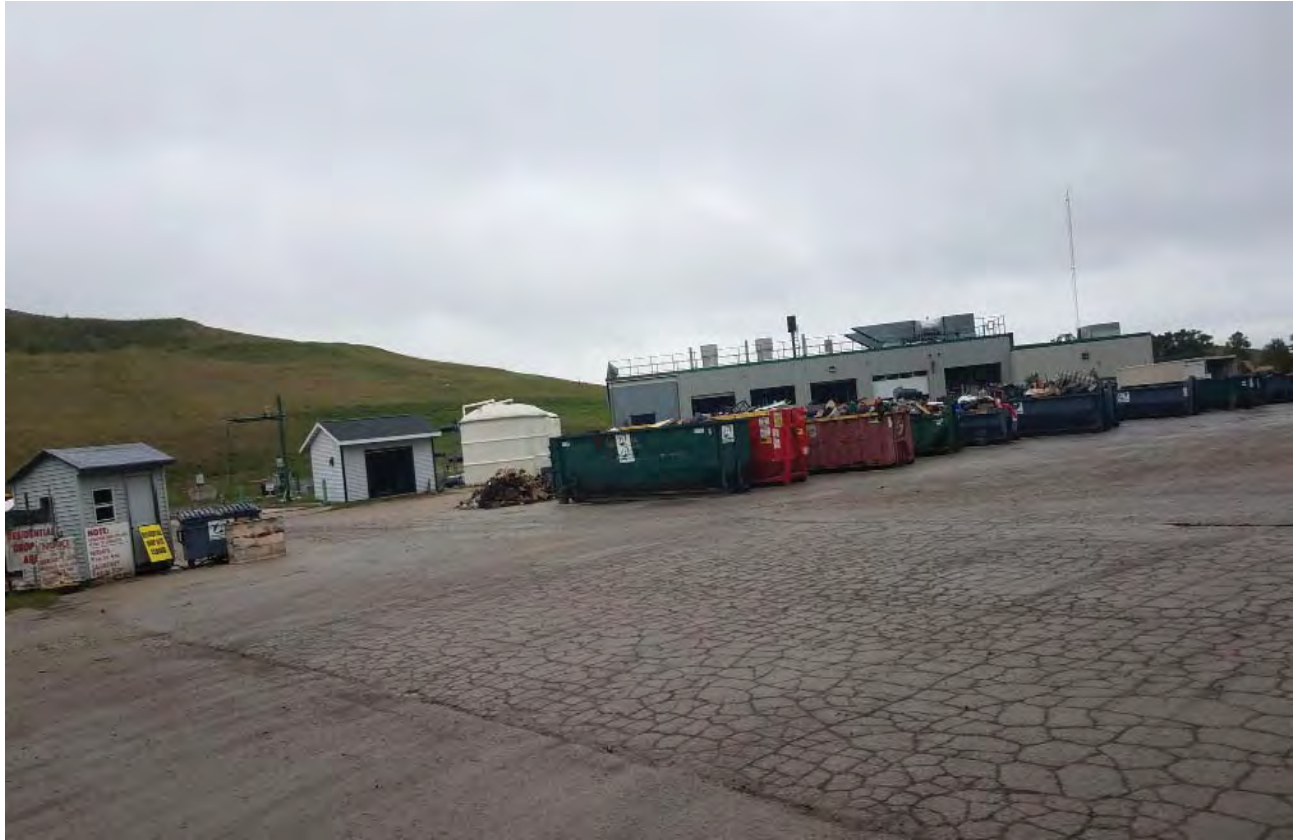
Residential Drop-off yard and gas plane

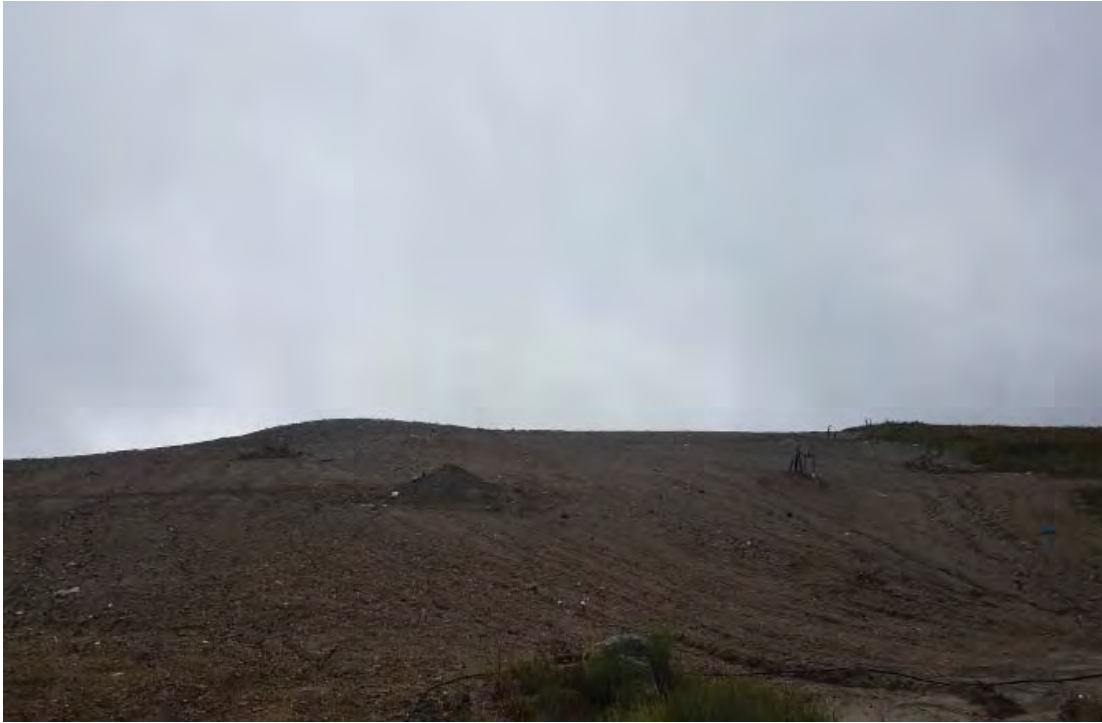
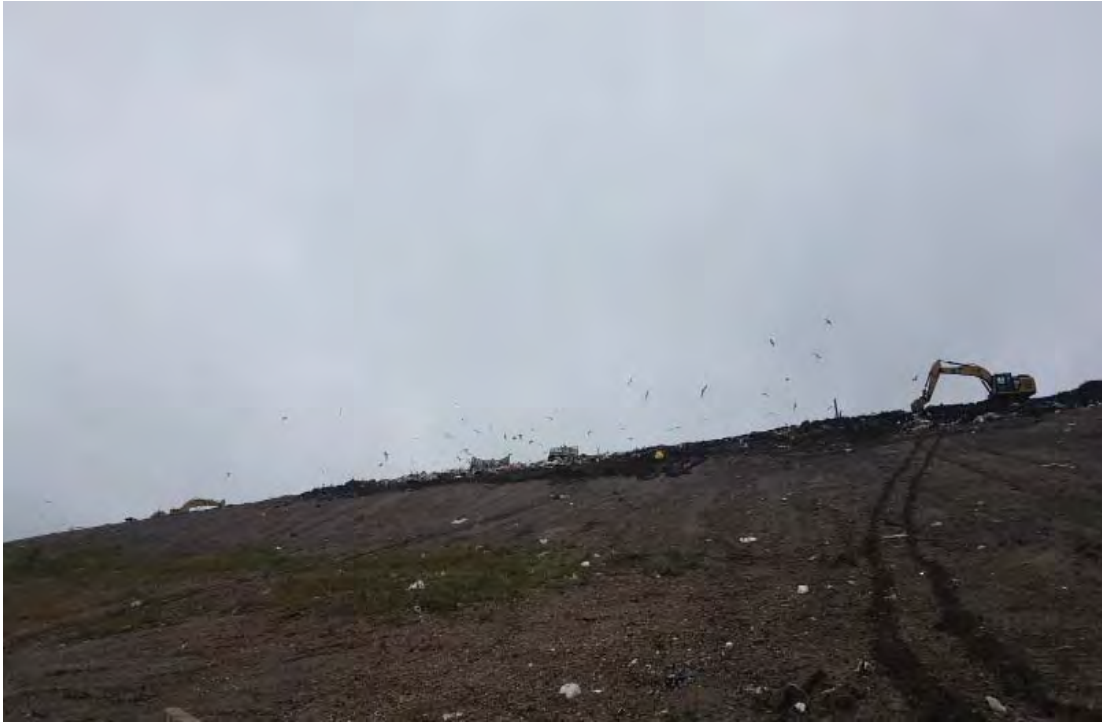
West slope of Phase 7 South, recently backdragged

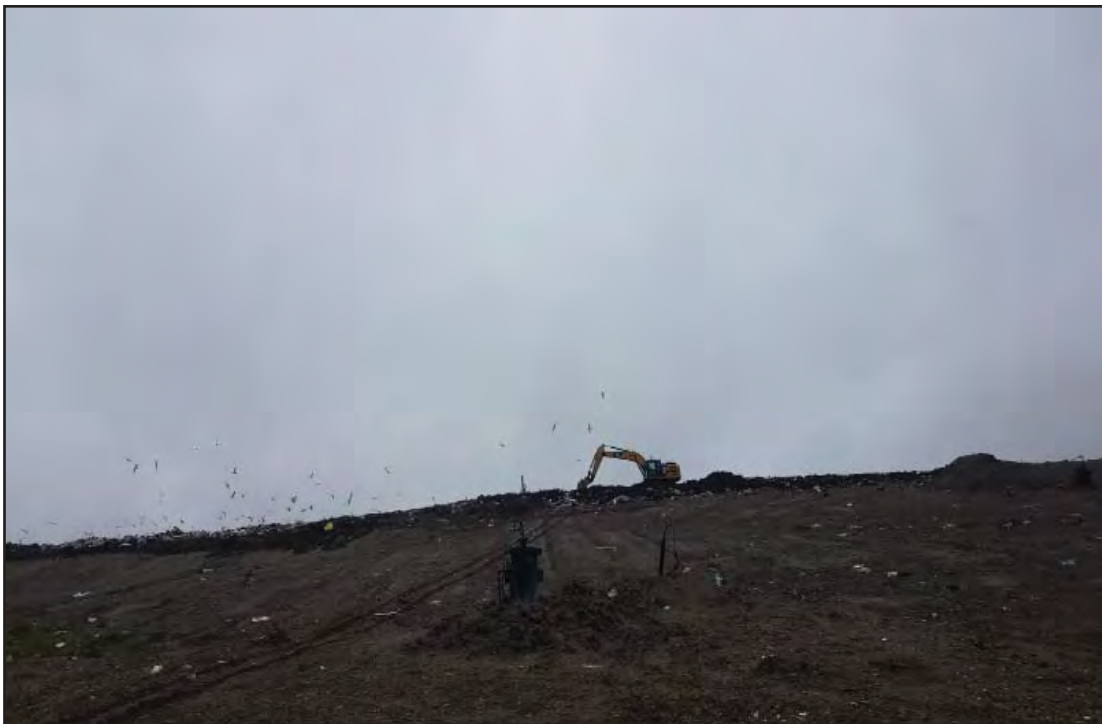
West slope of Phase 7 South, recently backdragged; area around access road where most odors are discovered

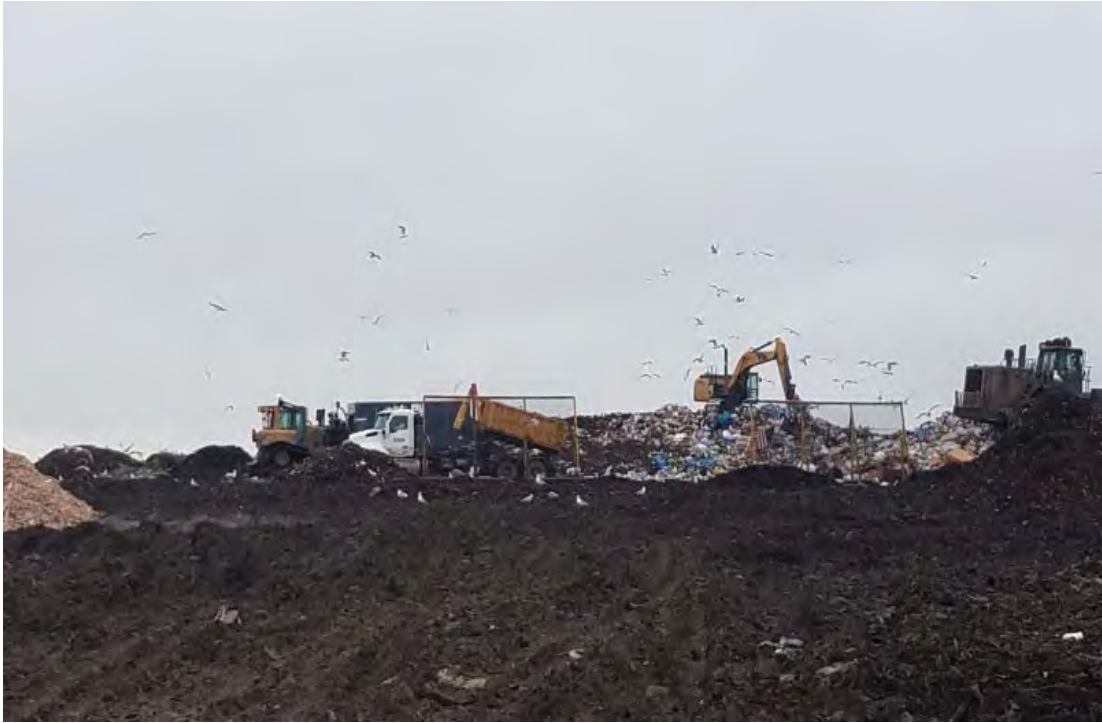
Working face, lift developing on West edge of Phase 7 South

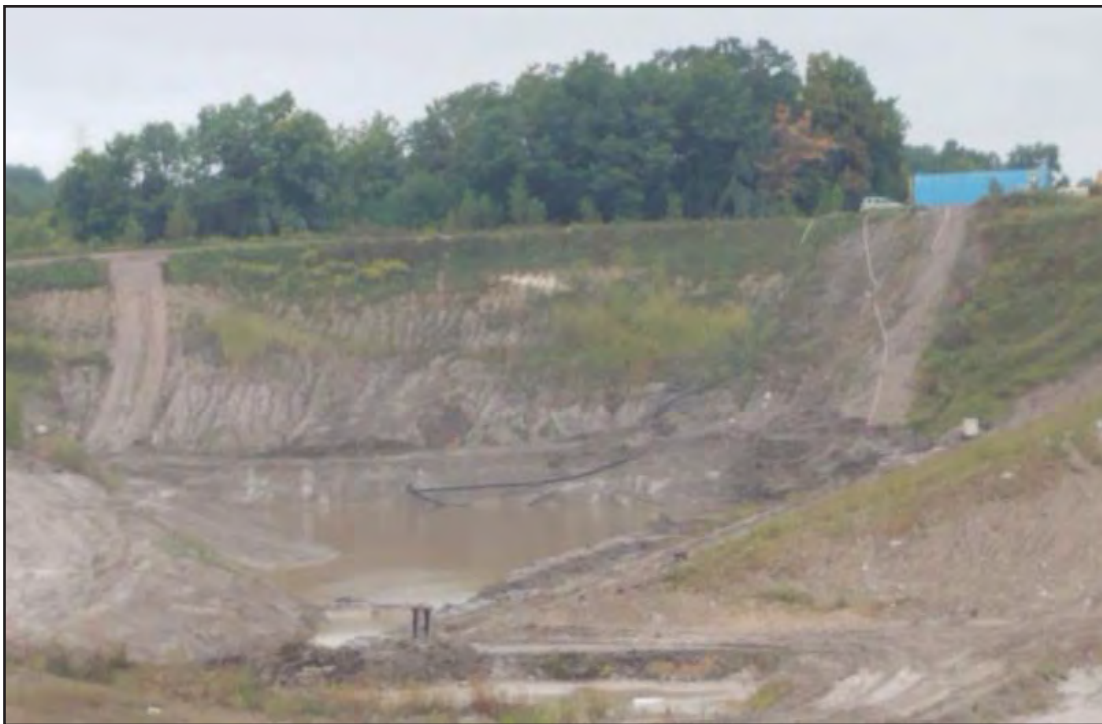
Temp sed basin viewed from South

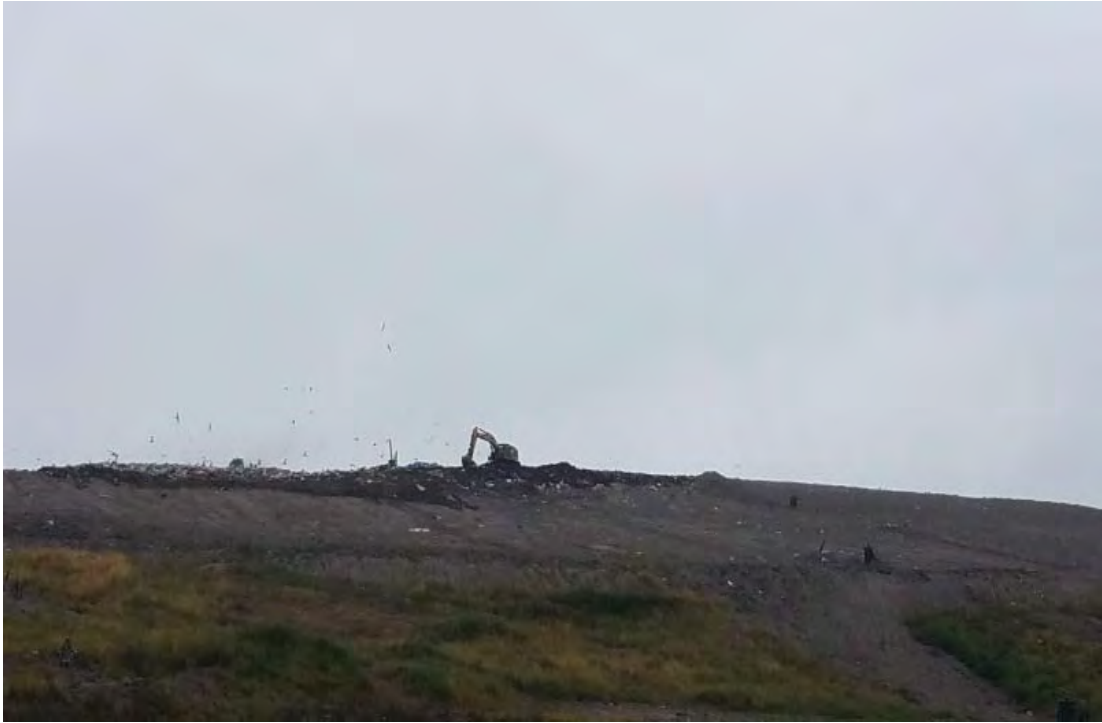
Well raising at top of West slope Phase 7

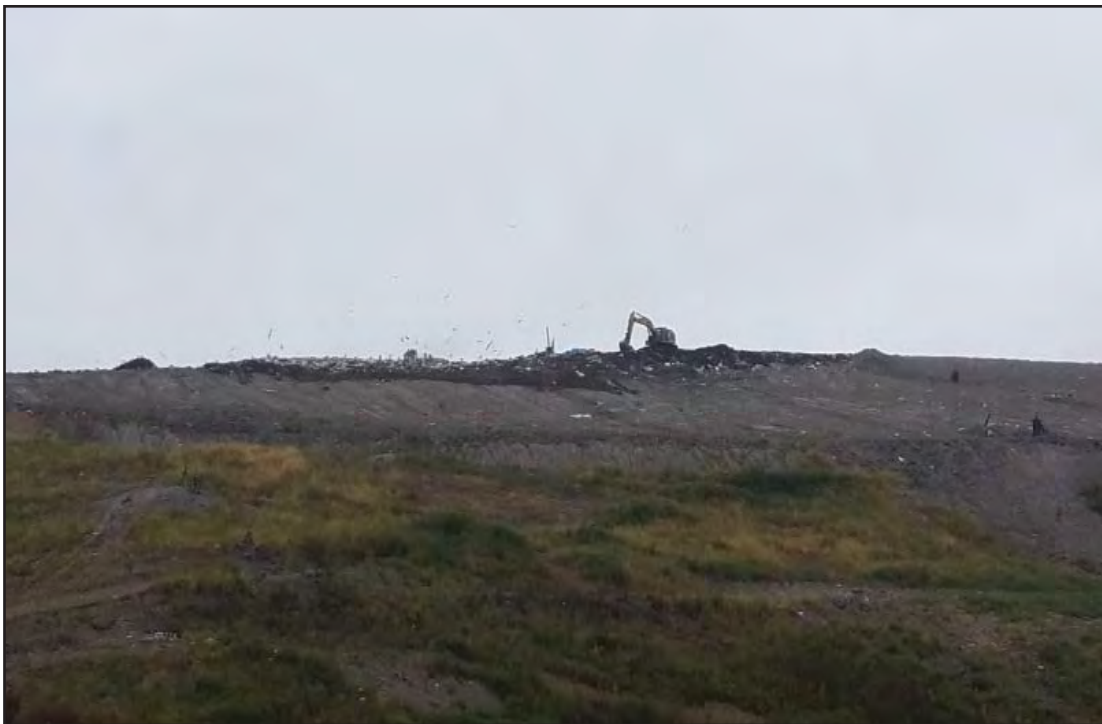
West slope of Phase 7, waste placement right along West edge at top of slope

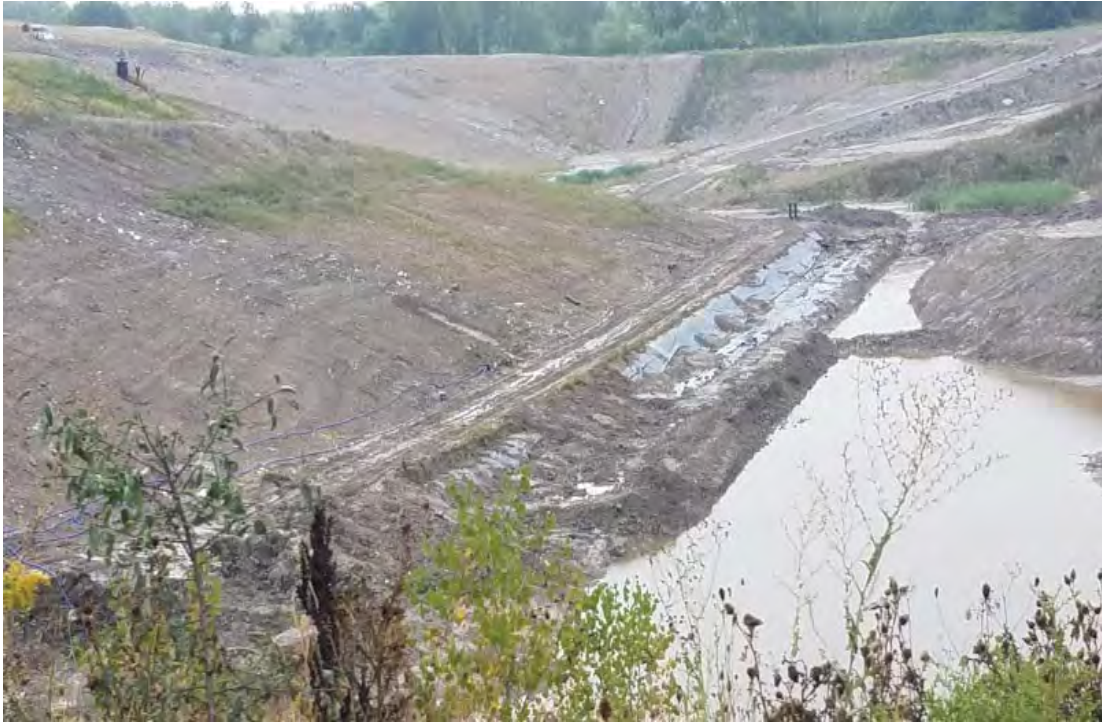
Temp sed basin viewed from the North, earth berm to separate leak from rain-flap and remainder of basin

- Temp Sed basin/Phase 7 rainflap repairs ongoing
 - Awaiting availability of liner crew
 - Well redrills and horizontal gas well scheduled for end of September

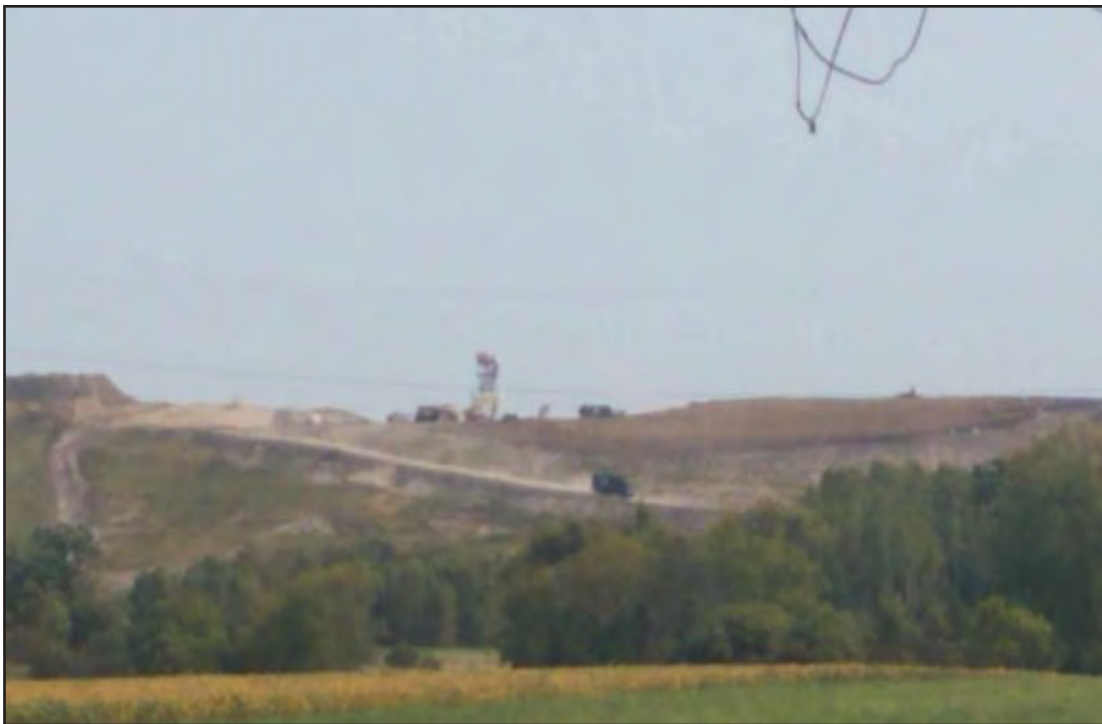
Overview of landfill from West

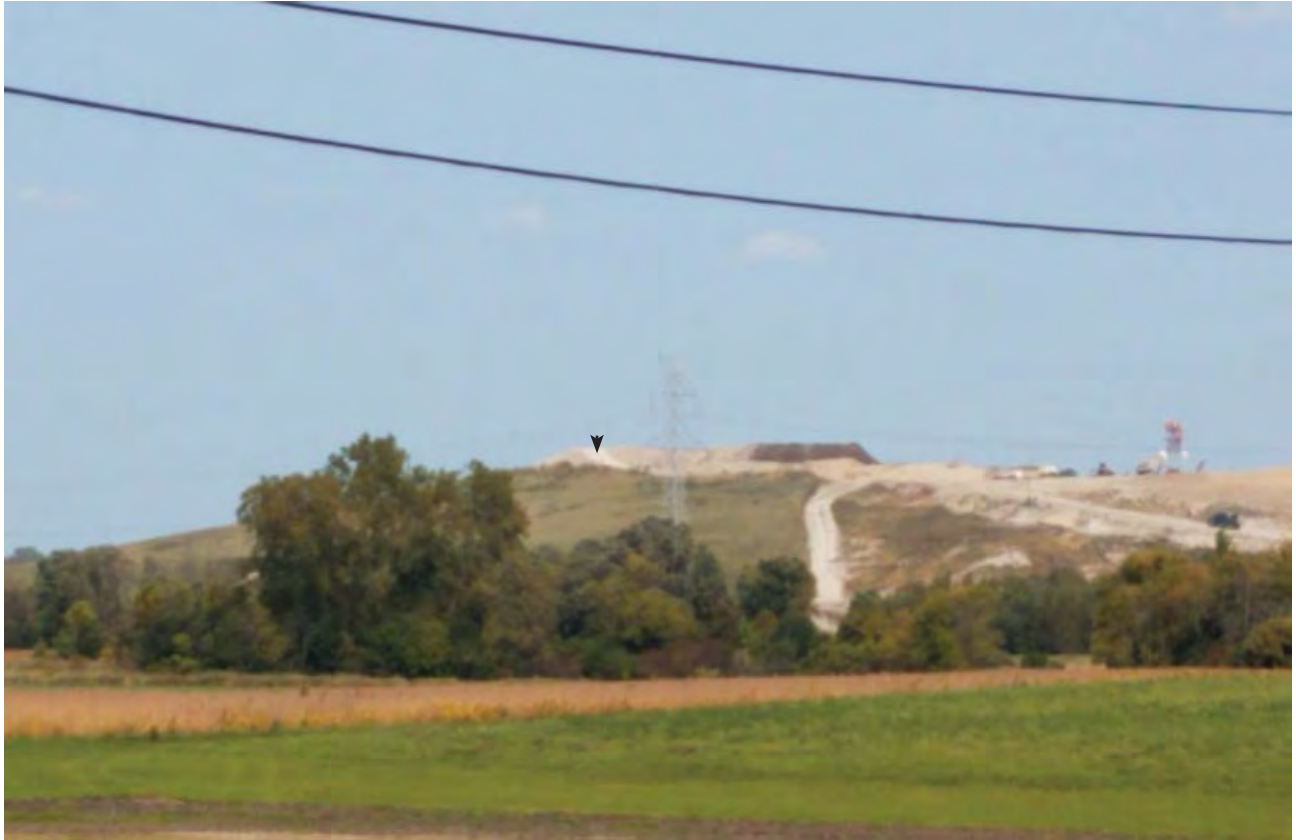
Phase 3 viewed from the West at a distance, new soils from cleaning up temp sed basin in center of photo, dark soil

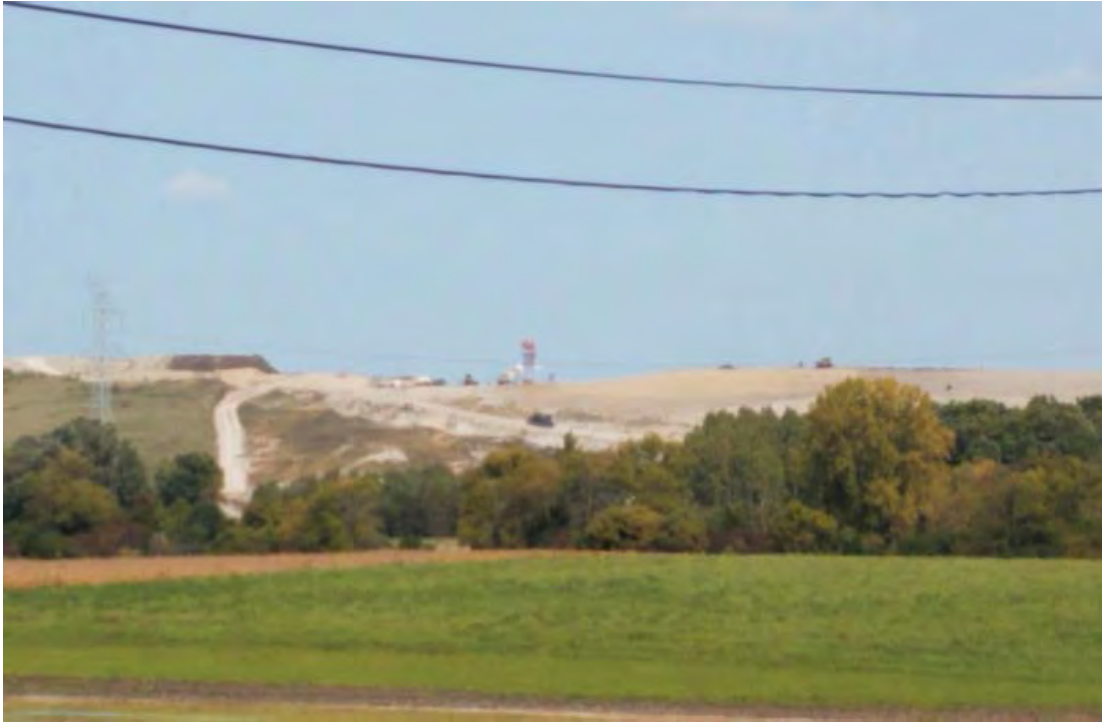
Phase 3 & 7 viewed from a distance and the West

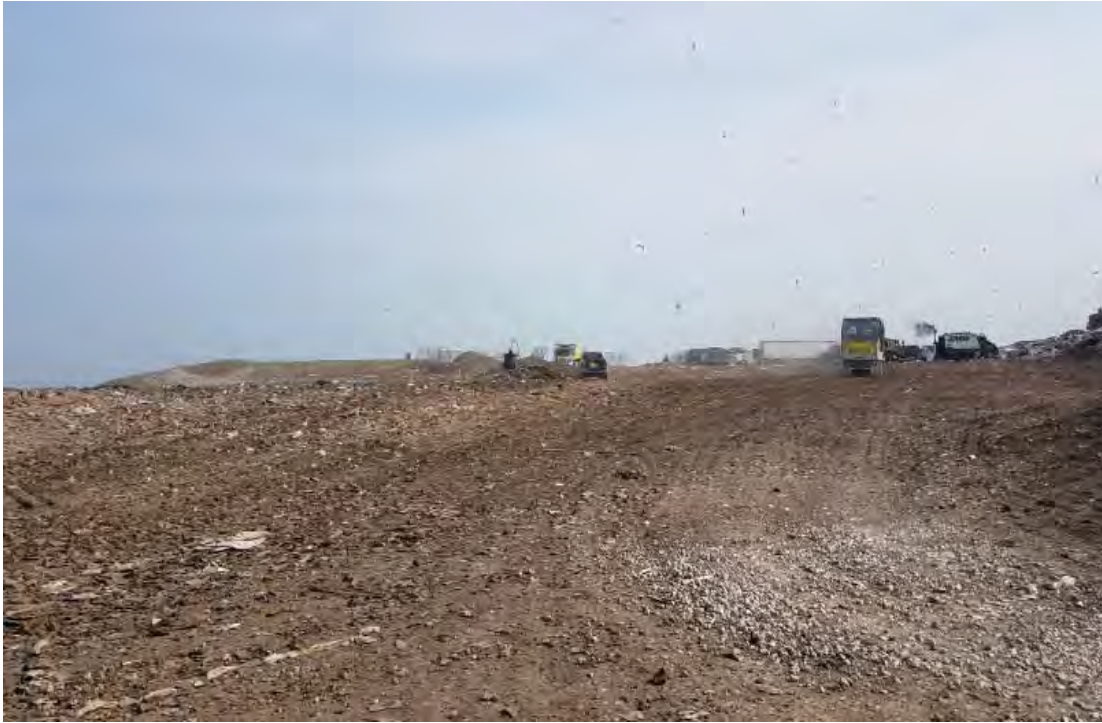
East portion of Phase 7, viewed from North, working face and new lift to the right of picture

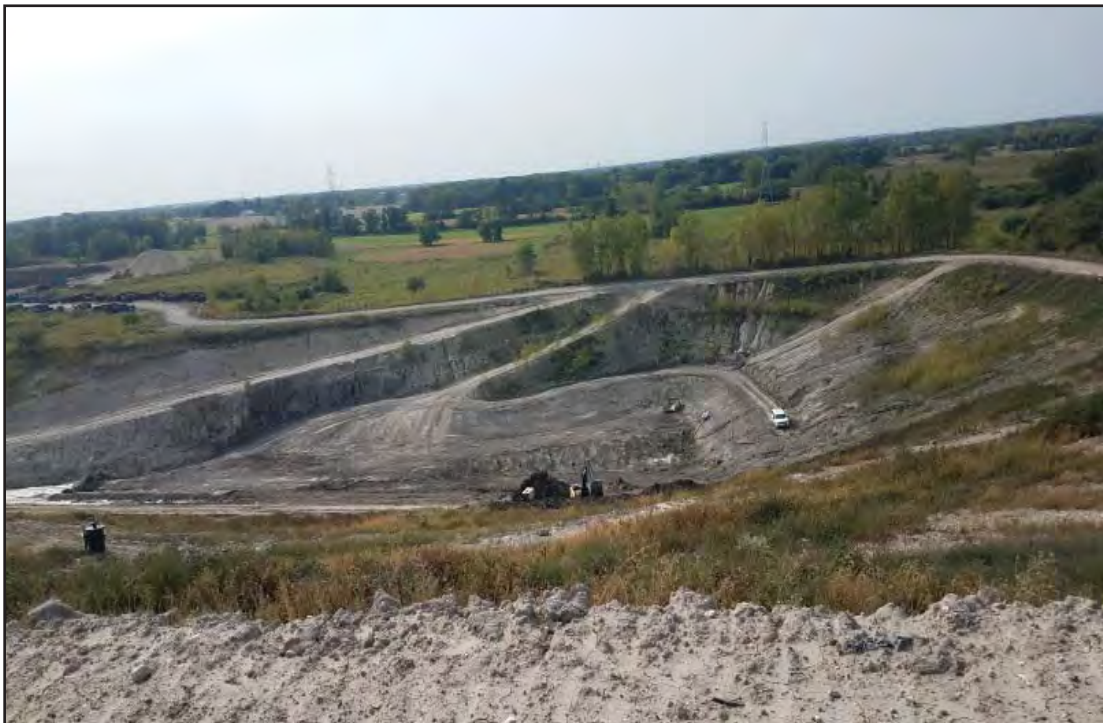
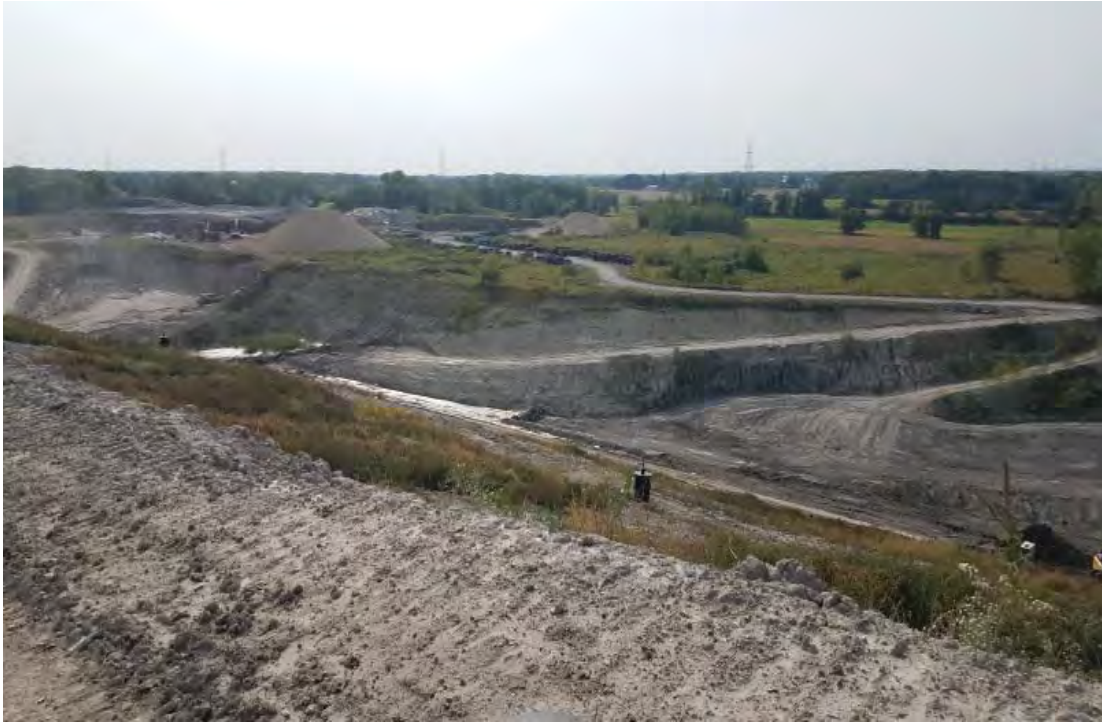
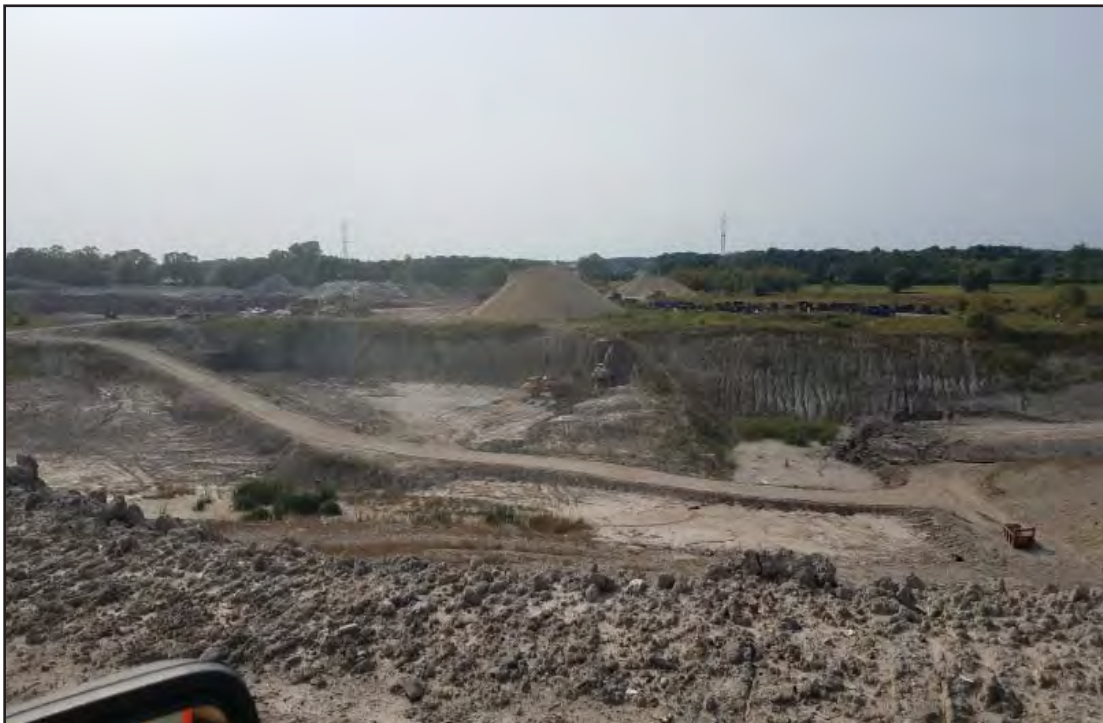
Temp sed basin, clean and dry

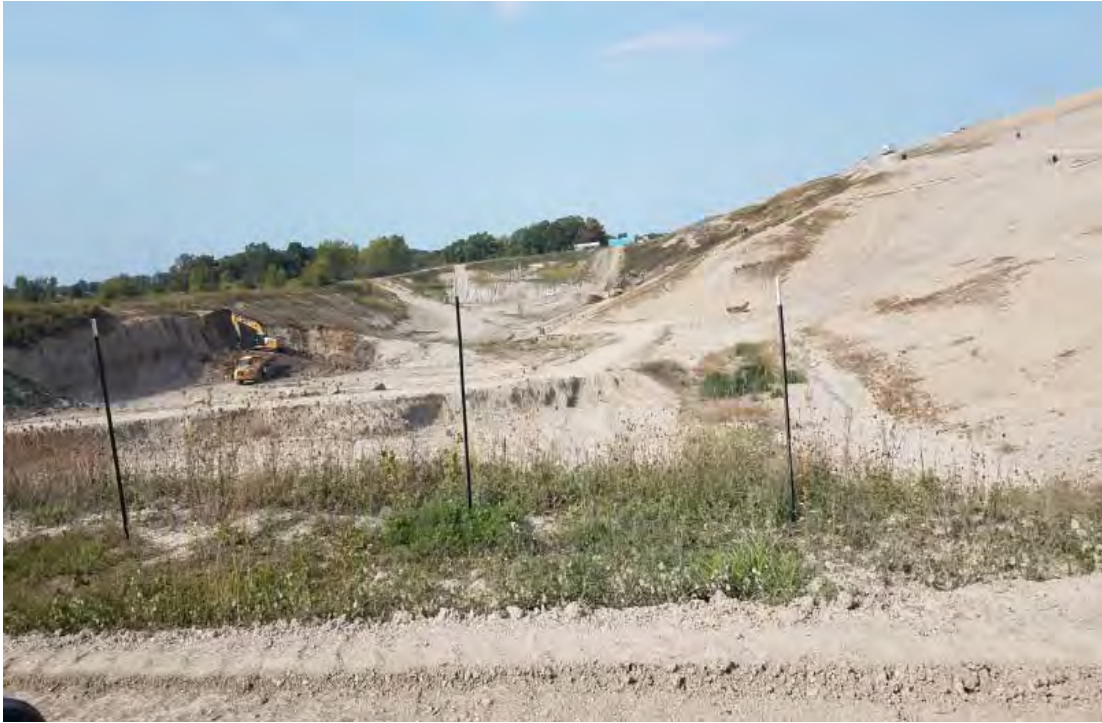
View North into Temp Sed Basin
