2020 Year End Summary of Audits of the Emerald Park Landfill

Prepared For:
City of Muskego
Green For Life Emerald Park Landfill Standing Committee

2020 Green For Life Emerald Park Landfill Year End Compliance Officer Report and Audit Summary

TO: Advanced Disposal Services Emerald Park Standing Committee
FROM: Jo-Walter Spear, Jr., P.E.
COPIES: File
DATE: 03/29/2021
PROJECT NUMBER: 1012.10030

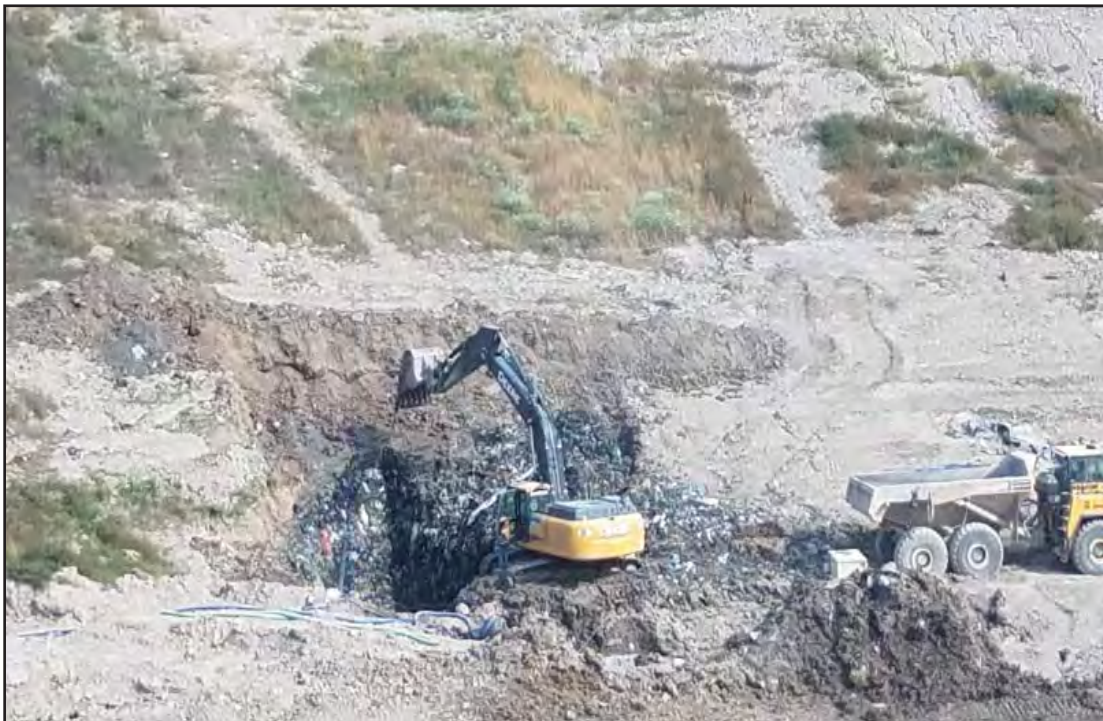
Excavation to sump, materials being placed in working face and covered

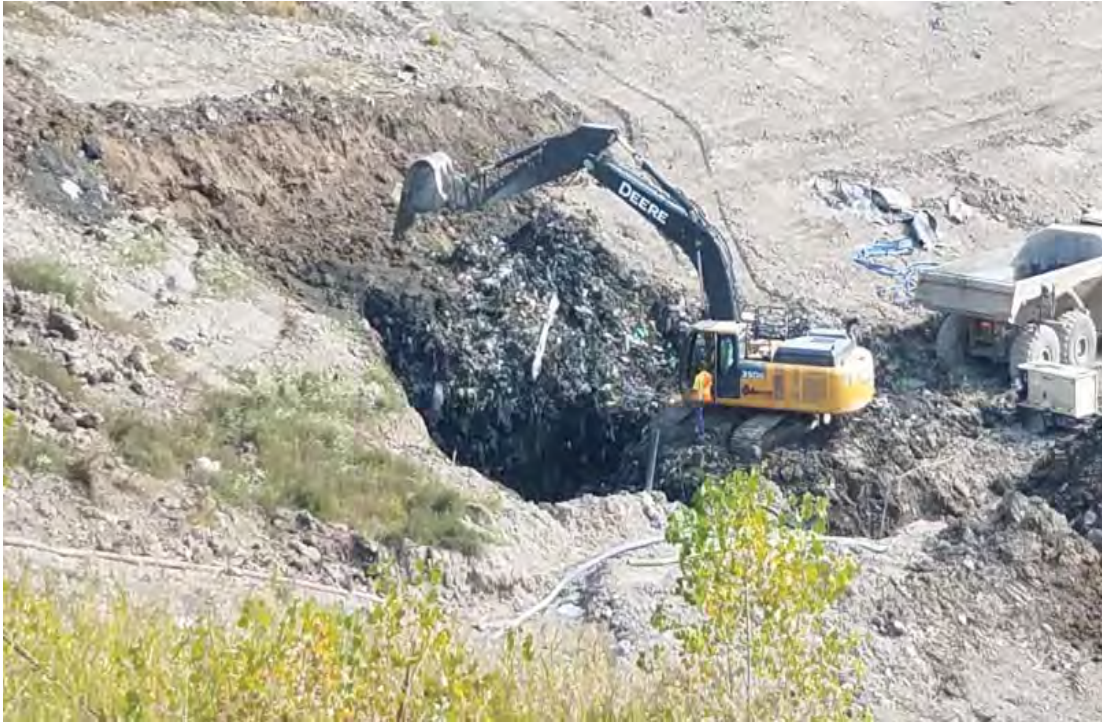
Sump at Northwest Corner of Phase 7 South, being investigated for issues.
Excavation to bottom of cell will be a potential odor source

- Rain flap repair awaiting liner crew to arrive on site
 - Contractor restoring sum in Northwest corner of Phase 7 South. Sump being cleaned by hydraulic equipment

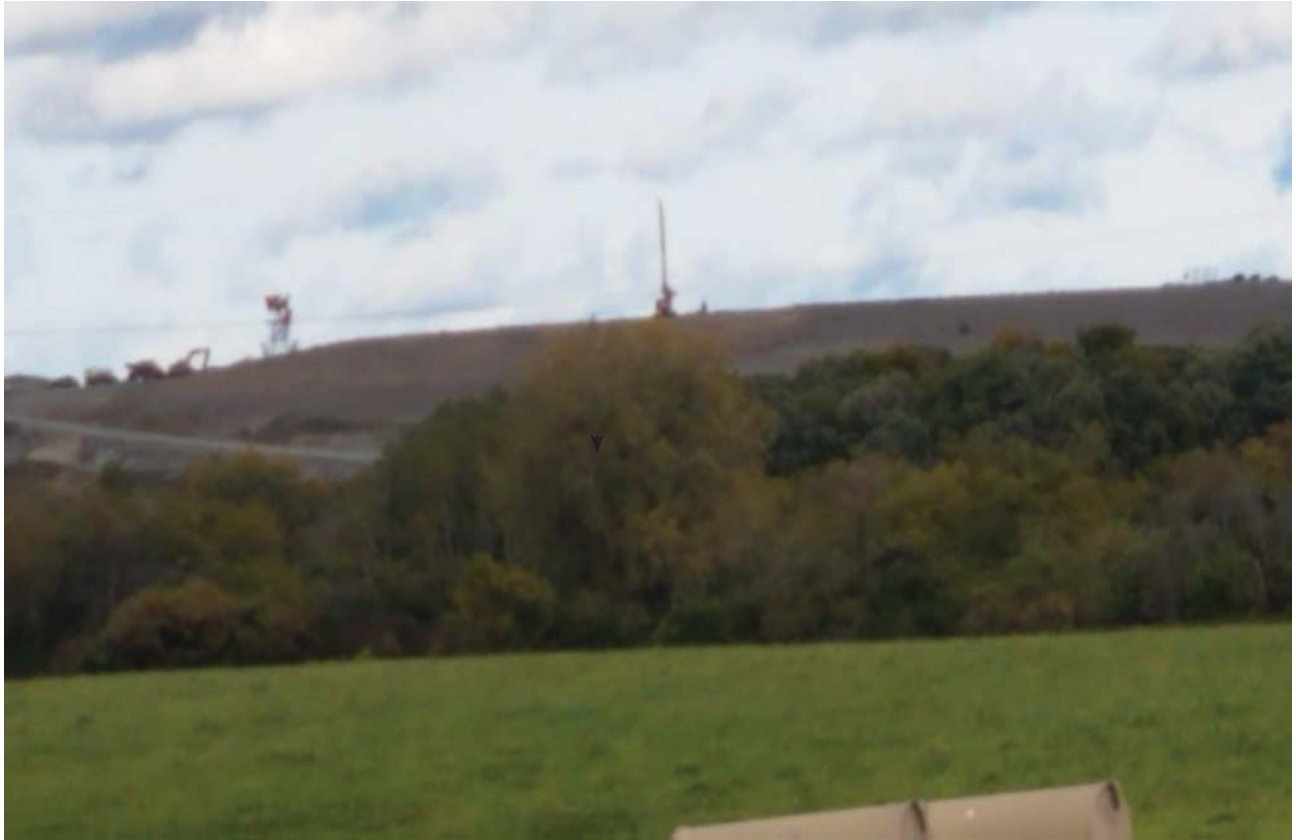
Rig in center of Phase 7 placing well.

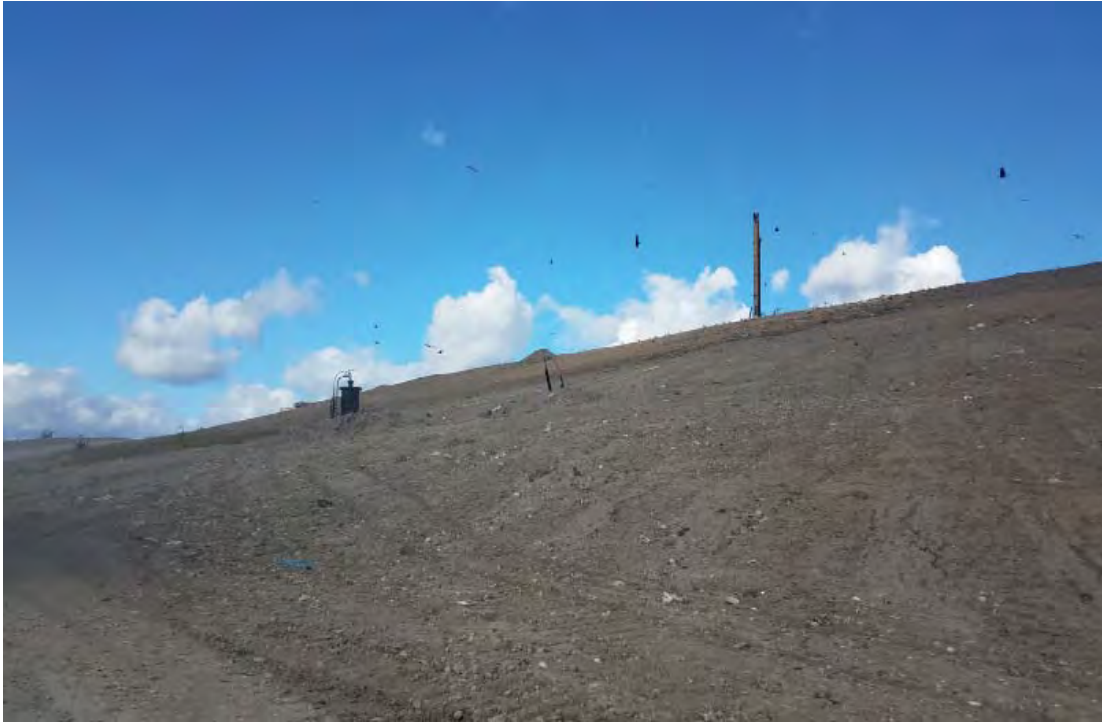
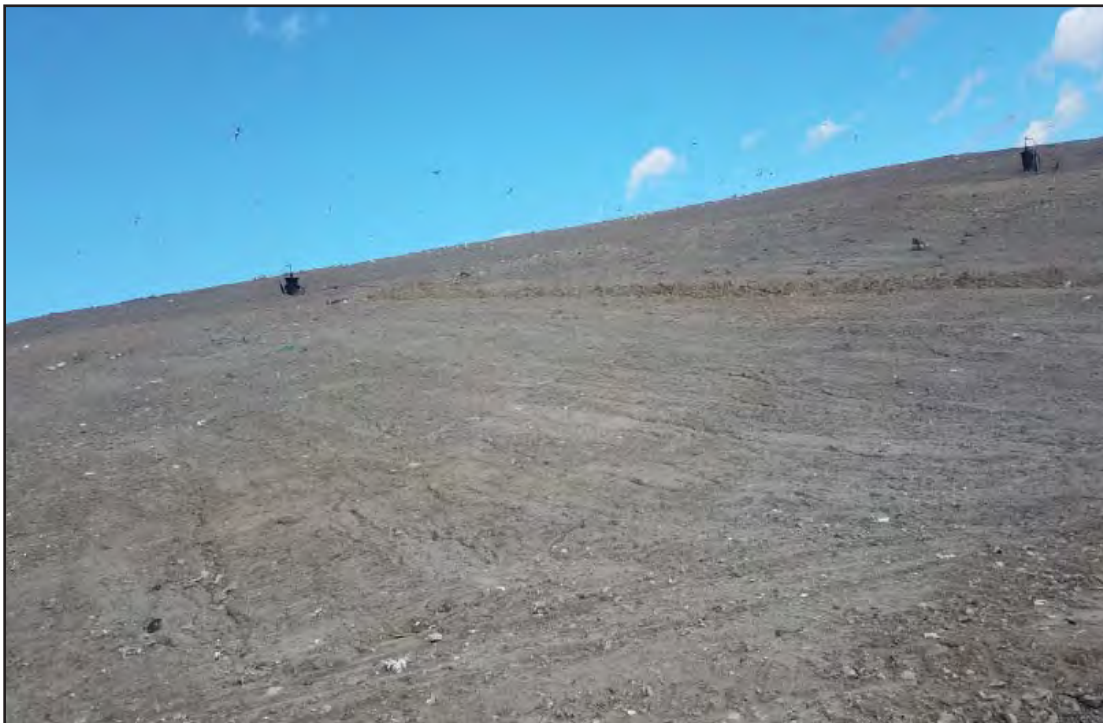
Phase 7 South West slope redressed.

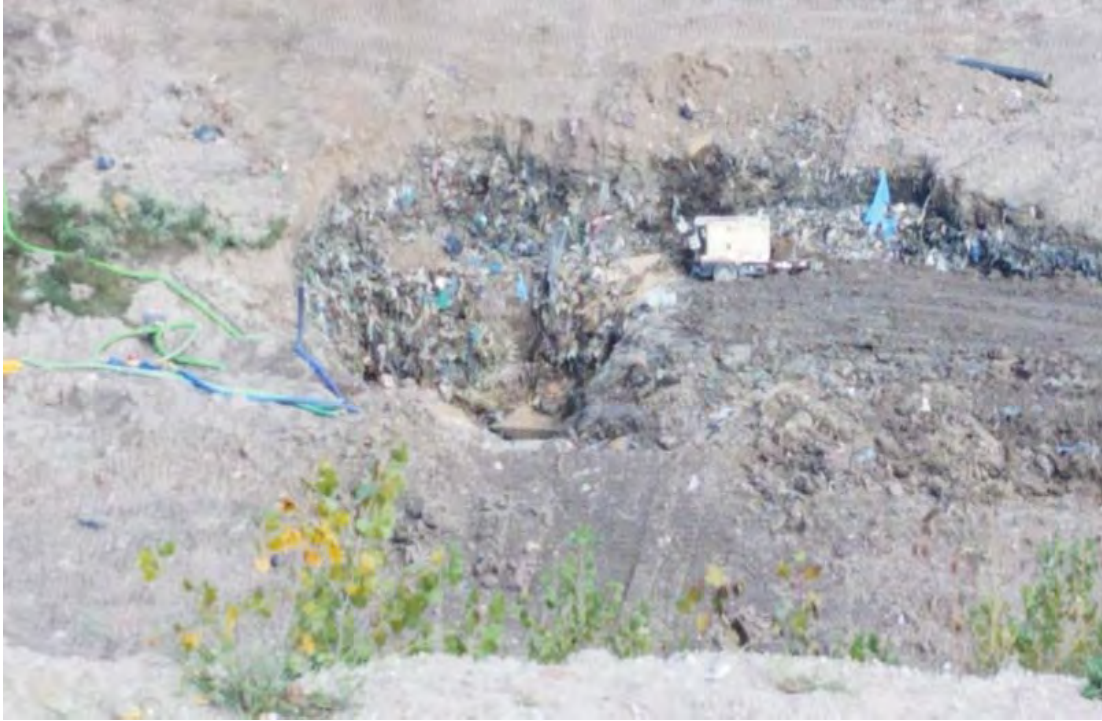
Phase 7 sump exposed by excavation

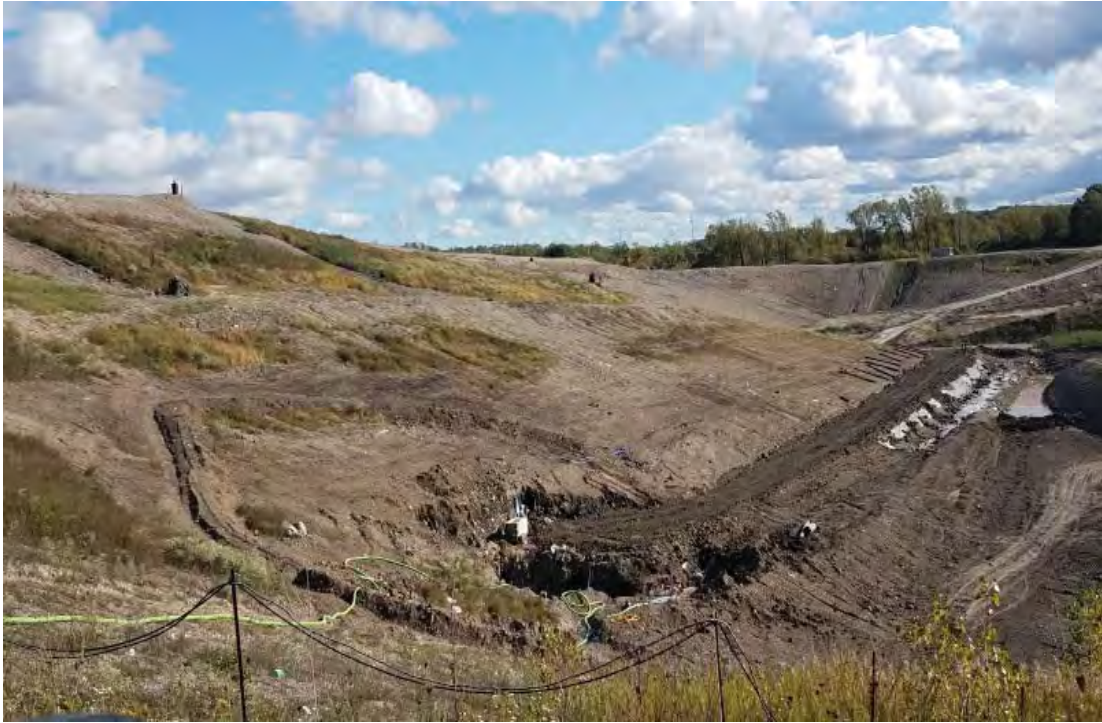
Excavation to sump adjacent to temp sed basin

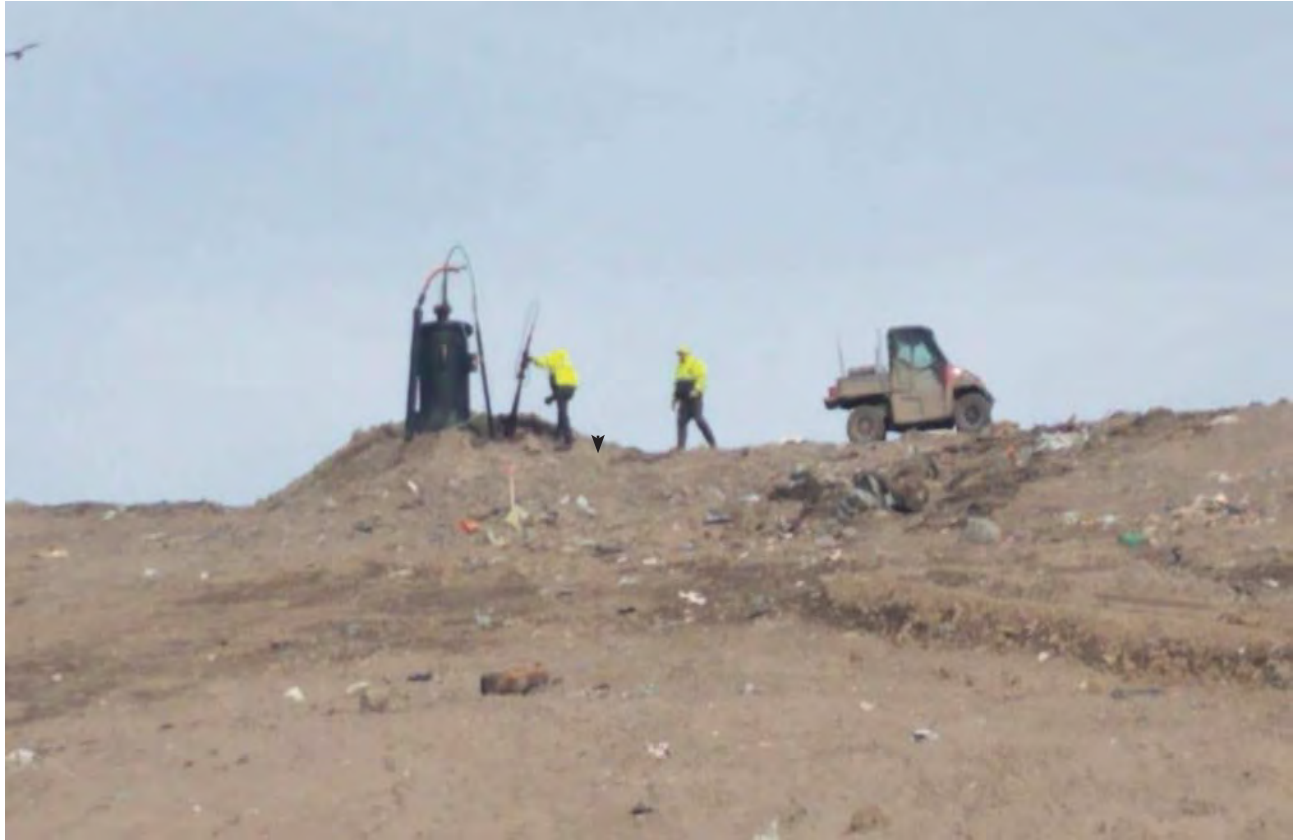
Gas techs adjusting connections at new well and trench well connections

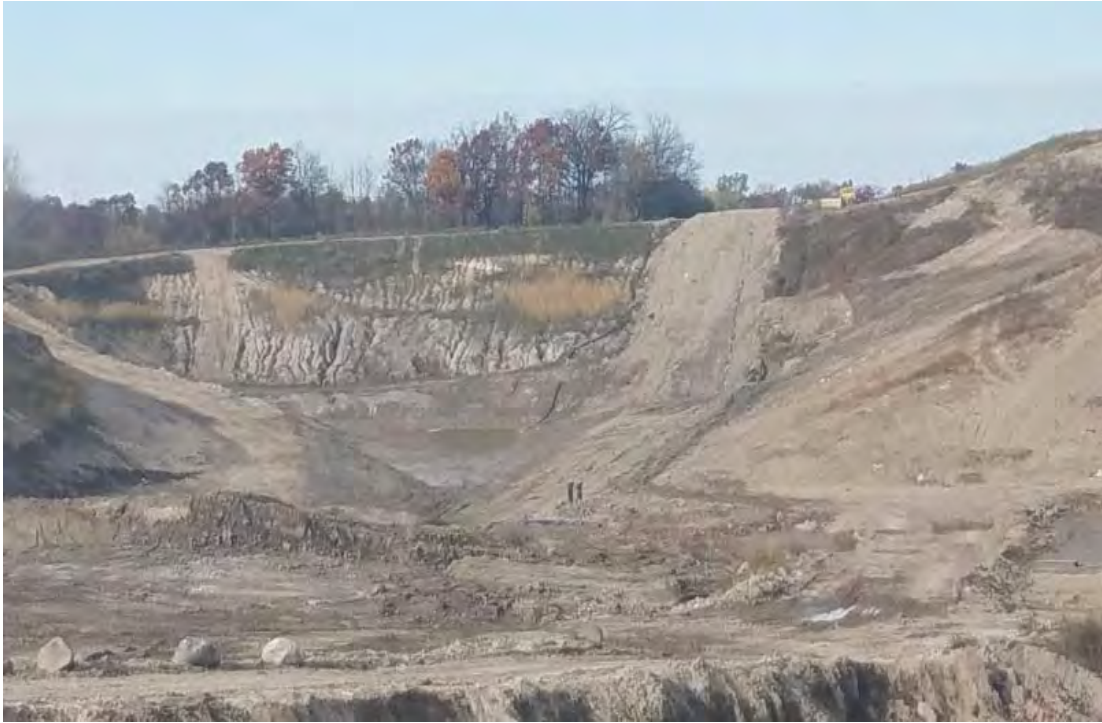
Temp sed basin viewed from the South, reshaped for better protection of rain-flap

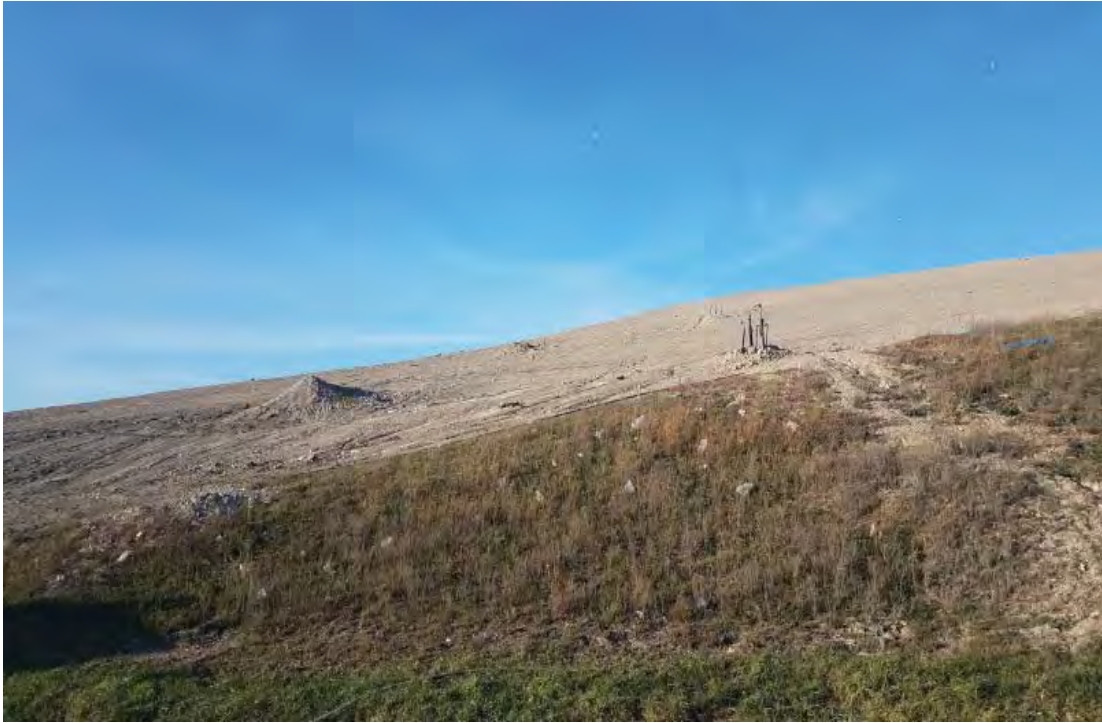
South slope of Phase 7 South and Phase 6, recently dressed with cover

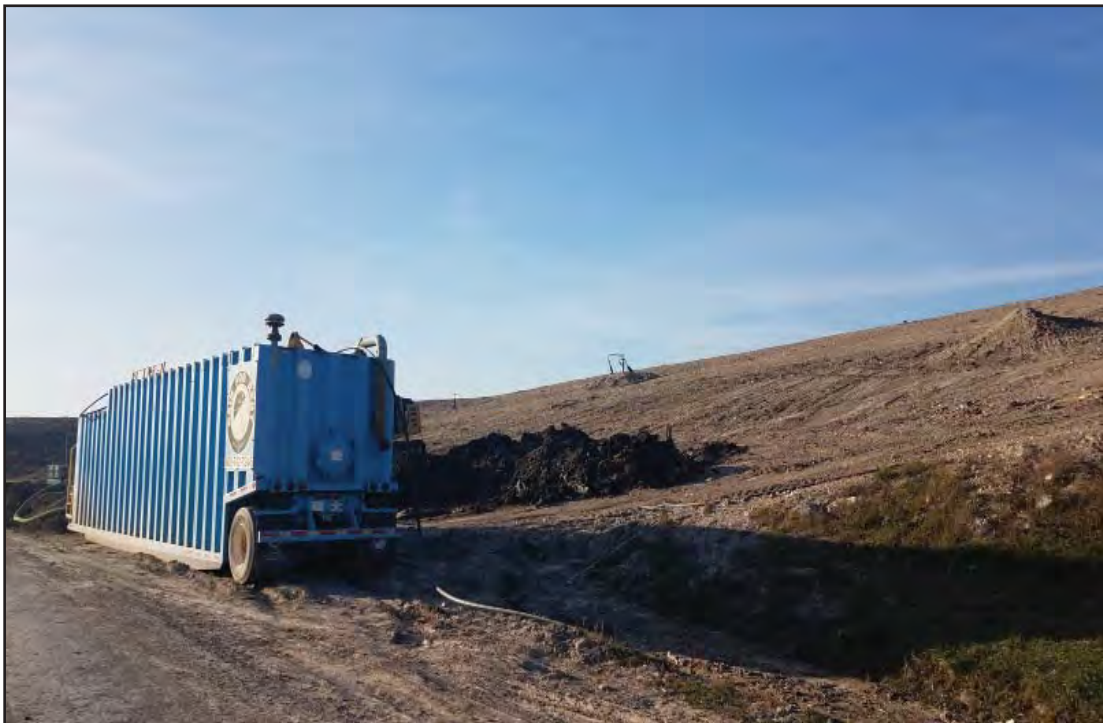
Drip leg work at North end of Phase 7 South, tanker not in use

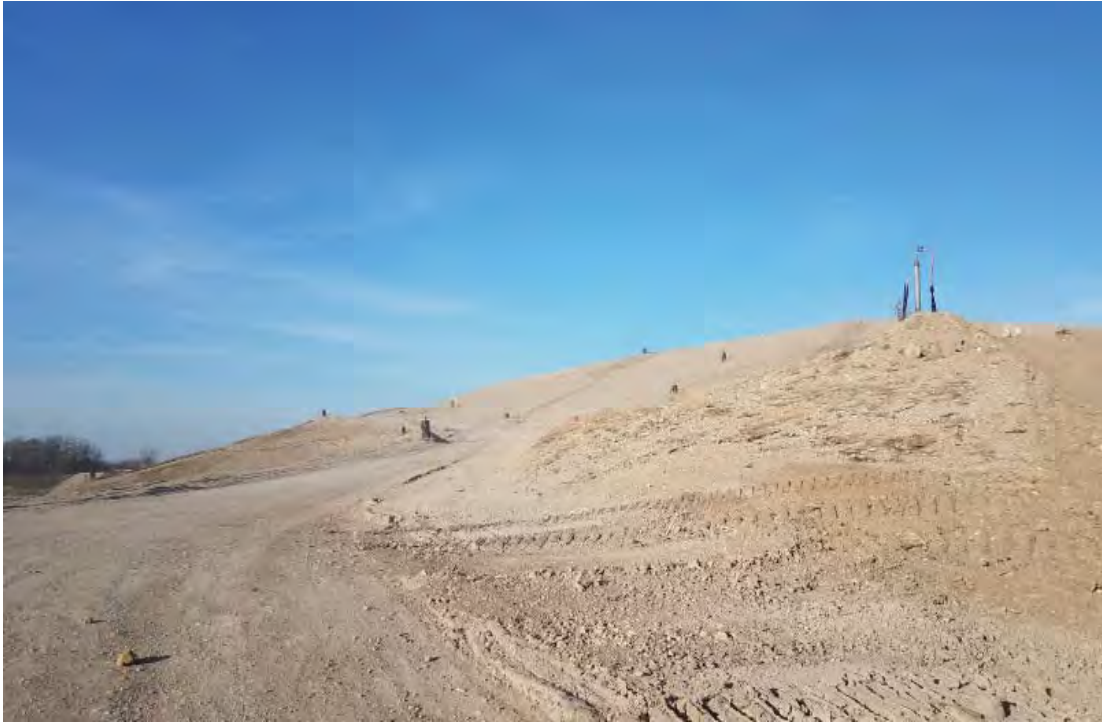
Access road with trench well on right hand side for gas collection

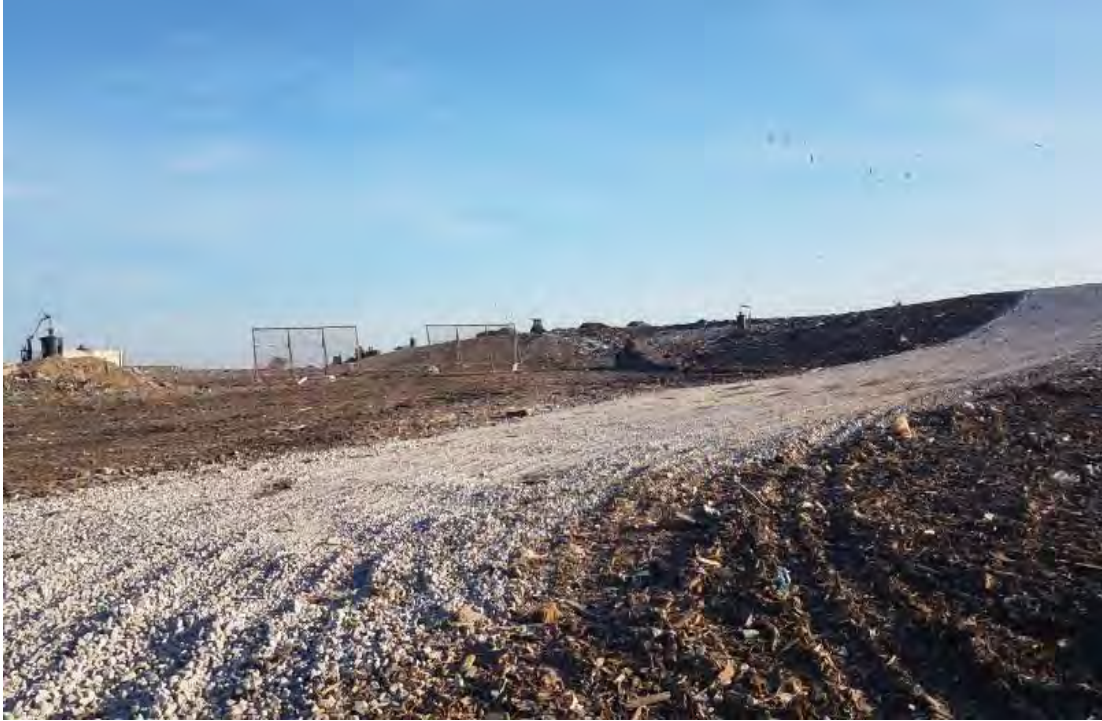
Travelway with stone to improve travel conditions across Phase 7

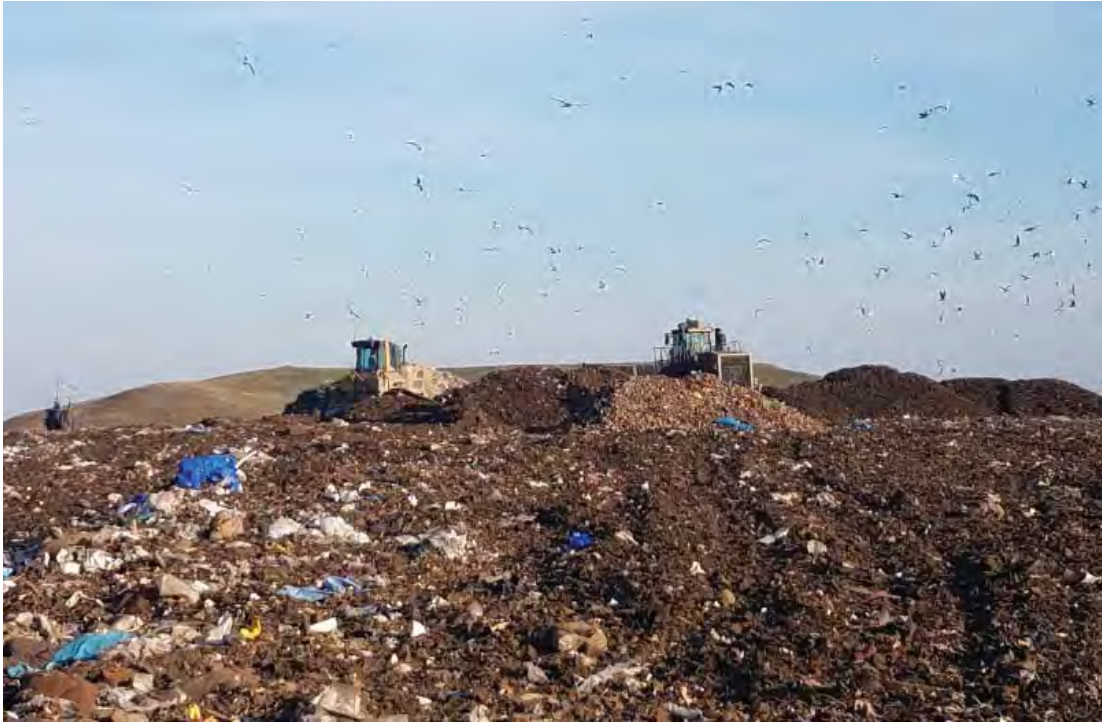
Active area in Southeast corner of Phase 7 South, abundance of autofluff for daily cover stockpiled

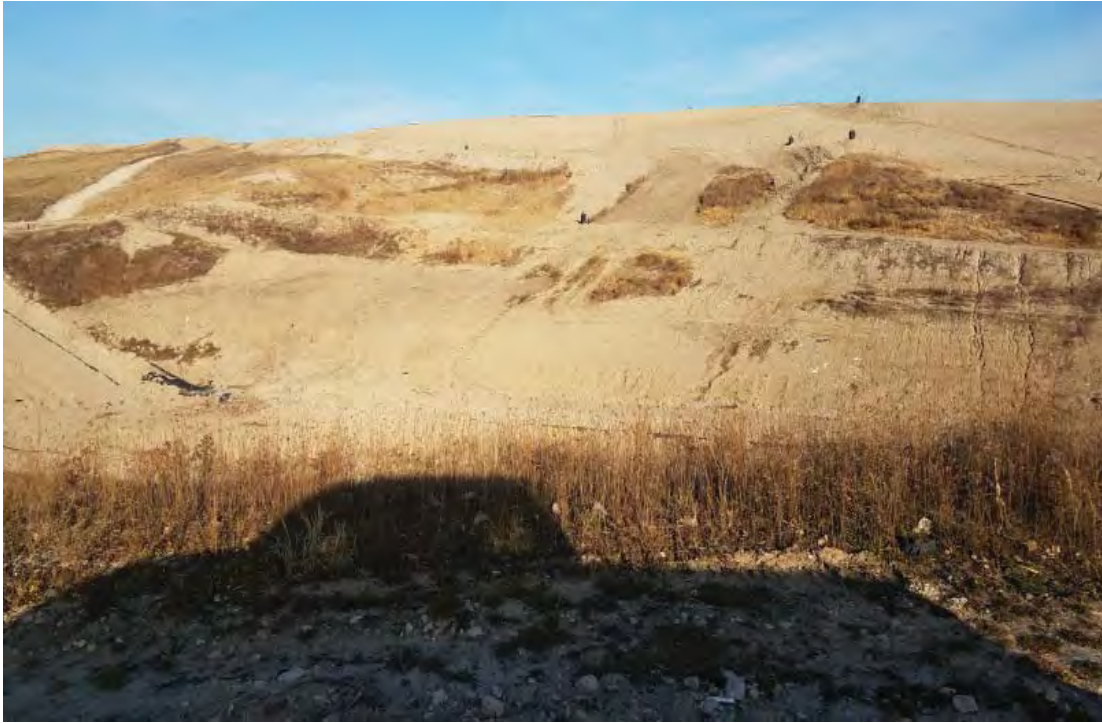
Rainflap exposed and repair at Northwest corner of Phase 7

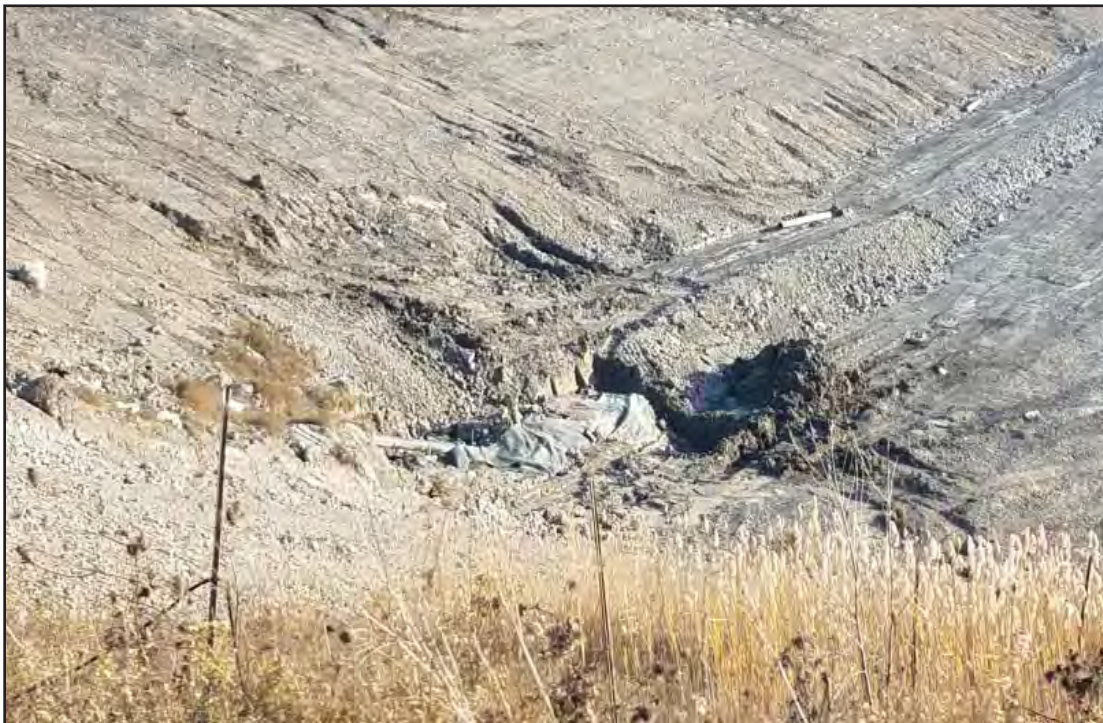
Restored sump at base of Phase 7 Slope

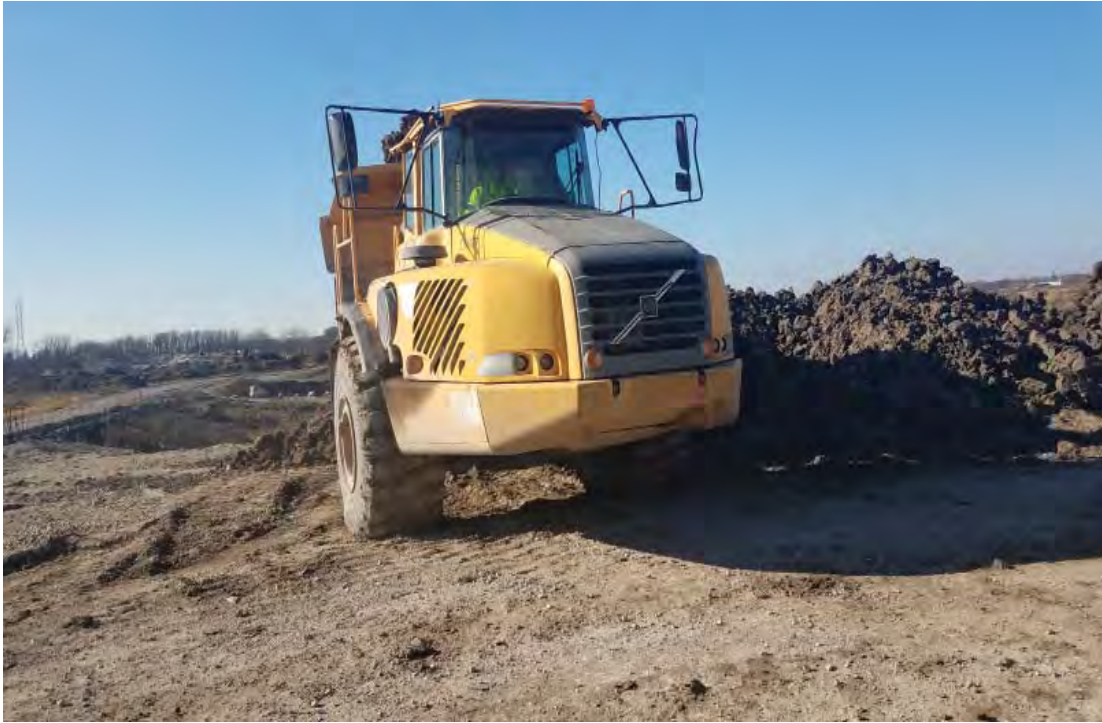
Soils being added to West slope of Phase 7 South to improve intermediate cover

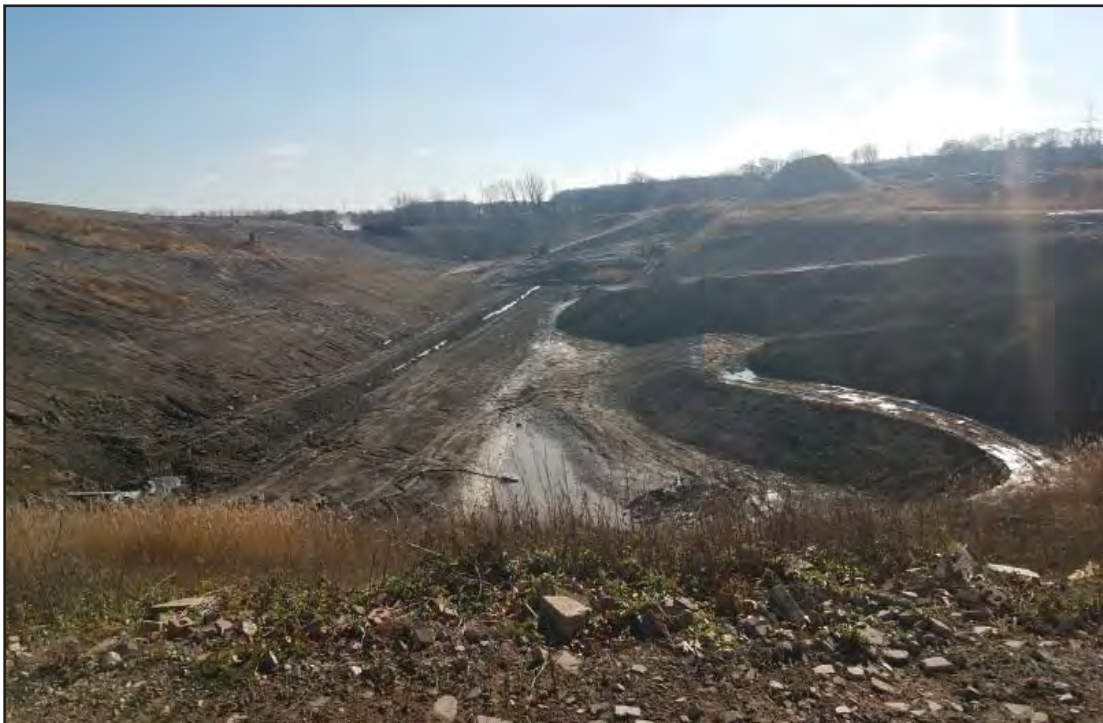
Temp sed basin viewed from the North, and repaired rain flap and berm

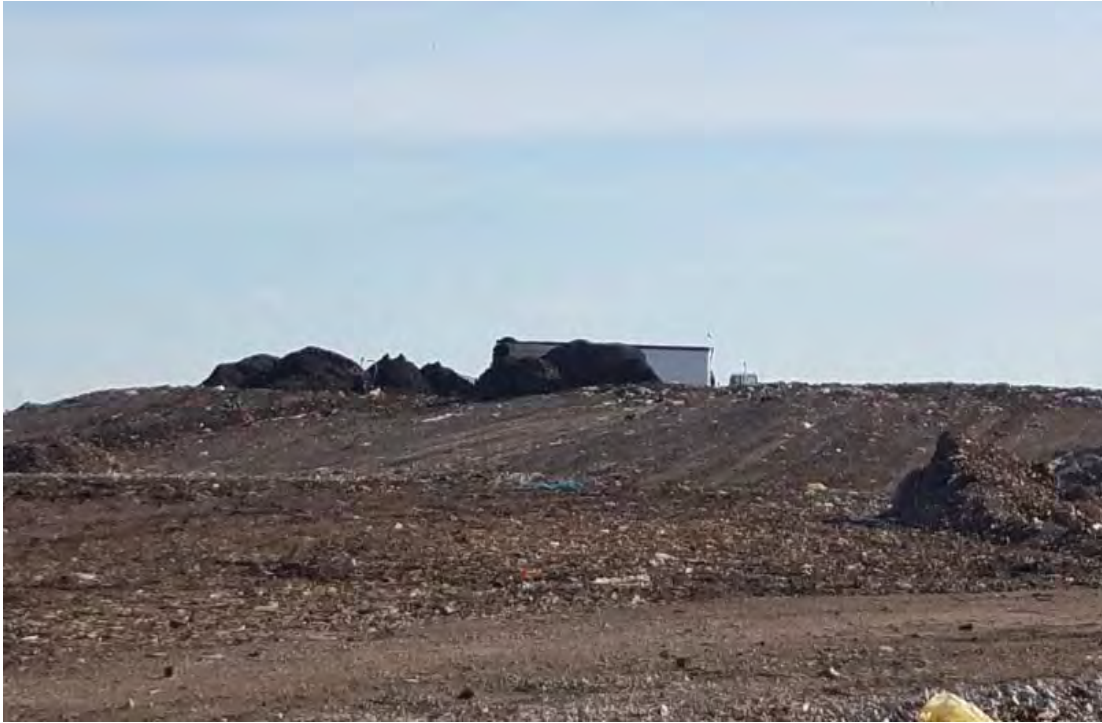
Stockpiled autofluff adjacent to working face

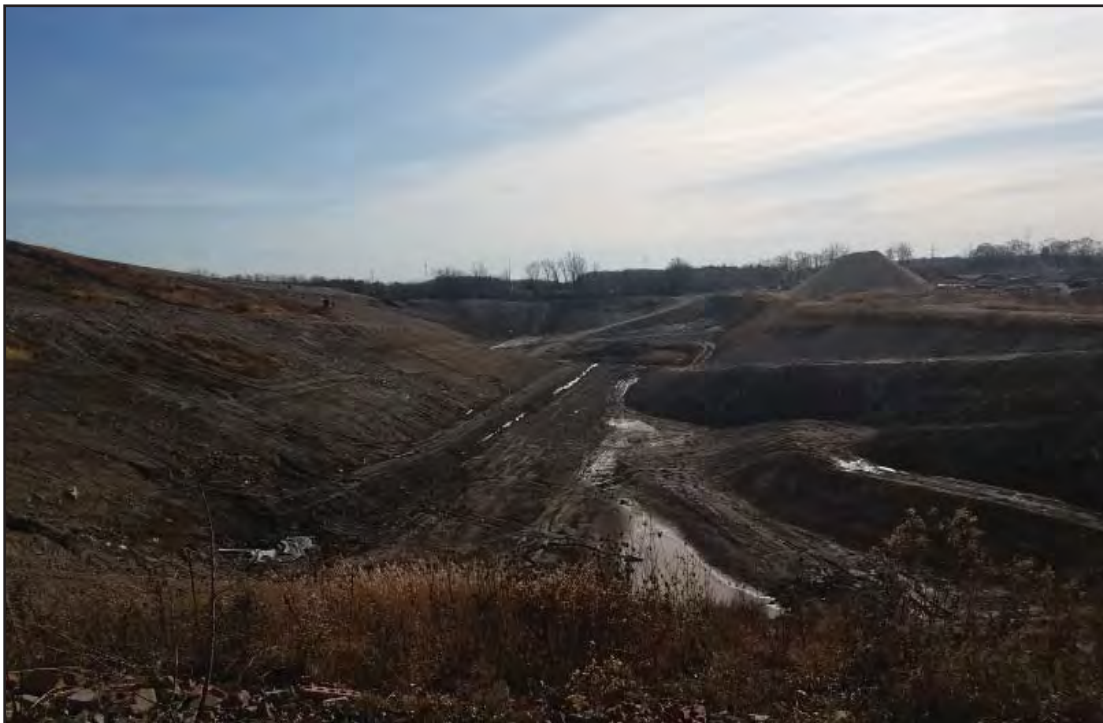
Temp sed basin and repaired rainflap with new access road

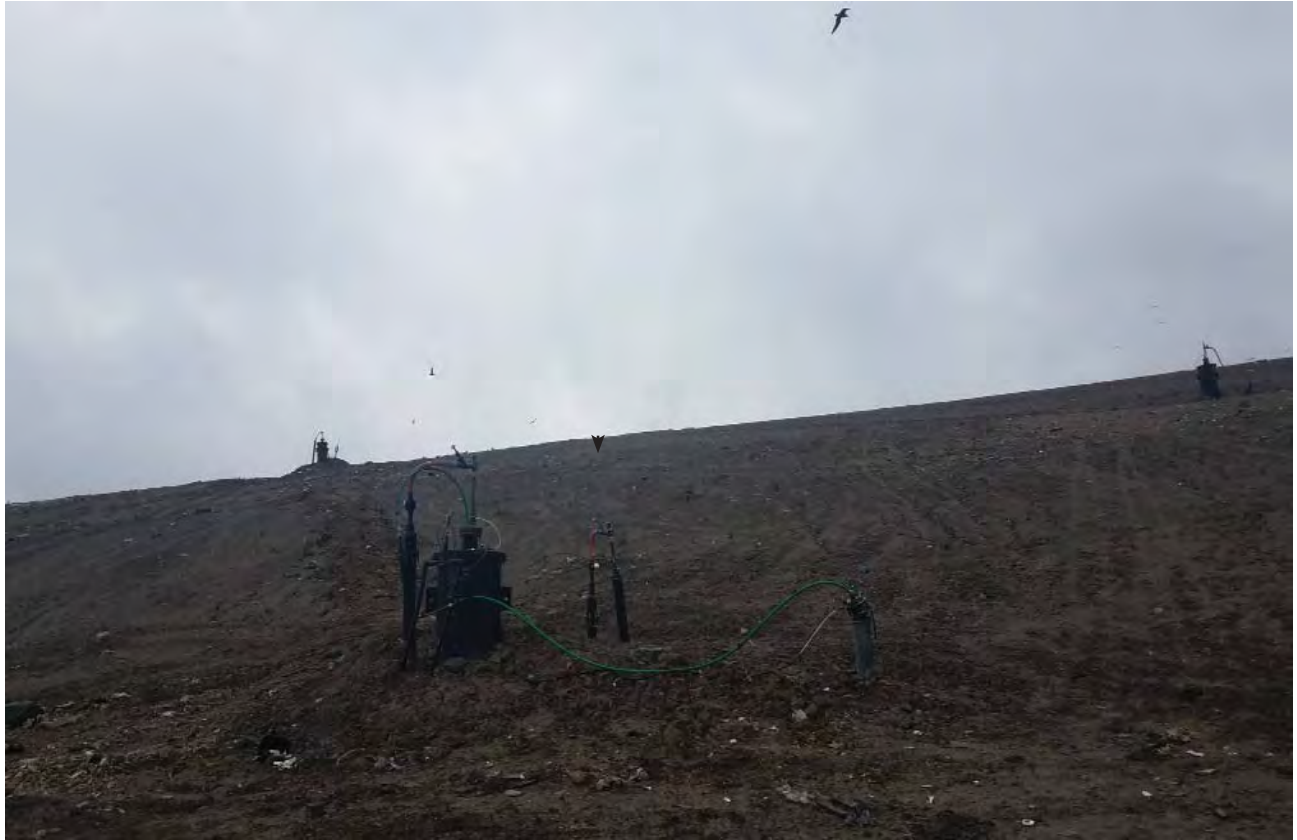
West slope of Phase 7 South, improved gas collection

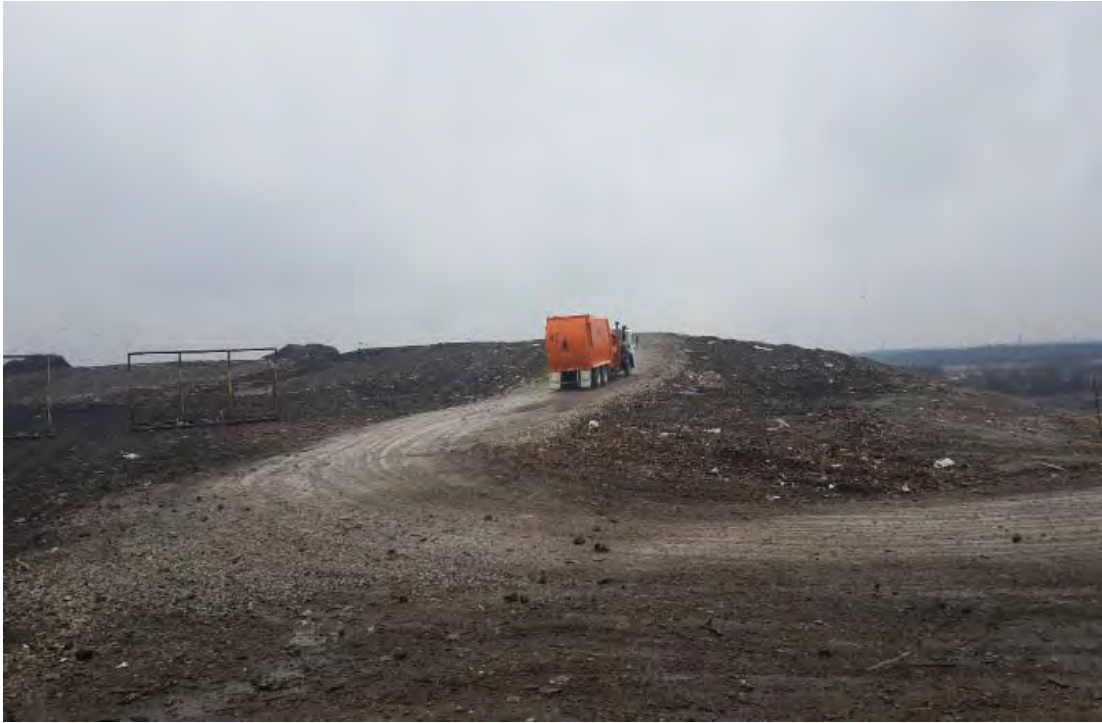
Access road to Working face, area very tight, face is small due to volume

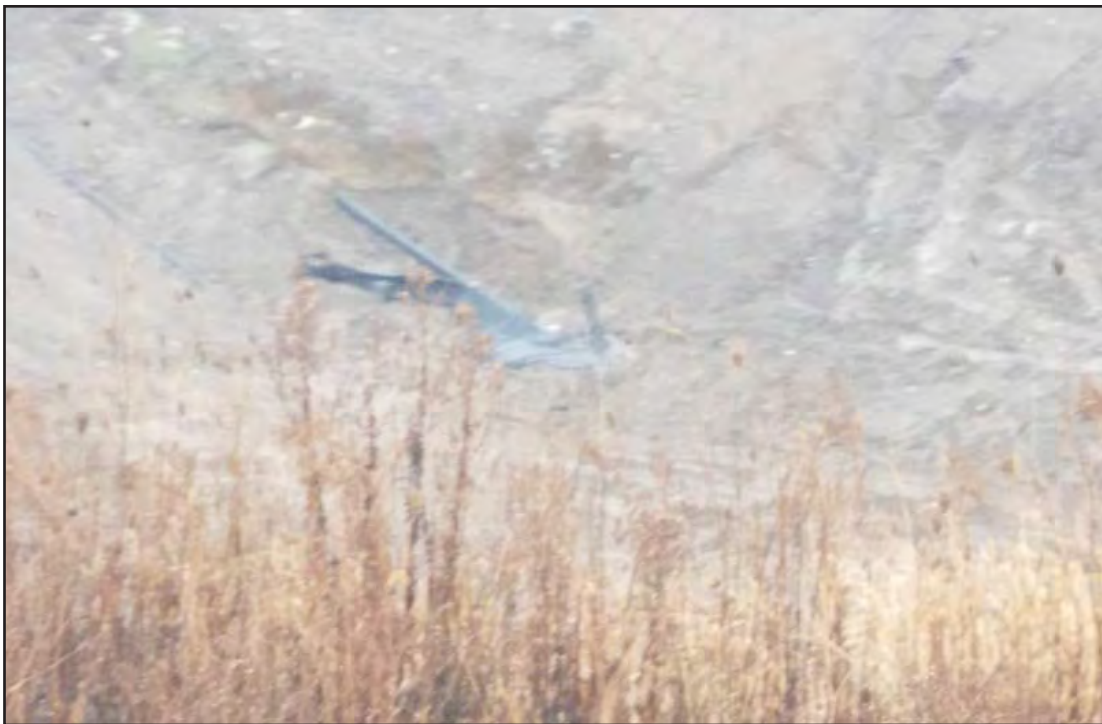
West slope of Phase 7, leachate sideslope riser exposed

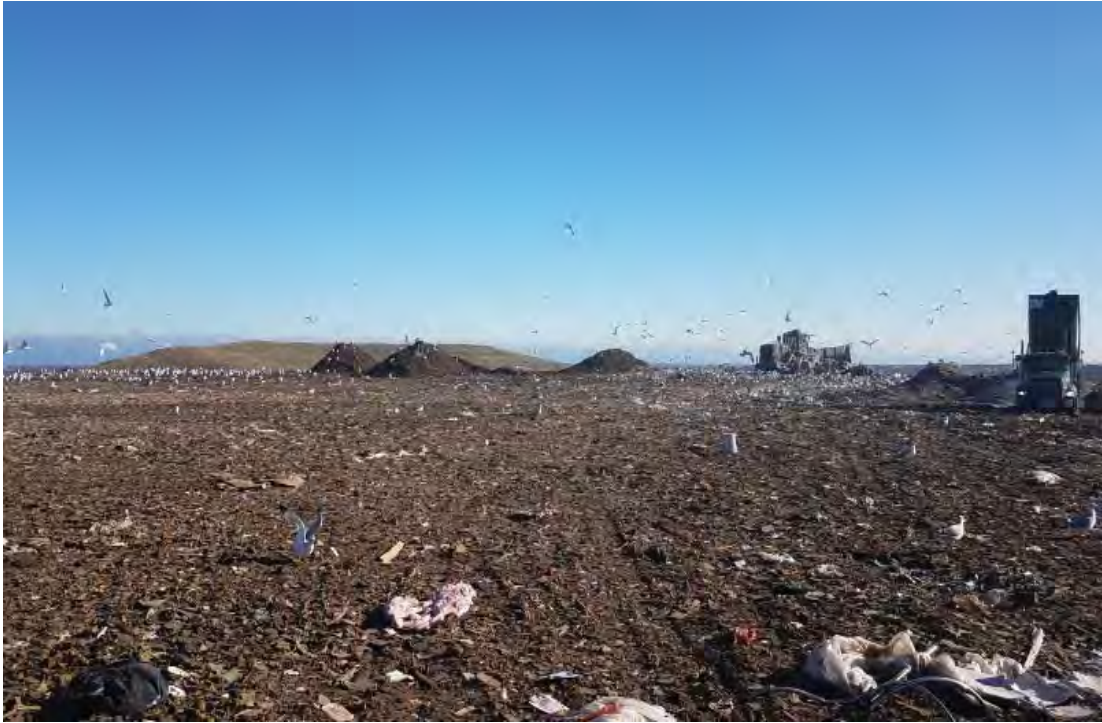
Cover materials stockpiled in active area

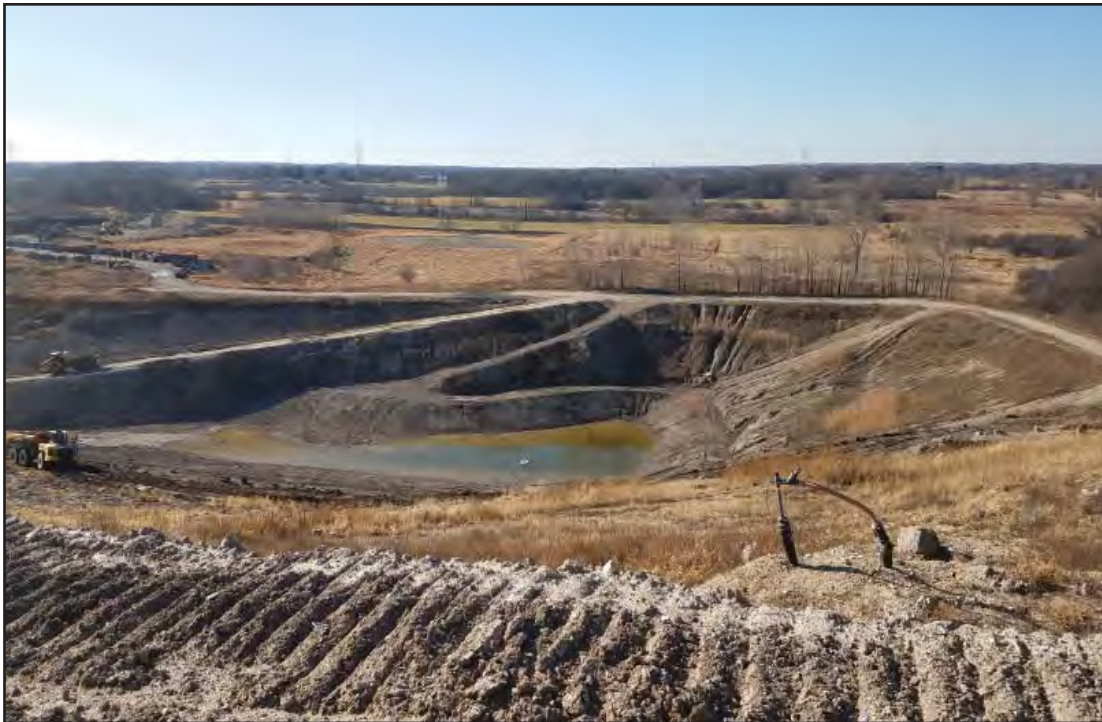
Temp sed basin pumping to clear water to basin #1

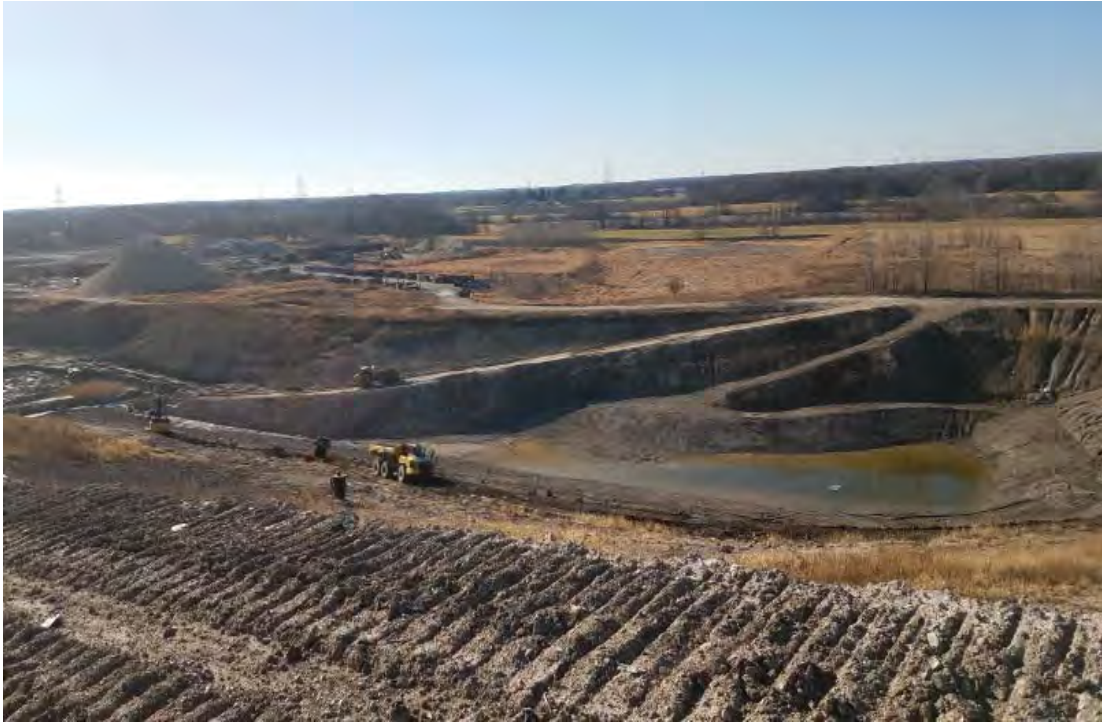
Temp sed basin restored

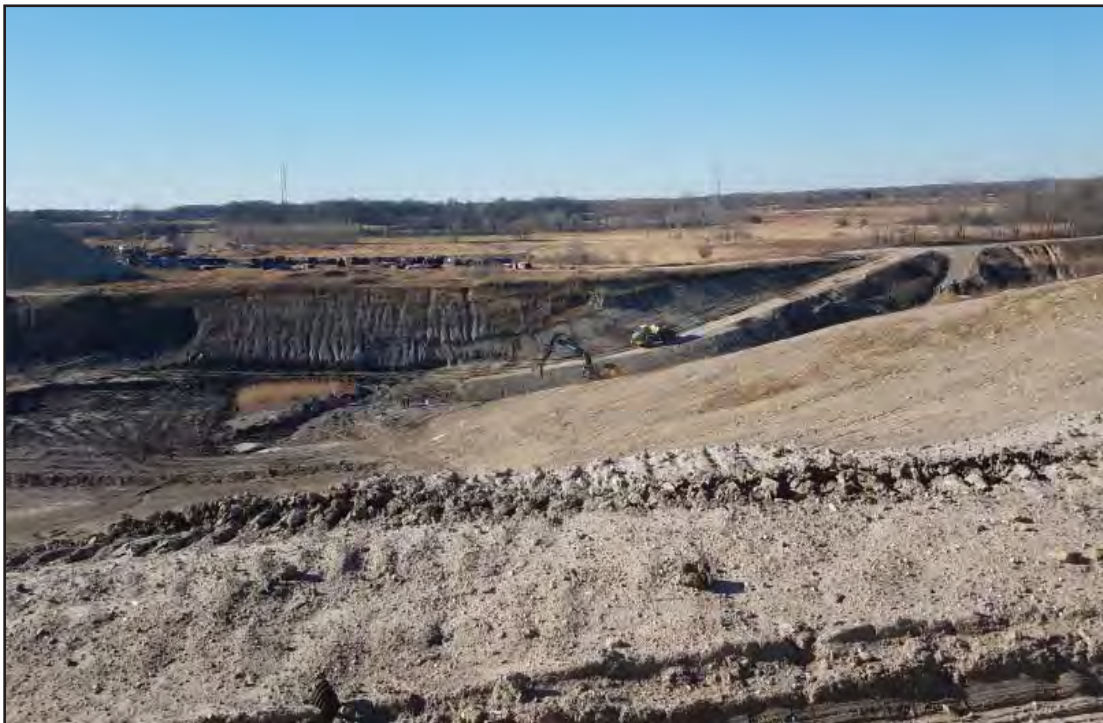
Contractor excavating future Phase 8 to provide material for construction of Phase 7 West slope berm
