2020 Year End Summary of Audits of the Emerald Park Landfill

Prepared For:
City of Muskego
Green For Life Emerald Park Landfill Standing Committee

2020 Green For Life Emerald Park Landfill Year End Compliance Officer Report and Audit Summary

TO: Advanced Disposal Services Emerald Park Standing Committee
FROM: Jo-Walter Spear, Jr., P.E.
COPIES: File
DATE: 03/29/2021
PROJECT NUMBER: 1012.10030

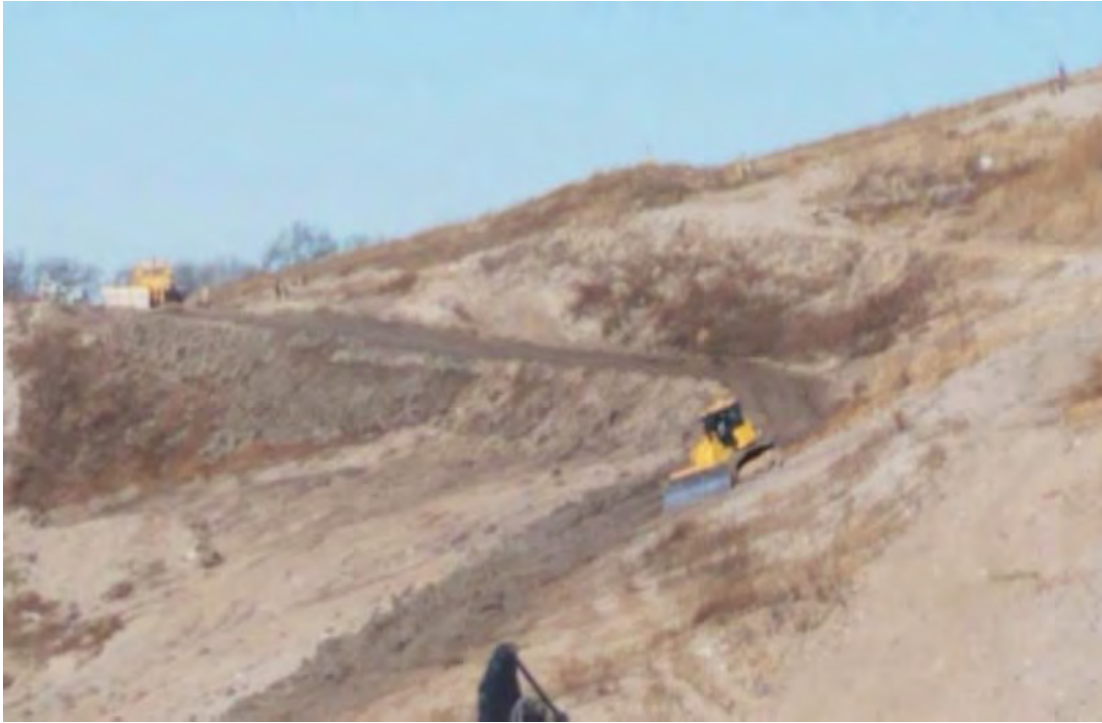
Access road built over rainflap at toe of West slope of Phase 7

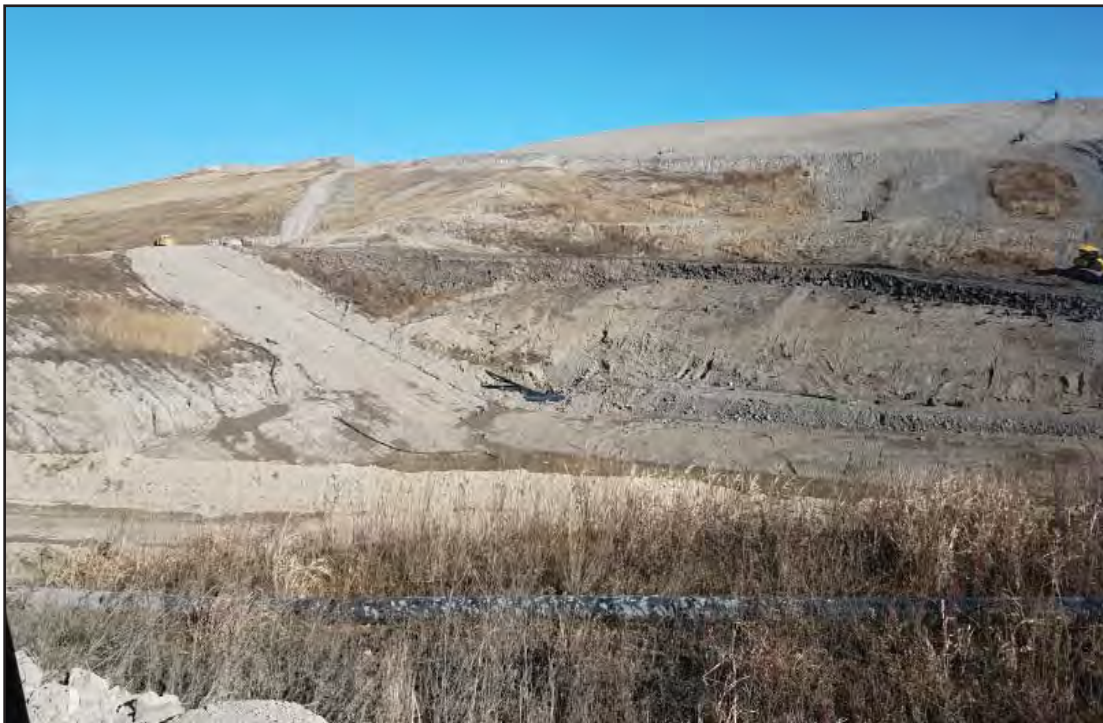
West slope of Phase 7, note new berm construction to move runoff from North to South

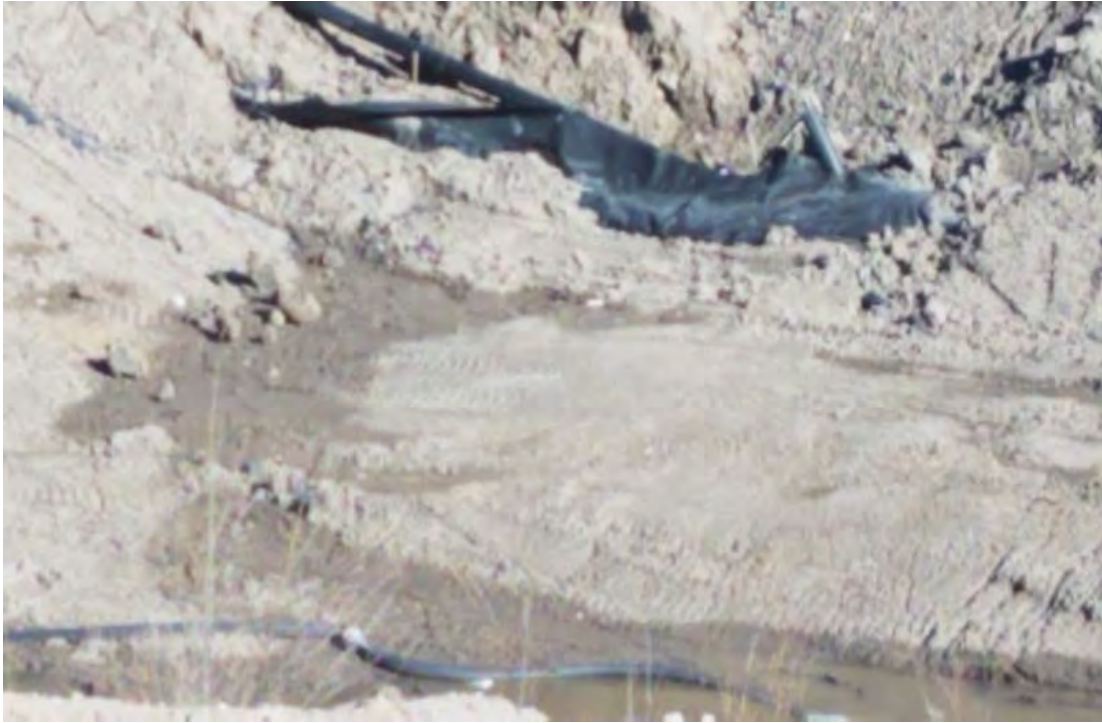
Header for leachate collection

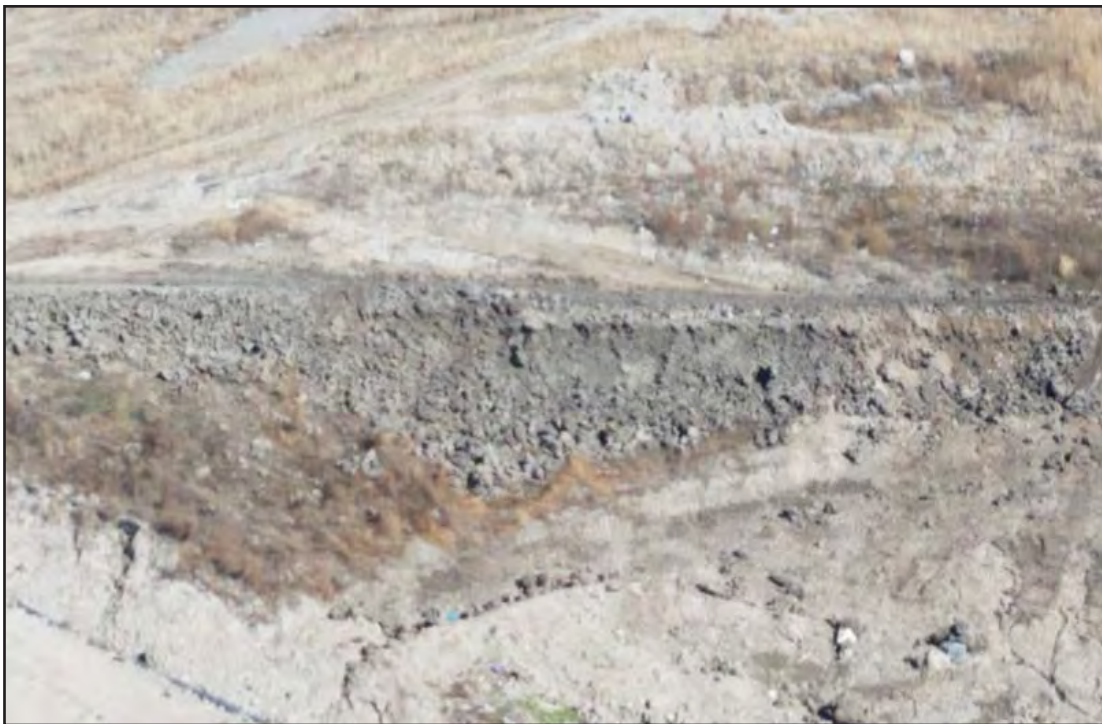
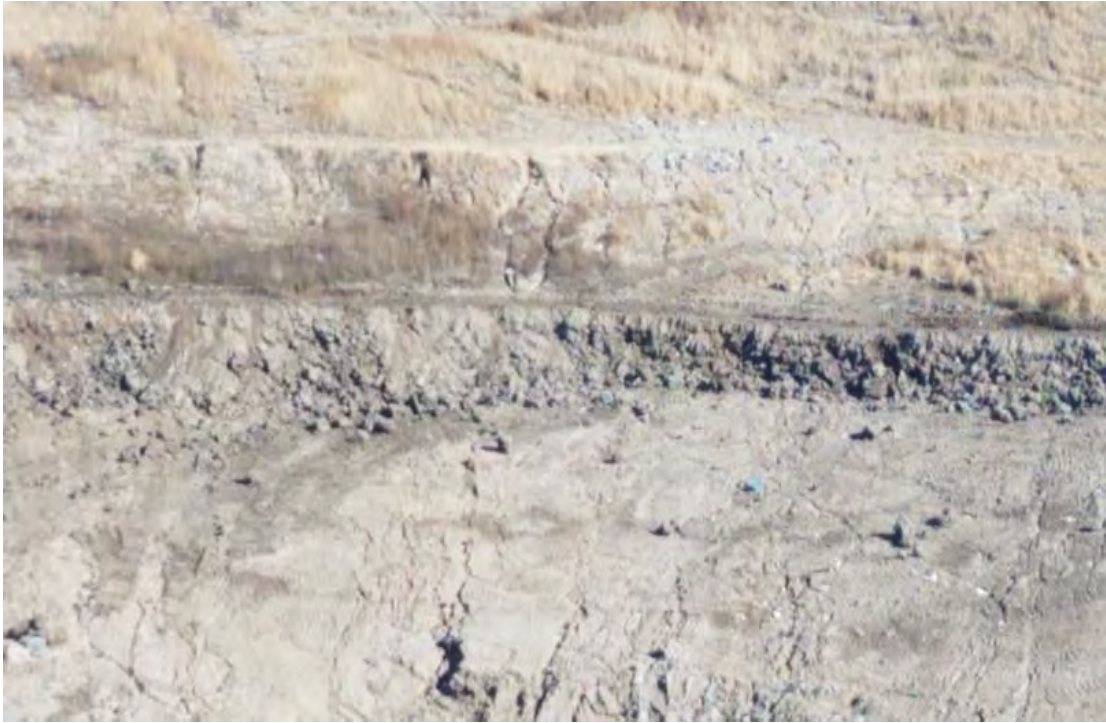
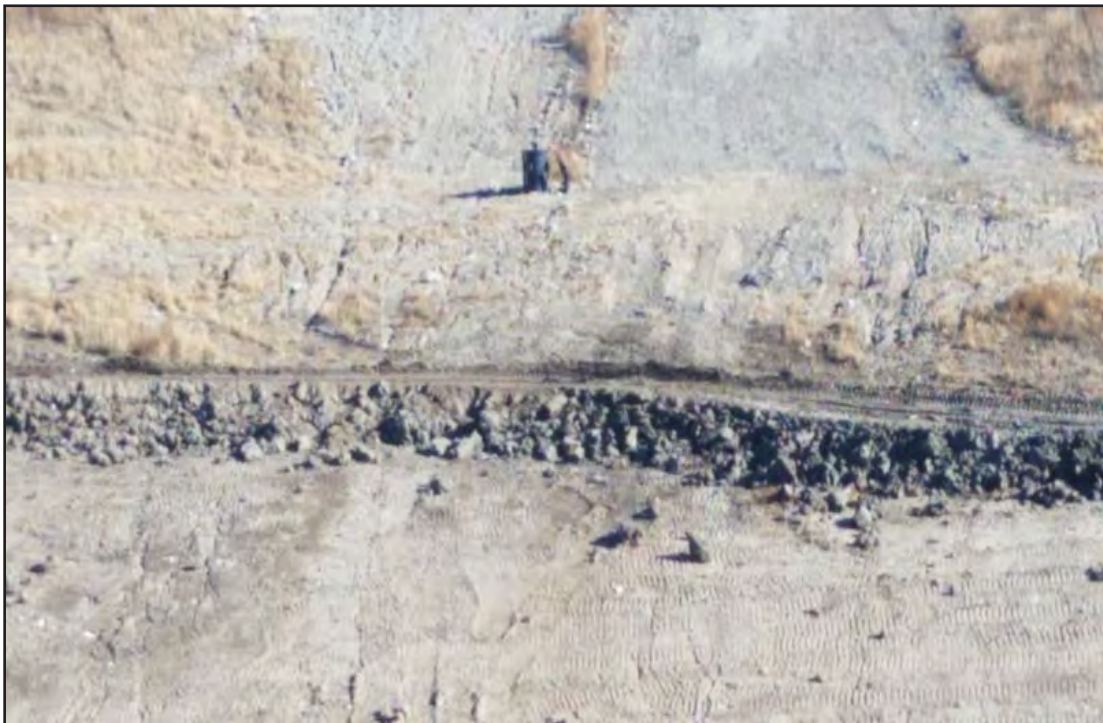
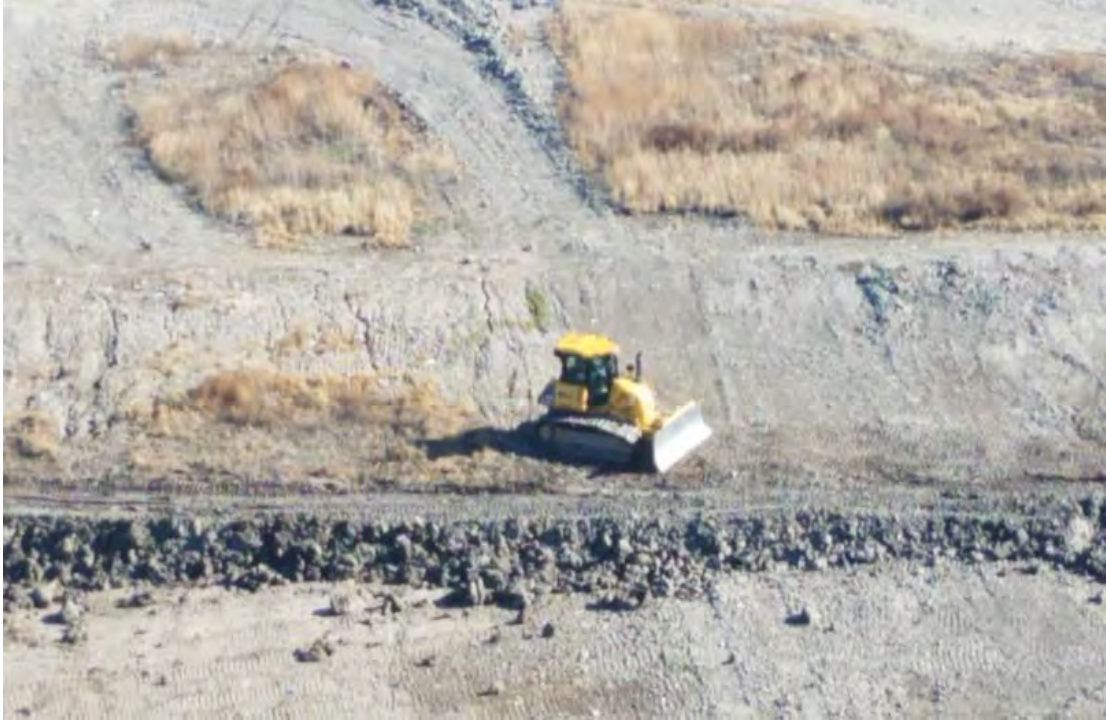
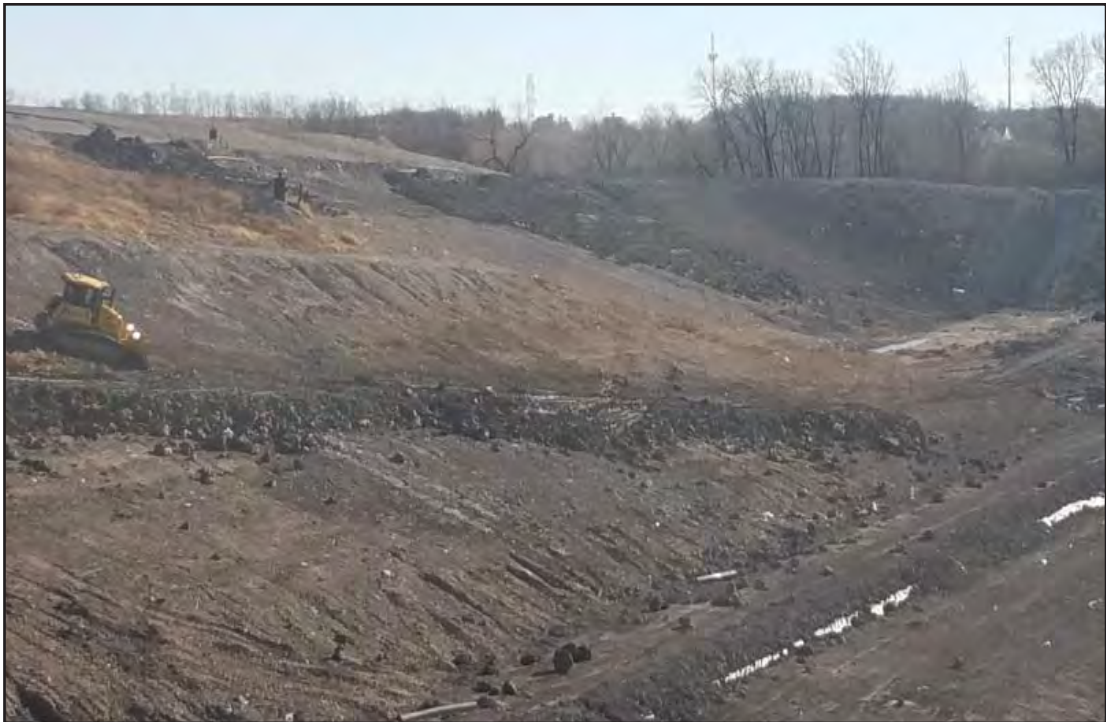
Berm development on West Slope of Phase 7

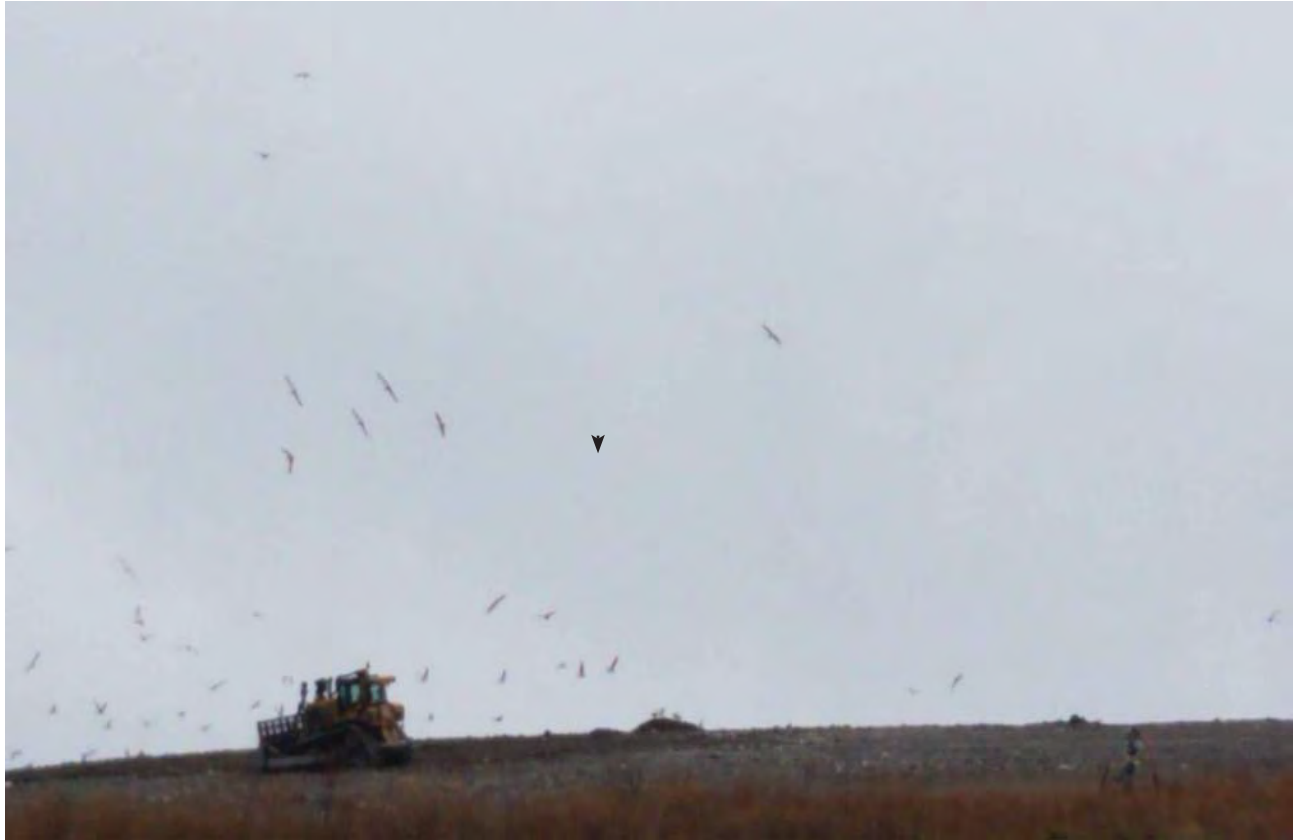
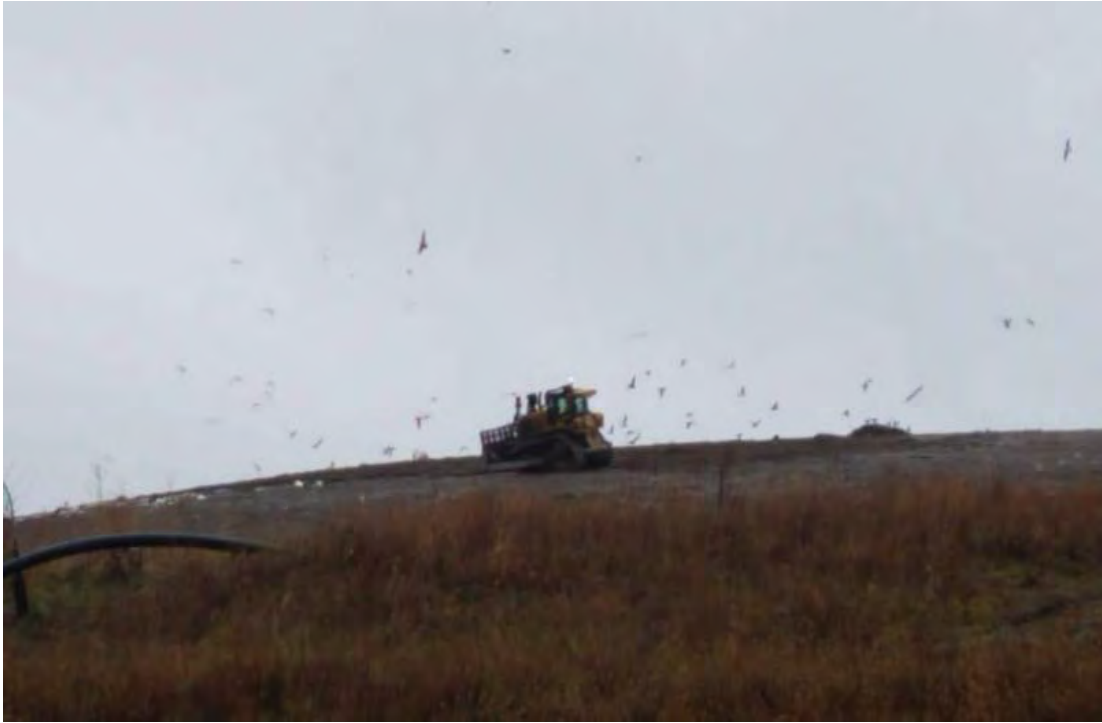
Dozer spreading cover on South top of slope of Phase 7 South

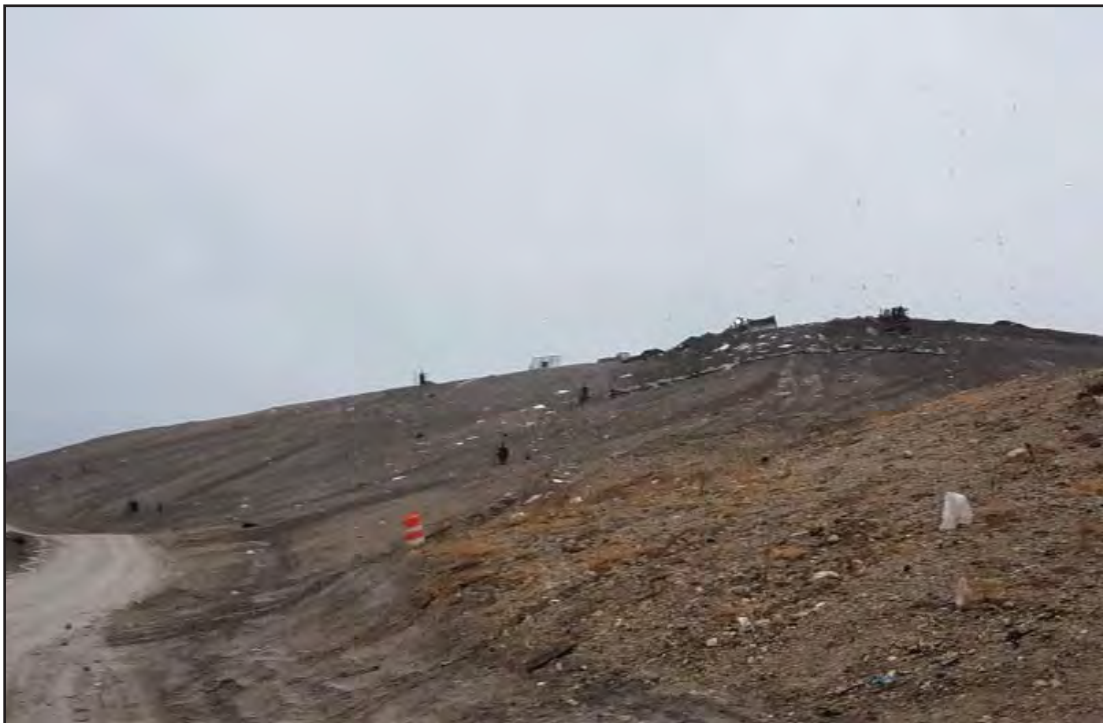
West slope of Phase 7, along access road, probable location of odors and placement of horizontal trench

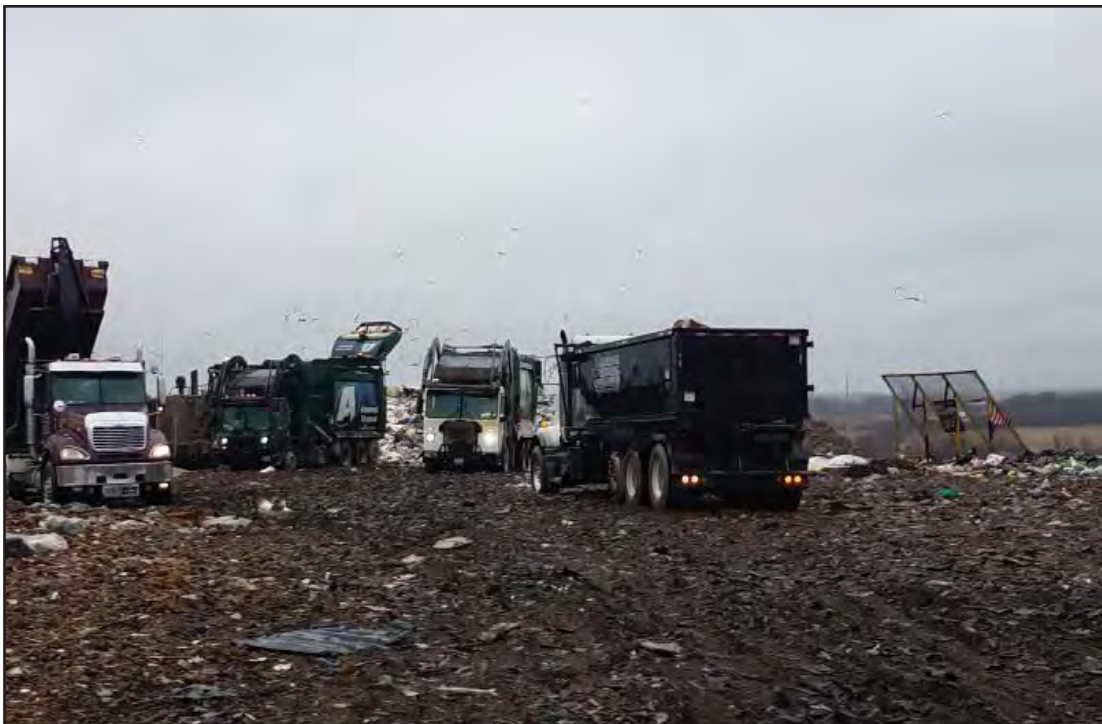
Tipping at Working face, two trucks active, one arriving and one departing

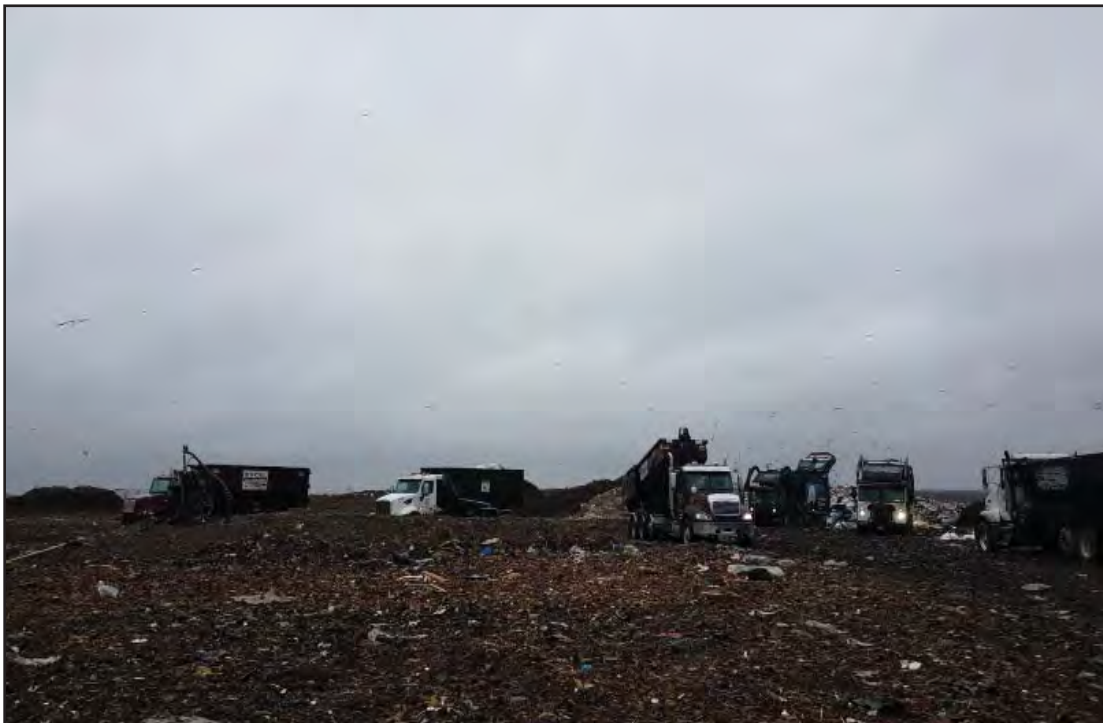
Working face very small and tucked up to create berm

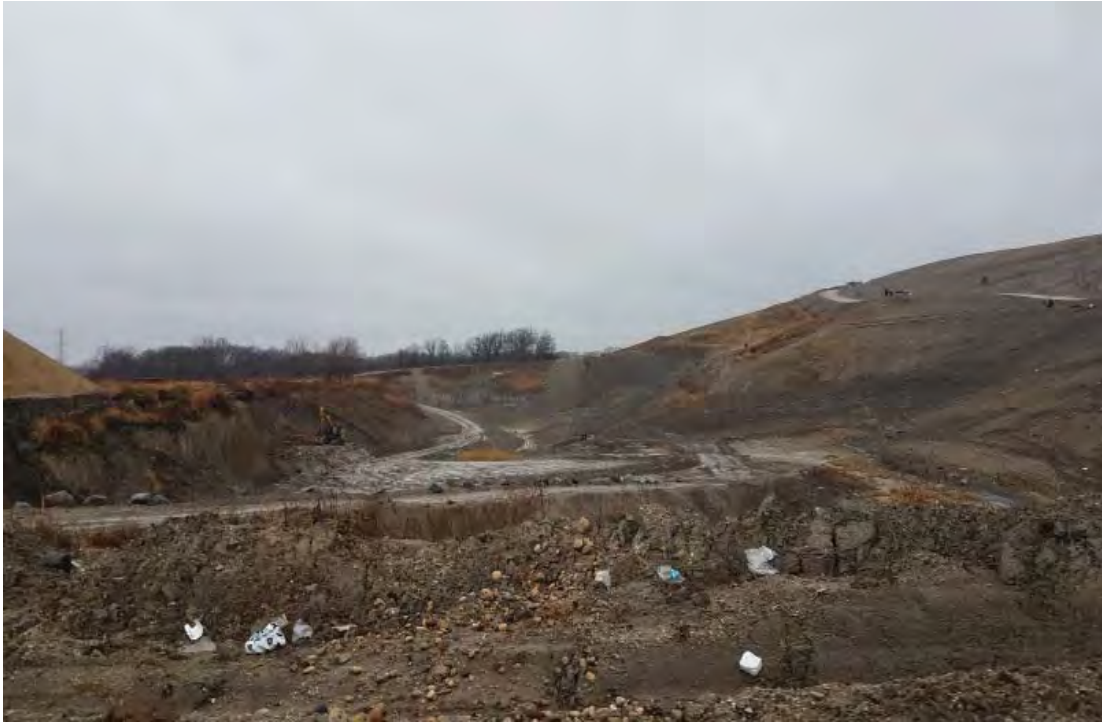
Temp sed basin viewed from access road to the South

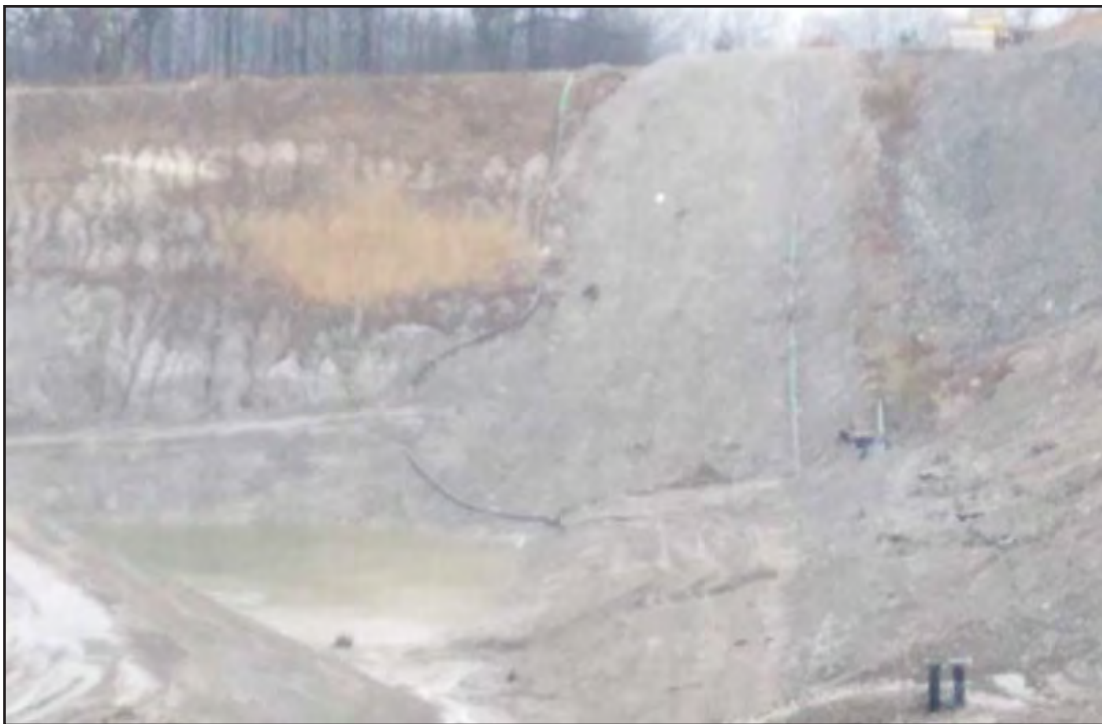
Temp sed basin and leachate header viewed from the South

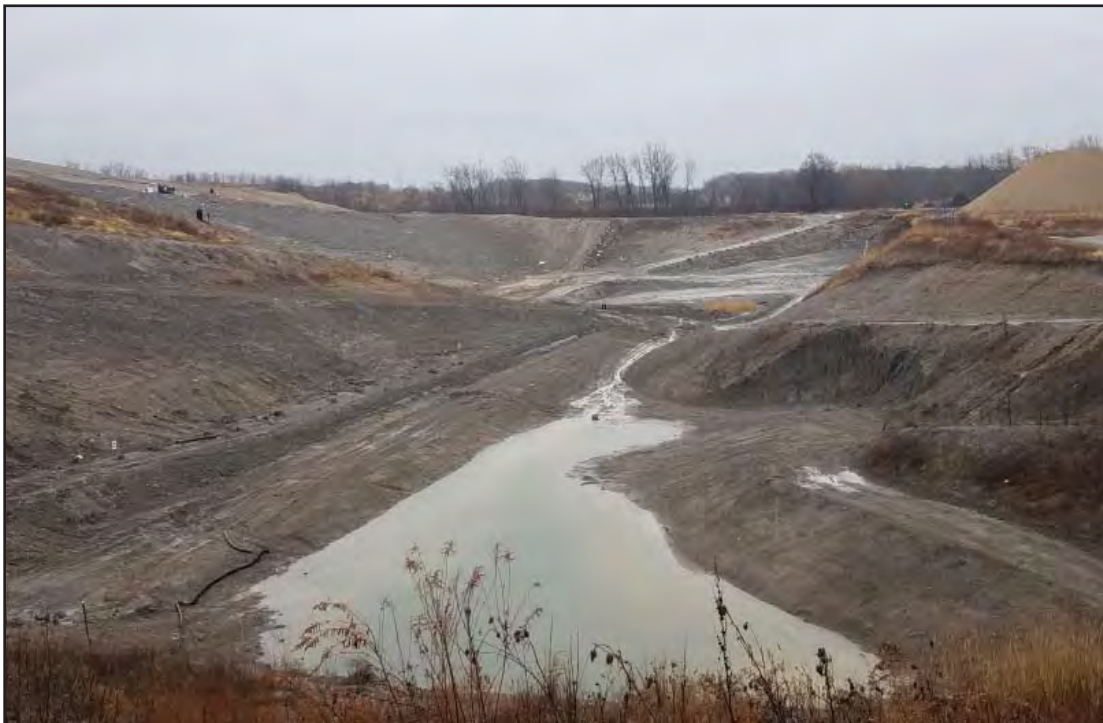
- Temp sed basin pump offline and pulled for repairs
 - Basins have freeboard
 - Erosion minimal
- E) Odor Control
- No odors onsite
 - Offsite odor wafting on 8 Mile Road at end of screening berm

Temp sed basin viewed from the South, currently not pumping

- L) Other Comments
- Pump repair mandatory for temp sed basin
 - Hydrogen Sulfide filter media swap expected to be conducted next week and be complete by end of the year.

* Pump repair mandatory for temp s&d basin

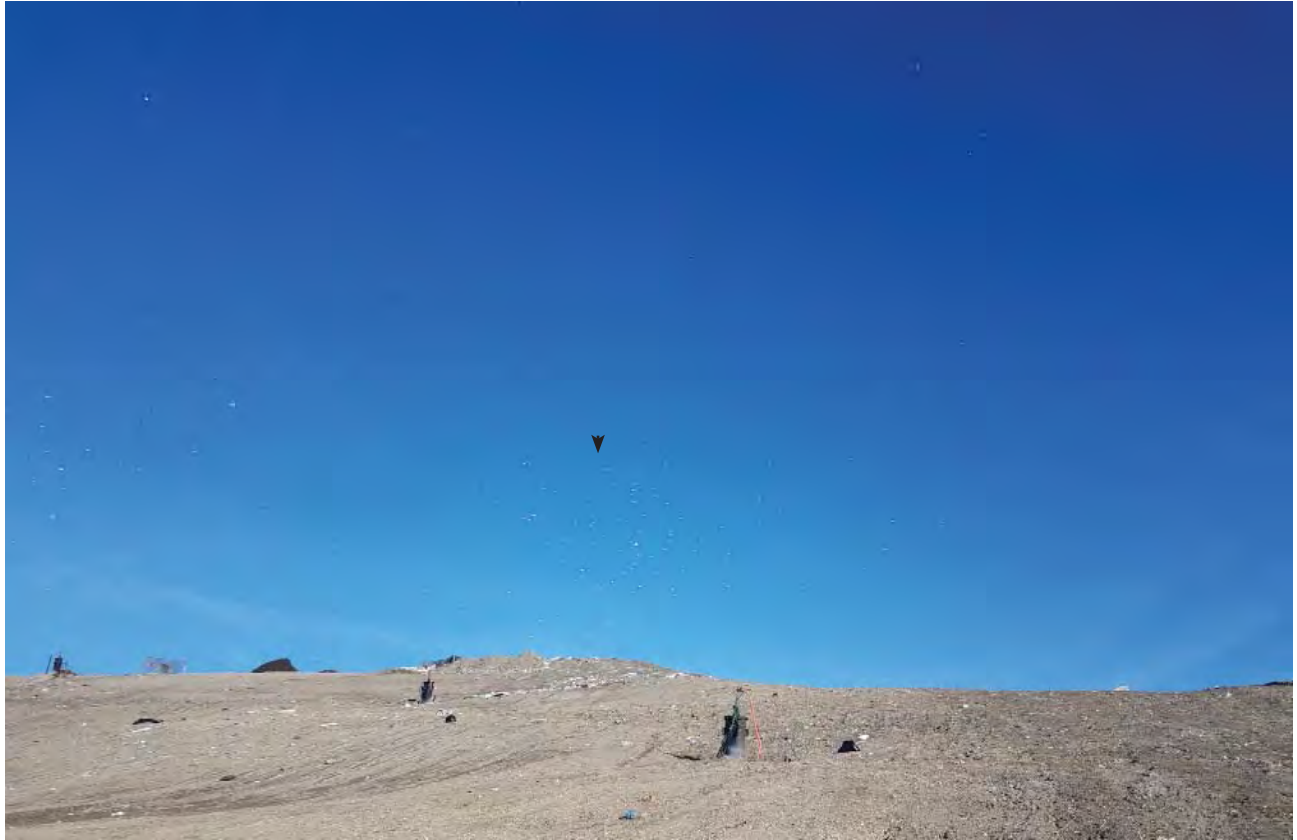
Previous area of flagging and litter on Southwest corner of Phase 7 South

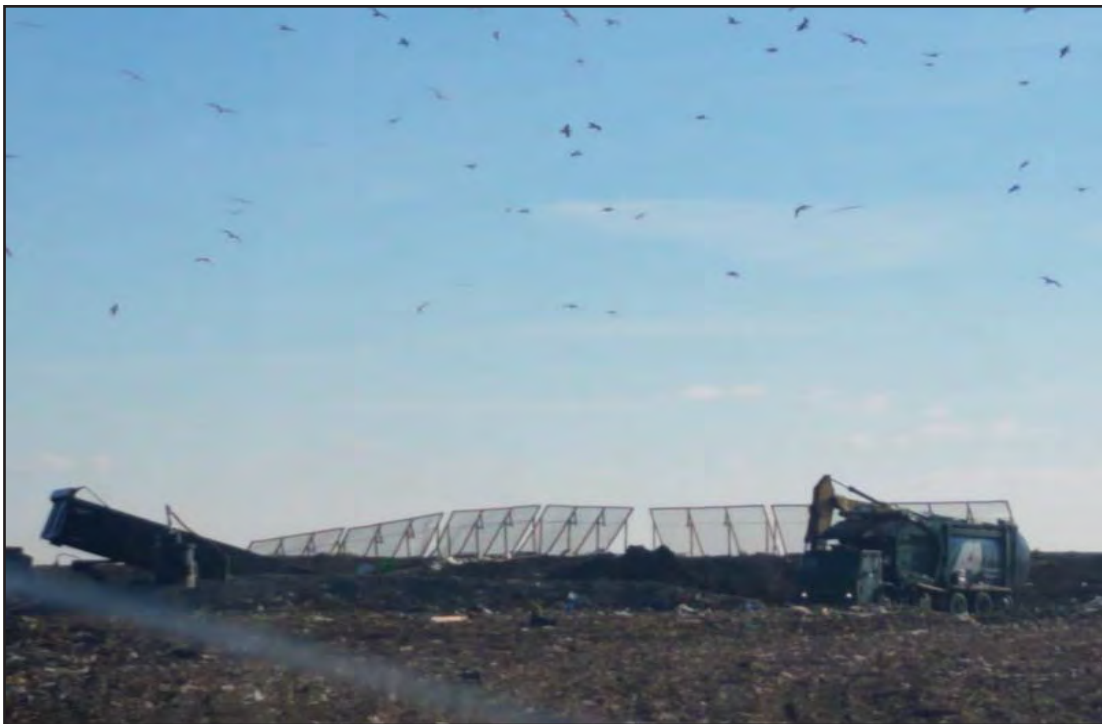
Mobile fences relocated to catch litter and prevent travel off the active area
