2020 Year End Summary of Audits of the Emerald Park Landfill

Prepared For:
City of Muskego
Green For Life Emerald Park Landfill Standing Committee

2020 Green For Life Emerald Park Landfill Year End Compliance Officer Report and Audit Summary

TO: Advanced Disposal Services Emerald Park Standing Committee
FROM: Jo-Walter Spear, Jr., P.E.
COPIES: File
DATE: 03/29/2021
PROJECT NUMBER: 1012.10030

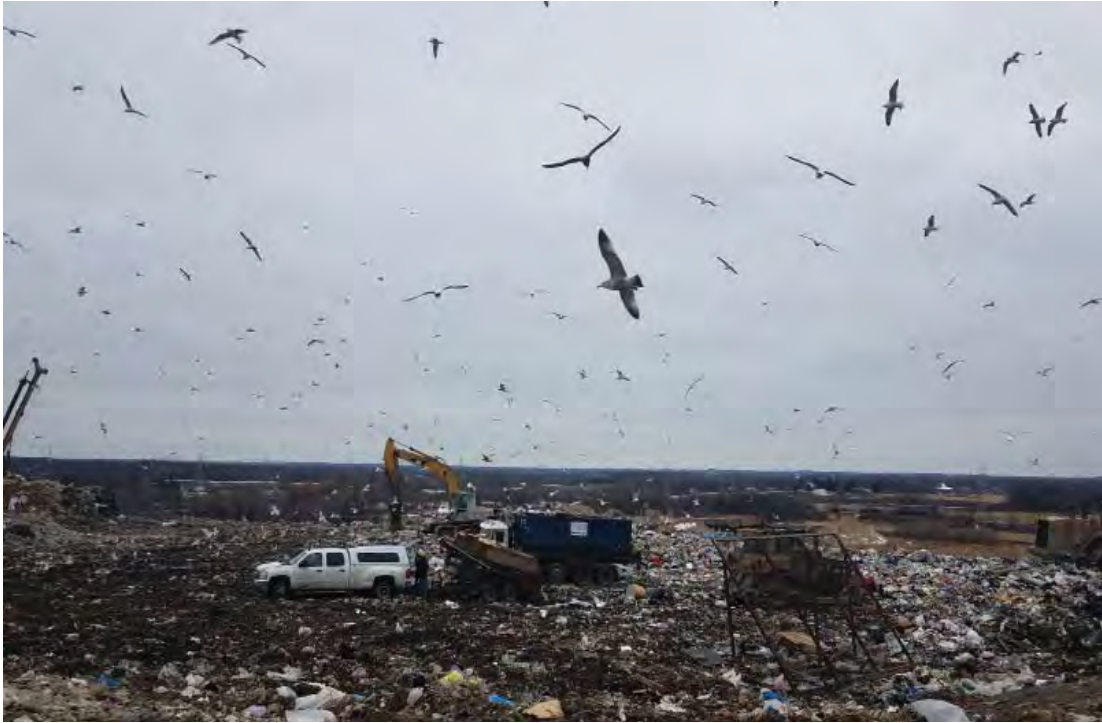
Working face in Northwest corner of Phase 7 South

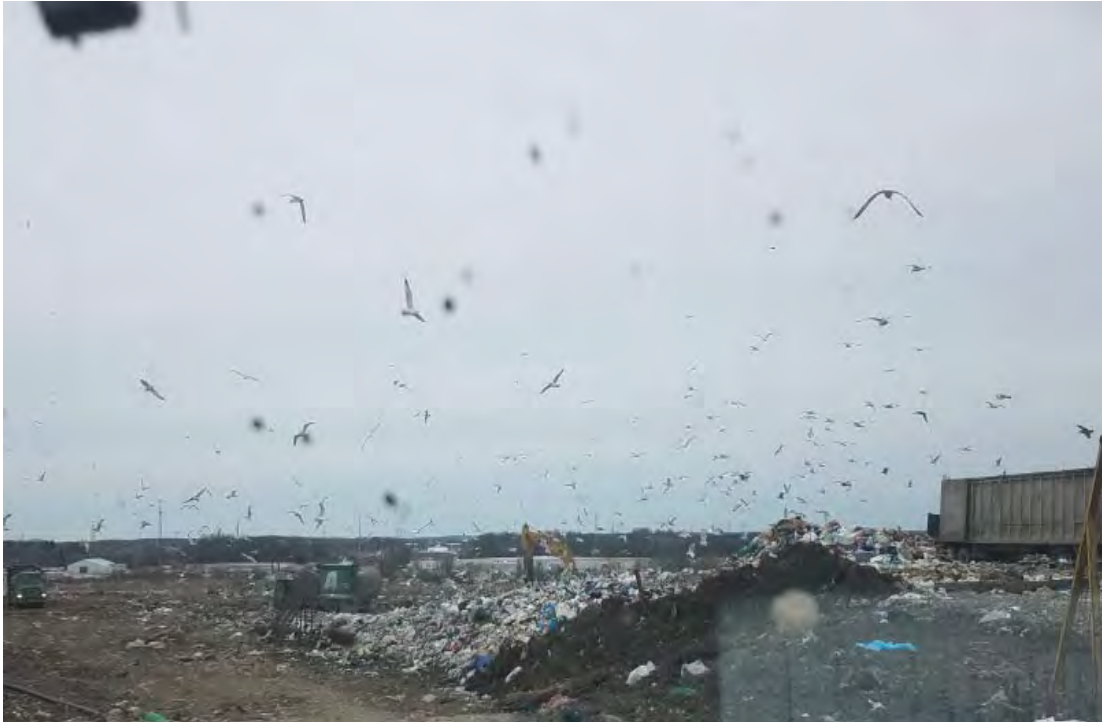
Active tipping in Phase 7 South, roughly the middle

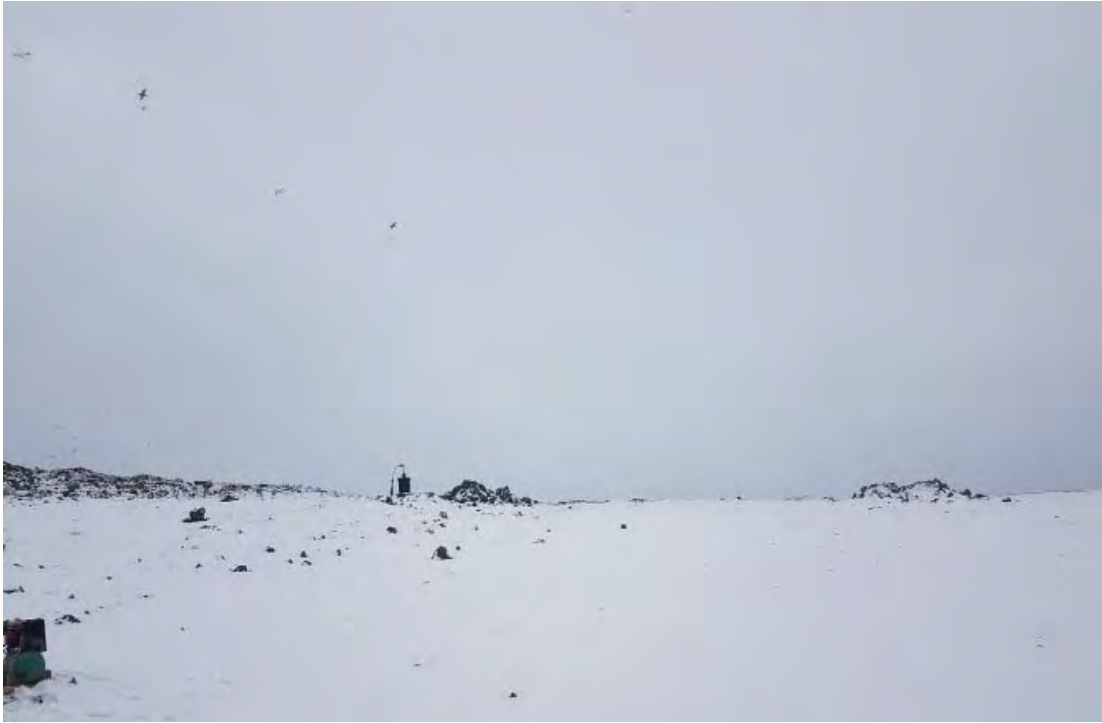
West slope of Phase 7 South

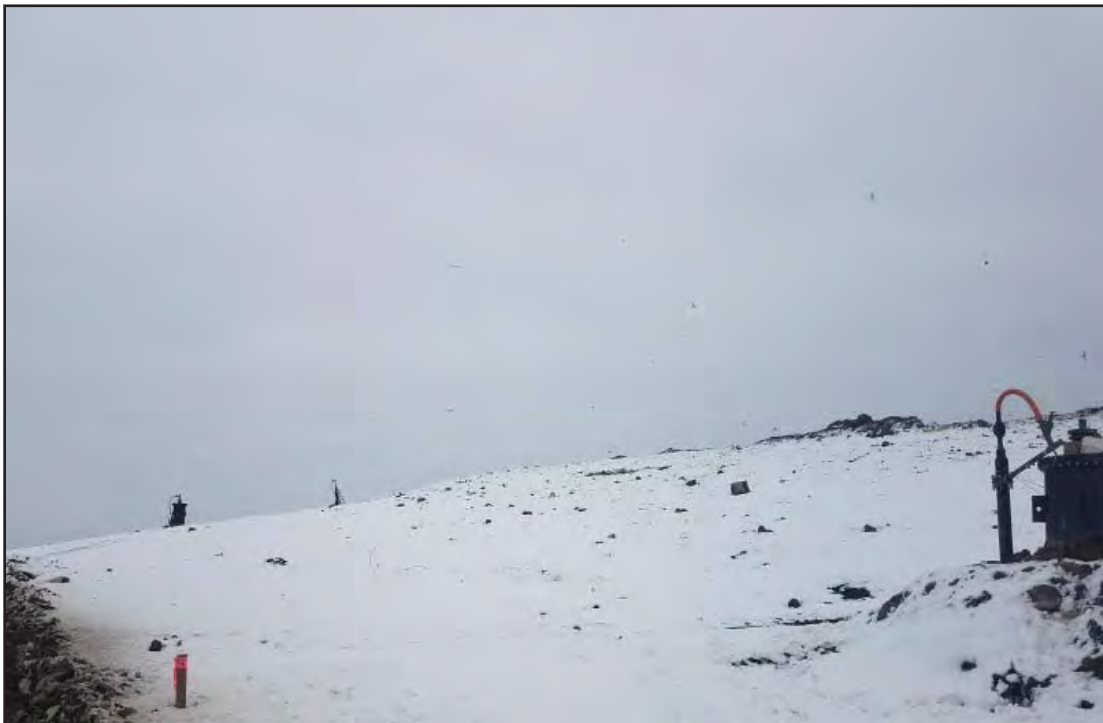
West slope of Phase 7 South, odor area

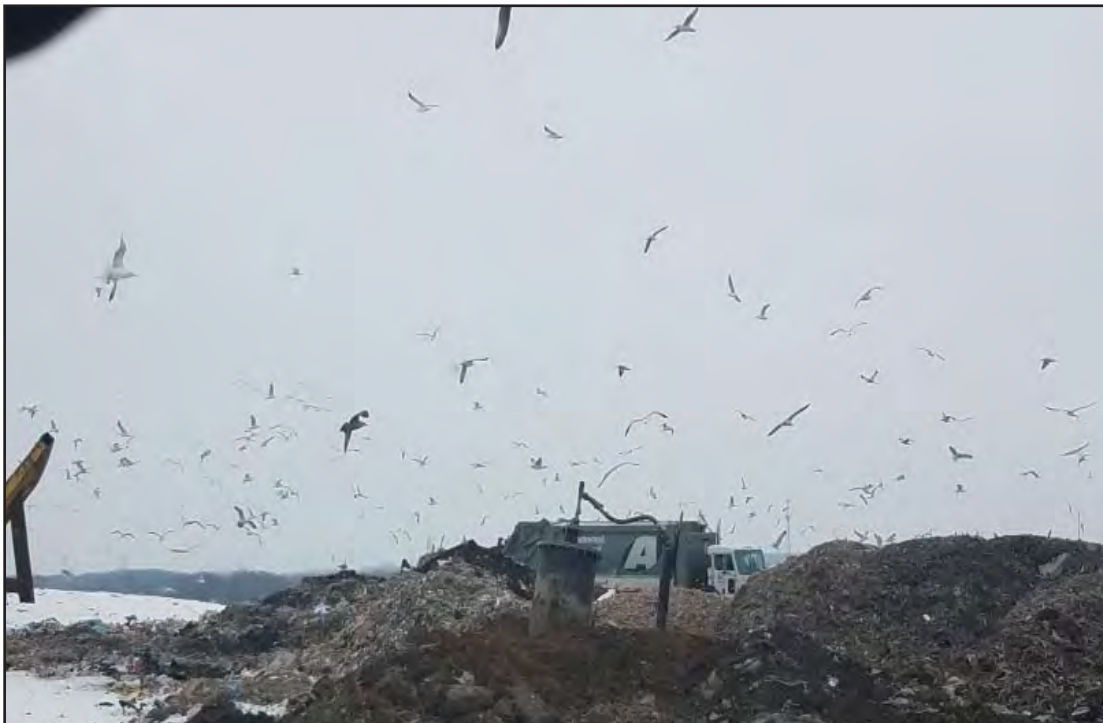
Additional alternative daily cover stockpiles

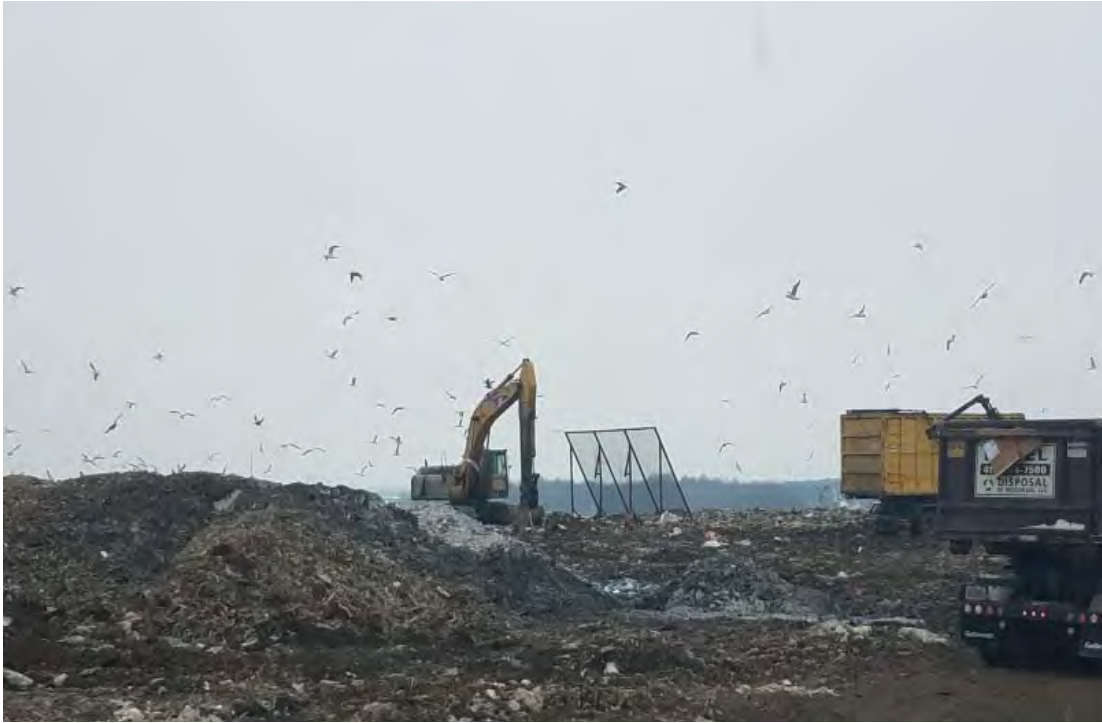
ADC stockpiled for use

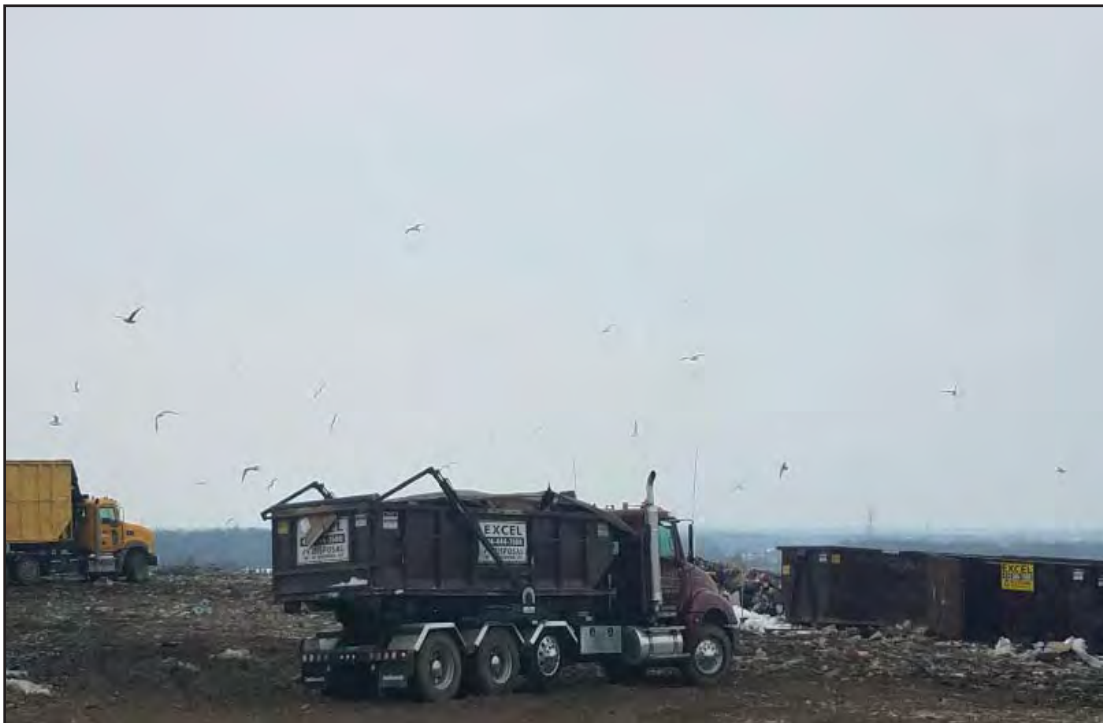
Roll offs and truck with frozen loads

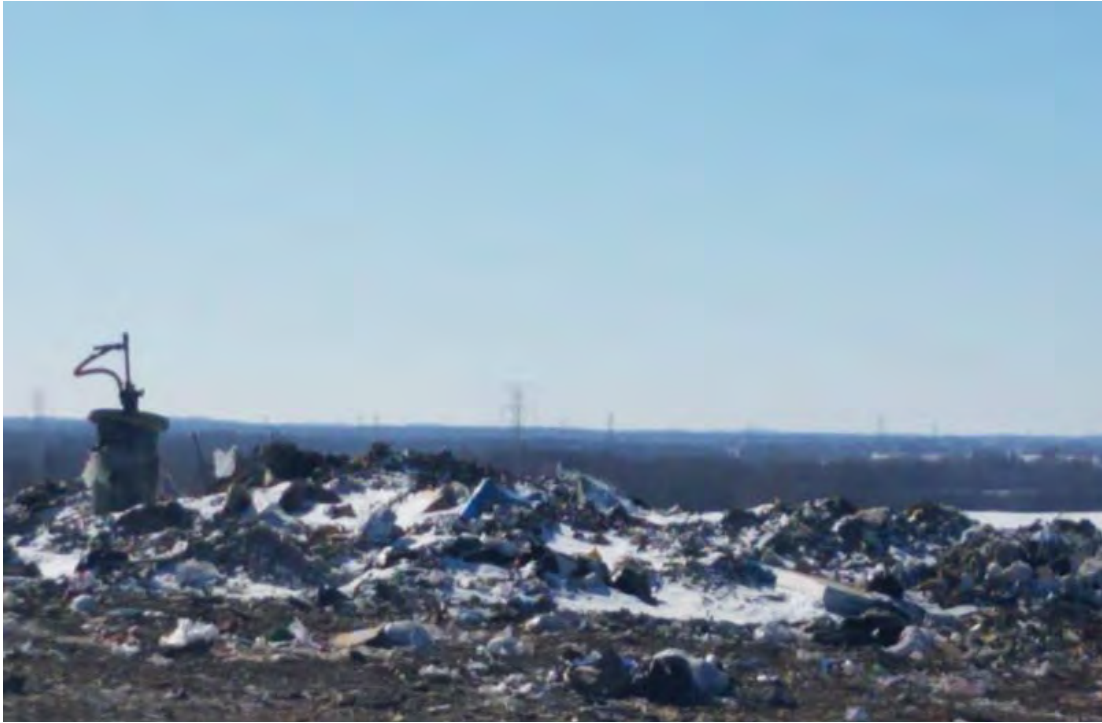
Previous covered waste and raised well

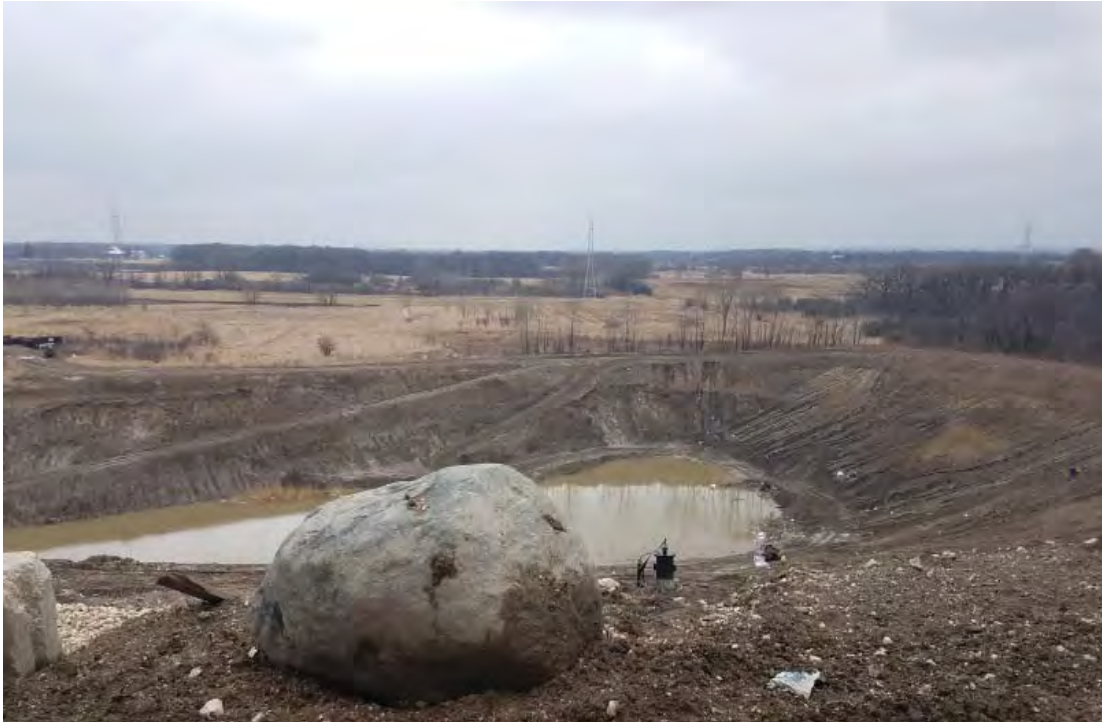
Temp sed basin thawed and surrounding slopes/soils

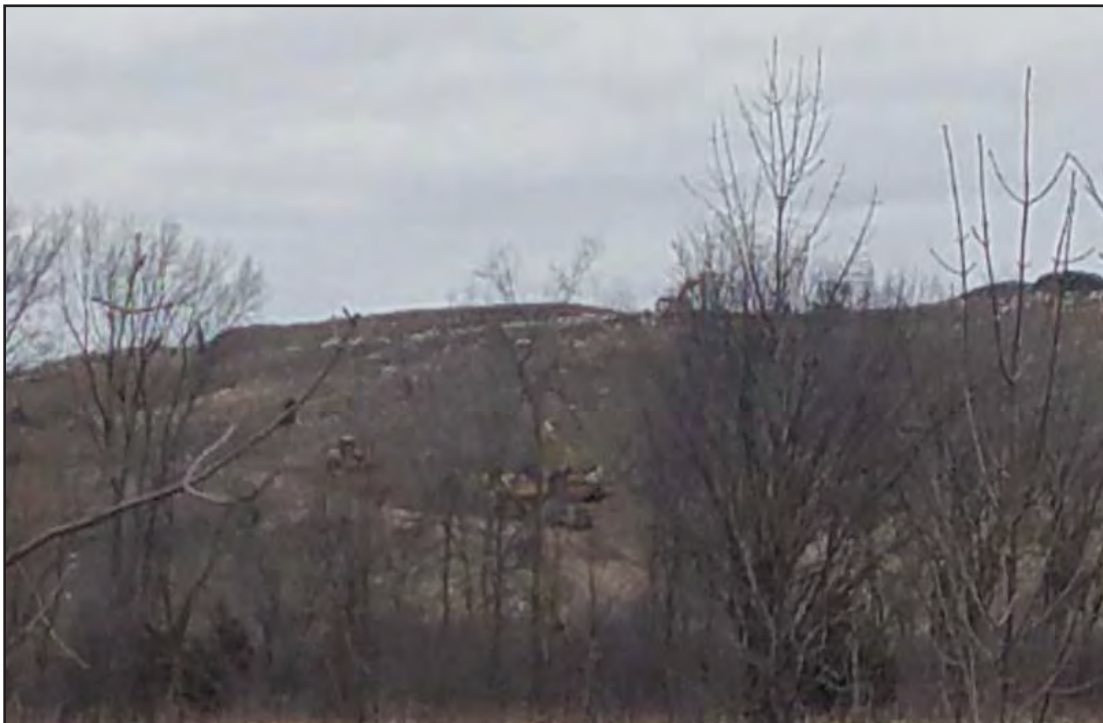
Trenching for line installation on West and South slope of Phase 7

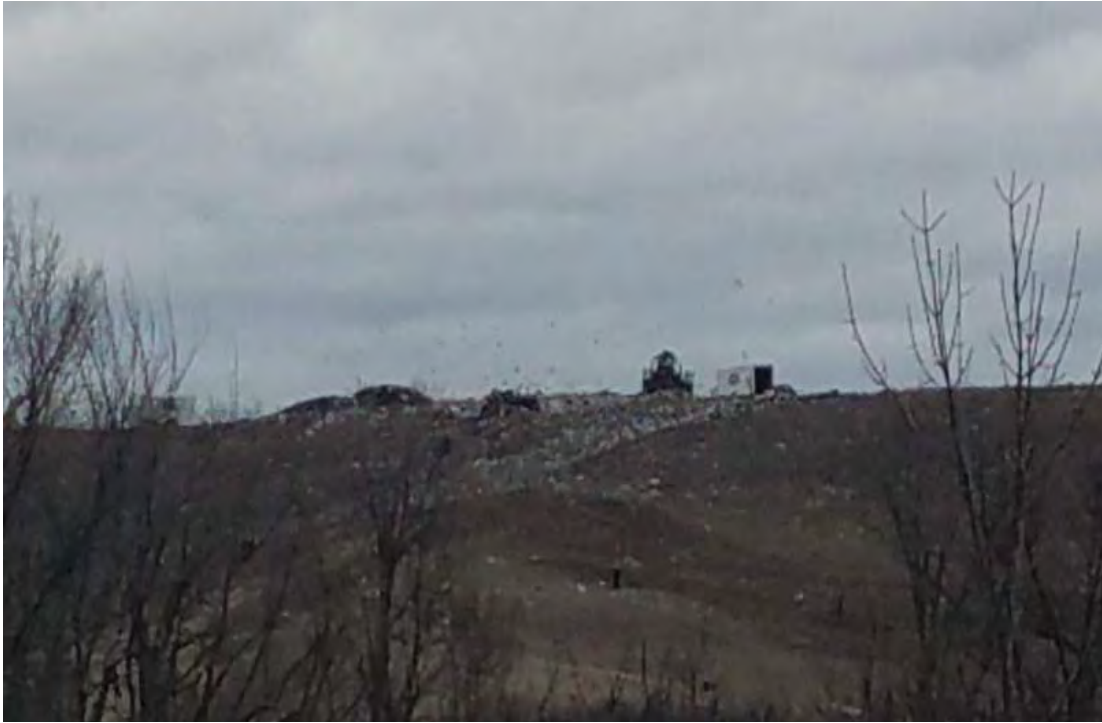
Working face in Phase 7 South viewed from Union Church Road

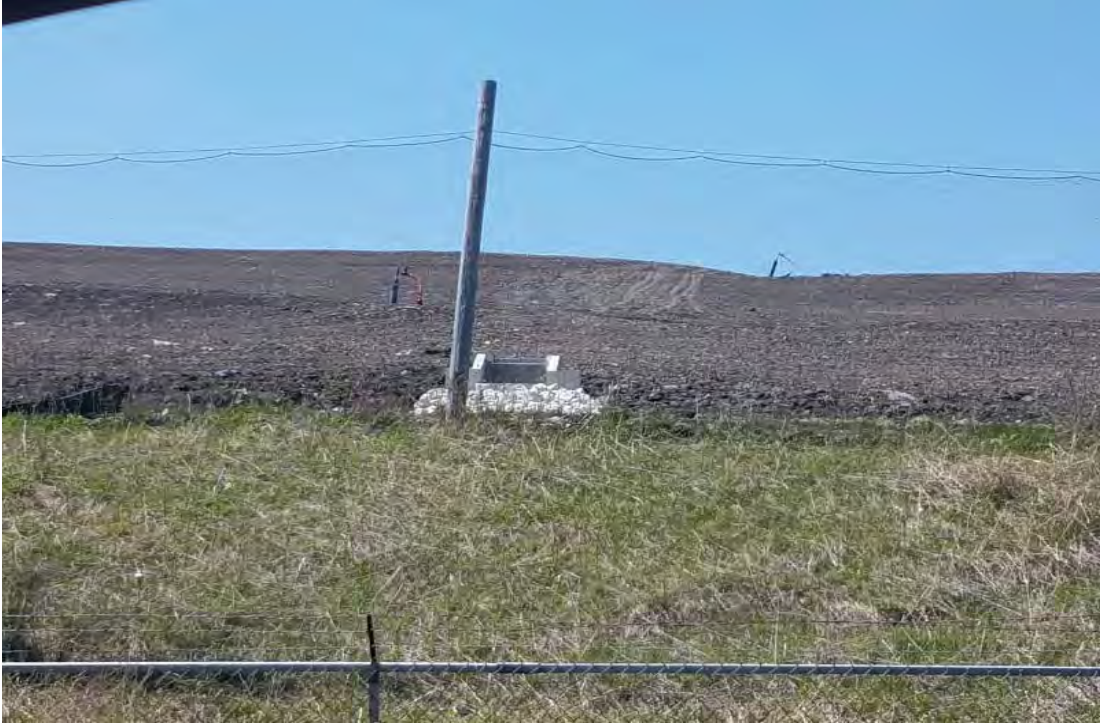
New energy diverter installed in Clearwater Pond Expansion Cap

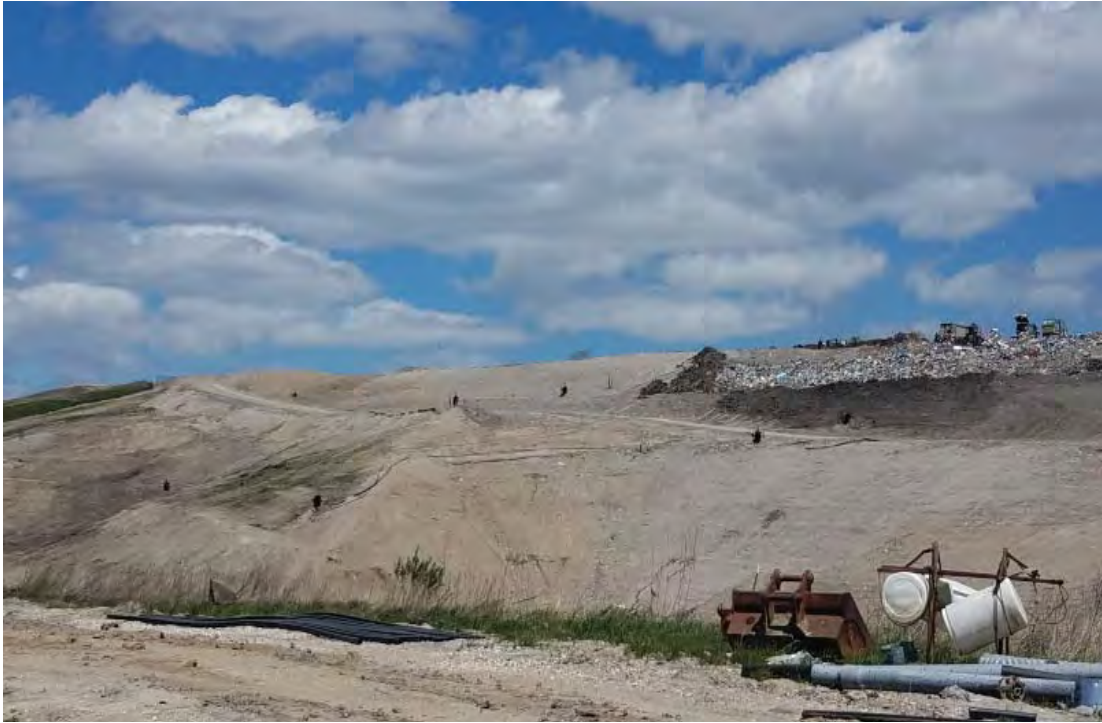
Phase 7 North, West slope

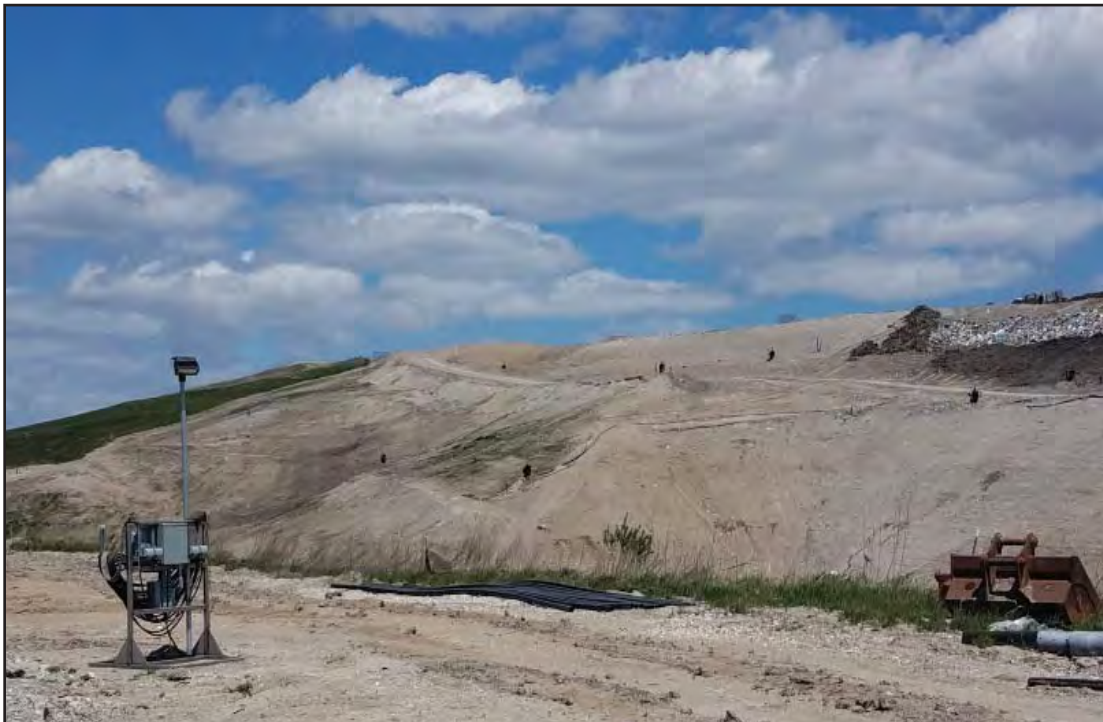
Phase 7 North & South, West slopes overview

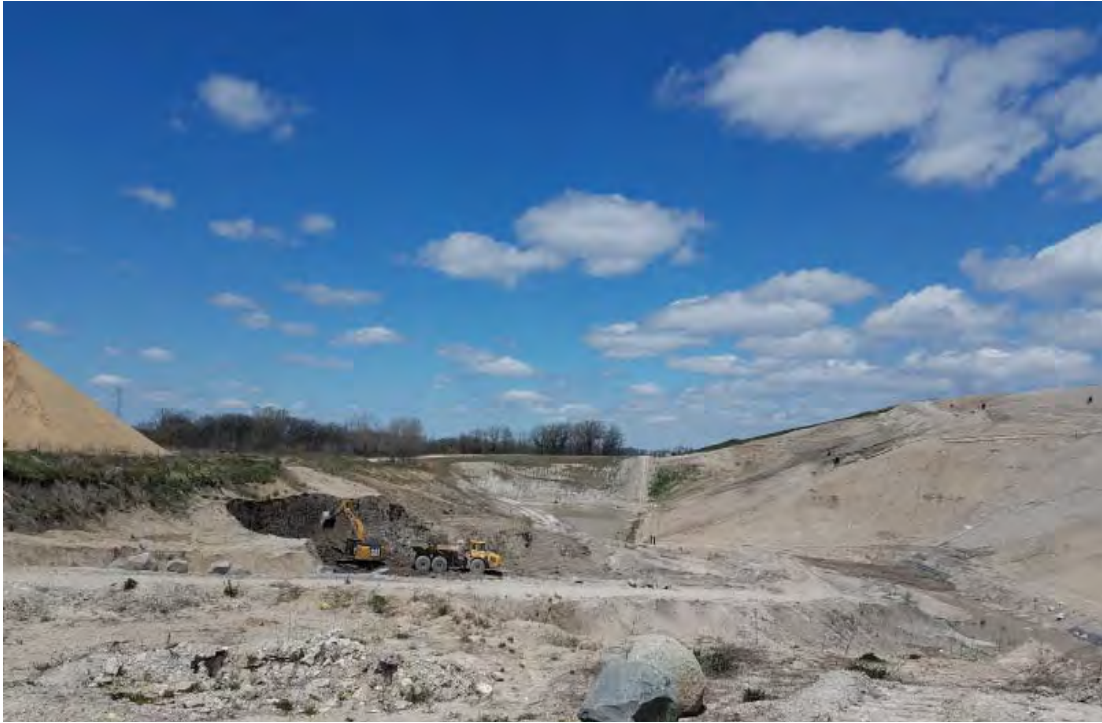
West edge of landfill footprint viewed from the South

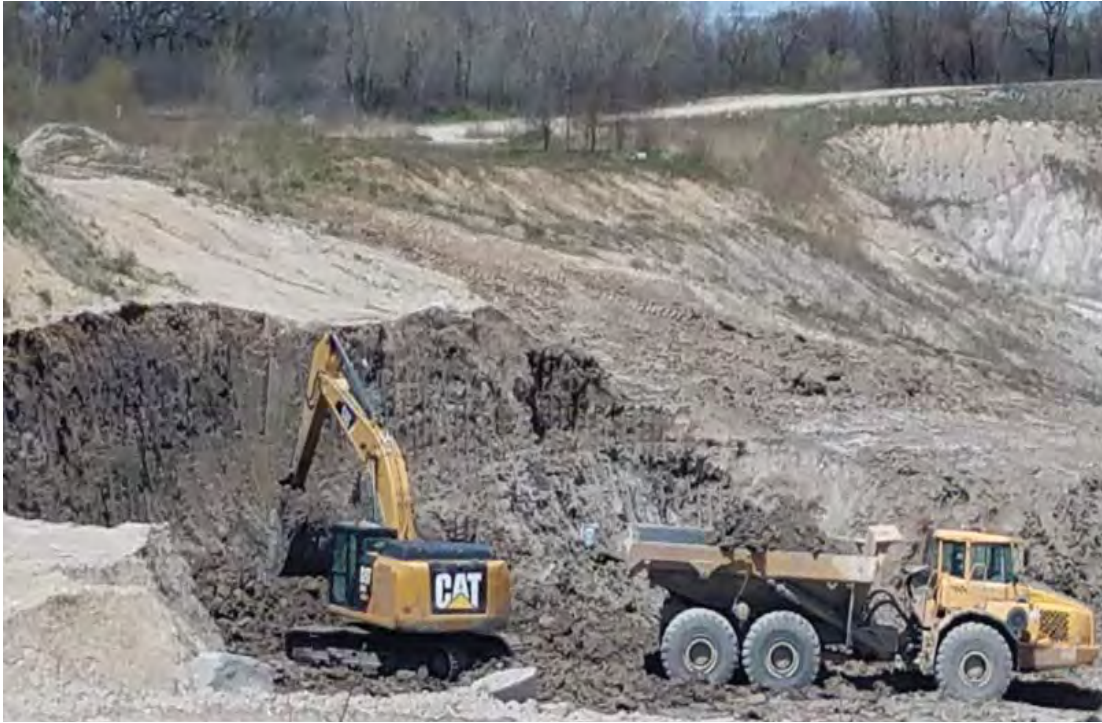
Continued excavation of future Phase 8, material being used for cover on slope

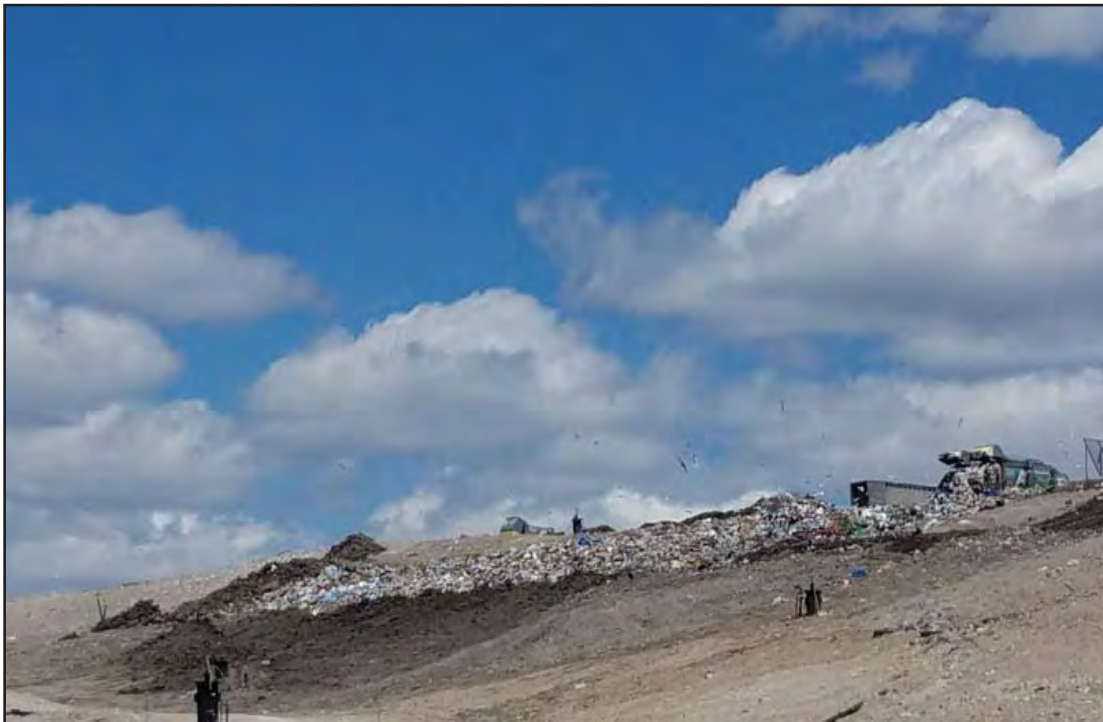
Working face at top of West slope of Phase 7 South

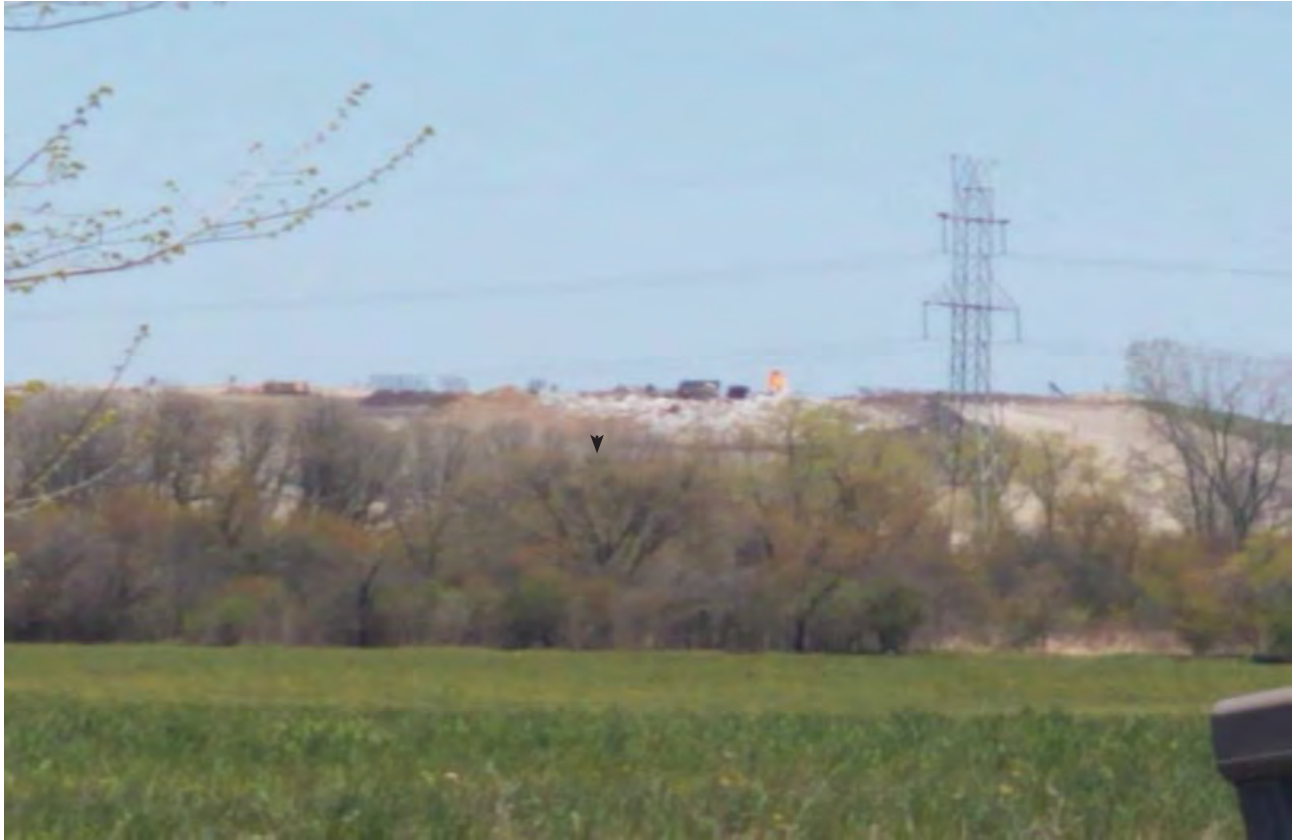
Site viewed from Union Church Road

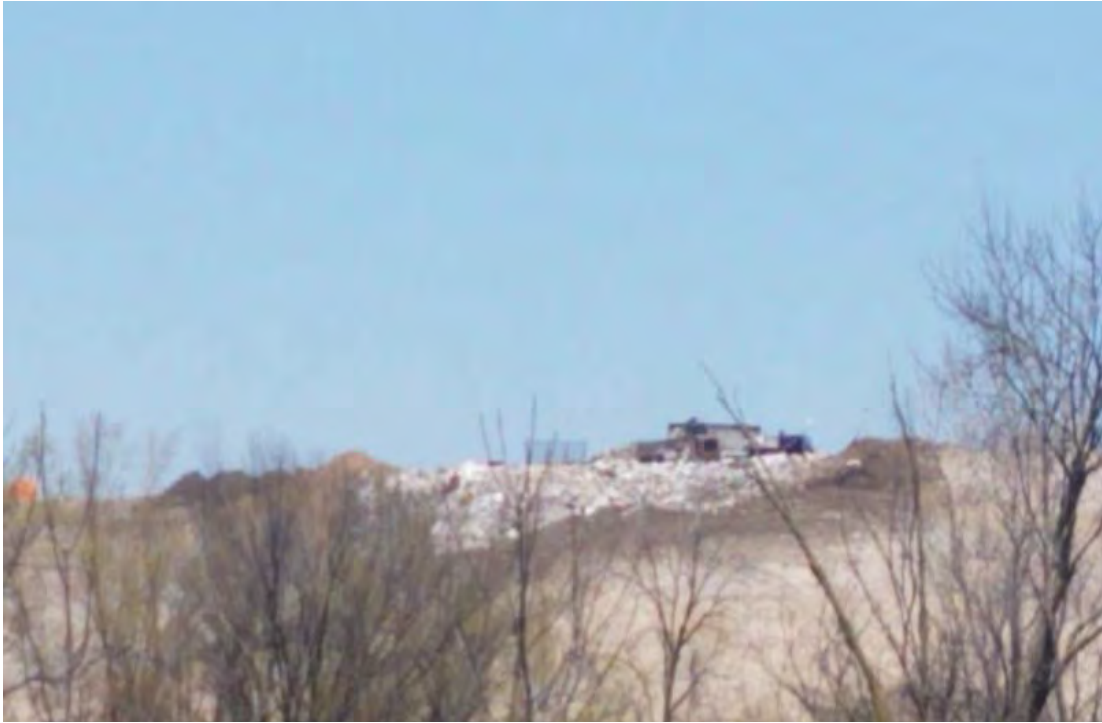
Site viewed from Union Church Road

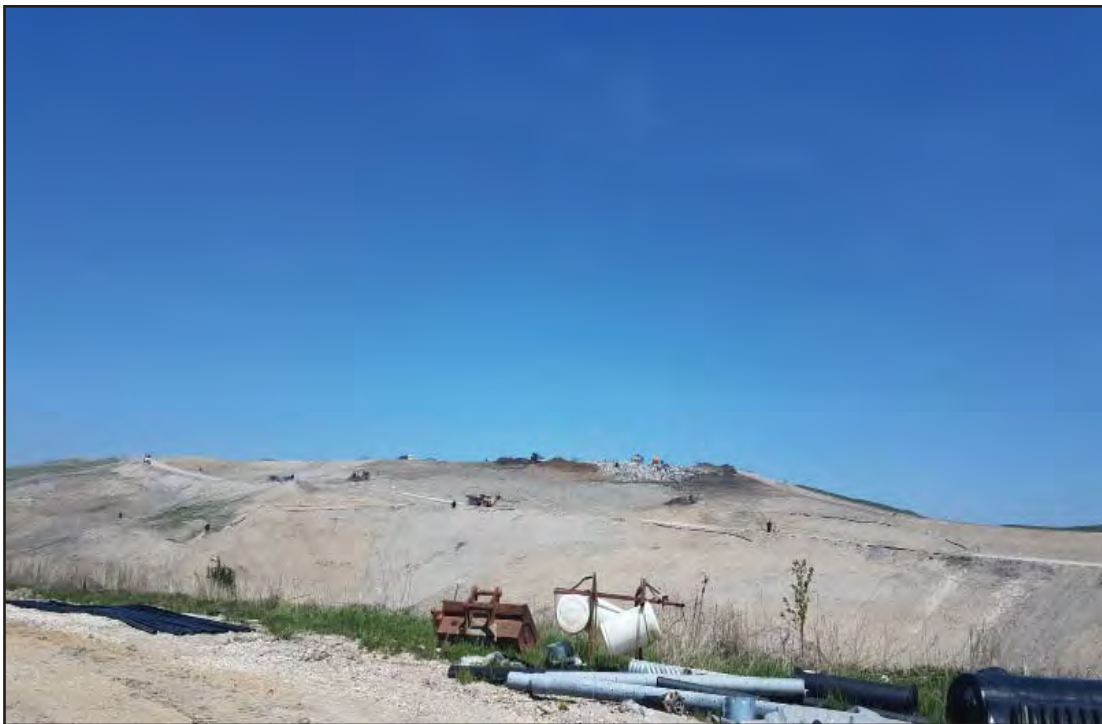
West slope of footprint

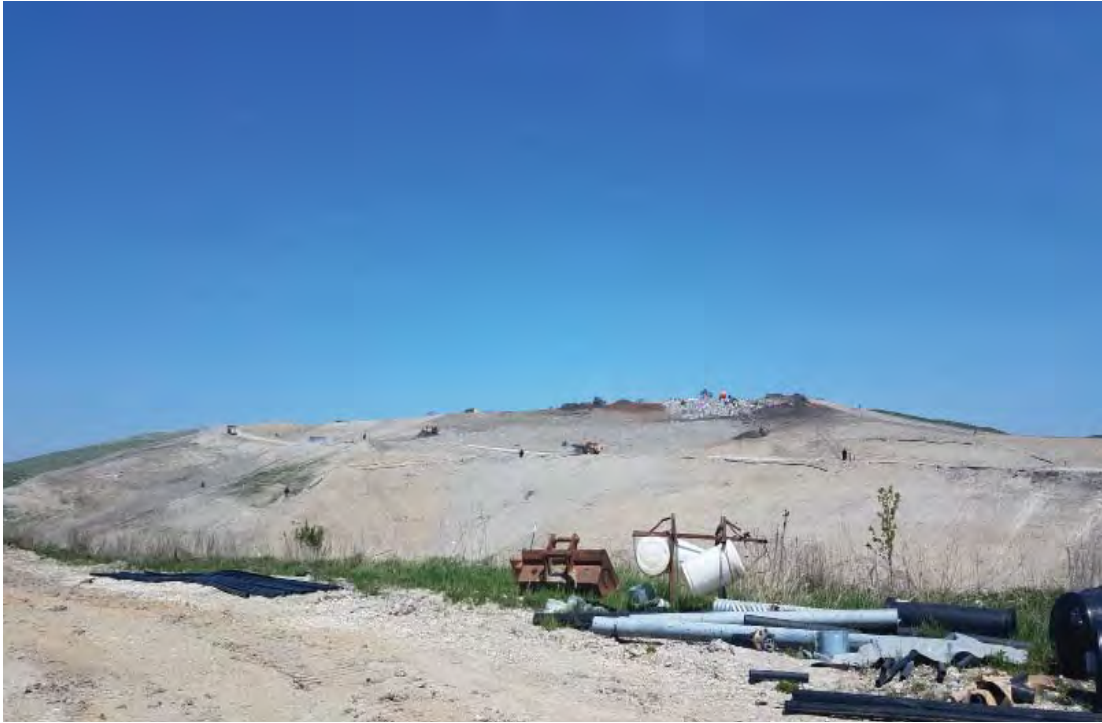
Landfill viewed from the West

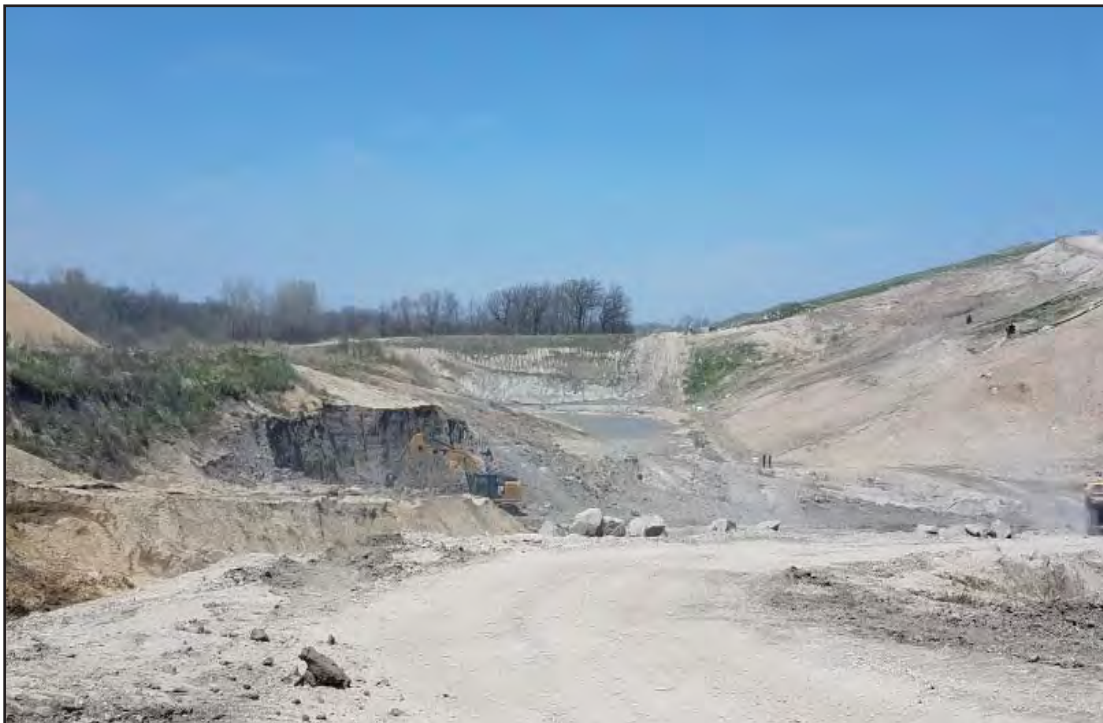
Future Phase 8 and temp sed pond

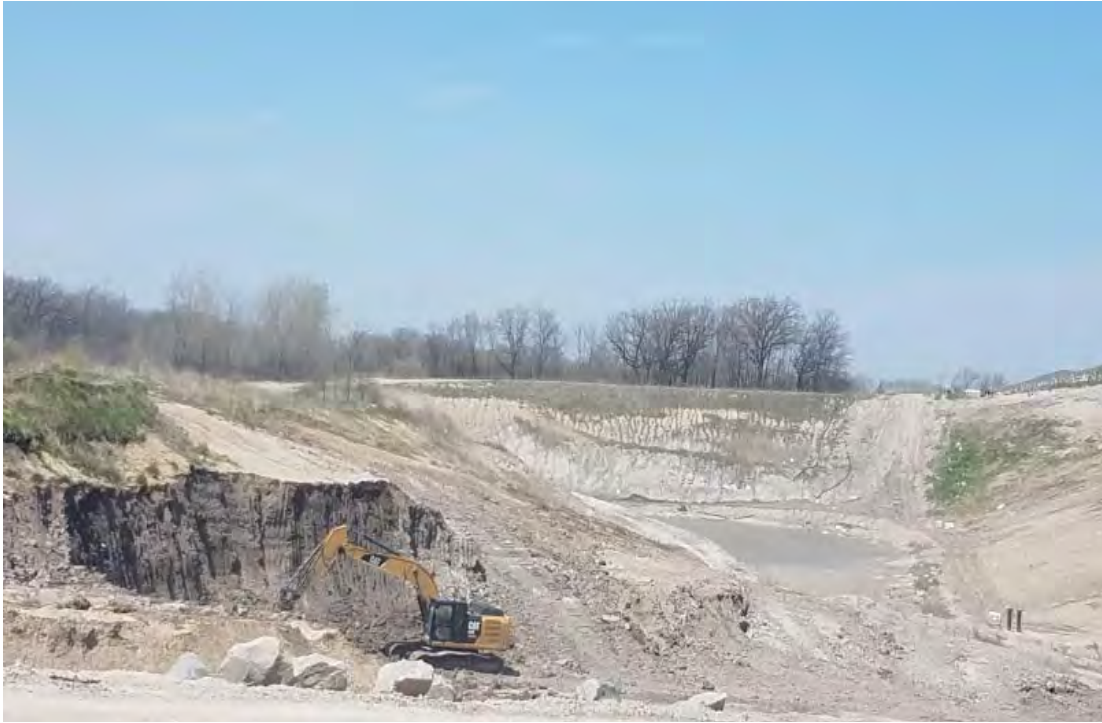
Phase 7 North, West slope

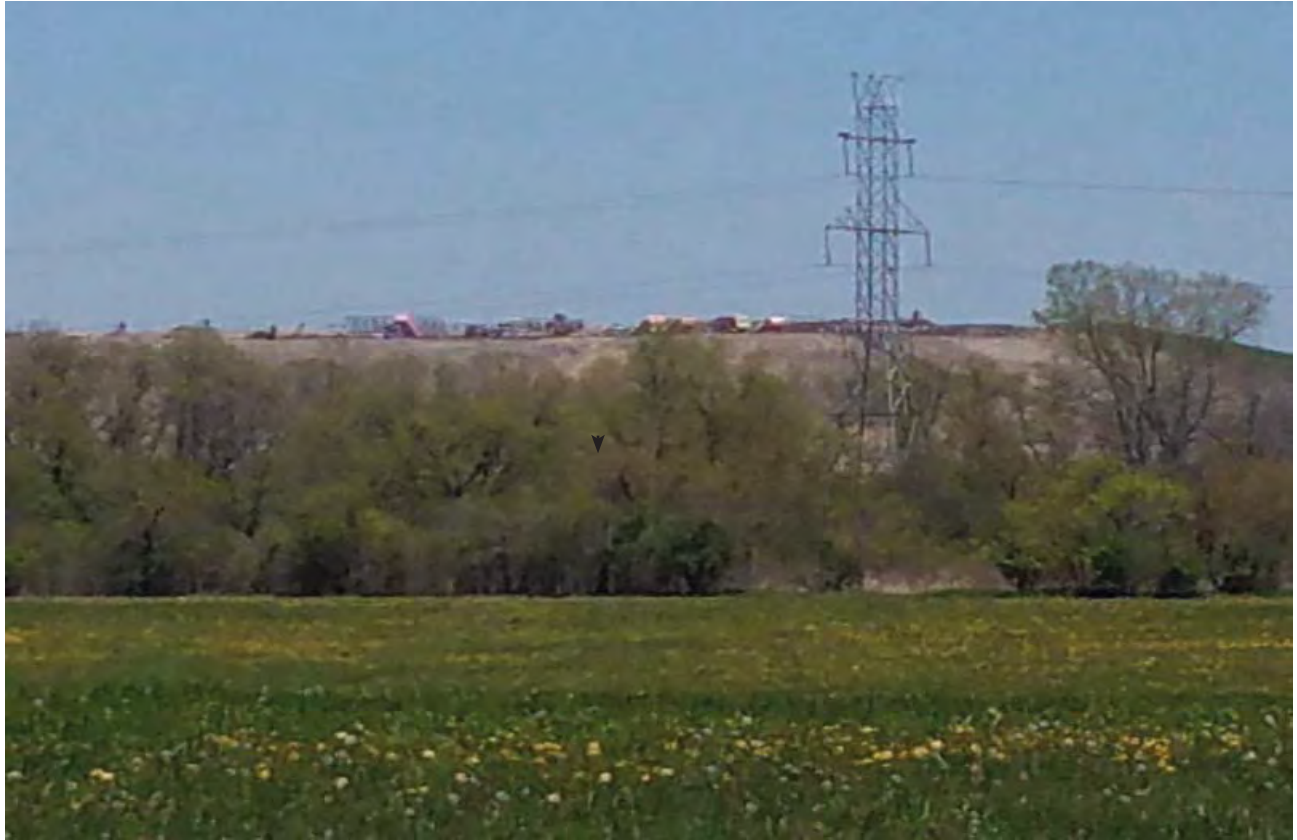
Site viewed from Union Church Road, trucks very active

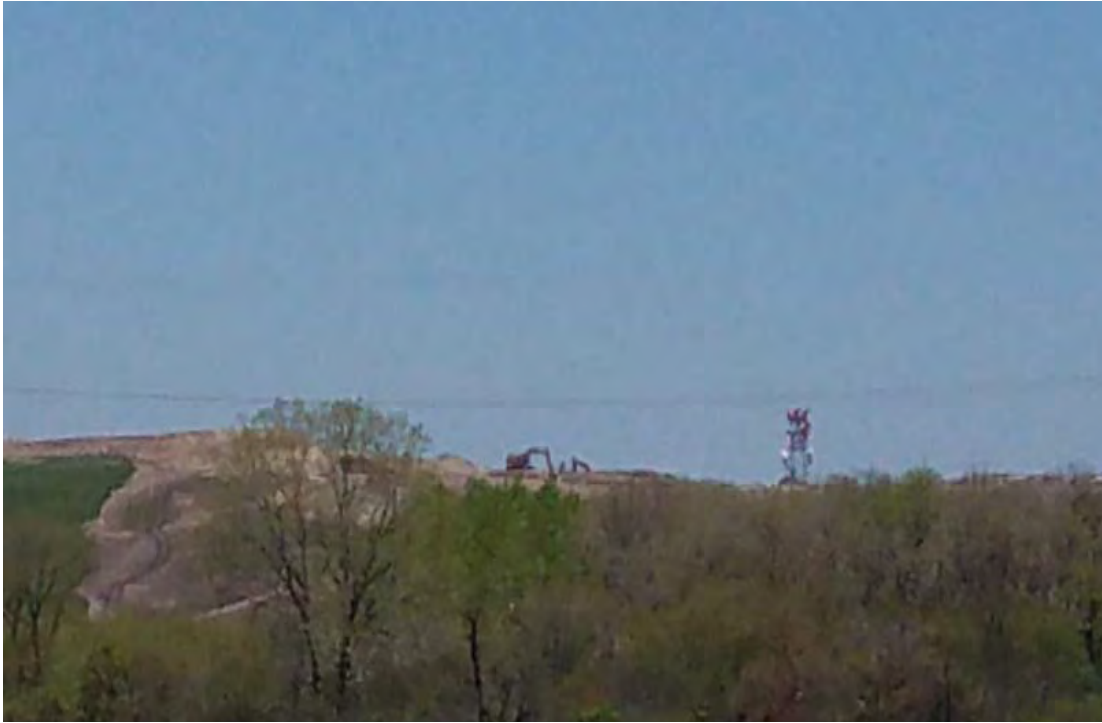
Site viewed from Union Church Road

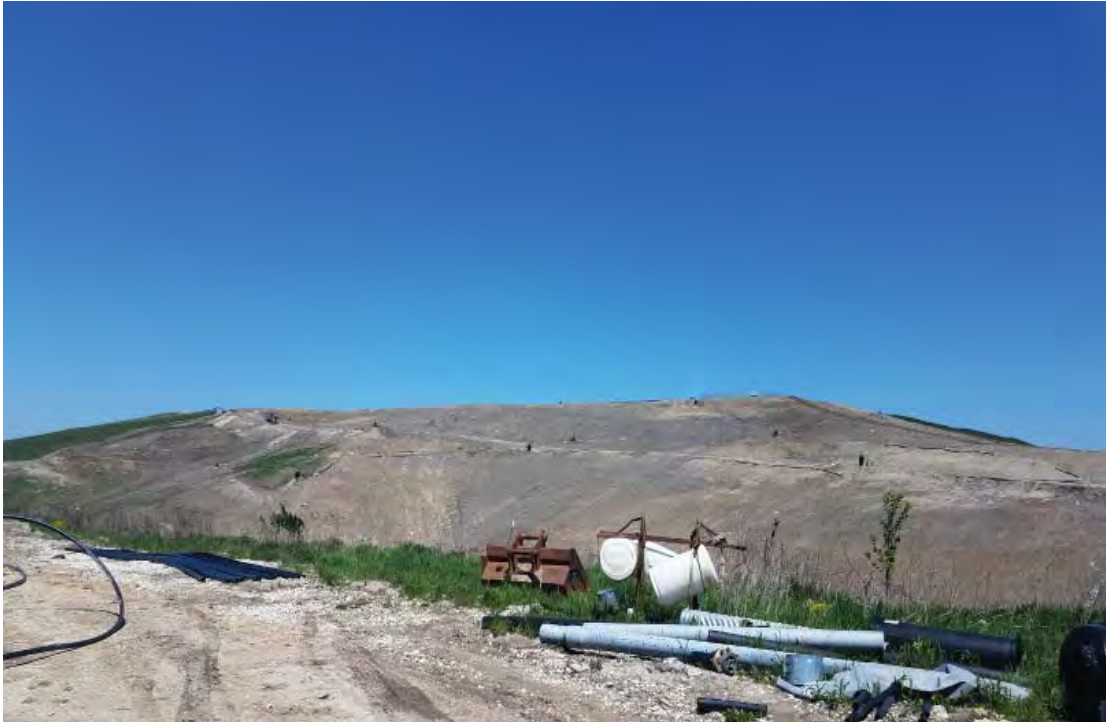
Landfill viewed from the West

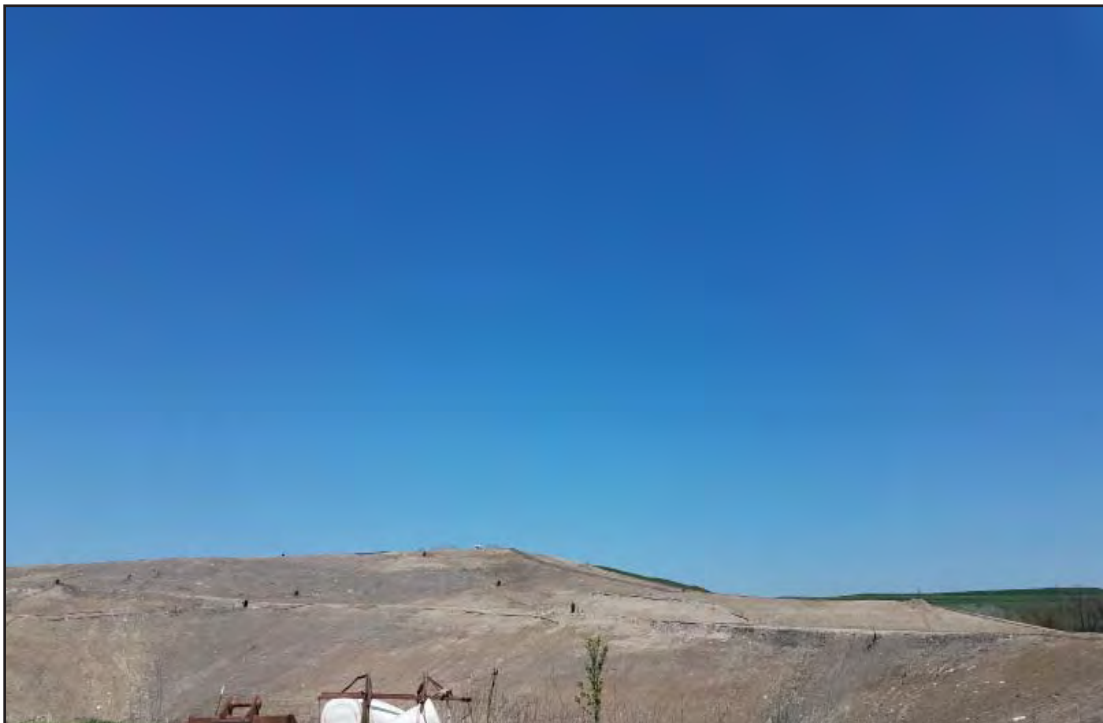
Overview of West slopes

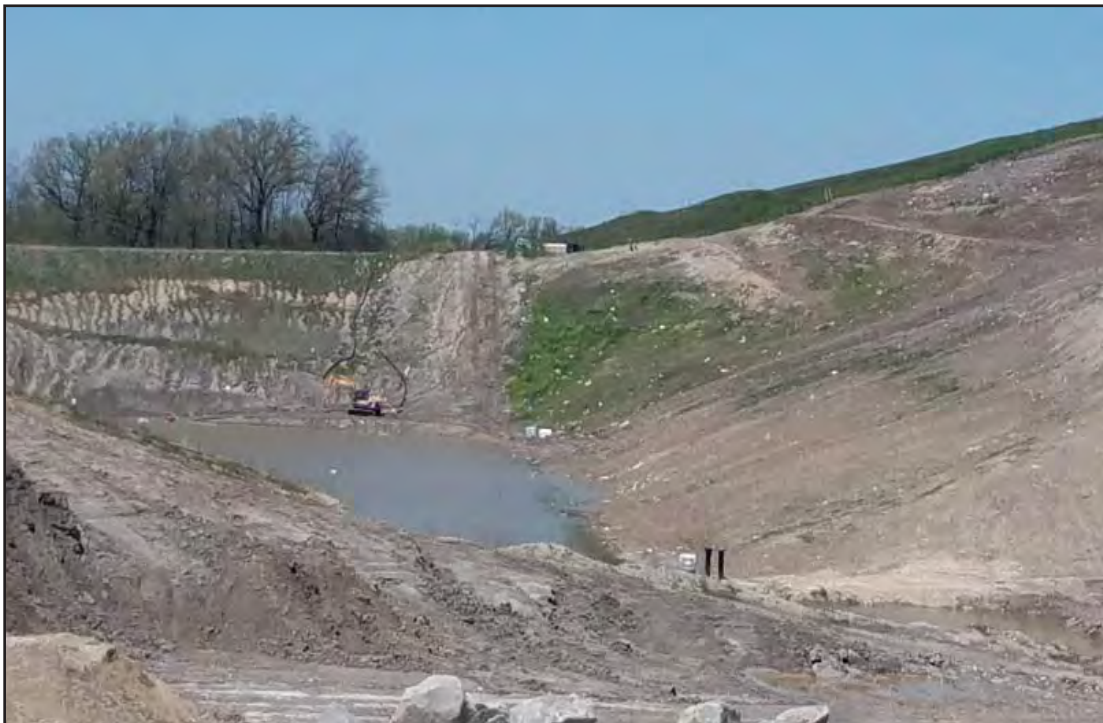
Temp sed basin, North end against Phase 7 North
