2020 Year End Summary of Audits of the Emerald Park Landfill

Prepared For:
City of Muskego
Green For Life Emerald Park Landfill Standing Committee

2020 Green For Life Emerald Park Landfill Year End Compliance Officer Report and Audit Summary

TO: Advanced Disposal Services Emerald Park Standing Committee
FROM: Jo-Walter Spear, Jr., P.E.
COPIES: File
DATE: 03/29/2021
PROJECT NUMBER: 1012.10030

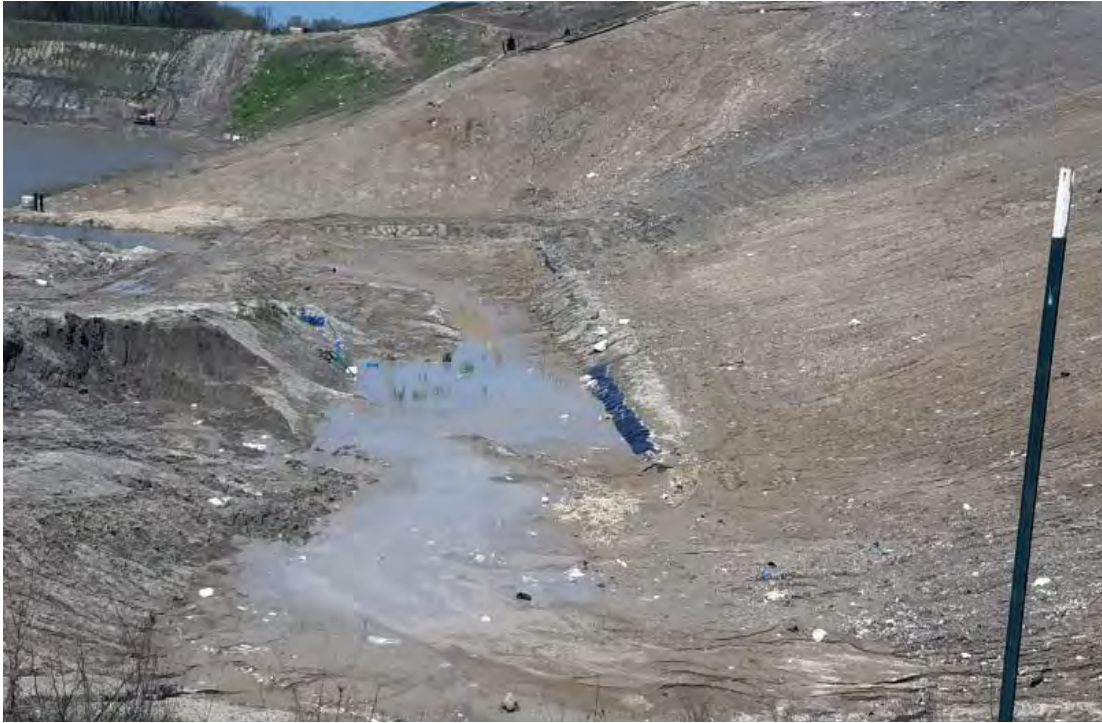
Siltation in South end of the Temp Sed basin, silt is higher than rain flap of Phase 7 South

- Basins draining well, temp sed basin well drained by pumping
- Erosion about site minimal
 - Erosion into temp sed basin at South end has sediment higher than the rain flap to Phase 7 South Phase 1. To be addressed as weather/wet conditions allow.

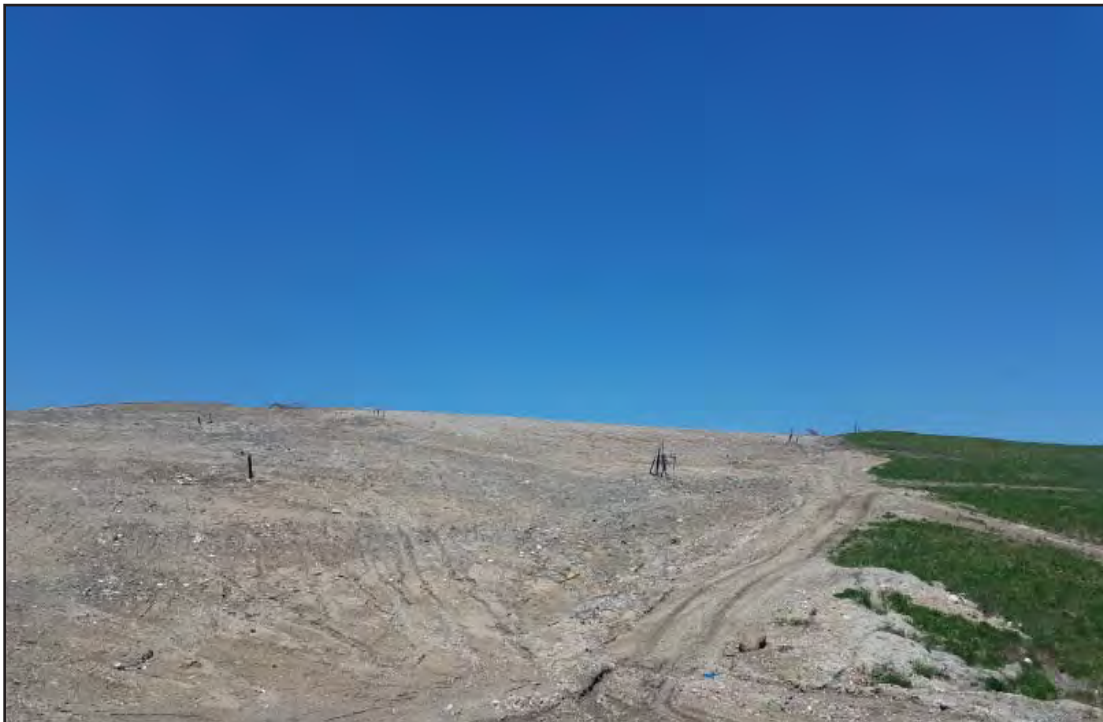
South slope with some erosion after two days of storms

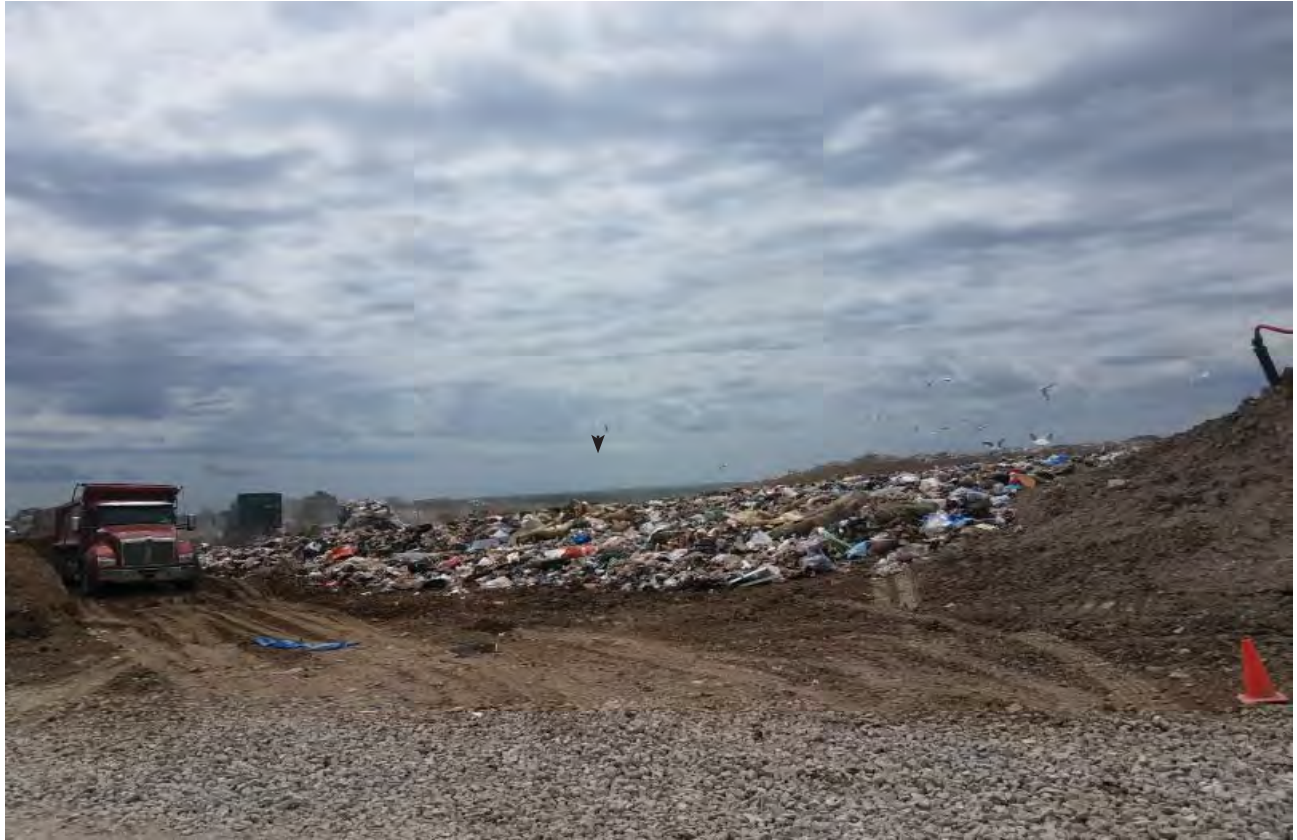
Working face viewed from North, in Phase 7 North

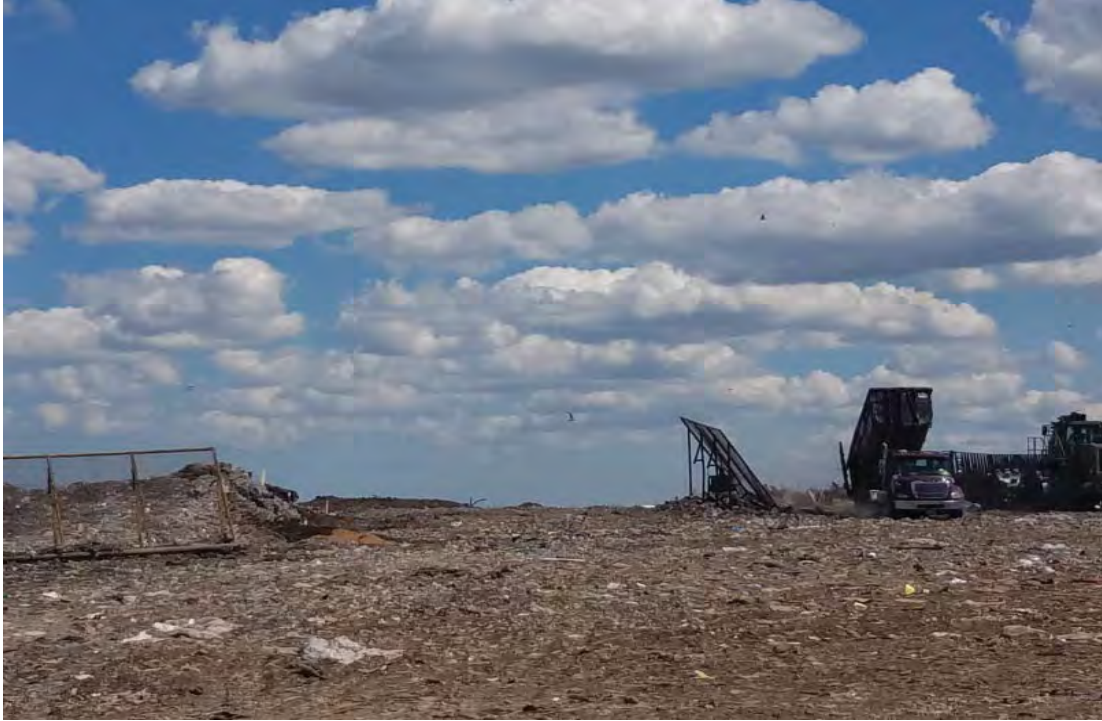
View across active area

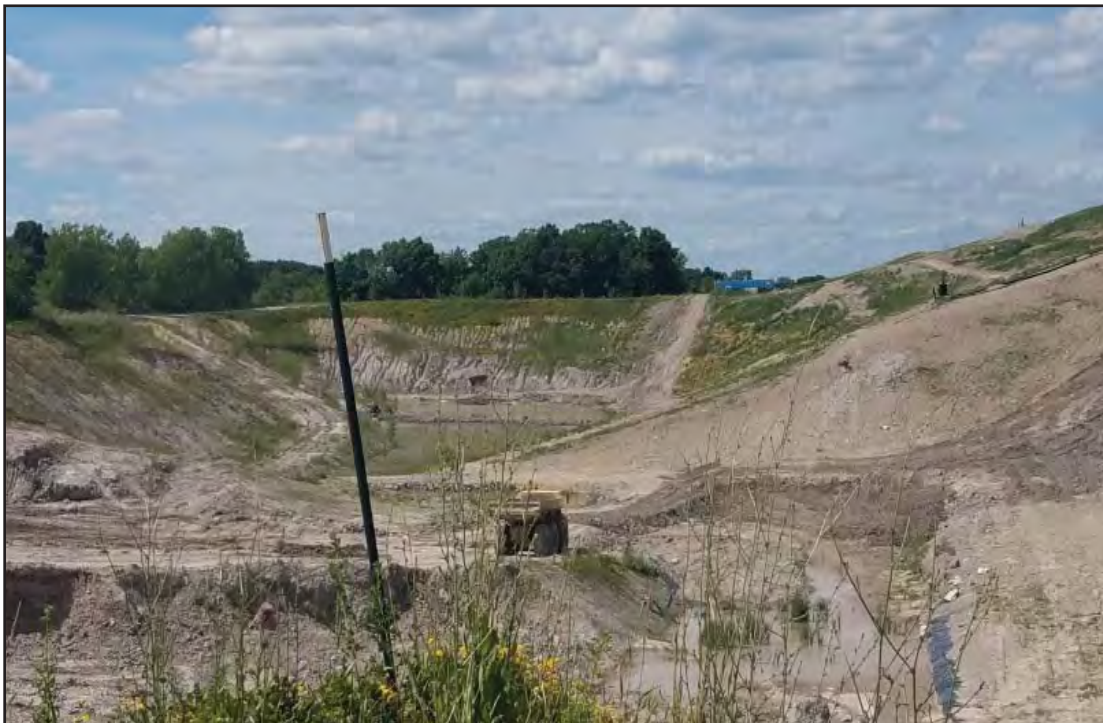
View across temp sed basin, South to North

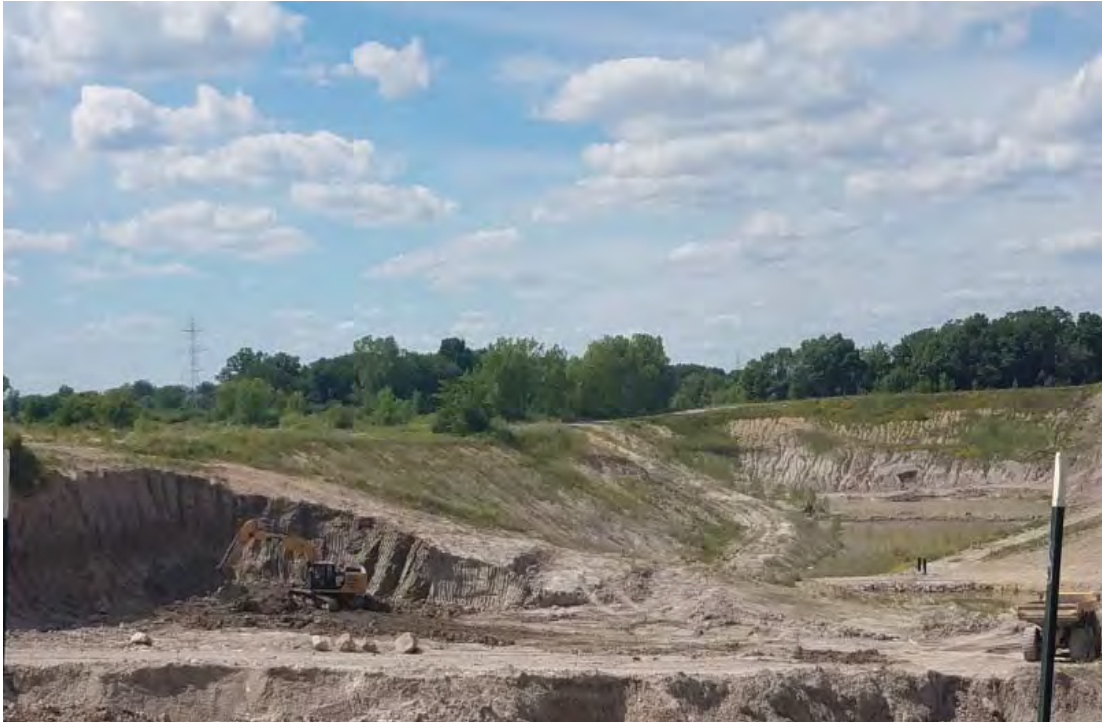
View across temp sed basin, South to North

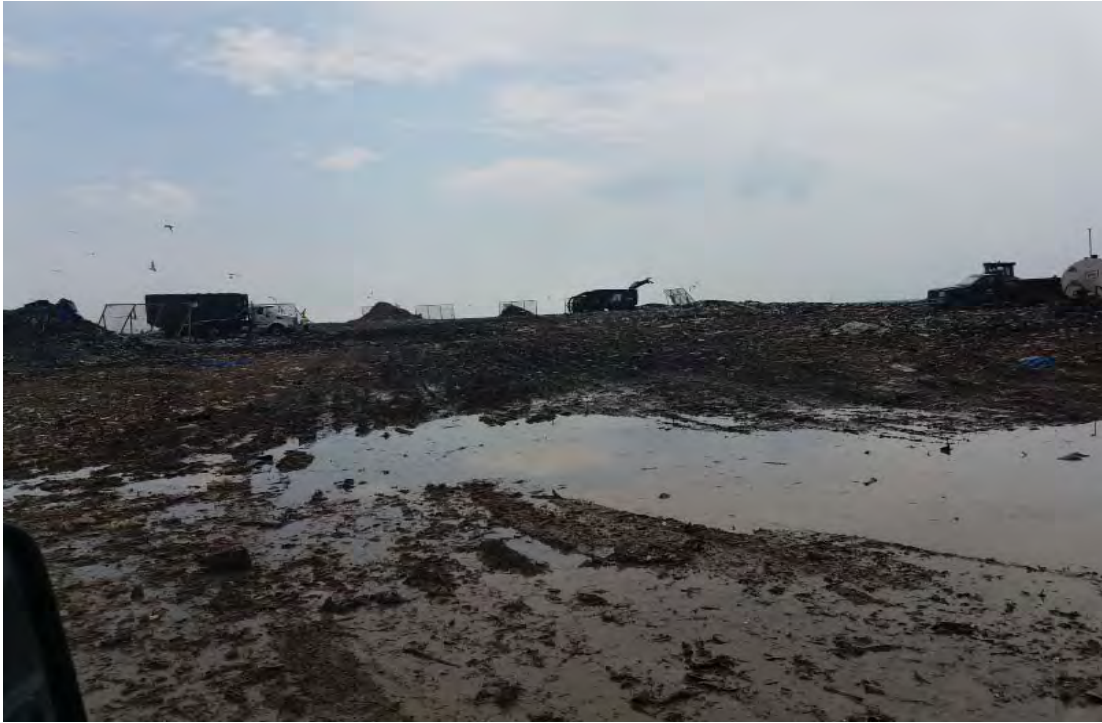
Water pooled about active area

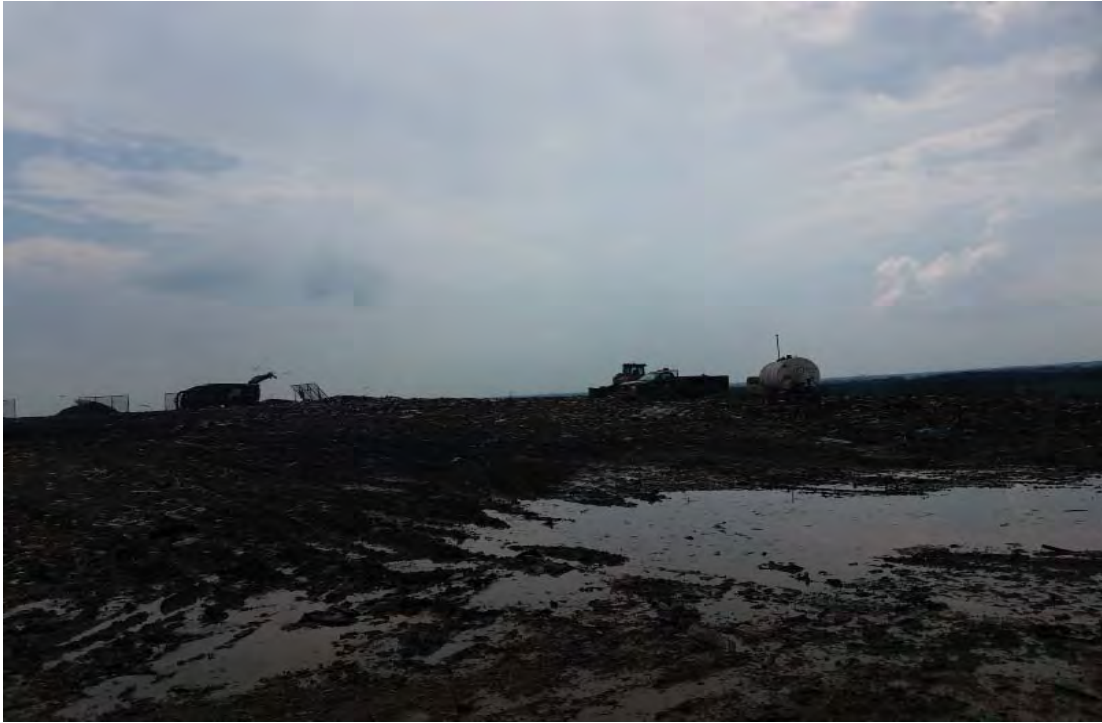
Water pooled about active area

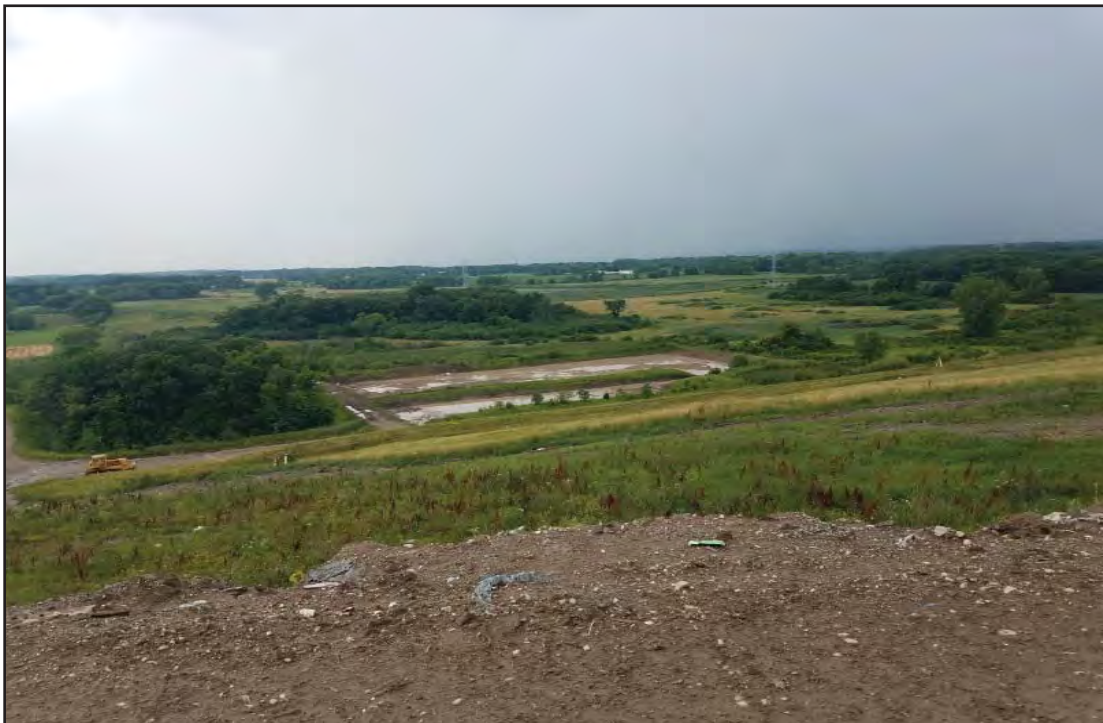
Basin #1 receiving very little water from Phases 1 thru 3 and not from Temp Sed Basin

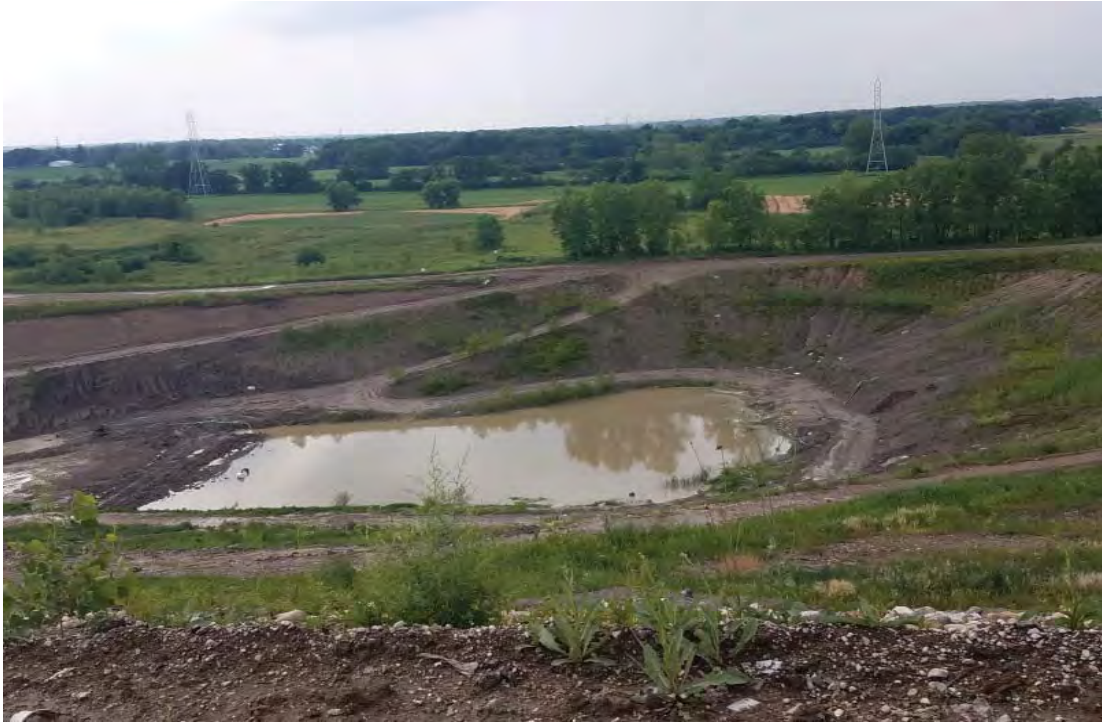
North "bay" of Temp Sed Basin

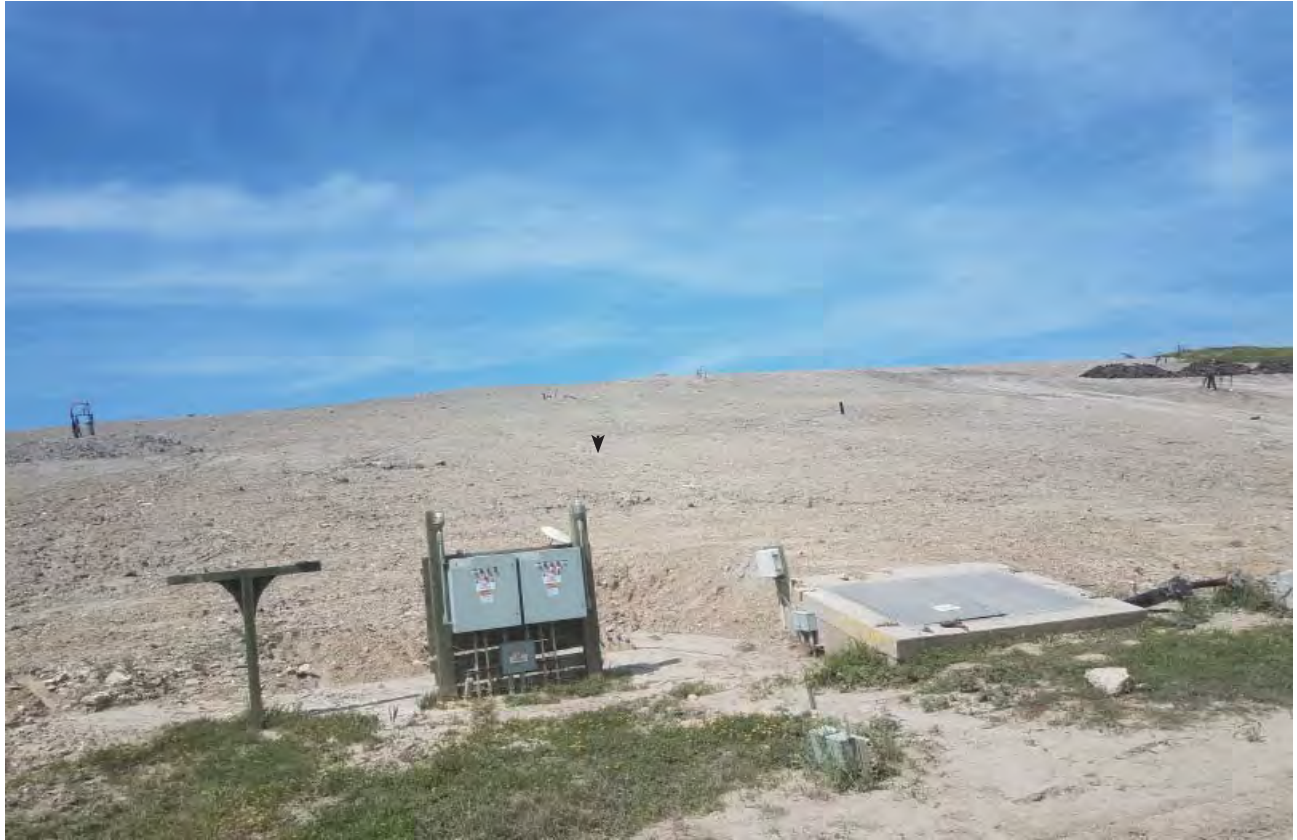
Toe of South slope of Phase 7 South

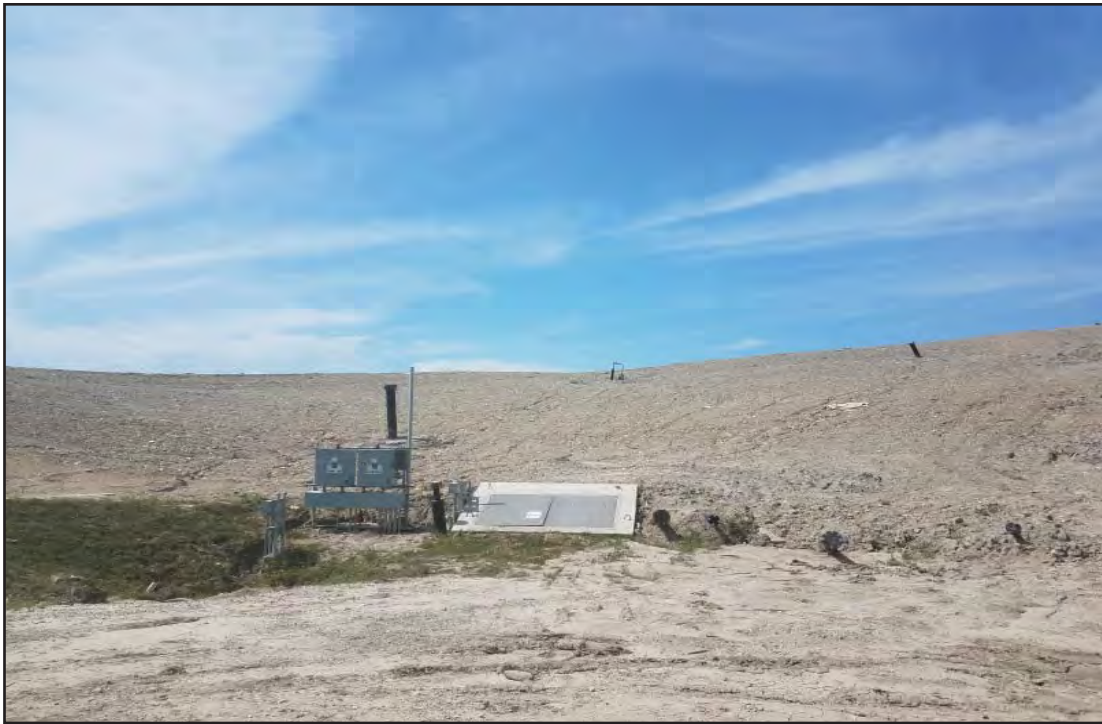
South slope of Phase 7 South

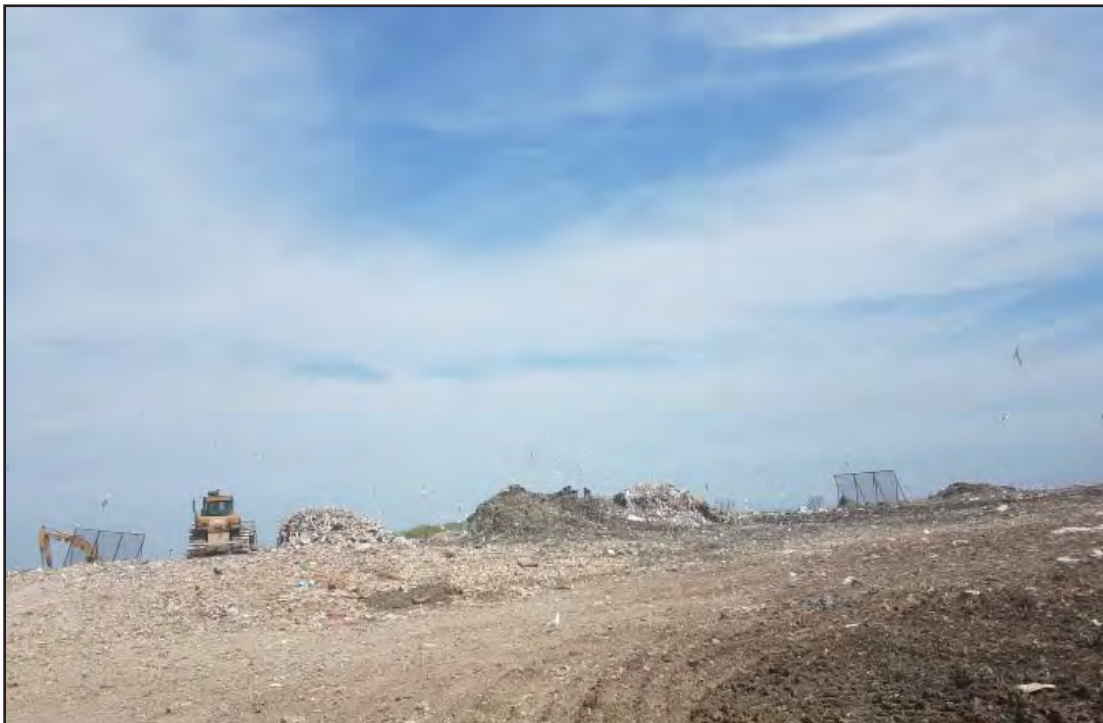
Phase 7 viewed to the East

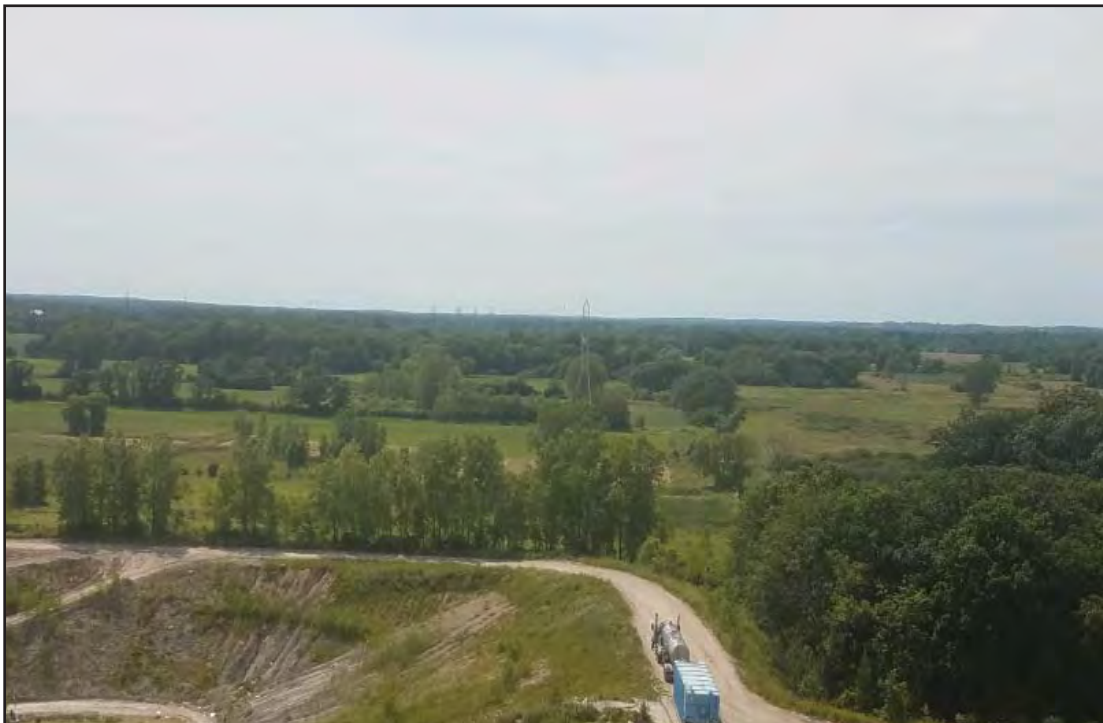
Tanker truck receiving filtered water from temp sed basin

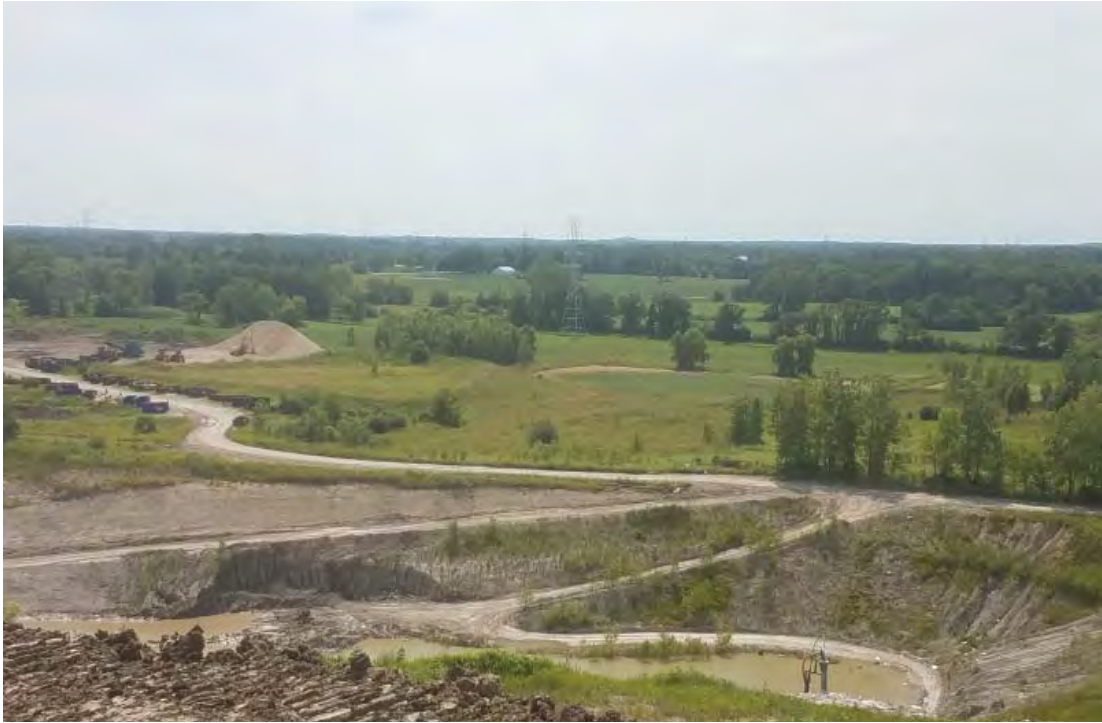
View across temp sed basin, East to West

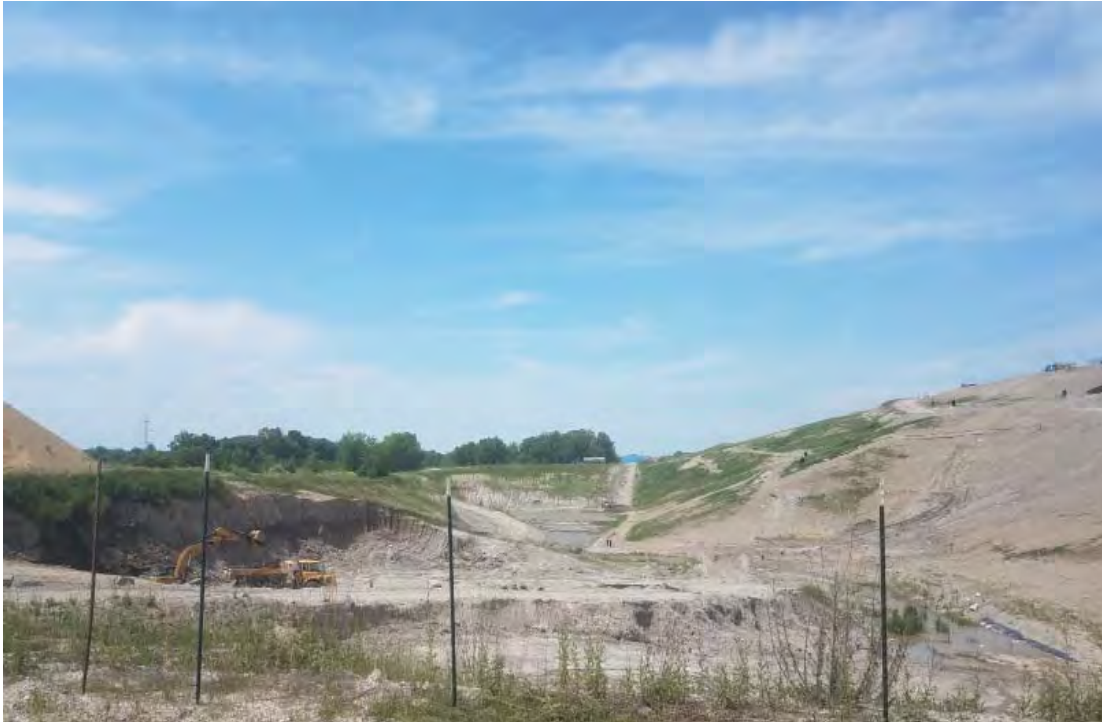
North end of Phase 7 viewed from West, East slopes in good repair

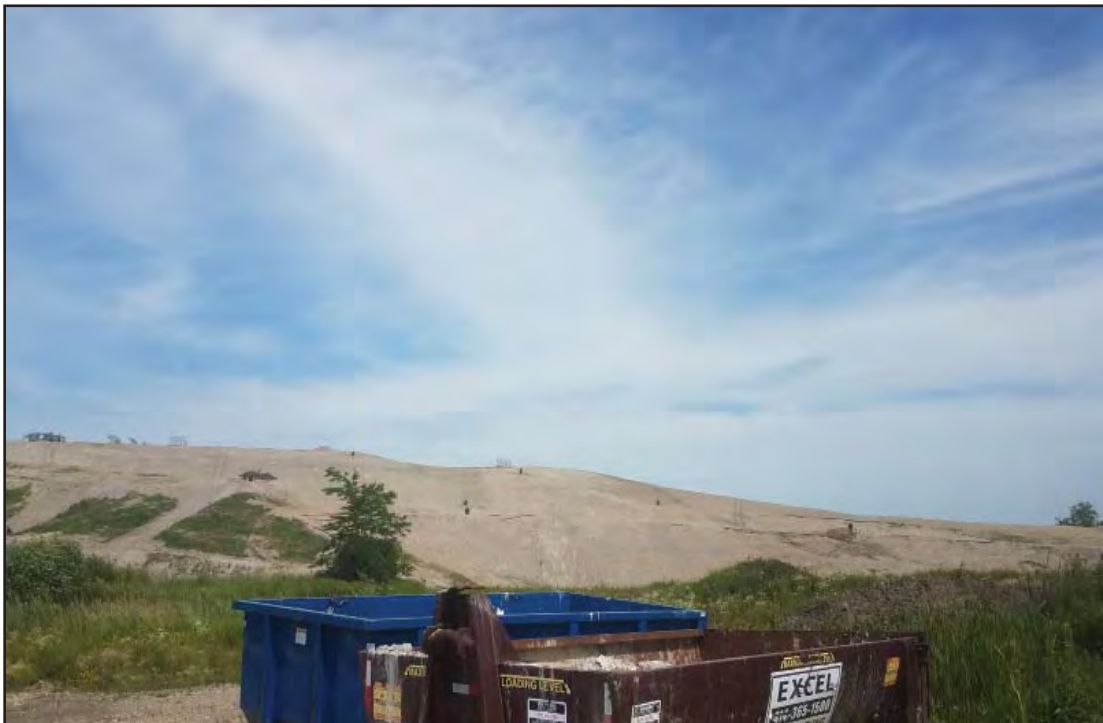
South end of Phase 7 viewed from the West

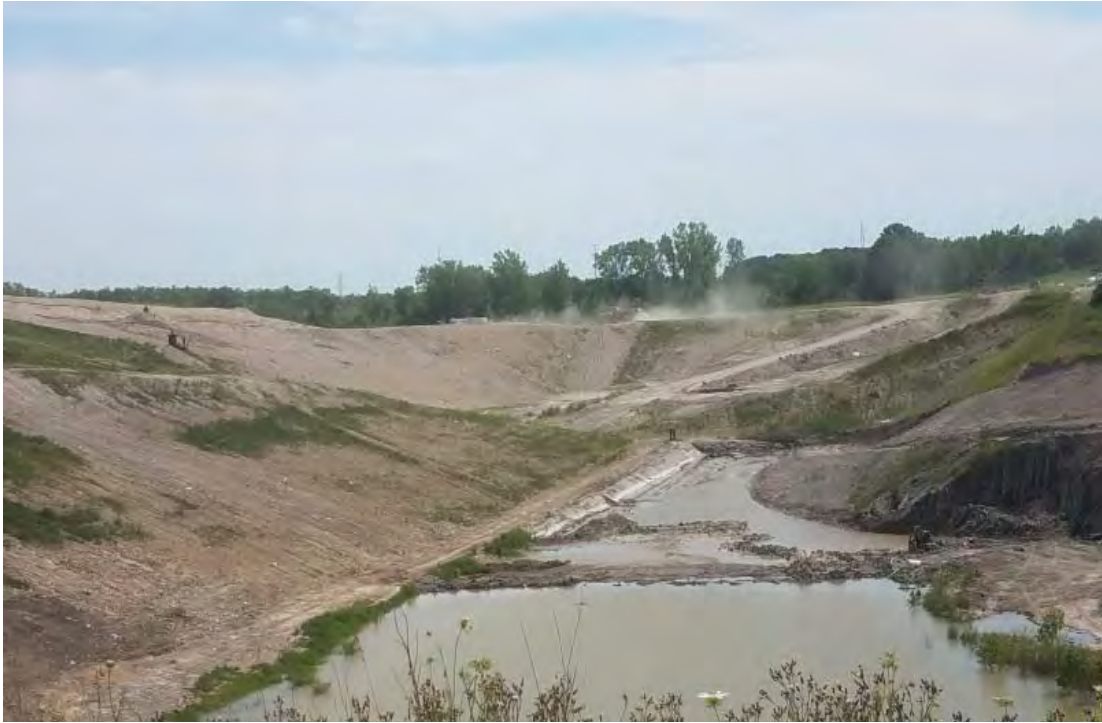
Temp sed basin broken into bays to aid in cleanup and restoration after leach-ate contamination

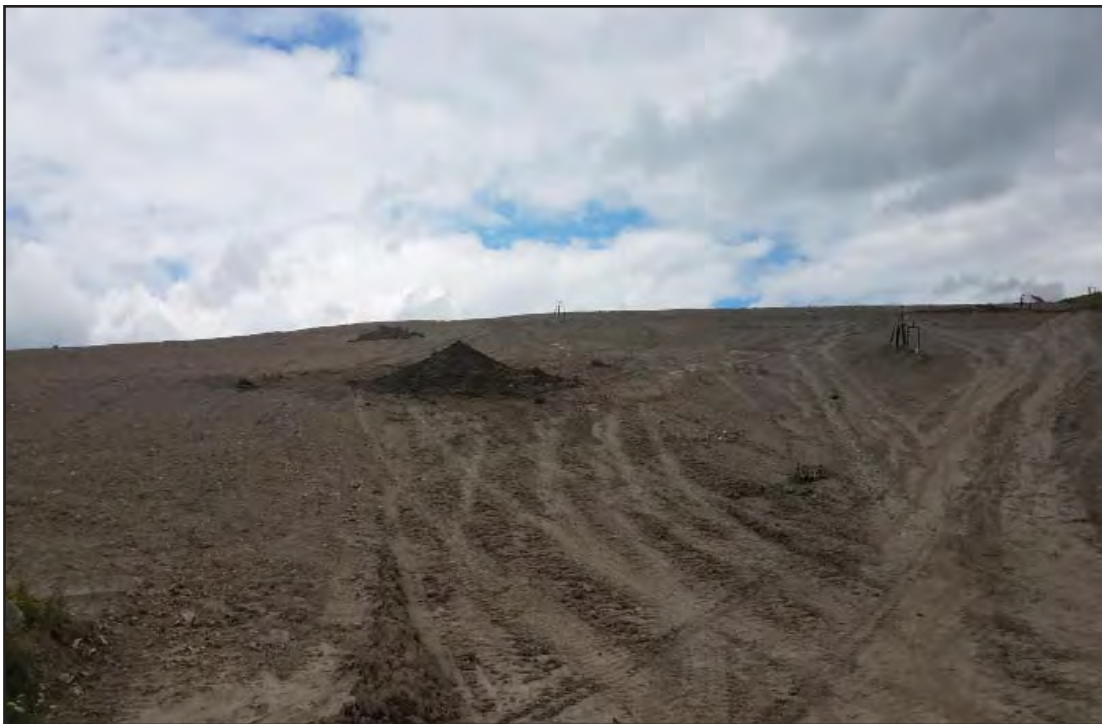
South slope of Phase 7 South

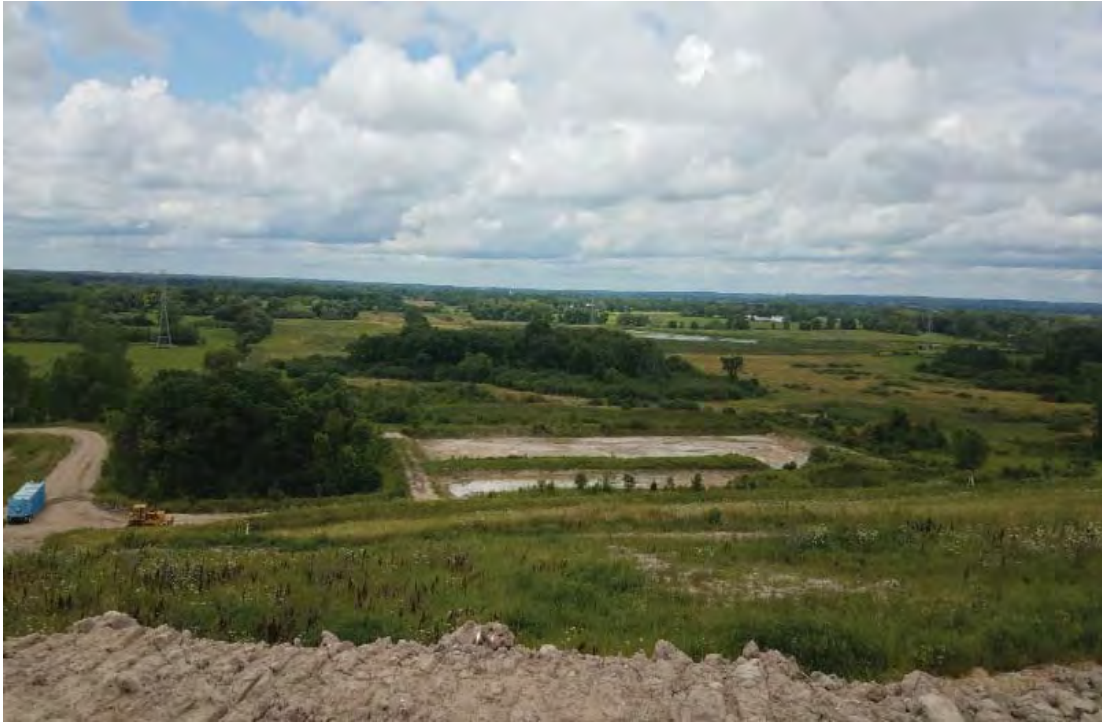
West slope of Phase 3

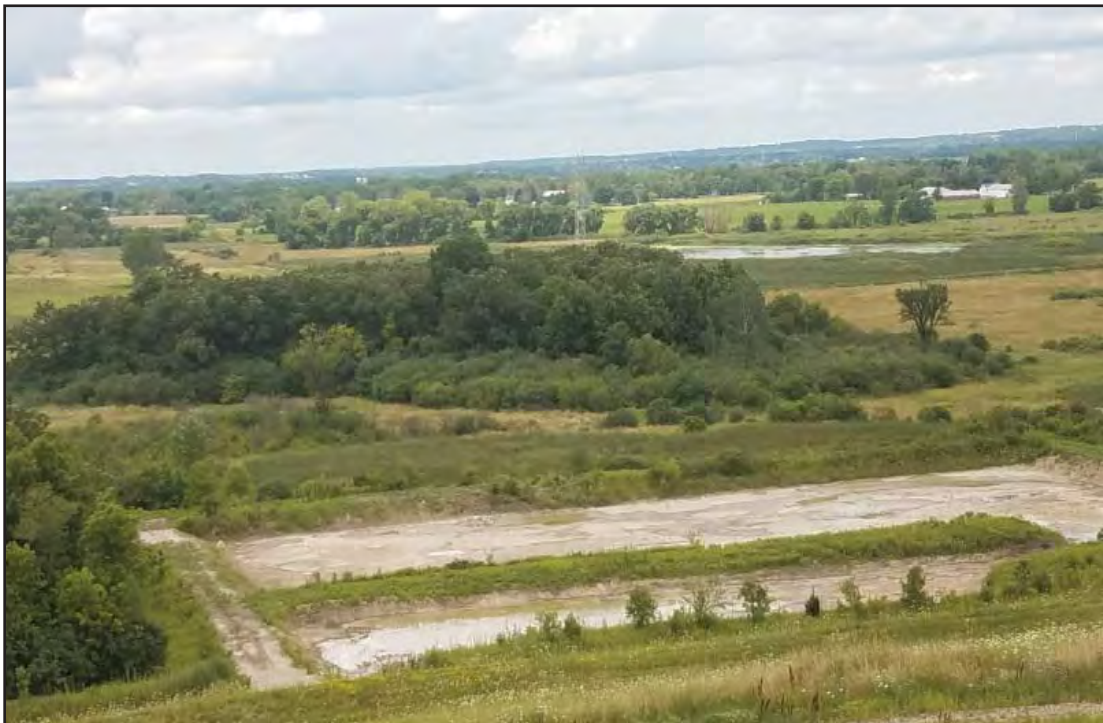
Basin 1

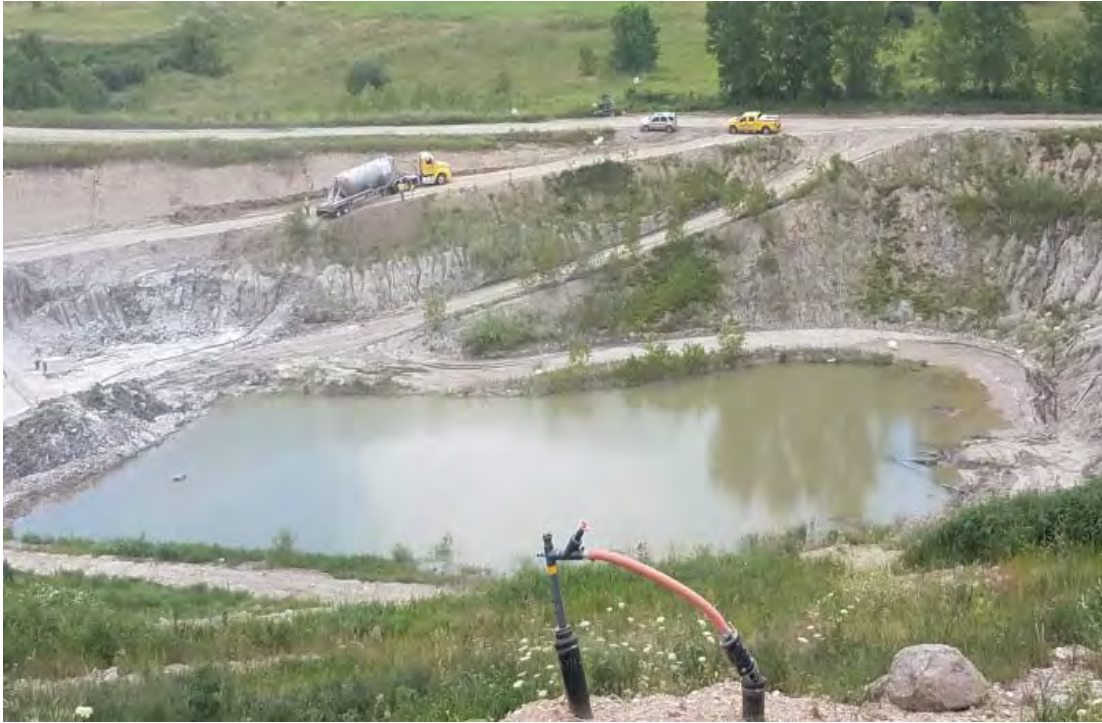
North end of temp sed basin, still being pumped/treated

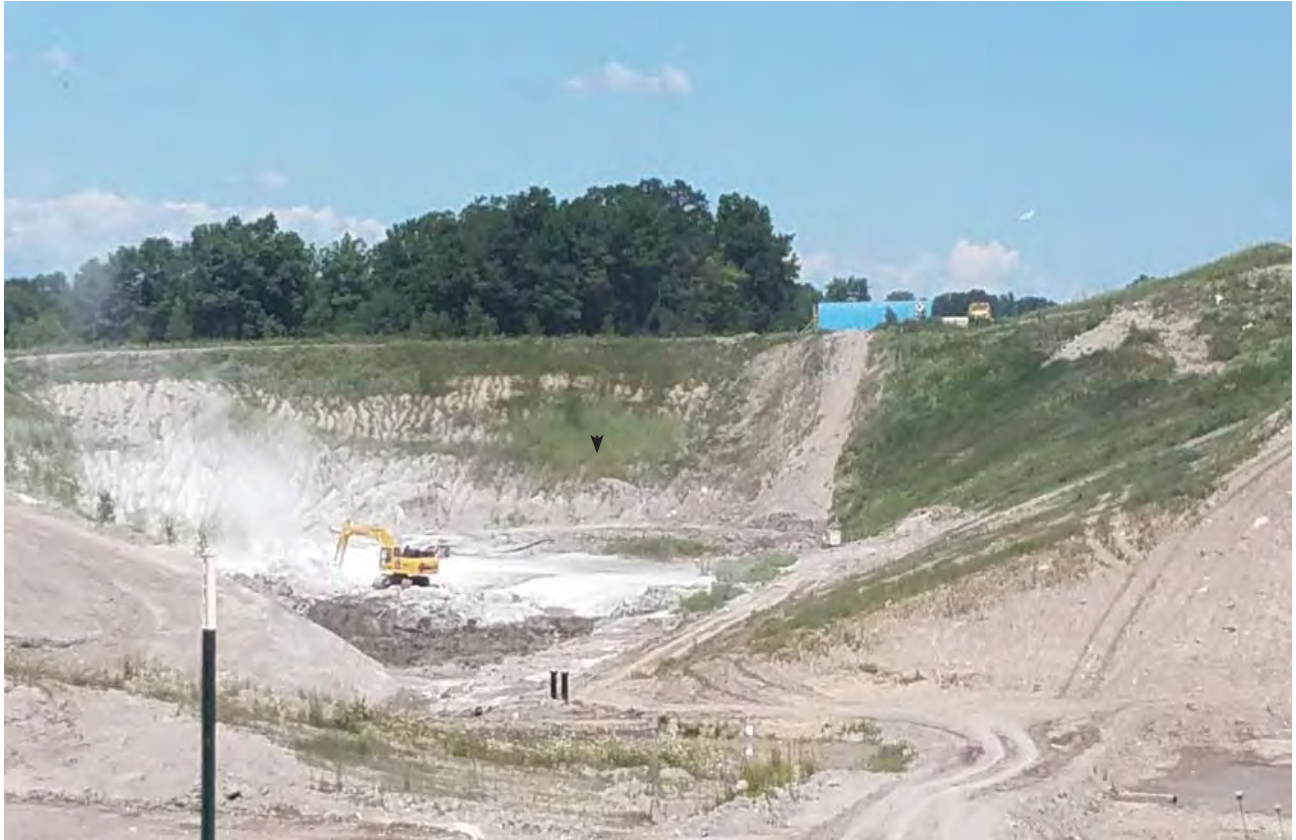
Temp sed basin and West slope of Phase 7

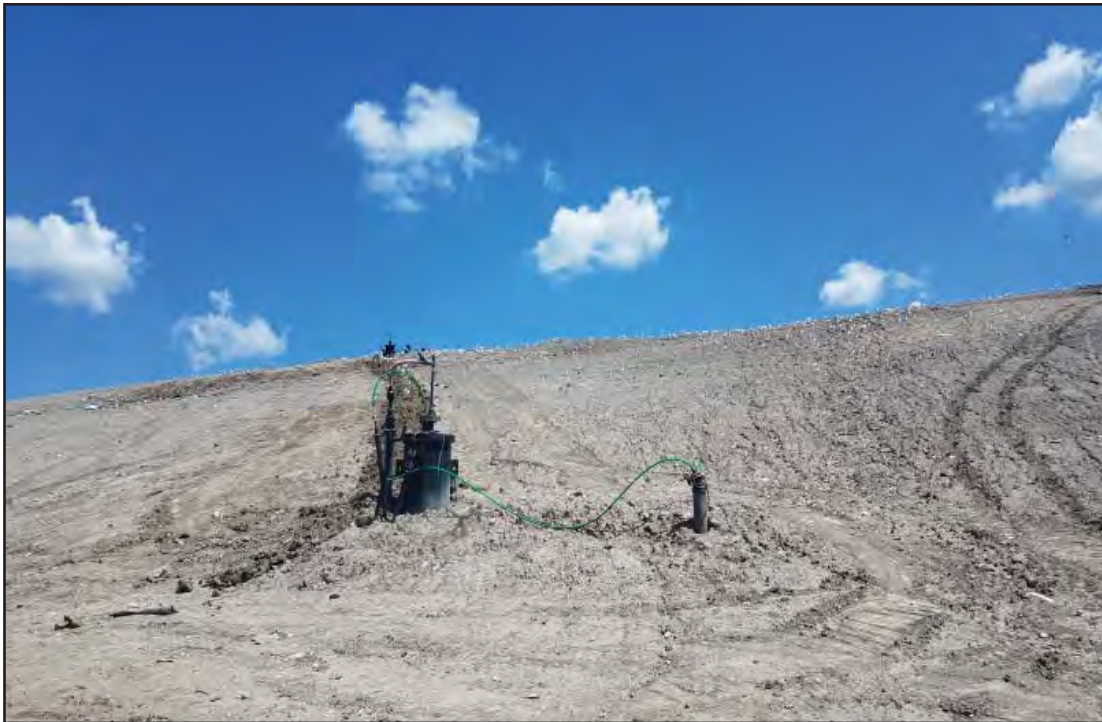
South slope of Phase 7 South

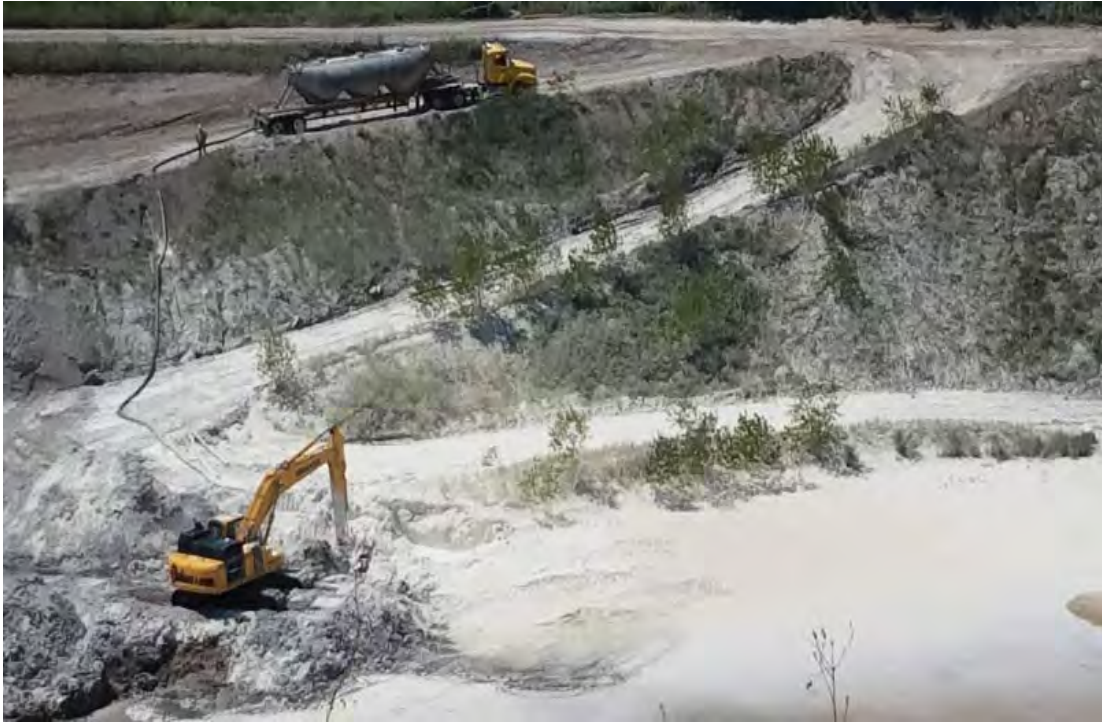
Temp sed basin being solidified and material removed

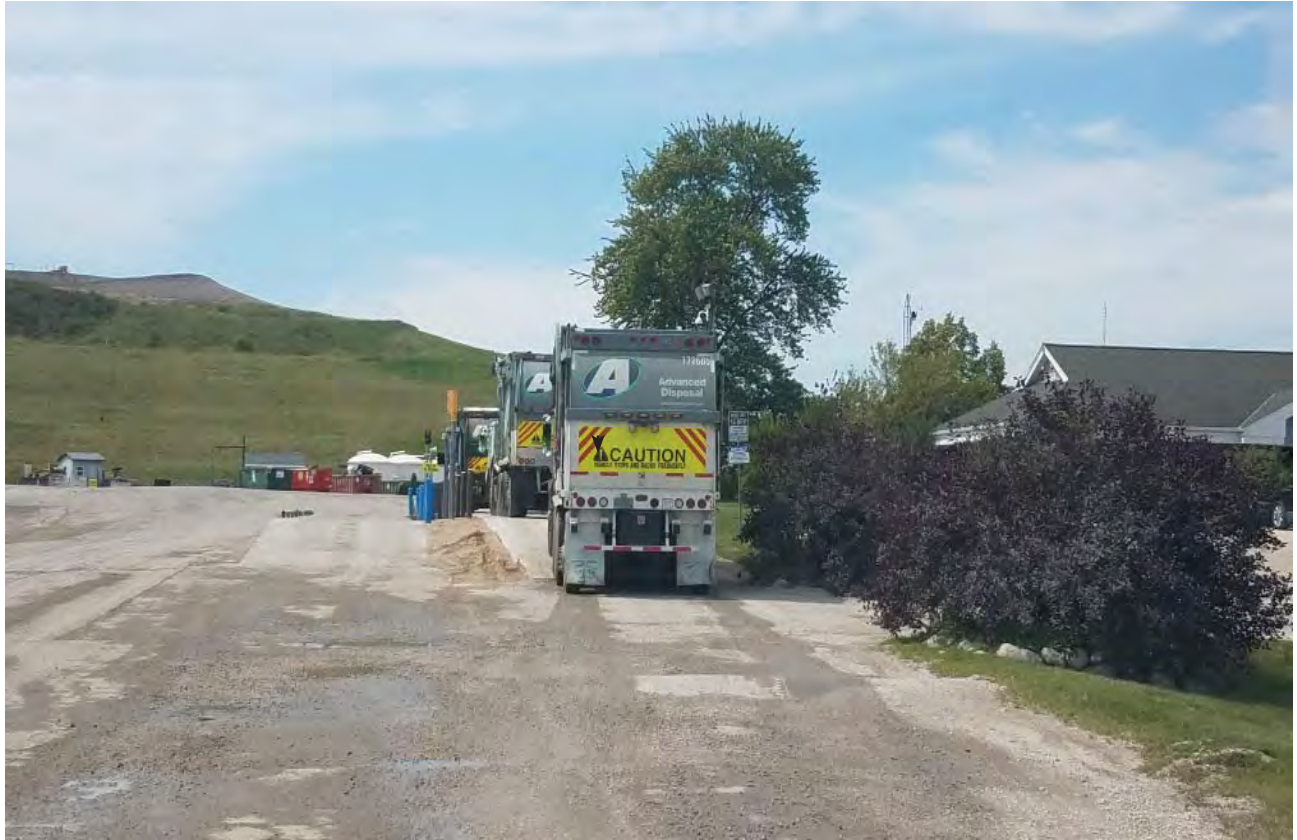
New inbound scale operational

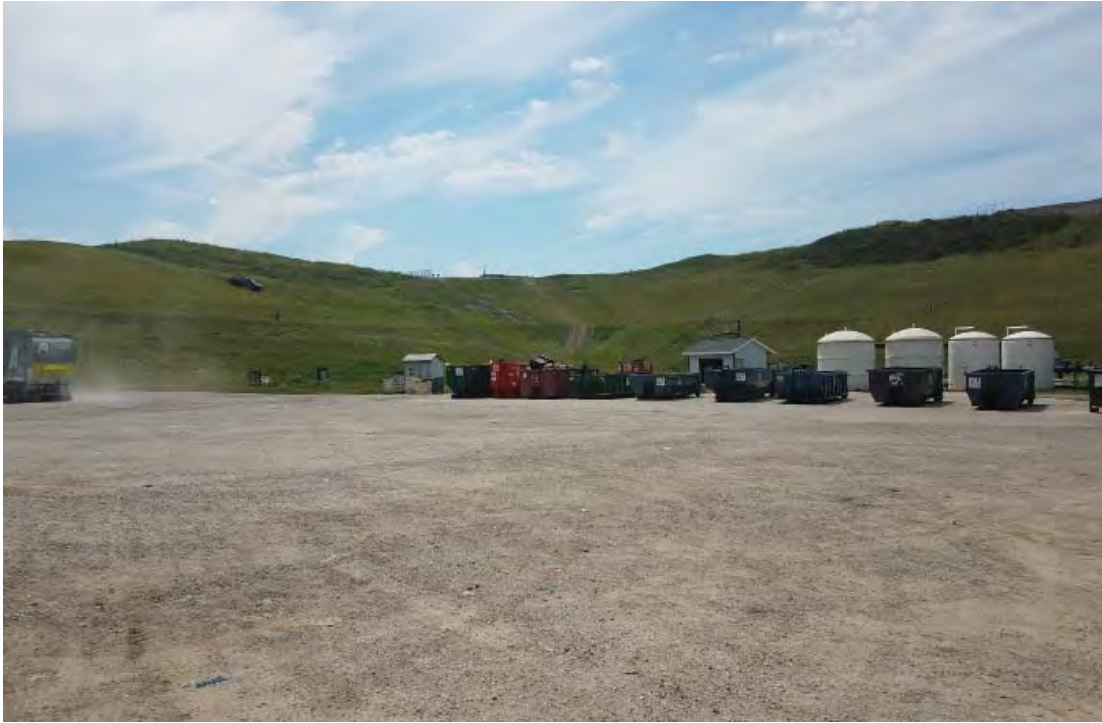
Residential drop off area clean and boxes mostly empty
