2020 Year End Summary of Audits of the Emerald Park Landfill

Prepared For:
City of Muskego
Green For Life Emerald Park Landfill Standing Committee

2020 Green For Life Emerald Park Landfill Year End Compliance Officer Report and Audit Summary

TO: Advanced Disposal Services Emerald Park Standing Committee
FROM: Jo-Walter Spear, Jr., P.E.
COPIES: File
DATE: 03/29/2021
PROJECT NUMBER: 1012.10030

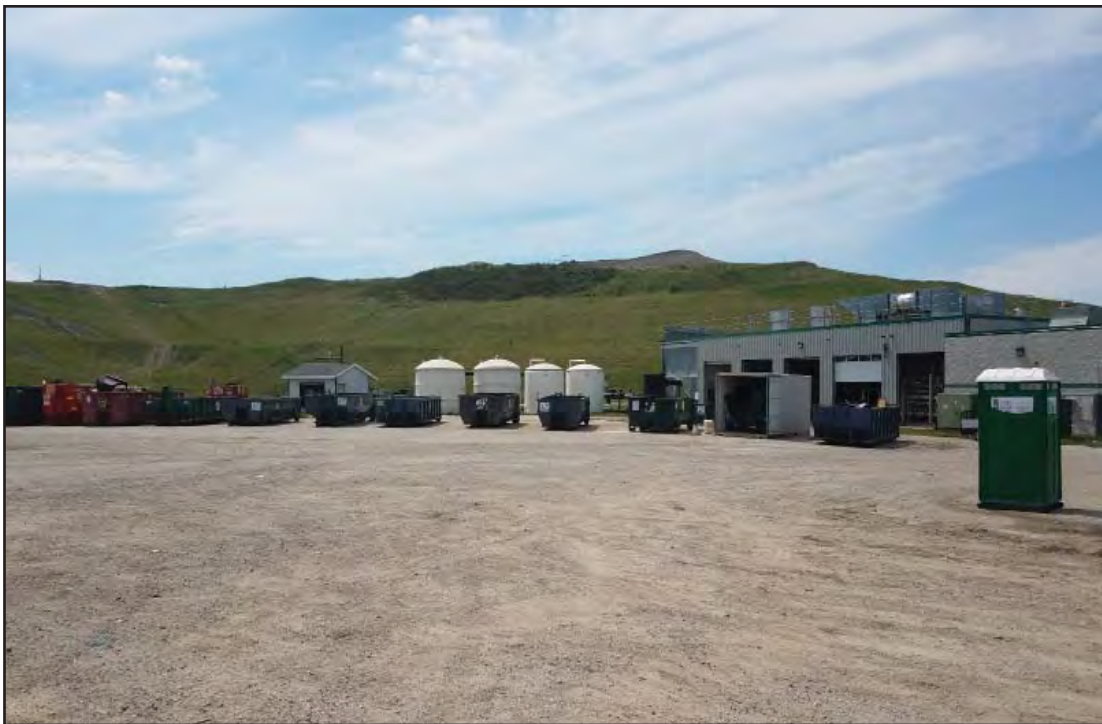
Residential drop off area clean and boxes mostly empty

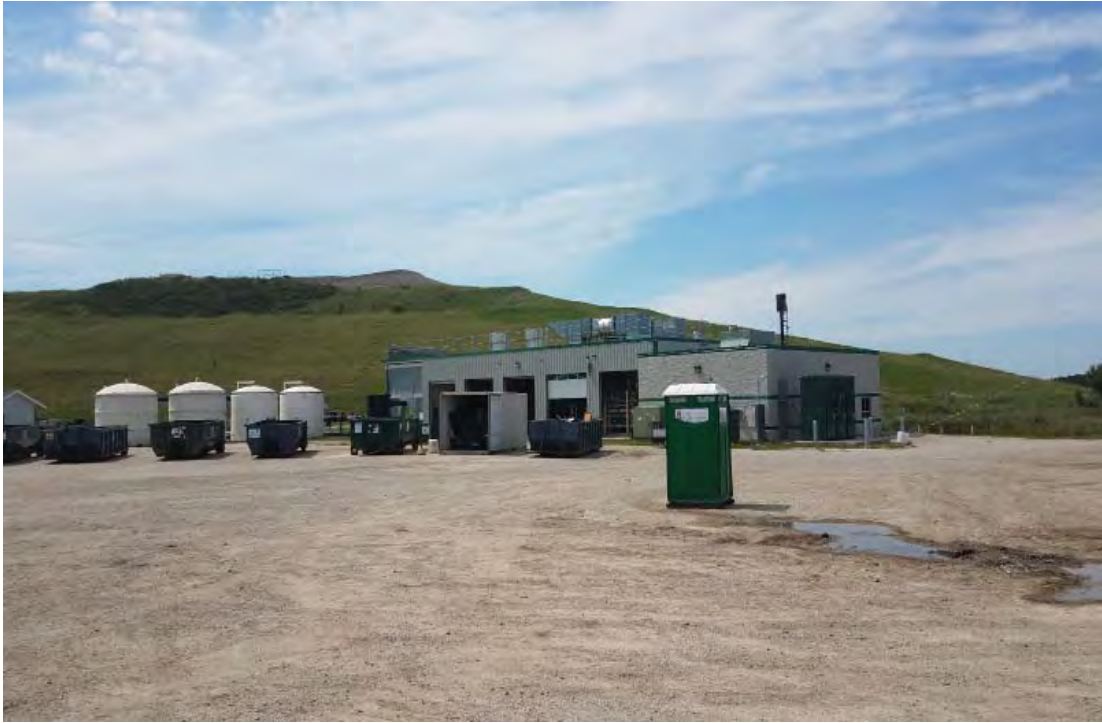
Residential drop off area clean and boxes mostly empty

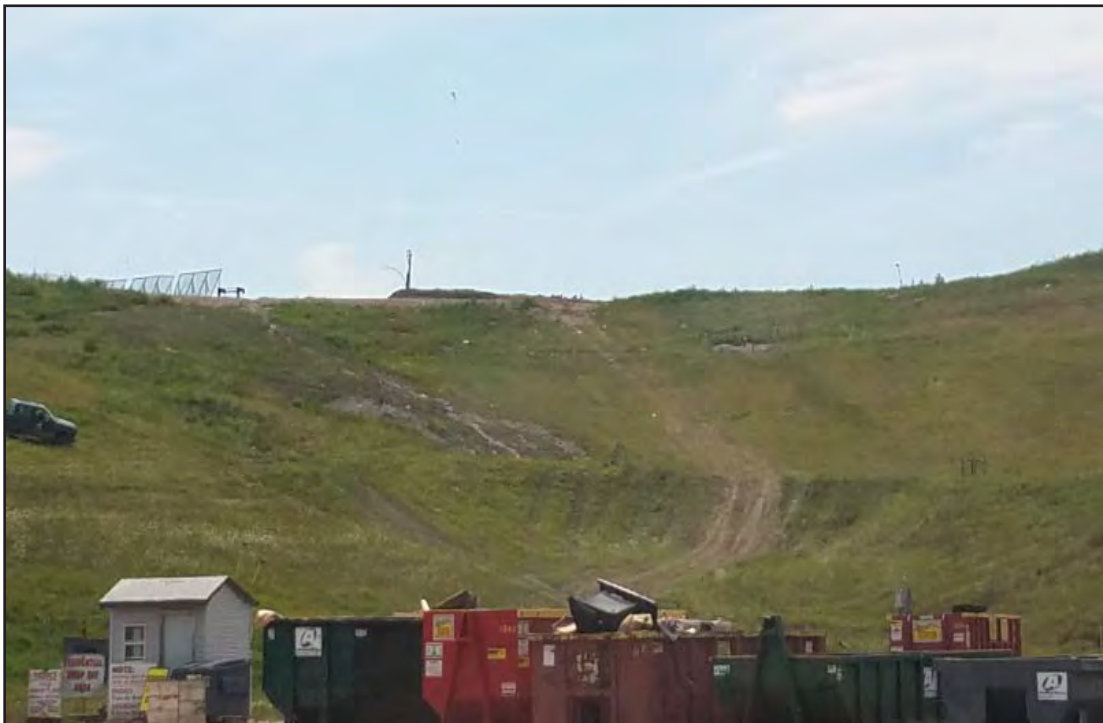
Travel over Phase 4 has started erosion locations

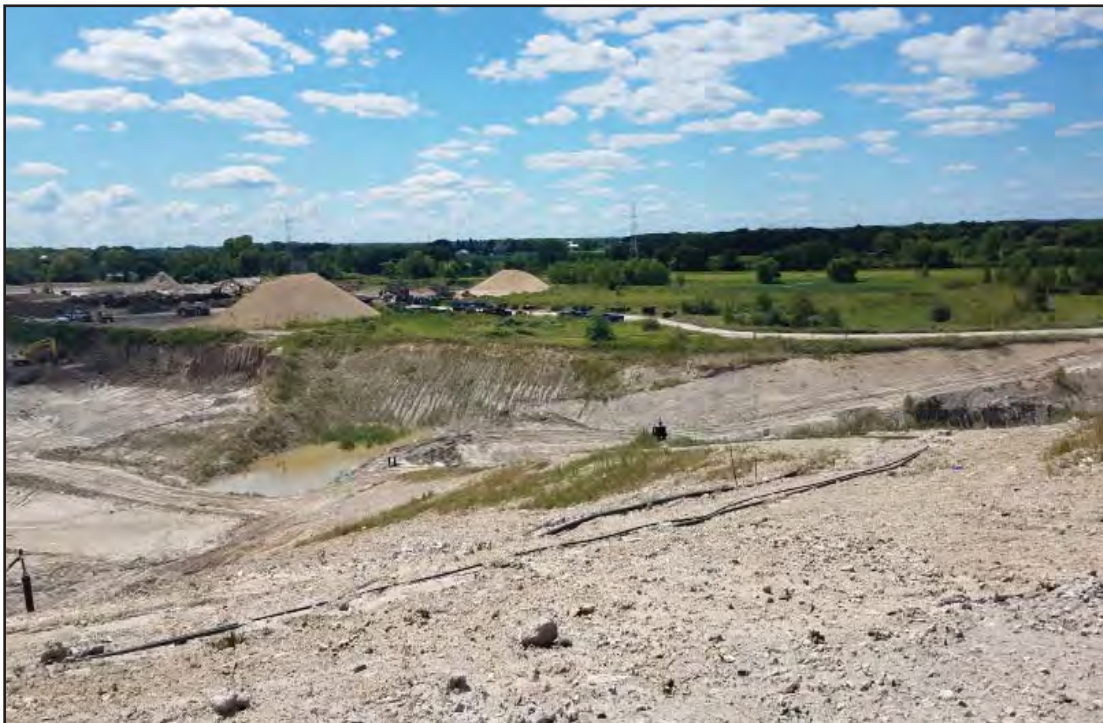
West slope of Phase 7 South

* Slope grading maintenance on West Slope of Phase 7 South

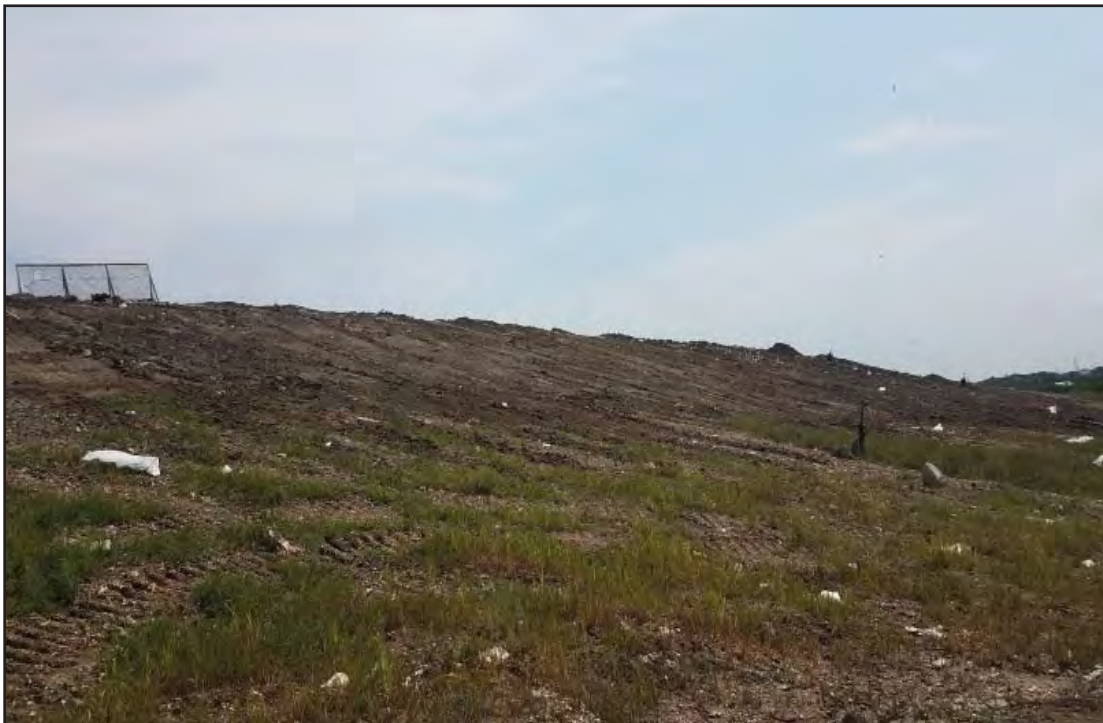
West slope of Phase 7 South, some regrading done uphill, left, in photo

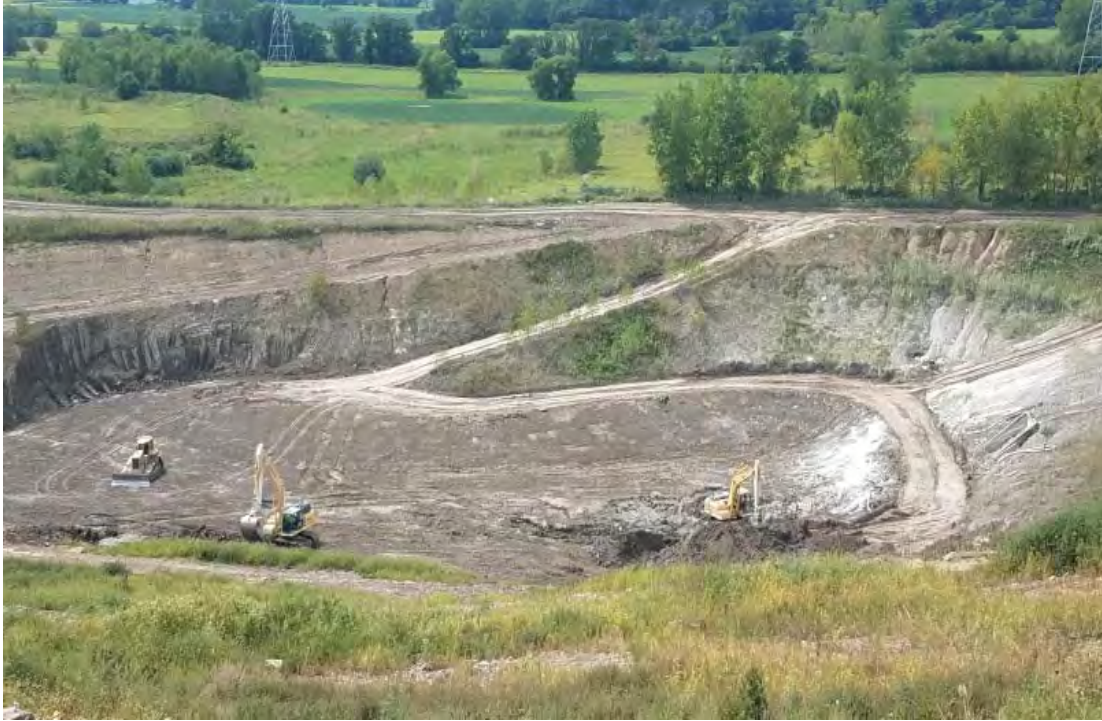
Final cleanup of Temp Sed Basin after release and seep

- New outfall construction for Basin #1 ongoing
 - Temp sed basin cleaning and repair of the rain flap seep ongoing. Final repair requires the activities of a liner crew for liner repairs.

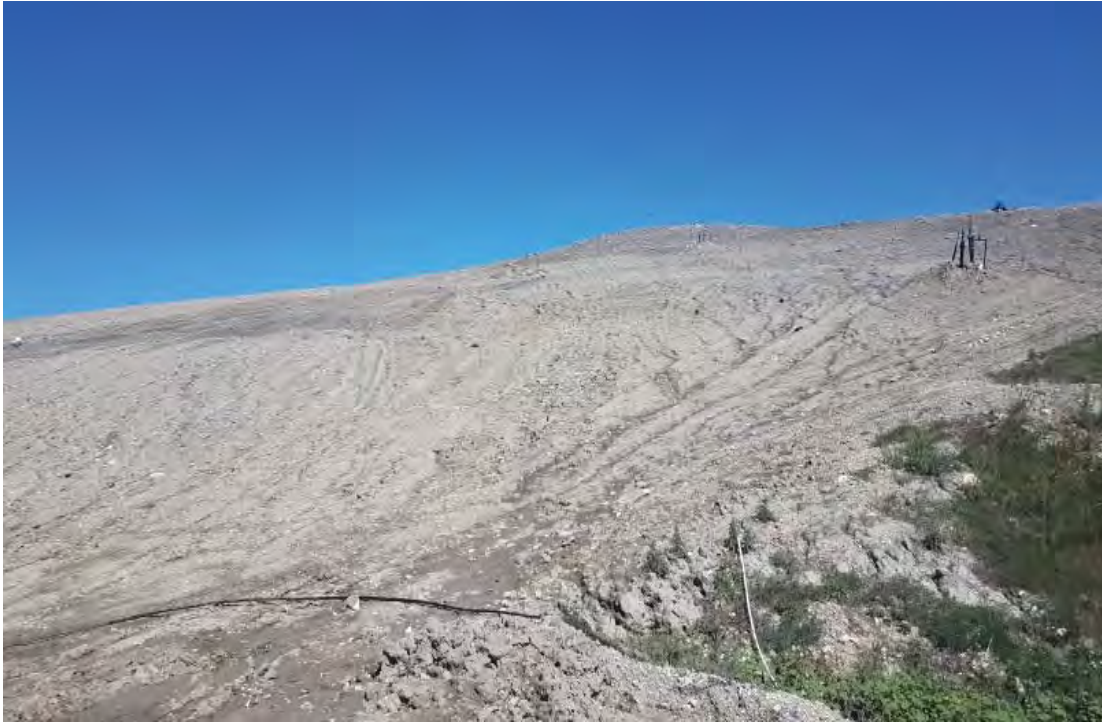
East edge of Phase 7 South, South slope

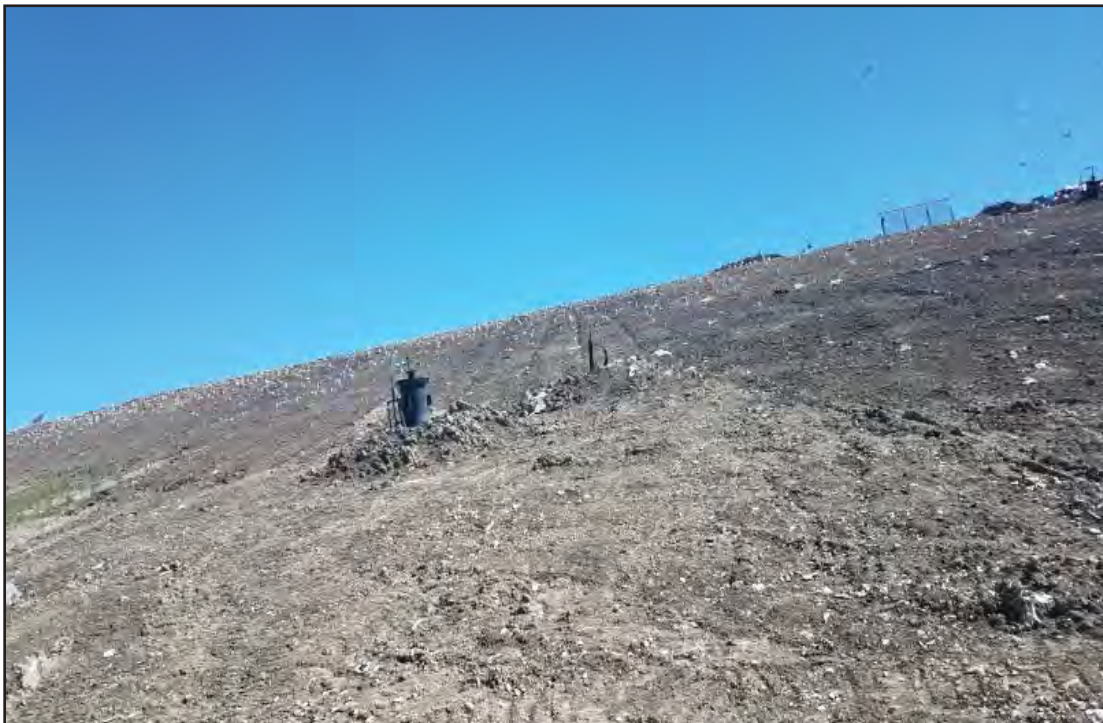
West slope of Phase 7 South

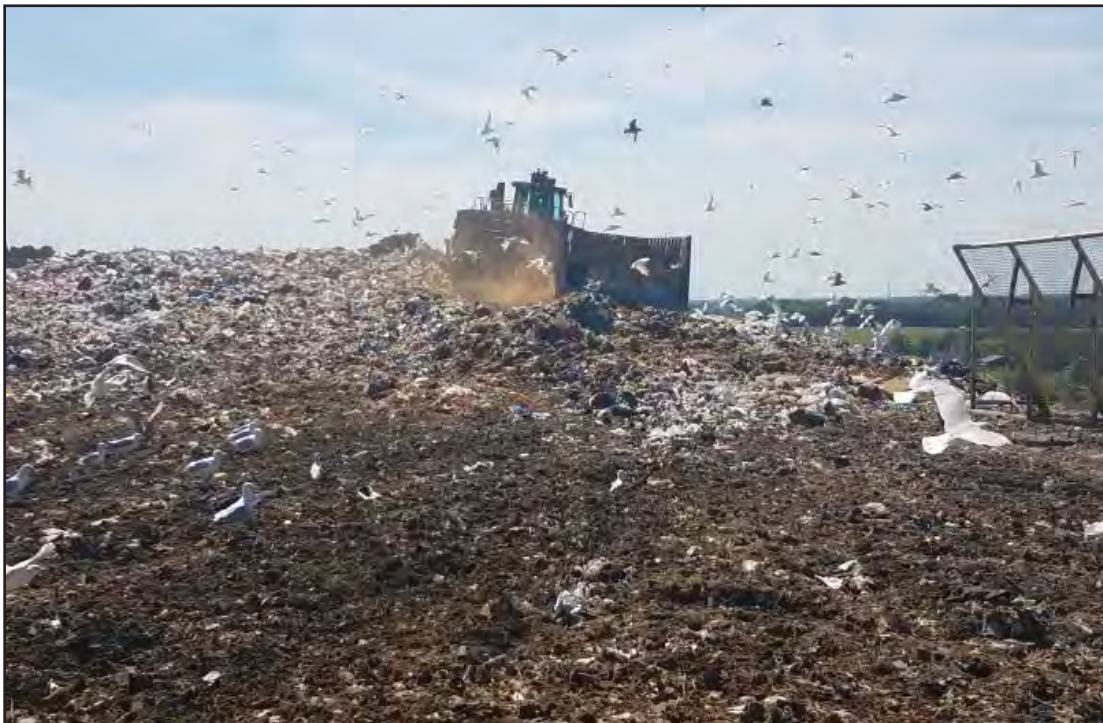
Working face activities

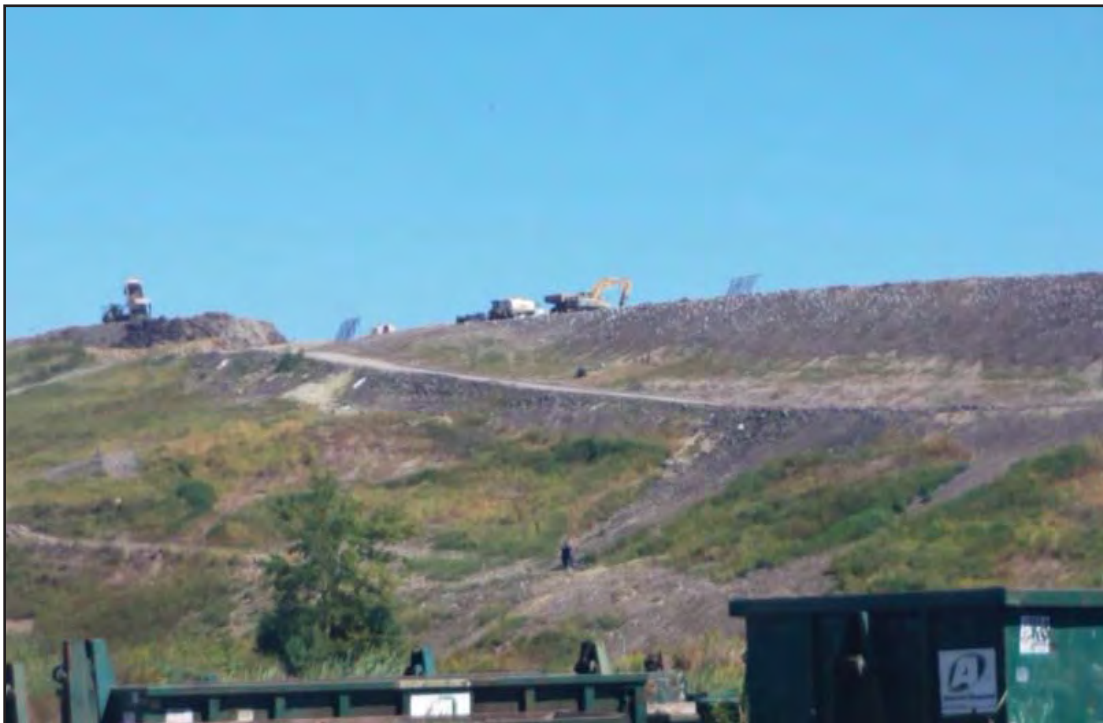
Stockpiling of soils from Temp Sed Basin on Phase 3

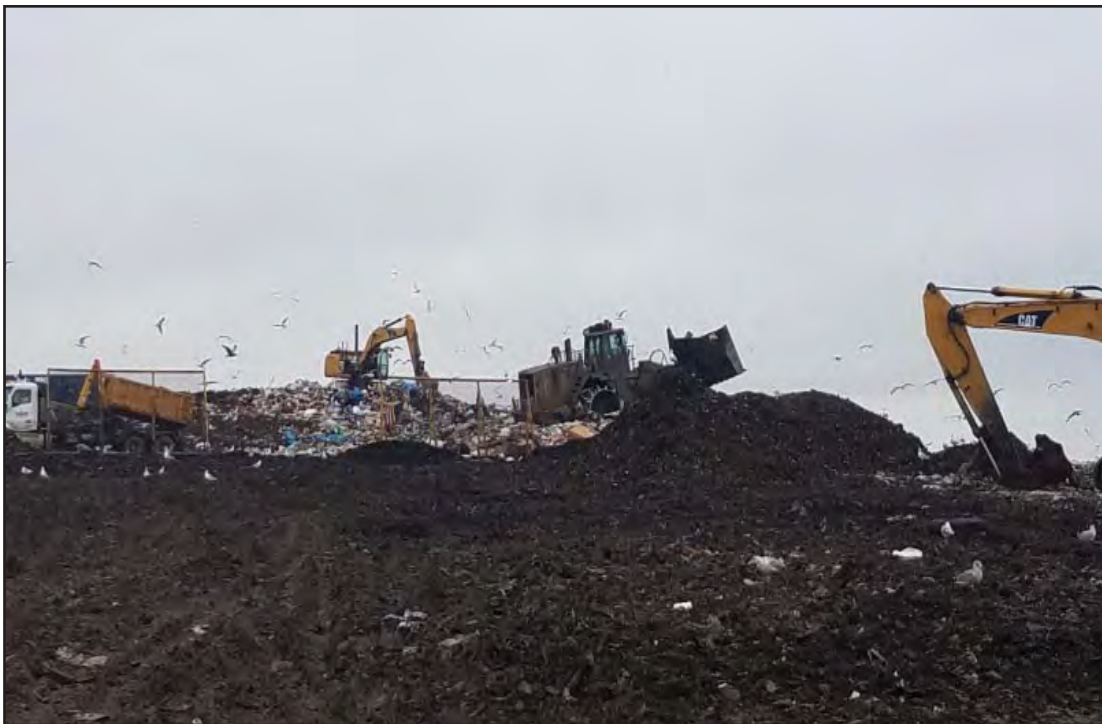
Working face viewed from North

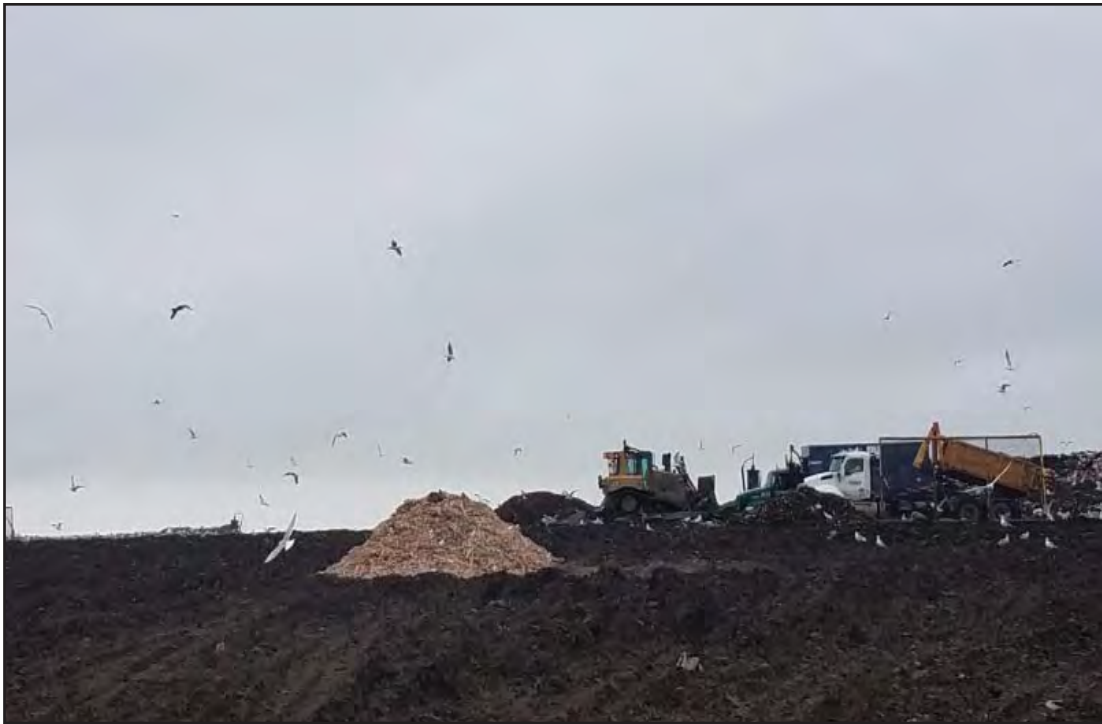
Active area

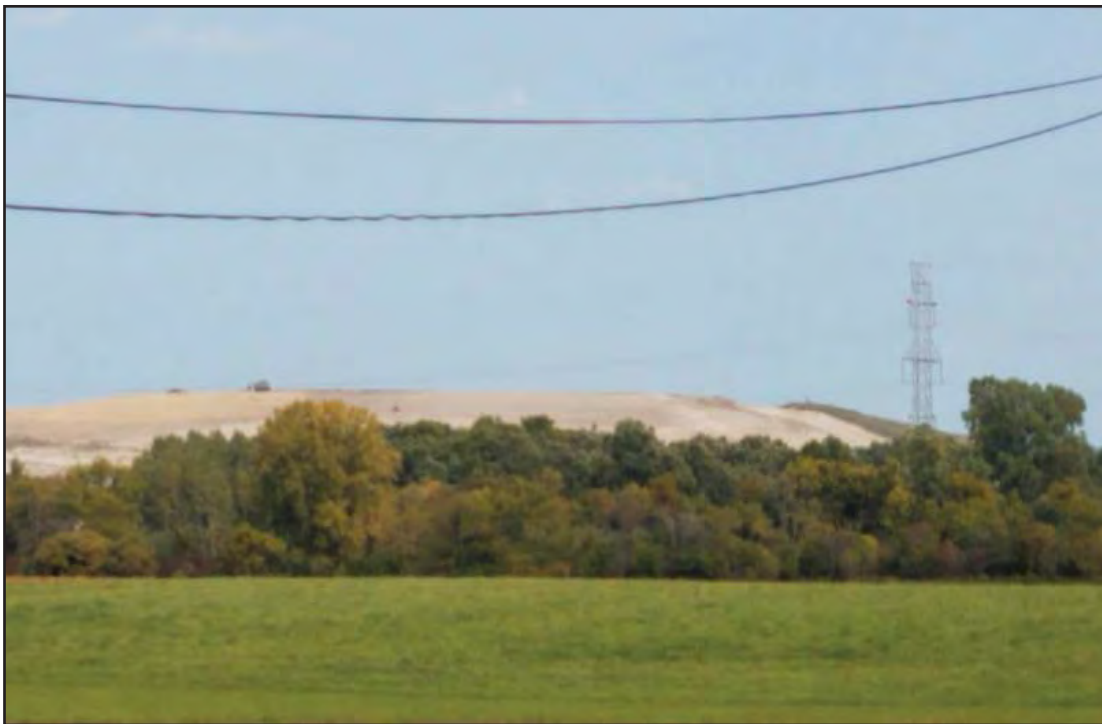
Phase 7 viewed from a distance and the West

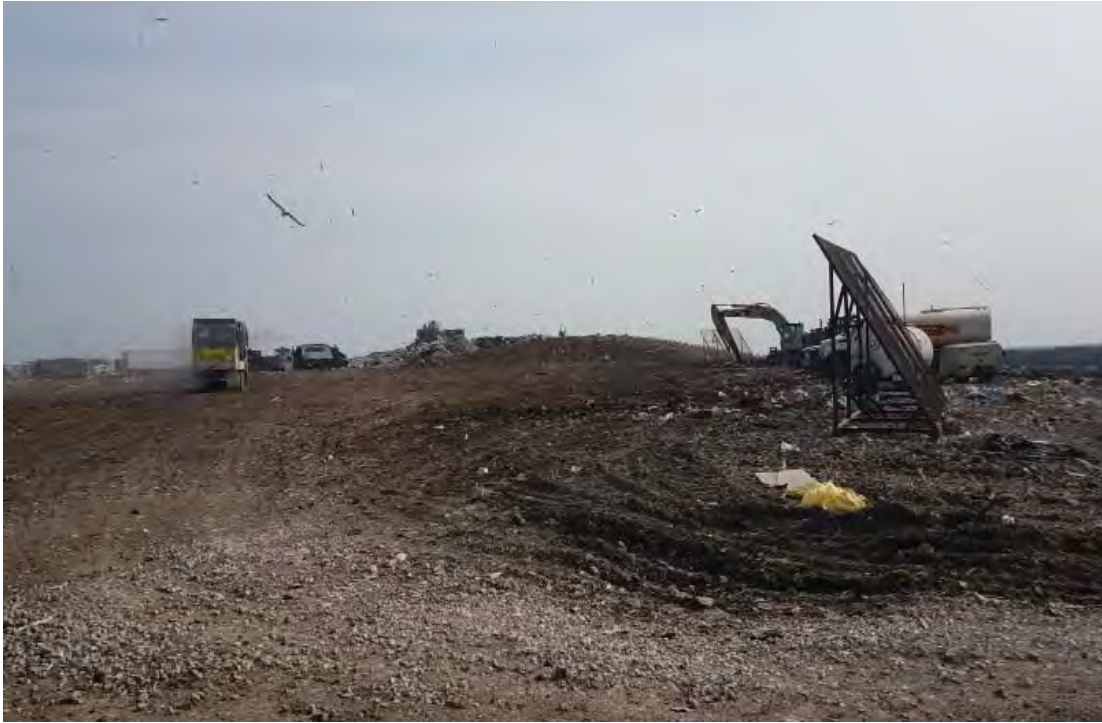
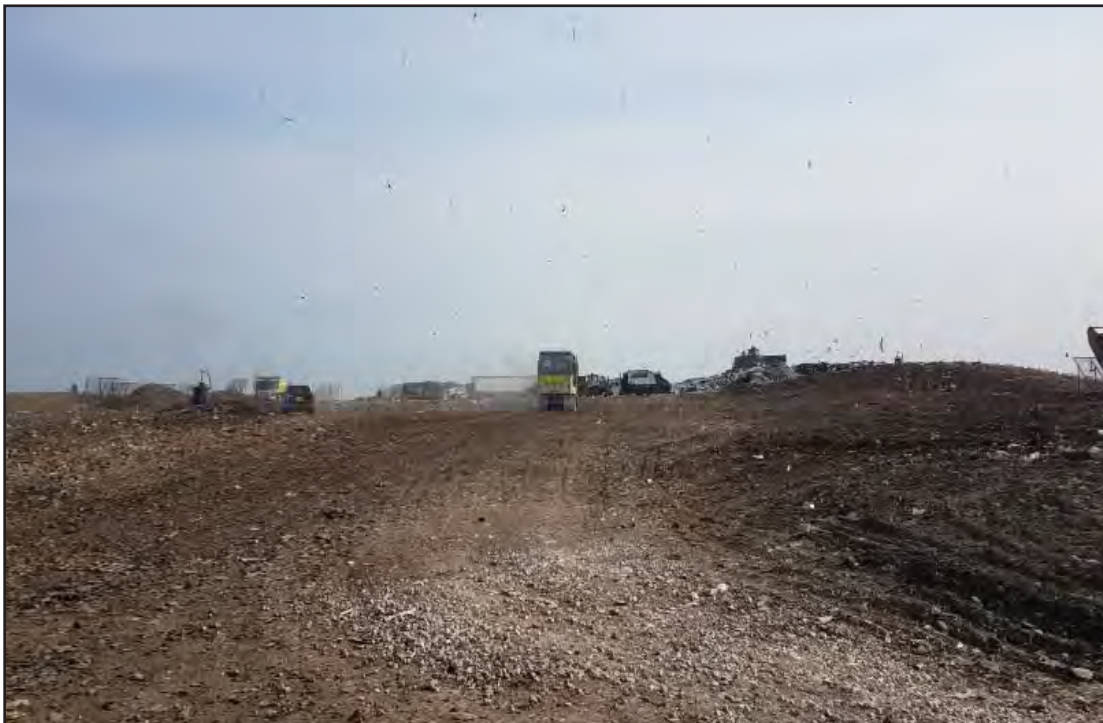
Working face in distance, viewed from North

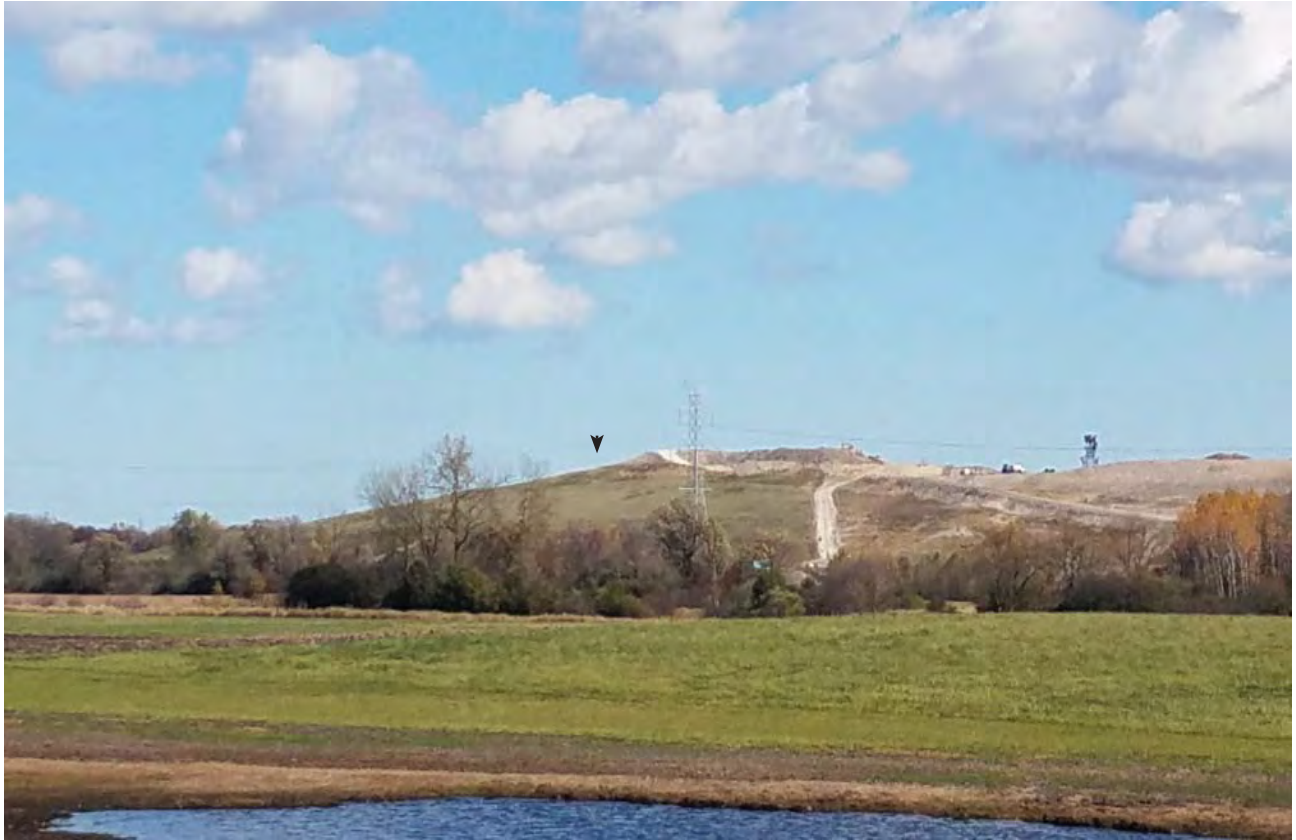
Phase 3, West slope. Erosion from Haul Truck activities.

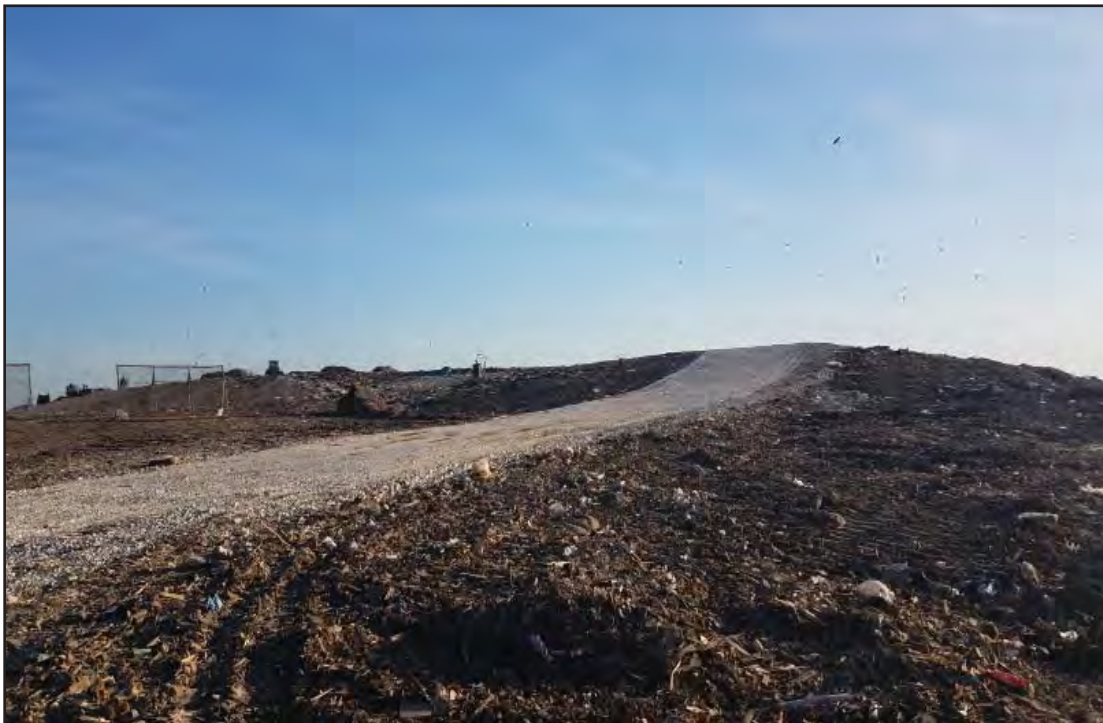
Travelway with stone to improve travel conditions across Phase 7

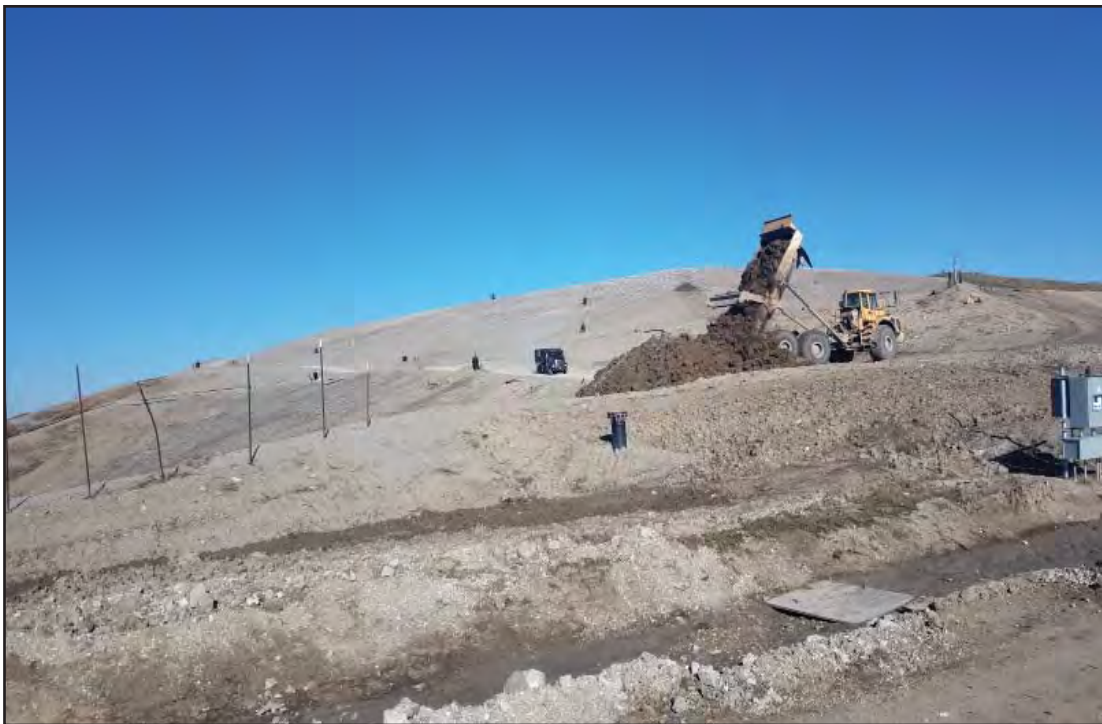
Soils being added to West slope of Phase 7 South to improve intermediate cover

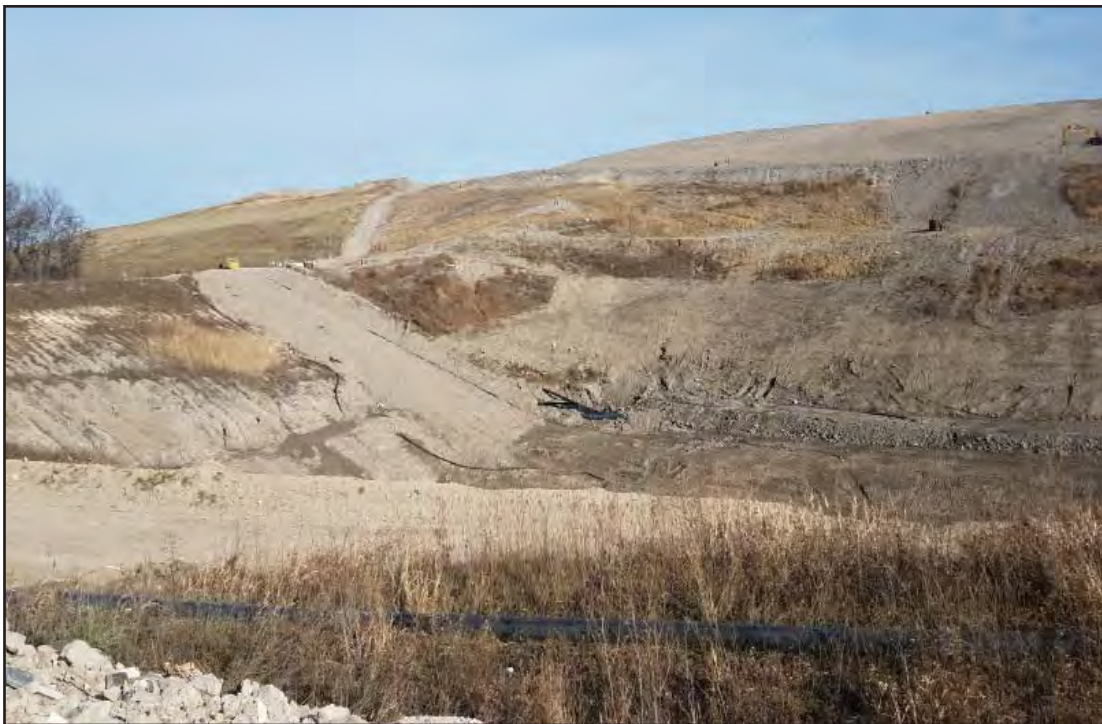
West slope of Phase 7, leachate sideslope riser exposed

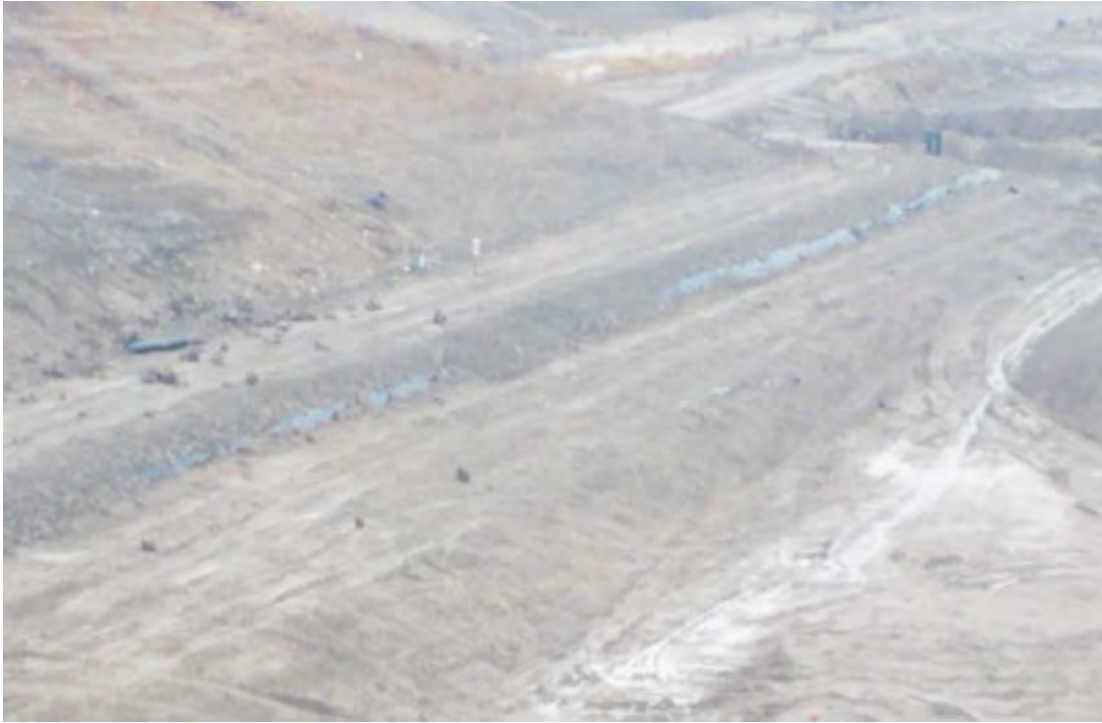
Access road built over rainflap at toe of West slope of Phase 7

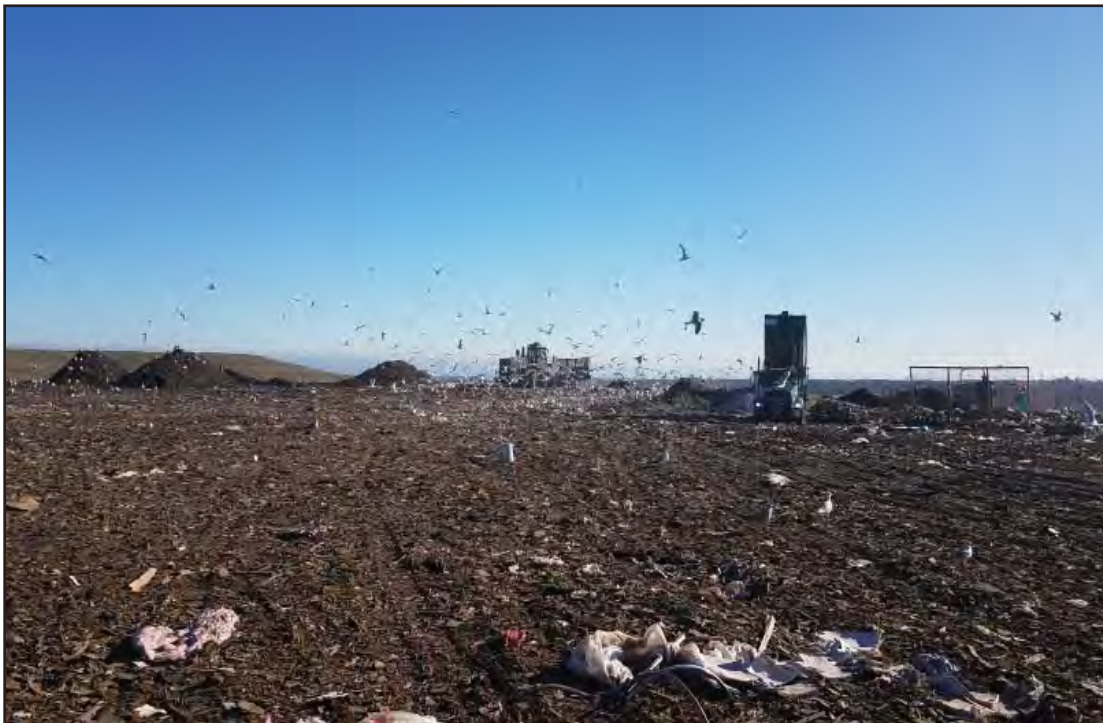
Active area viewed from the West

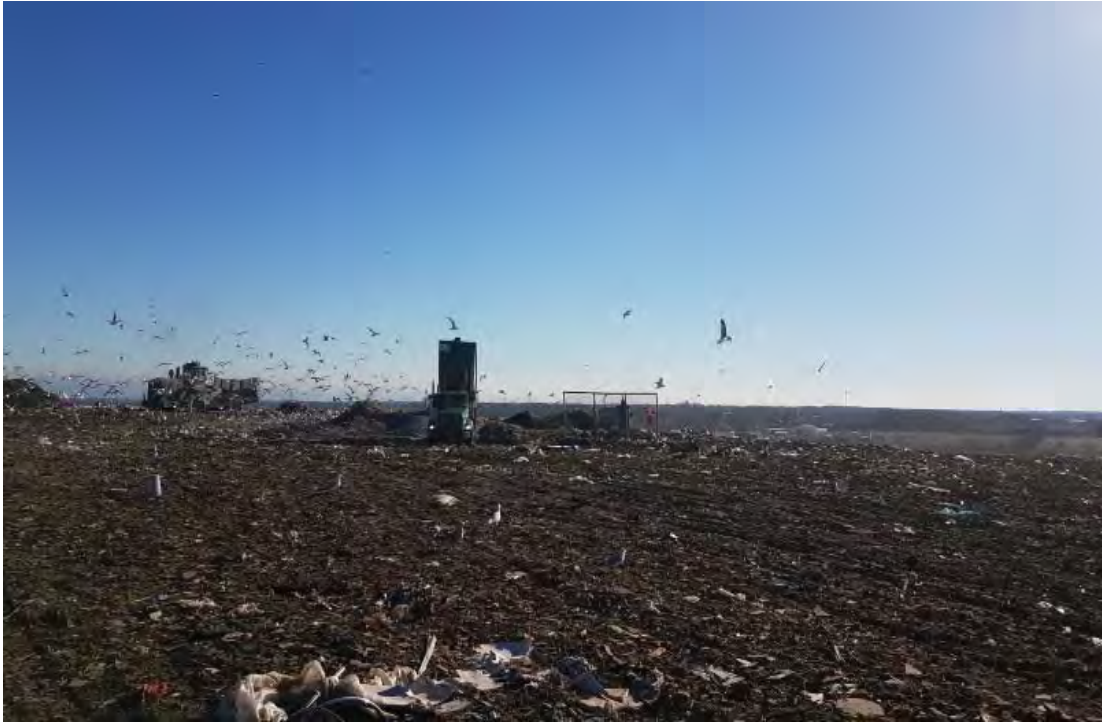
Tipping in Phase 7 South, Southern end

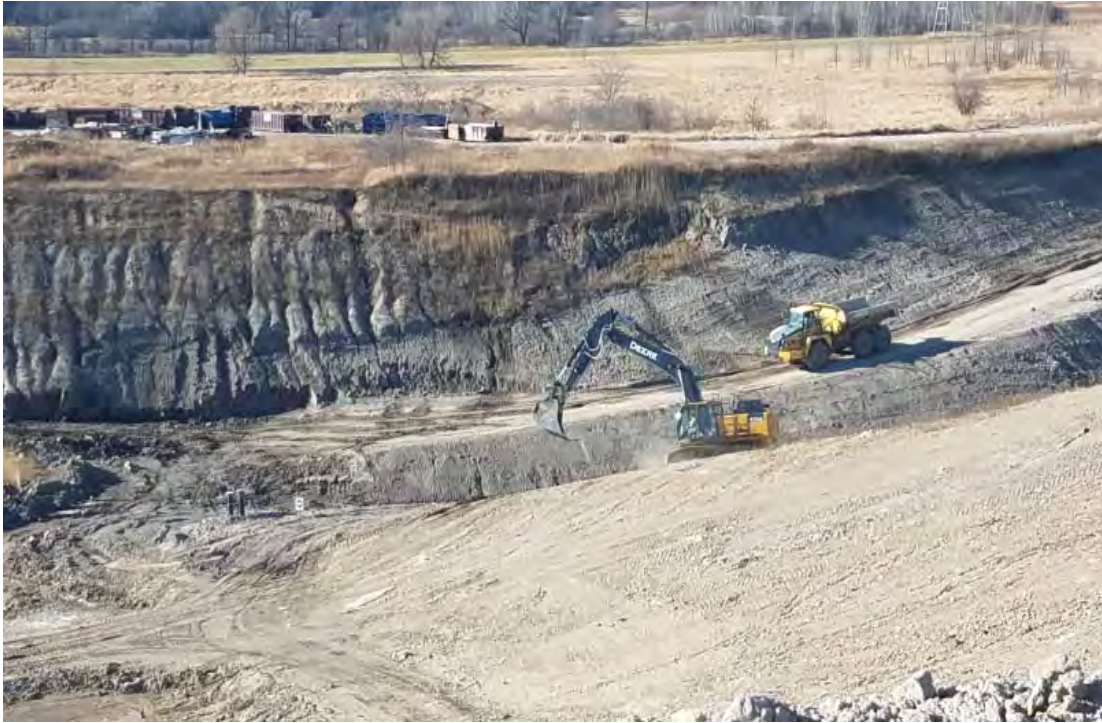
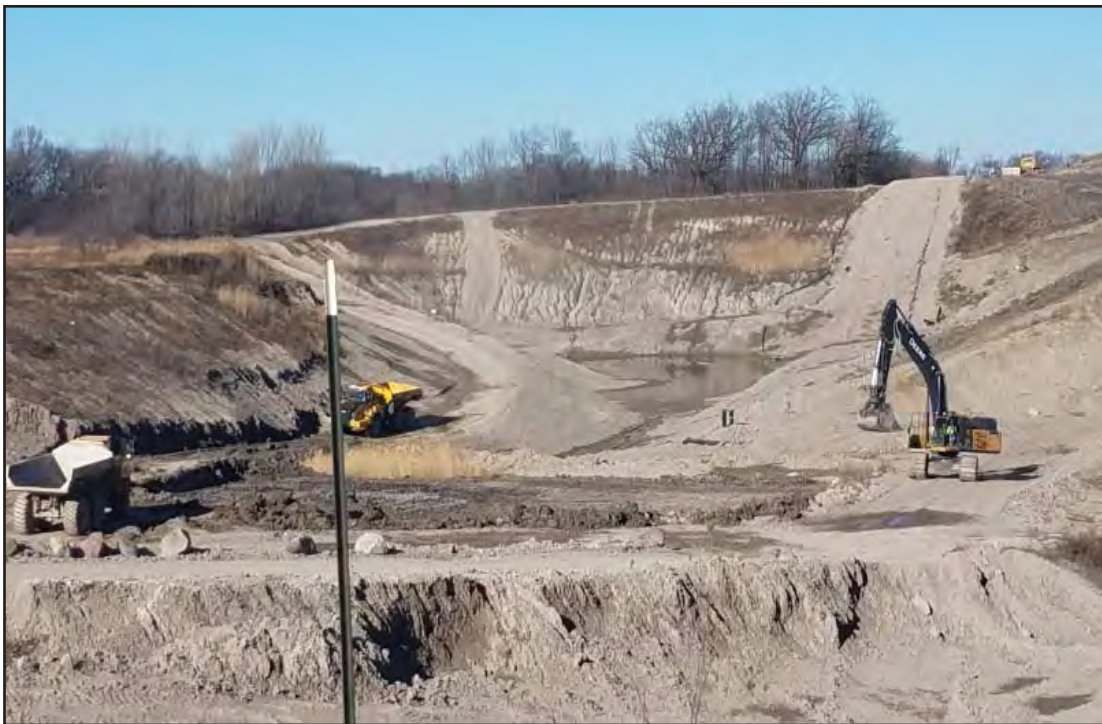
Contractor excavating future Phase 8 to provide material for construction of Phase 7 West slope berm

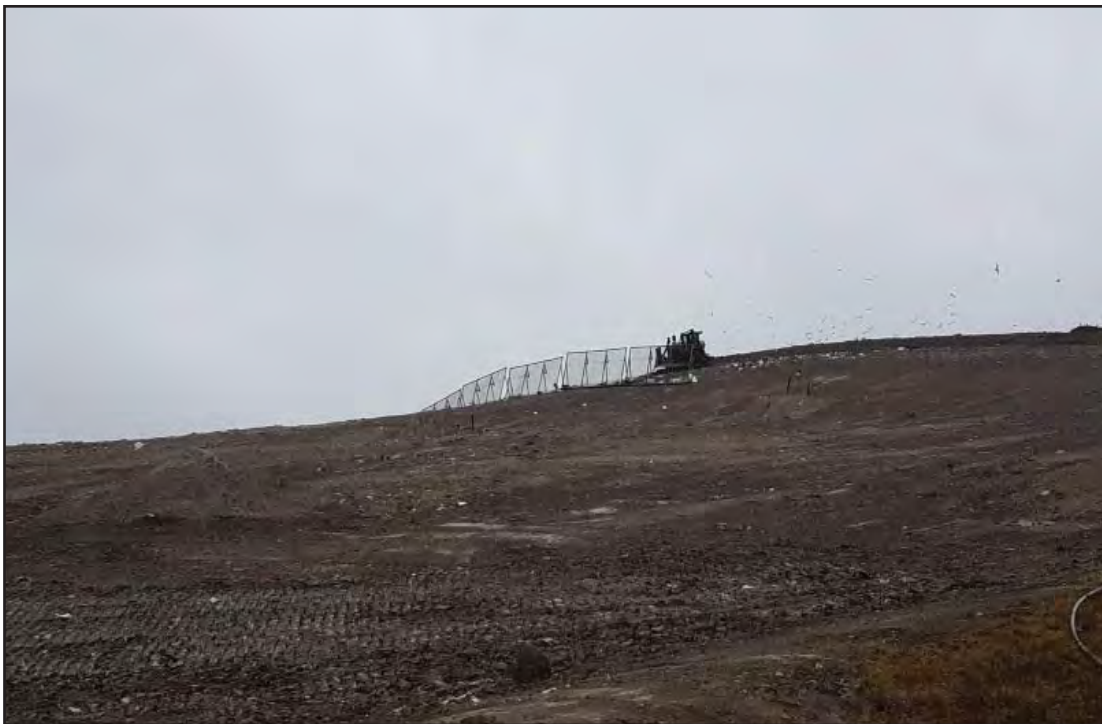
Dozer spreading cover on South top of slope of Phase 7 South

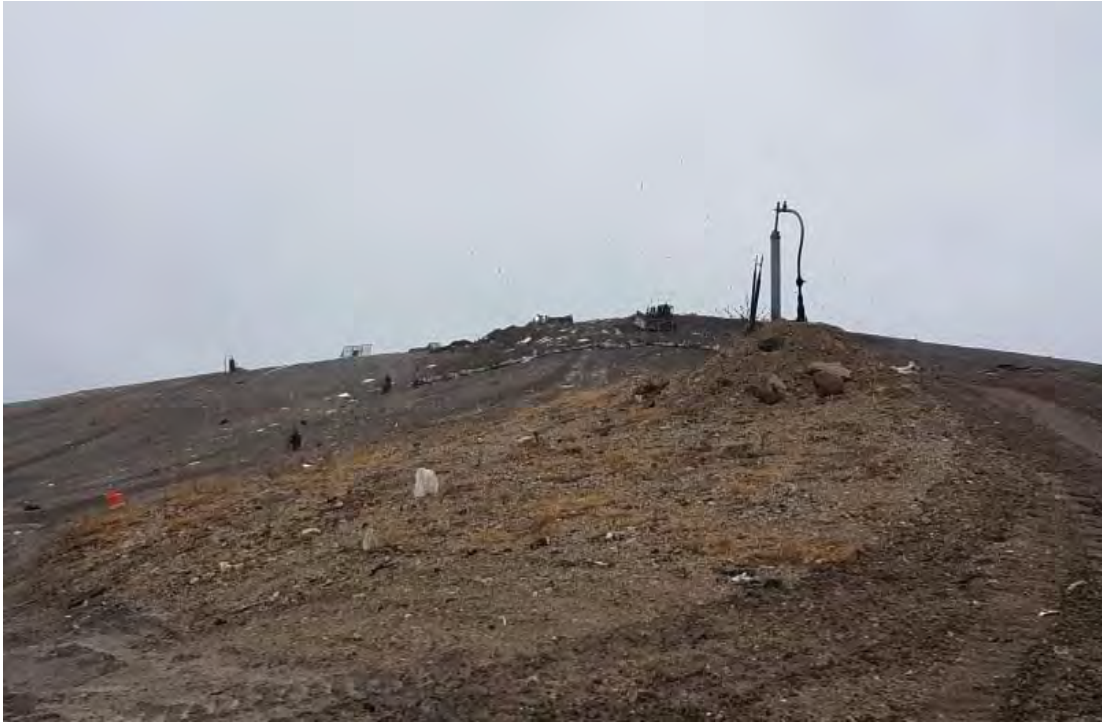
Southeast corner of Phase 7 South

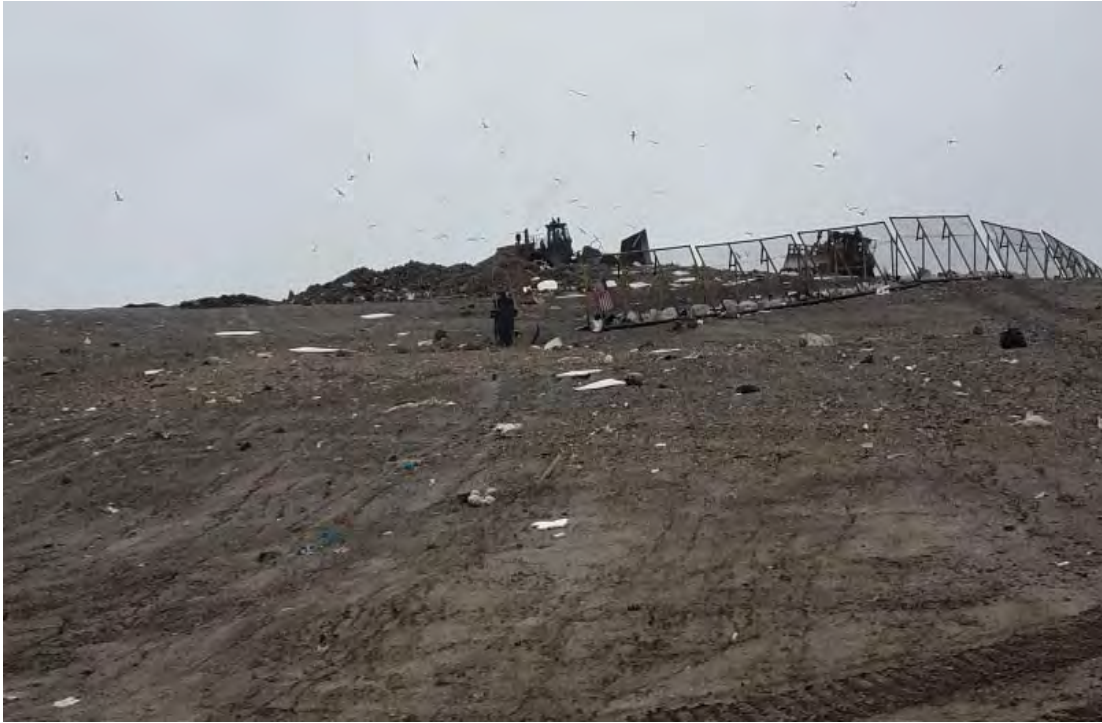
Phase 7 North across to Phase 7 South

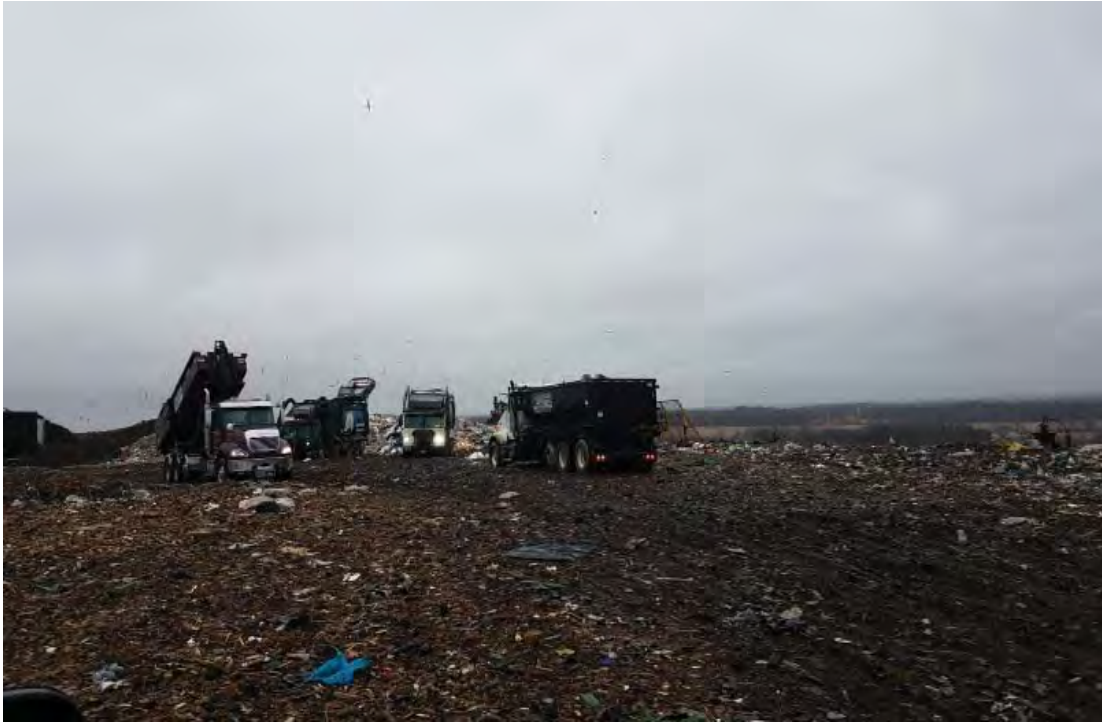
Trucks moving about active area
