2020 Year End Summary of Audits of the Emerald Park Landfill

Prepared For:
City of Muskego
Green For Life Emerald Park Landfill Standing Committee

2020 Green For Life Emerald Park Landfill Year End Compliance Officer Report and Audit Summary

TO: Advanced Disposal Services Emerald Park Standing Committee
FROM: Jo-Walter Spear, Jr., P.E.
COPIES: File
DATE: 03/29/2021
PROJECT NUMBER: 1012.10030

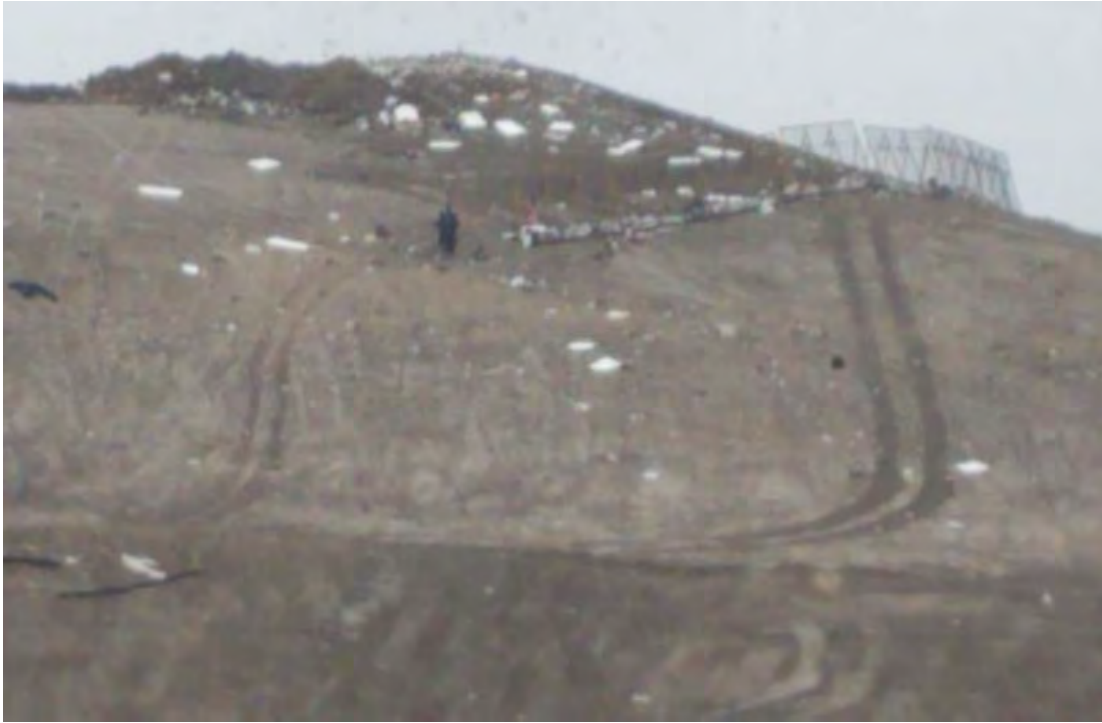
Southeast corner of Phase 7 South, some flagging and litter from previous waste placement

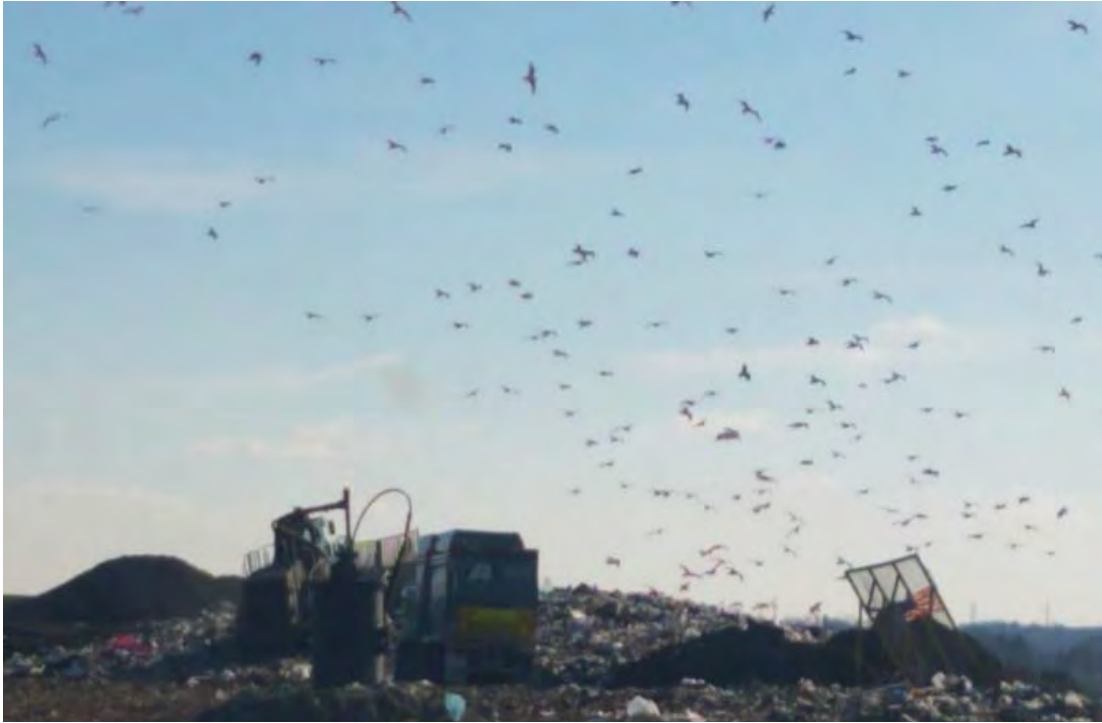
Continuation of lift/berm construction around outer top of slope If Phase 7 to protect inner future working faces
